Volume V

Appendix G.4

Group 1 Matrix Brief on Maintenance, Material, and Management

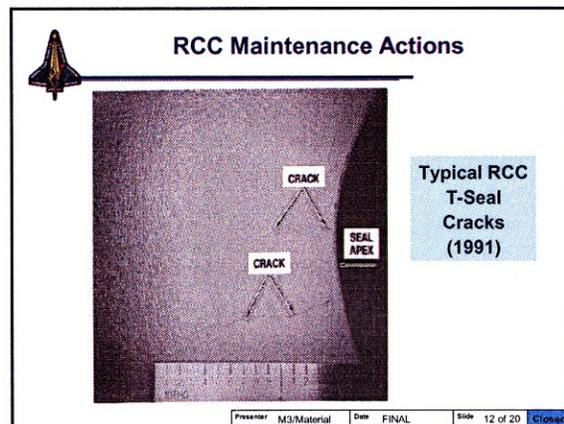
RCC Maintenance Actions

- Background / Facts:**
 - RCC T-Seal Cracking investigation documented in Rockwell Report LTR 4088-2401, November 1991
 - Sectioned OV-104, 17R (worst cracking) and 18R (3rd worst case) for failure analysis
 - No substrate cracks
 - Laminates significantly distorted
 - OV-104 panel 17R had oxidation damage
 - Removed coating from several other T-seals – no substrate cracks found
 - Conclusions from failure analysis (metallurgical, fractography, etc.)
 - Cracks only in SiC layer
 - Cracks due to variations in fabrication lay up process resulting in different laminate distortions

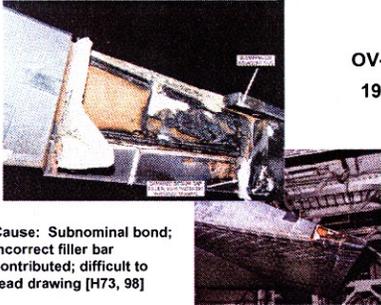
Lost Inboard Elevon Drain Tile

**STS-103
OV-103, Flight #27
19 December 1999**

Cause: Subnominal bond; incorrect filler bar contributed; difficult to read drawing [H73, 98]

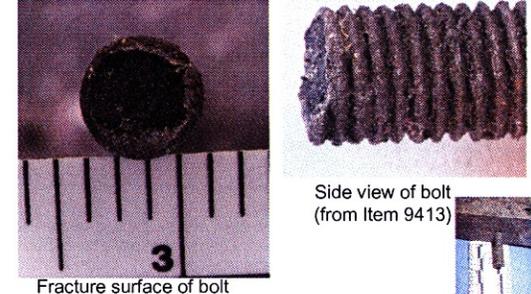
Carrier Panel A-286 Bolt

Fracture surface of bolt (from Item 9413)

Side view of bolt (from Item 9413)

Higher magnification photos of fracture surface of bolt from Item 9413

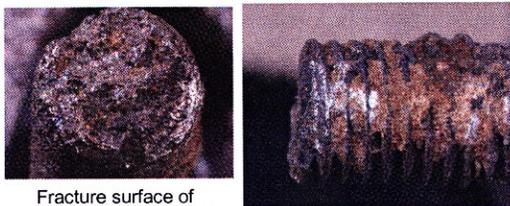
Fracture Surface

Similar features found on bolt from left wing lower spar fitting at panel 17

Fracture surface of bolt from Item 866 Side view of bolt

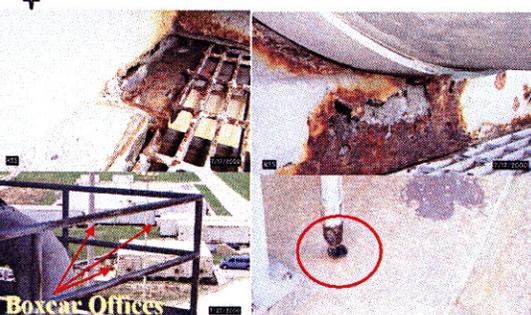
Aging Infrastructure Corrosion/Boxcars at Pad 39A

Boxcar Offices

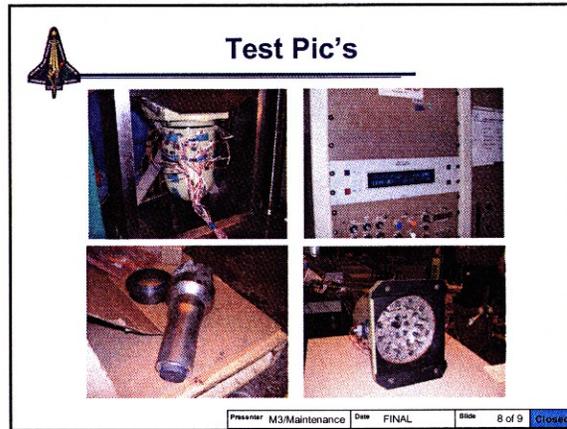
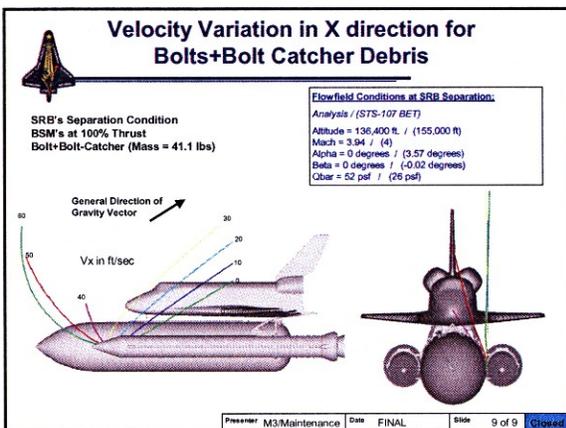
Maintenance
Separation Bolt Certification

- **Action / Issue:** Separation bolts manufactured by Pacific-Scientific were not adequately NDI'd before flight on STS 107
- **Background / Facts:**
 - USA replaced Hi-Shear as the prime contractor for separation bolts in May 2000. Certification of new bolts may have been done without adequate NDI (magnetic particle) of the internal bore
- **Findings:**
 - P-S used Pacific Magnetic and Penetrant for NDI verification
 - PS/PMP used same NDI specifications as Hi-Shear
 - First lot (Lot AAN) used on STS 107 and installed on STS 114
 - All NDI results were approved and certified by PS, USA, and DCMA
 - 2nd lot (AAP) magnetic particle inspection eval'ed by DCMA NDI expert
 - Determined process inadequate WRT analysis of Magnetic Part. Insp.
 - ASTM E 1444-01, par. 5.7.3 stipulates use of a borescope
