Lessons Learned from  
Accidents Involving  
Remotely Piloted and  
Autonomous Aircraft

# Crash Course

Peter W. Merlin

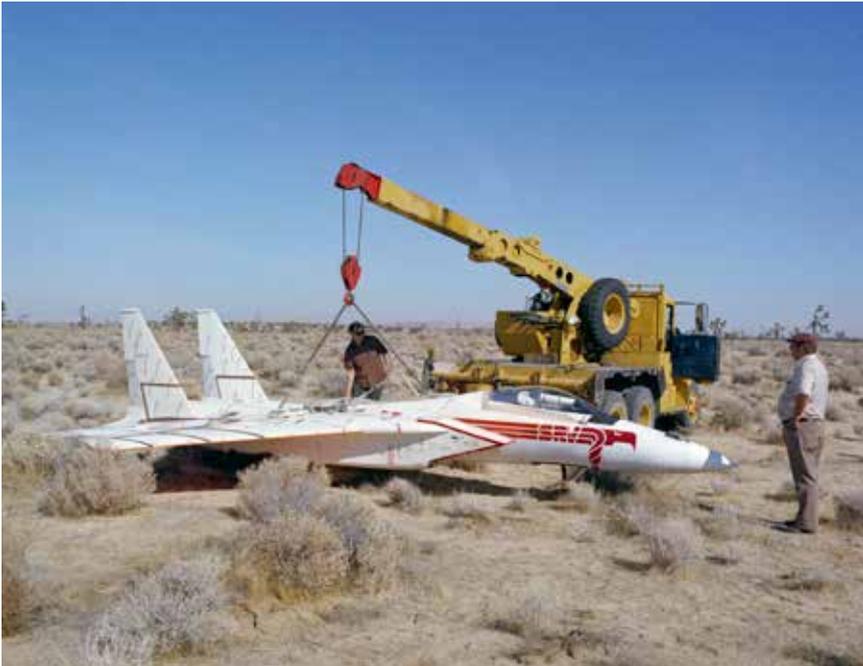
Recovery personnel prepare to lift the F-15 SRV off the Edwards Air Force Base PIRA after the vehicle's spin chute became entangled with the pitot tube. NASA

When flights resumed on February 18, 1981, the new nose parachute caught on the airplane's pitot tube after deployment. Einar Enevoldson guided the vehicle to a landing on the Edwards PIRA with only minor damage. No further problems were encountered during the remaining flights.<sup>25</sup>

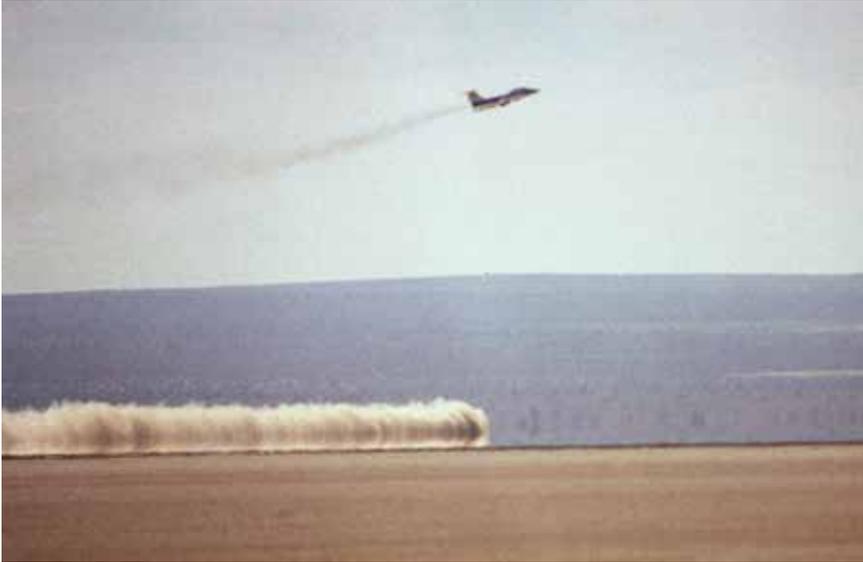
Observers aboard the TF-104G chase plane watch as the HiMAT slides across the dry lakebed on its belly. NASA

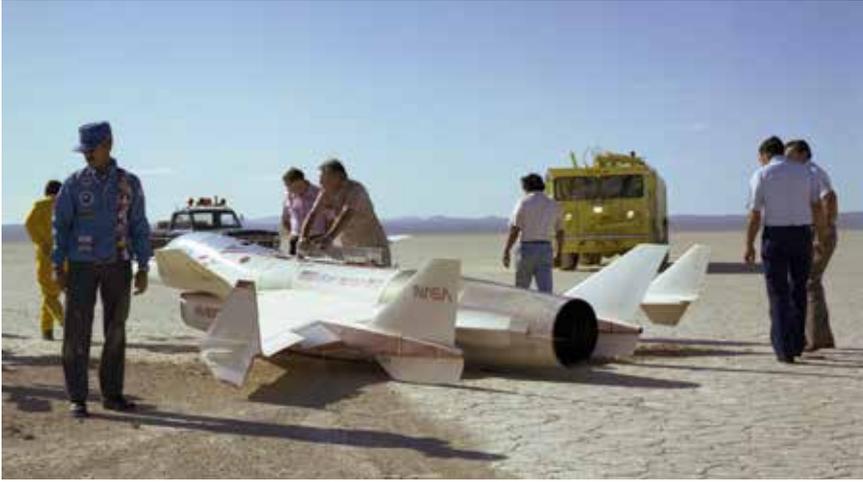
Investigators examine the HiMAT following its belly landing. Fortunately, damage was not extensive. NASA

The HiMAT PCS failure was caused by a mechanical malfunction. The landing gear malfunction stemmed from a software issue.

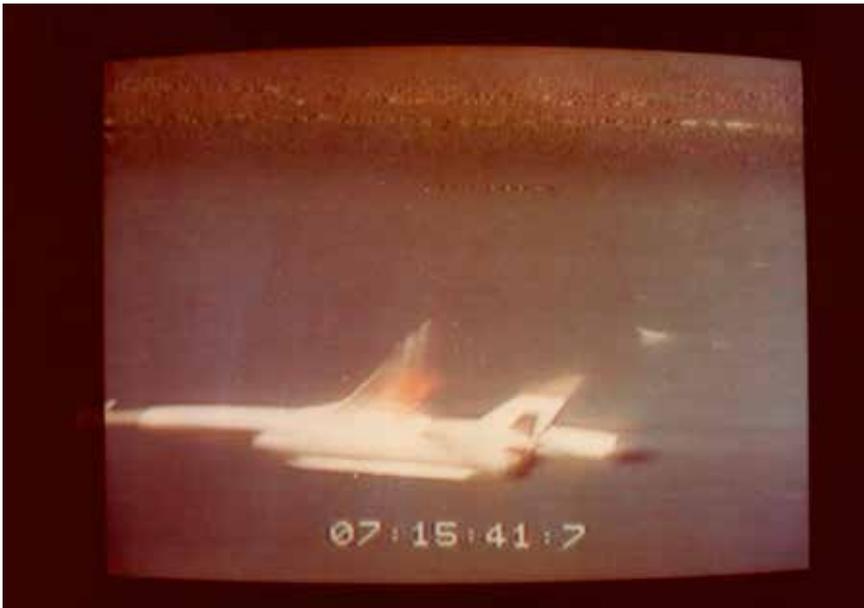
The DAST-1 experienced explosive flutter at Mach 0.825, leading to catastrophic failure of the right wing. NASA

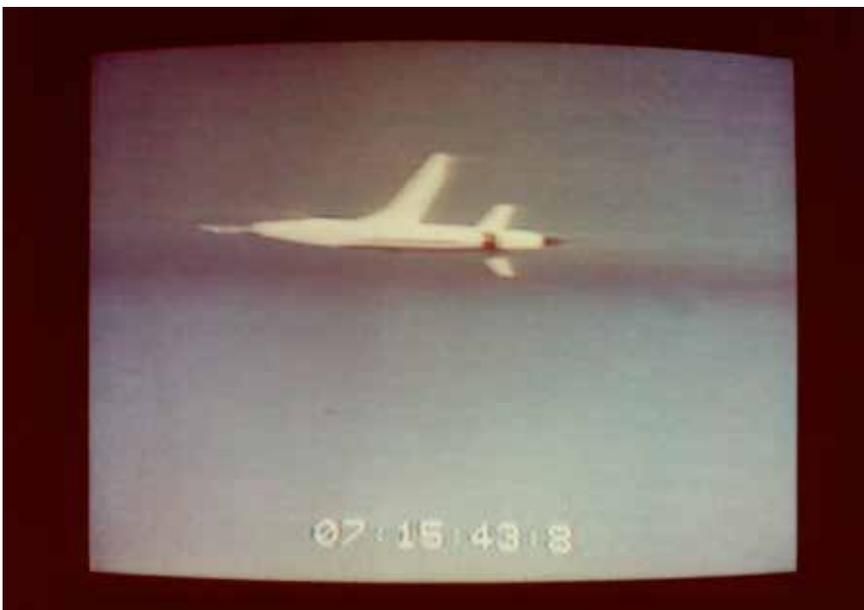
With only one remaining wing, the DAST-1 plummeted toward the ground. NASA

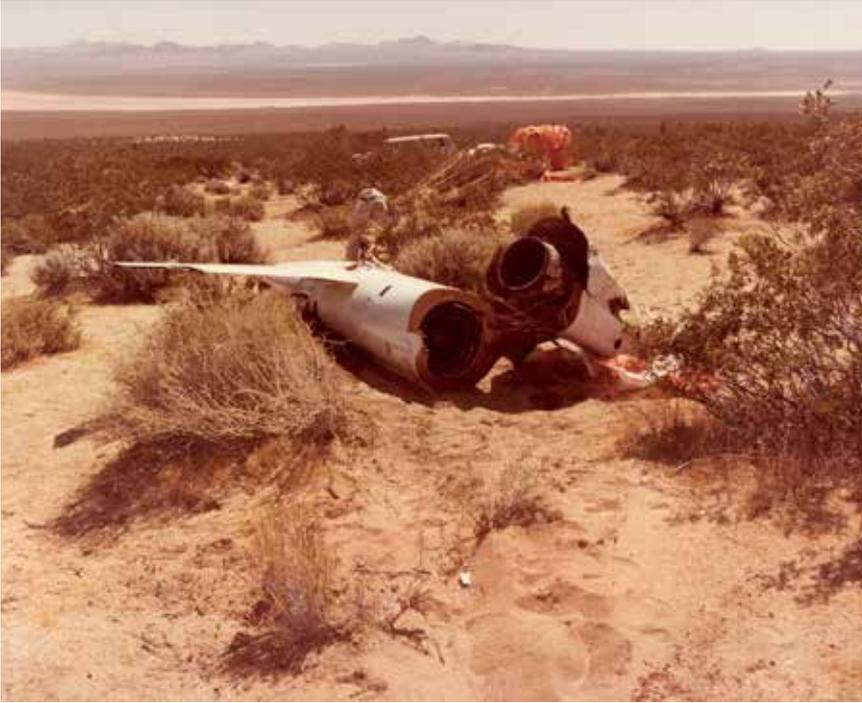
Because high-speed deployment conditions prevented full inflation of the main-parachute canopy, the DAST-1 was badly damaged when it struck the ground. NASA

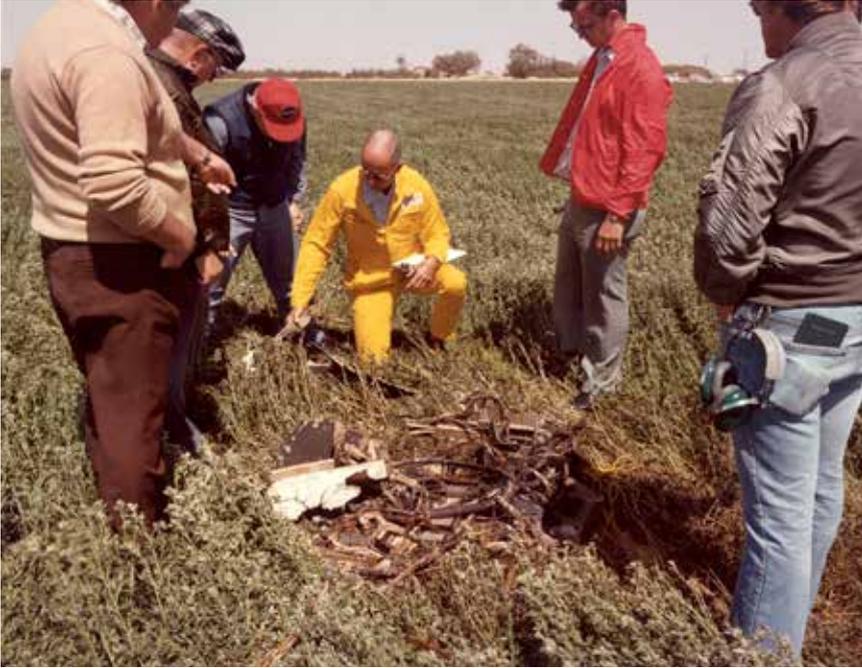
Investigators examine the DAST-2 wreckage at the crash site. The primary cause was traced to an electrical problem. NASA

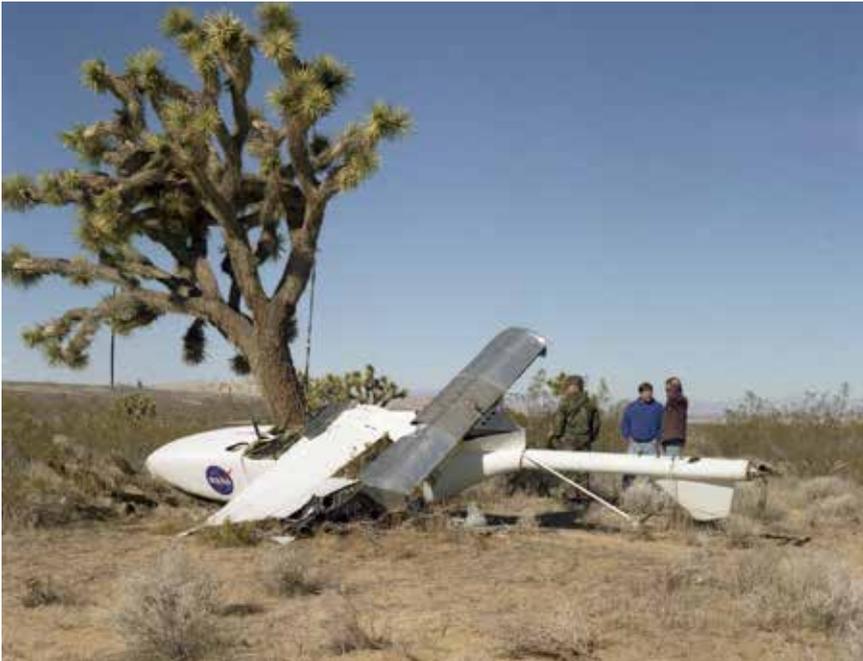
Members of the recovery crew examine the Perseus-A on the Edwards PIRA. NASA

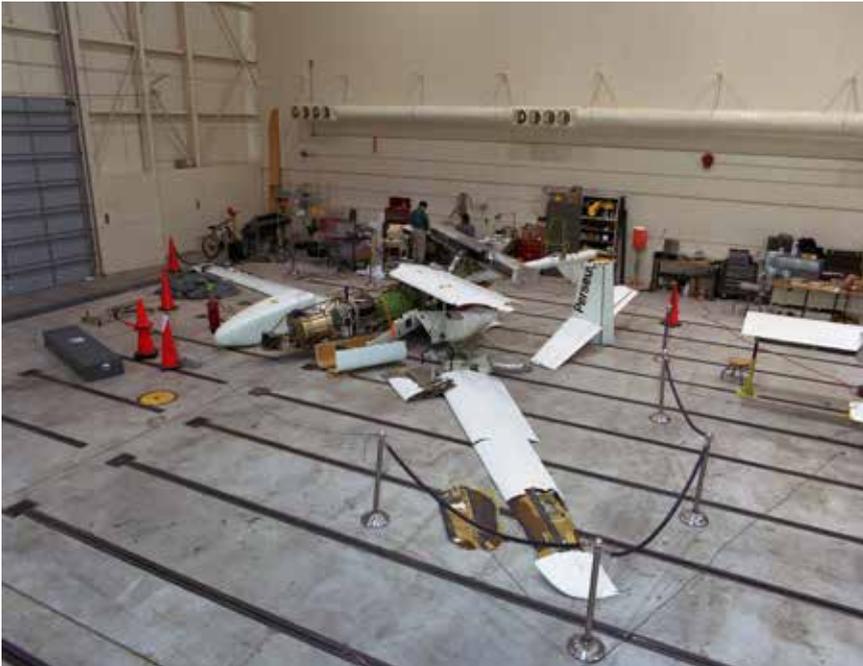
Investigators recommended that the Perseus vehicles not be flown again until the vertical gyro failure was resolved. NASA

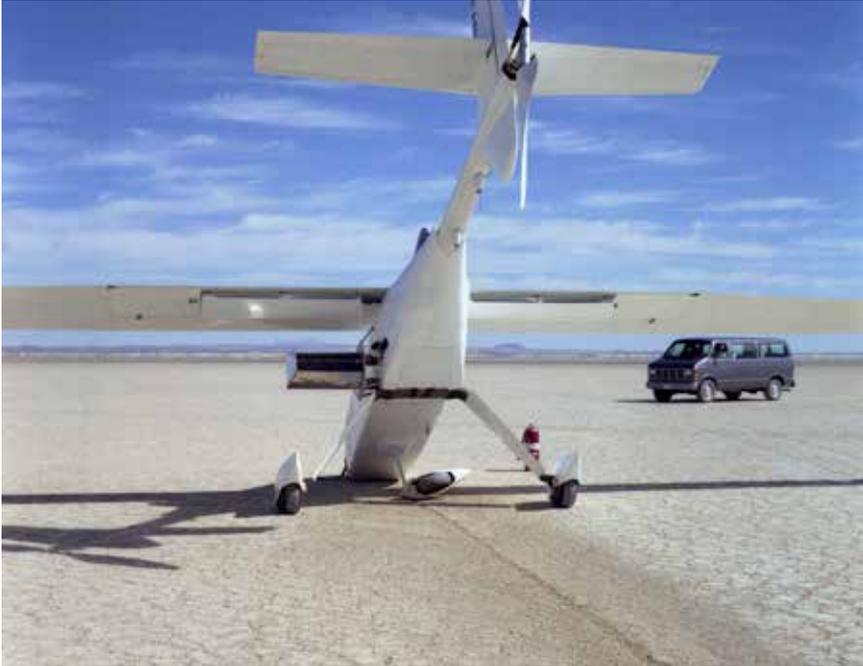
Nose-gear collapse following the maiden flight of Perseus-B damaged the vehicle's composite nose assembly. NASA

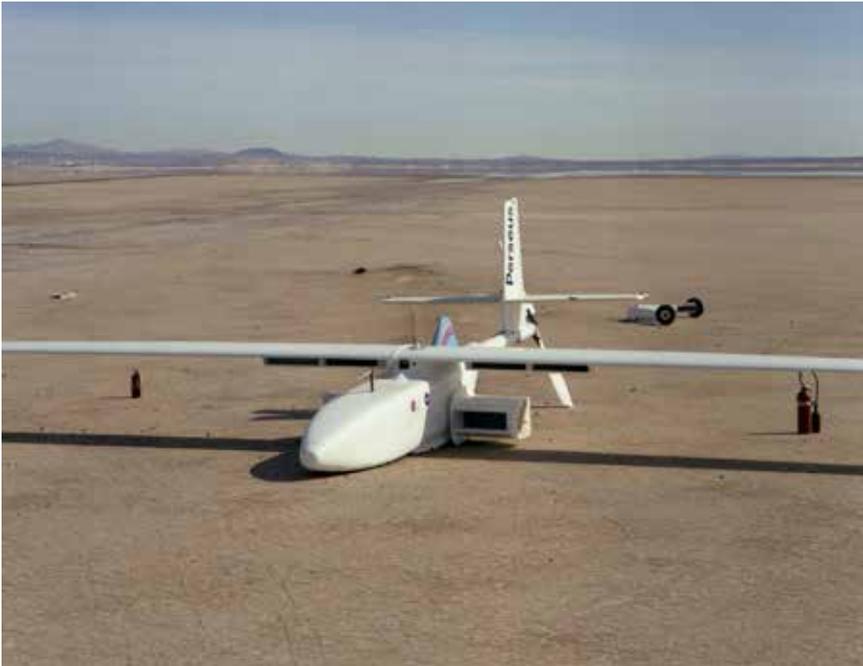
During a 1996 flight, a hard touchdown on the lakebed resulted in major damage to the landing gear, nose, and propeller tips. NASA

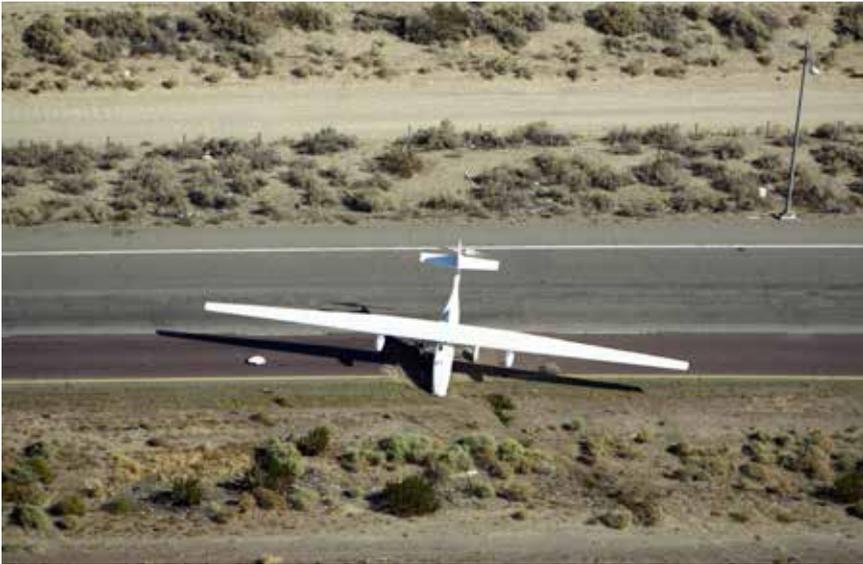
Failure of the flight-termination system led to an unplanned landing of Perseus-B on a major highway. NASA

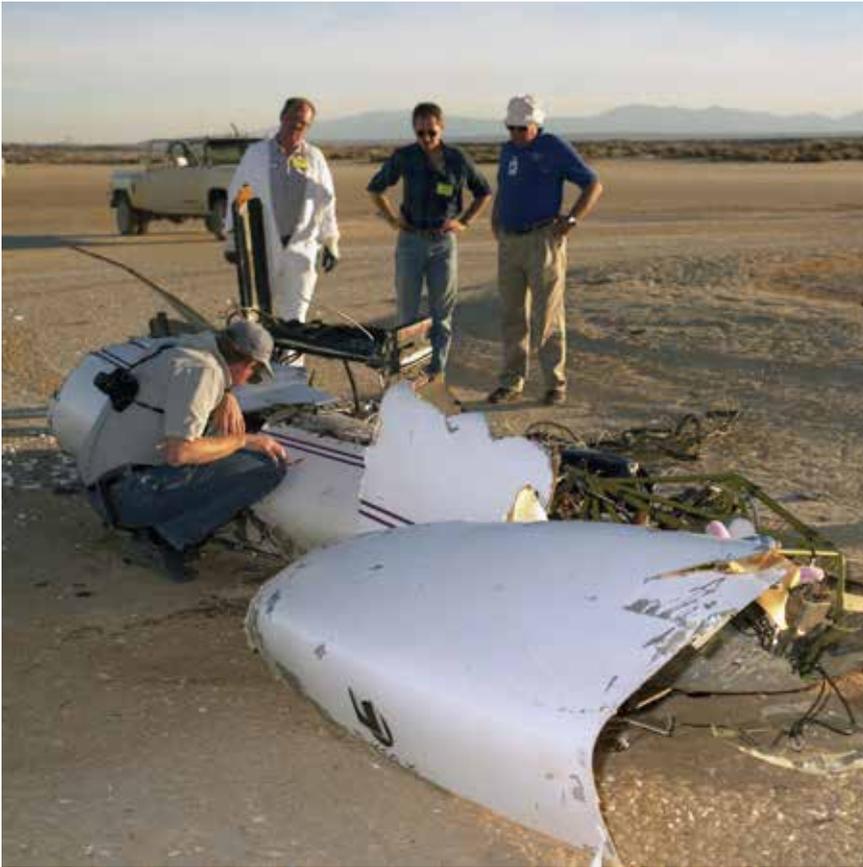
Investigators examine Theseus wreckage at the crash site near the north end of Rogers Dry Lake, within the boundaries of Edwards Air Force Base. NASA

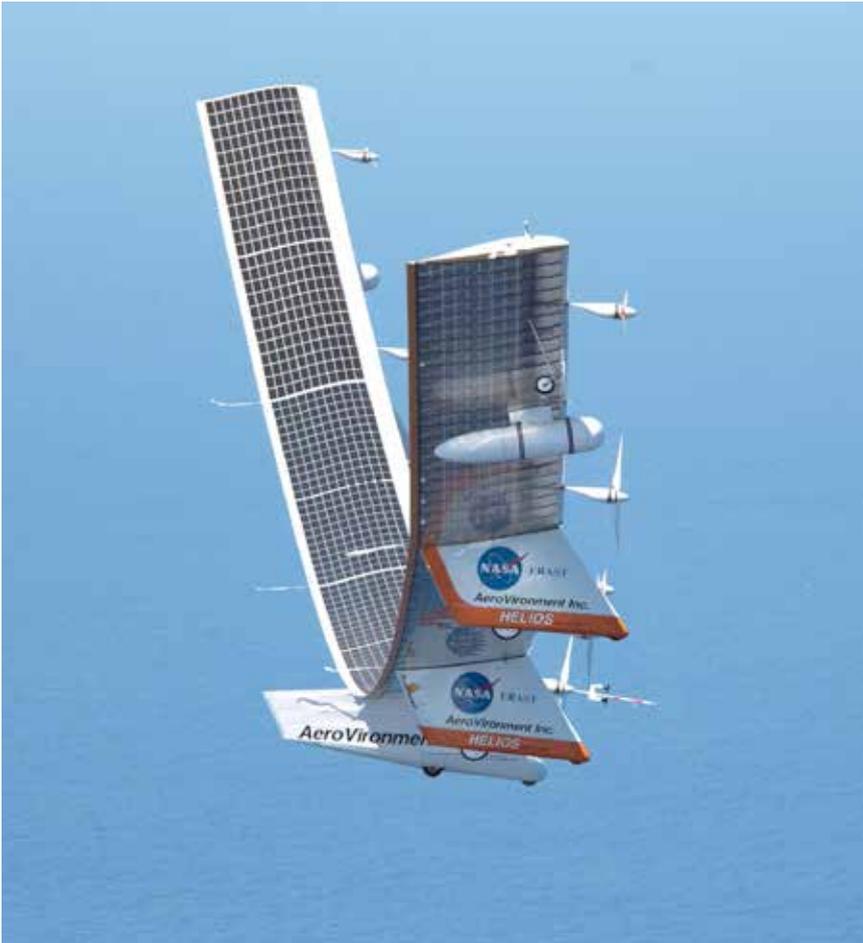
During a flight with excessively turbulent conditions, the Helios Prototype's wing structure experienced extreme dihedral. NASA

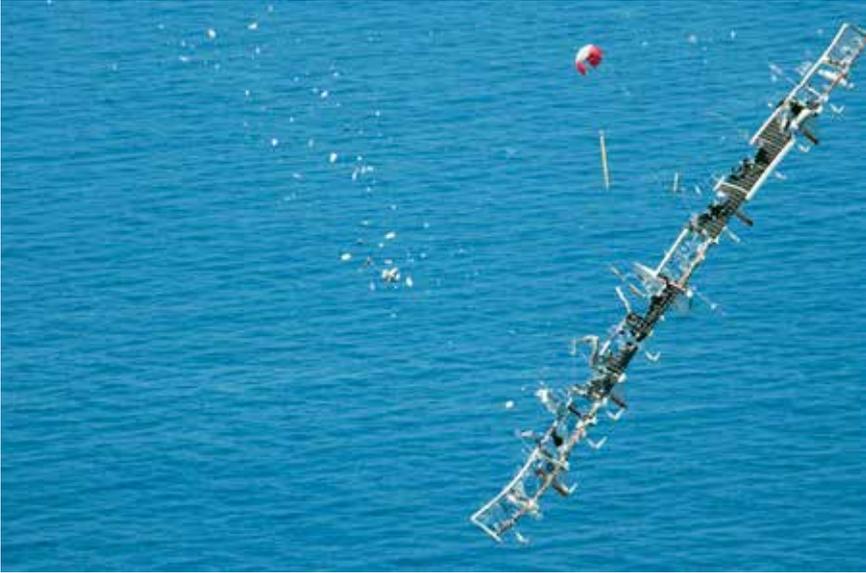
The Helios Prototype sheds parts as it plummets toward the ocean. The FTS worked exactly as designed. NASA

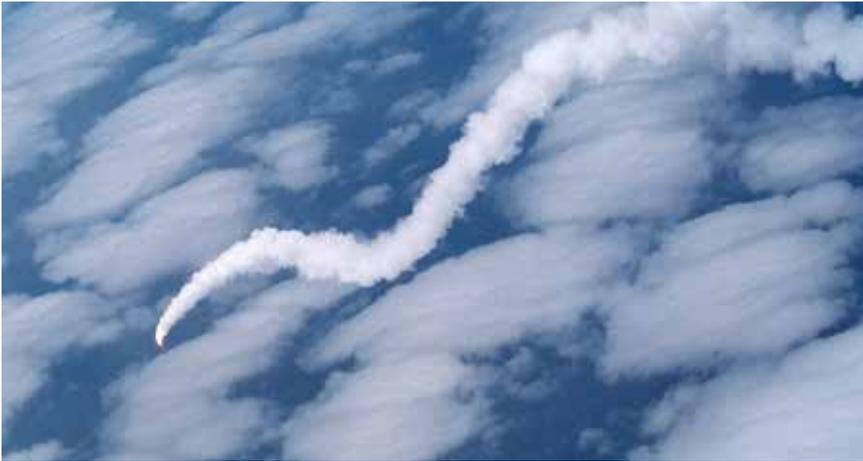
Divergent roll oscillatory motion caused by excessive control-system gain resulted from inadequate analytical modeling that allowed engineers to overestimate system safety margins. NASA

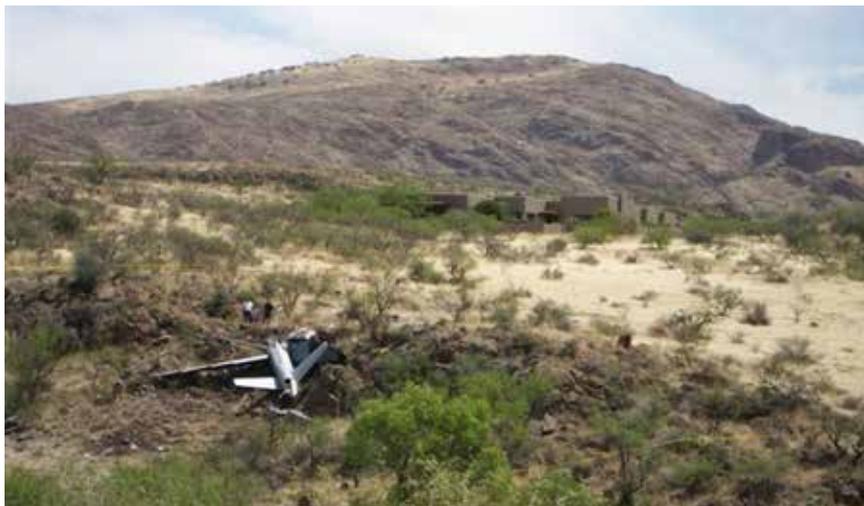
The MQ-9 crashed in a sparsely populated residential area, but there were no injuries or damage to private property. Mae Duggin
