NASA Independent Review Team
SpaceX CRS-7 Accident Investigation Report
Public Summary

Date of Event: June 28th, 2015

Date of Report: March 12th, 2018

Public Summary

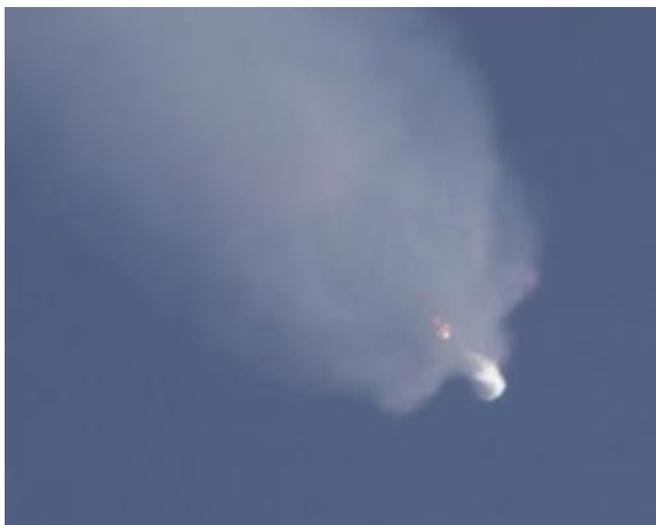
Time (UTC)	Event
14:23:31.062	Gas first seen to exit the second stage
14:23:32.083	Combustion event seen in area of the second stage
14:23:33.759	First view of Dragon separated from Falcon
14:23:38.288	Large combustion event and gas cloud
14:23:39.256	Thrust termination on first stage
14:23:39.339	Beginning of complete vehicle breakup

Figure 2. Gaseous Cloud from the Falcon 9 Universal Camera Site (UCS)-27 Tracking Camera

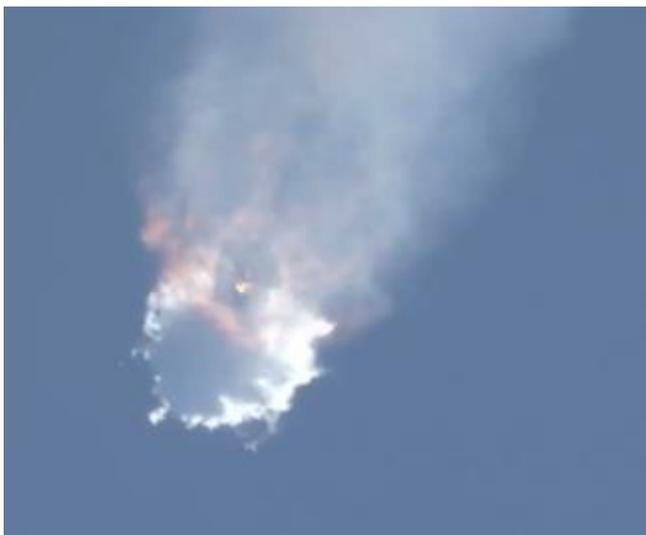
The SpX CRS-7 mission consisted of a SpaceX Falcon 9 version 1.1 launch vehicle and a Dragon spacecraft loaded with 4303 lbs (1952 kgs) of cargo. At approximately 139 seconds into flight, the launch vehicle experienced an anomalous event in the upper stage liquid oxygen (LOx) tank, resulting in the loss of the mission. The first stage of the vehicle, including all nine Merlin 1D engines, operated nominally. The Dragon spacecraft also indicated no anomalous behavior prior to the mishap, and survived the second stage event, continuing to communicate with ground controllers until it dropped below the horizon. Figure 2 shows a gaseous cloud emanating from the launch vehicle. Figure 3 shows the disintegration of the launch vehicle. Table 1 identifies the events seen on the video.

Figure 3. Falcon 9 Disintegration During Ascent UCS-7 Tracking Camera

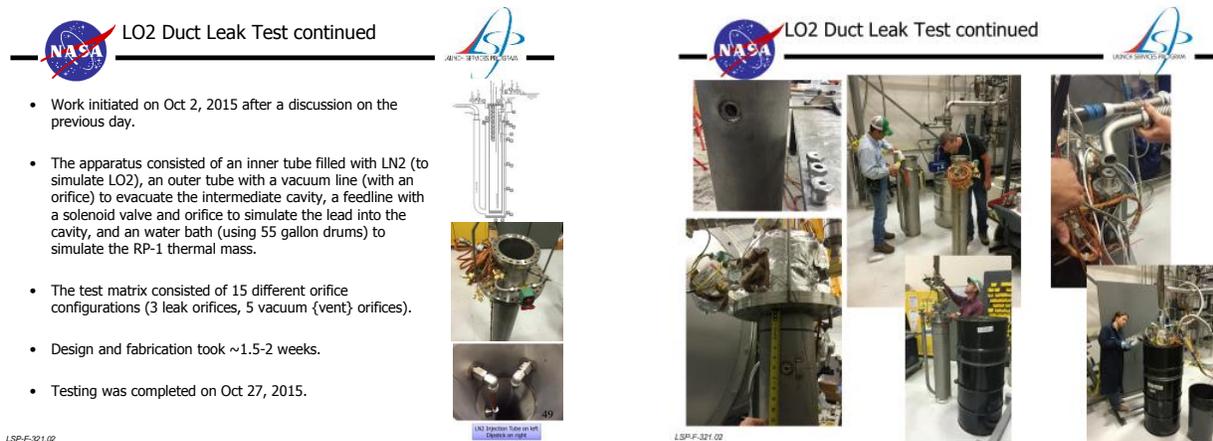
In addition to the independent review of the flight data, the independent review of the Falcon 9 systems and the independent review of the SpaceX AIT developed primary failure scenario, the NASA LSP IRT also developed and investigated multiple additional potential scenarios that could also explain some of the telemetry indications. This resulted in identifying two main alternative scenarios, each of which could have been the precipitating event in place of, or in addition to the “liberated COPV” scenario. A brief description of the two main alternative scenarios is that a leak could have occurred into the annulus of the LOx Transfer Tube that runs from the Stage 2 LOx tank down through the Stage 2 Rocket Propellant-1 (RP-1) tank and into the Stage 2 engine. Alternative Scenario #1 assumed “warm” RP-1 would leak into the annulus of the LOx Transfer Tube, and would warm the LOx, causing it to spew or “geyser”. However, thermal analysis quickly determined that insufficient thermal energy would be transferred from the RP-1 (that could have leaked into the annulus) to the LOx in the LOx transfer tube. While that alternative was proven non-credible analytically, a second similar alternative required detailed testing to prove or disprove the potential for occurrence. Initial modeling and analysis indicated that, if instead of RP-1 leaking into the annulus of the LOx Transfer Tube, LOx had leaked into the annulus, there might be sufficient thermal energy transferred from the RP-1 surrounding the LOx Transfer Tube to initiate LOx gasification, and eventual geysering. This became Alternative Scenario #2. Rapid actions were initiated using resources at Marshall Space Flight Center to construct a test chamber and conduct testing to validate thermal energy transfer assumptions that were being used in the models for this scenario development. (See Figure 4.) After a two-week run of tests, the IRT was able to determine that there was greater thermal energy transfer in Alternative Scenario #2, but still insufficient thermal energy to initiate a geysering occurrence within the total 800-900 millisecond time span of the failure event.

Figure 4. Alternate Scenario #2 Testing

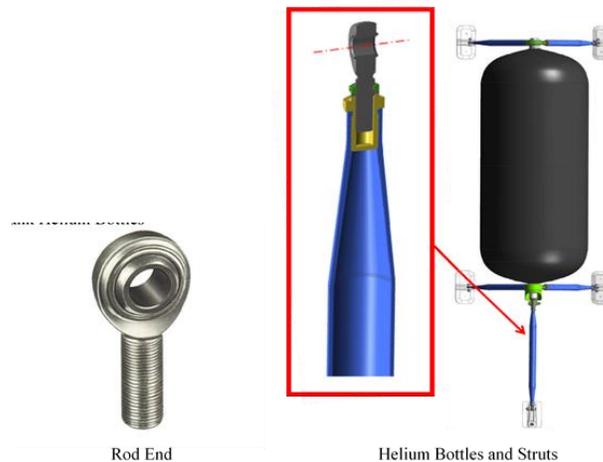
- It is credible the *initiating* cause was the failure of the axial strut supporting a COPV, which in turn liberated the aforementioned COPV, and which in turn ruptured the gaseous helium (GHe) plumbing system within the Stage 2 LOx tank.
- It is credible, that the COPV became liberated when a threaded cast stainless steel eye bolt (AKA: “rod end”, see Figure 5) of the COPV’s axial support strut broke under ascent loads, allowing the COPV to break free from its mounts, allowing it to accelerate, due to its buoyancy, to impact the LOx dome at the top of the LOx tank with great force.

Figure 5. Liquid Oxygen Tank Helium Bottle, Struts & Rod End

Technical Findings	
TF-1	Design Error: The use of an industrial grade 17-4 PH SS (precipitation-hardening stainless steel) casting in a critical load path under cryogenic conditions and flight environments, without additional part screening, and without regard to manufacturer recommendations for a 4:1 factor of safety, represents a design error – directly related to the F9-020 CRS-7 launch failure as a “credible” cause.
TF-2	General Finding: The use of commercially procured wire ropes to provide structural support to the LOx Transfer Tube Assembly, without regard for manufacturer’s caution to specify pre-stretched ropes in a length-critical application, is a general finding – not directly related to the F9-020 CRS-7 launch failure.
TF-3	General Finding: The use of a 0.01 standard cubic feet per minute (scfm) gaseous Nitrogen (GN2) flow rate to purge the LOx Transfer Tube Assembly annulus was a general finding – not directly related to the F9-020 CRS-7 launch failure.

Technical Recommendation		Finding(s) Addressed by Recommendation
TR-1	Additional attention warranted for evaluating design application using commercially sourced parts. SpaceX should apply particular emphasis to understanding manufacturer’s recommendations for using commercially sourced parts in flight critical applications.	TF-1, & TF-2
TR-2	SpaceX needs to establish and maintain the proper purge rates for stage testing and launch base operations.	TF-3
TR-3	SpaceX needs to re-think new telemetry architecture and greatly improve their telemetry implementation documentation.	TF-4
