RELEASE : 10-269

NASA Releases Report About Australia Balloon Mishap

The Nuclear Compton Telescope Balloon Launch Mishap Investigation Board was established on May 12, 2010, in accordance with NPR 8621.1, "NASA Procedural Requirements for Mishap and Close Call Reporting, Investigating, and Recordkeeping." The Investigating Authority was appointed to obtain and analyze evidence and facts; conduct necessary testing; impound property, equipment, and records; identify the causal and contributing factors relating to the mishap; and to recommend appropriate actions to prevent a similar mishap from recurring.

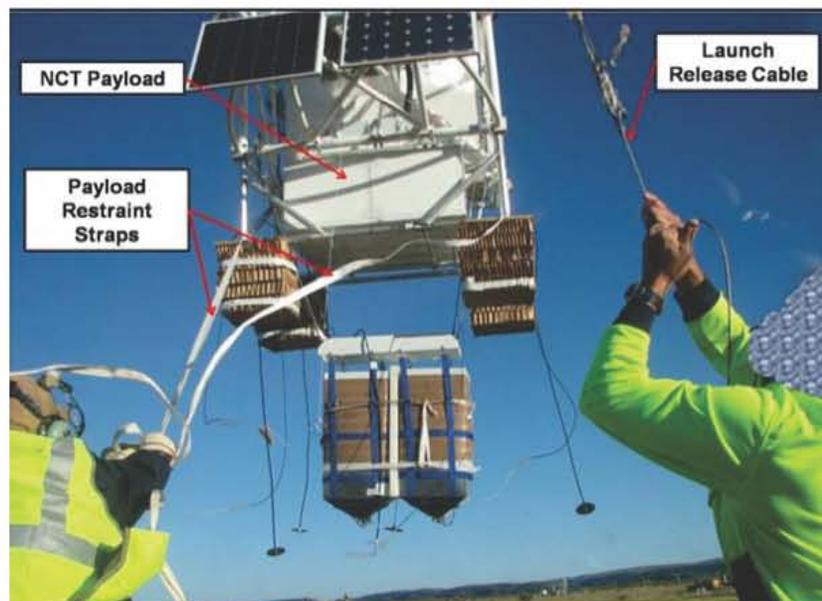
Key Event 32: Approximately 7 sec later, at **PET=86 sec**, the LD instructed the LVD to slow and stop to attempt a launch. When the LD pulled on the launch release lanyard, the launch restraint pin did not release the payload. During this launch attempt, the payload swung out away from the launch vehicle as a result of its inertia, and a team member riding on the launch vehicle with the LD lost hold of the payload controlling straps. The payload continued to swing as the LD tried again to pull the launch release lanyard to release the payload. Again, the payload did not release. The launch attempt, as viewed from the front of the launch vehicle, is shown in Figure 20. By about PET=90 sec, the vehicle was at a complete stop.

Figure 20. Actual NCT Launch Attempt

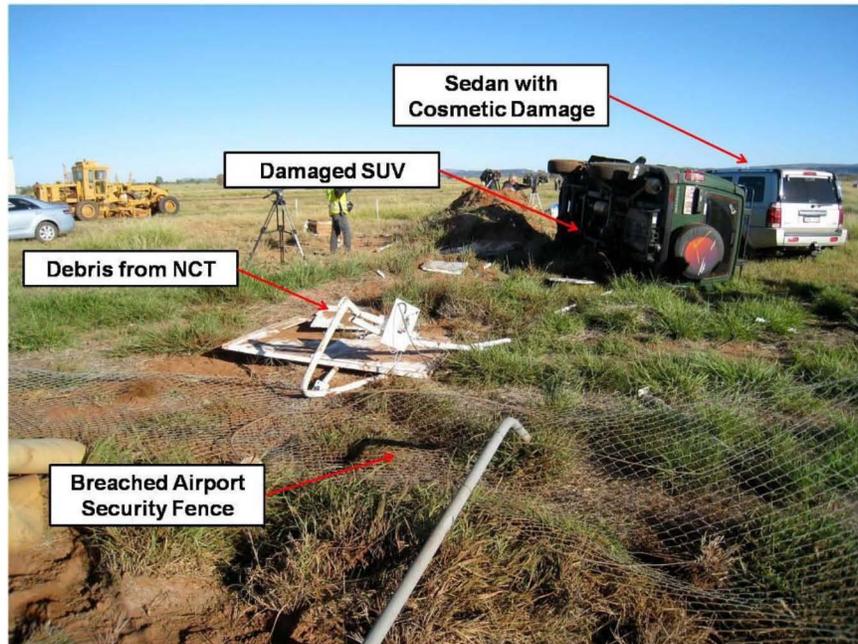
Key Event 47: At PET=177 s the dragging payload hit a spectator’s vehicle. At approximately the same time, the abort command was sent, releasing the balloon from the top of the parachute. After the balloon was separated from the parachute, the payload came to rest. Spectator locations at the time of impact and property damage are shown in Figures 26 and 27.

Figure 27. Damaged Vehicles and Airport Fence

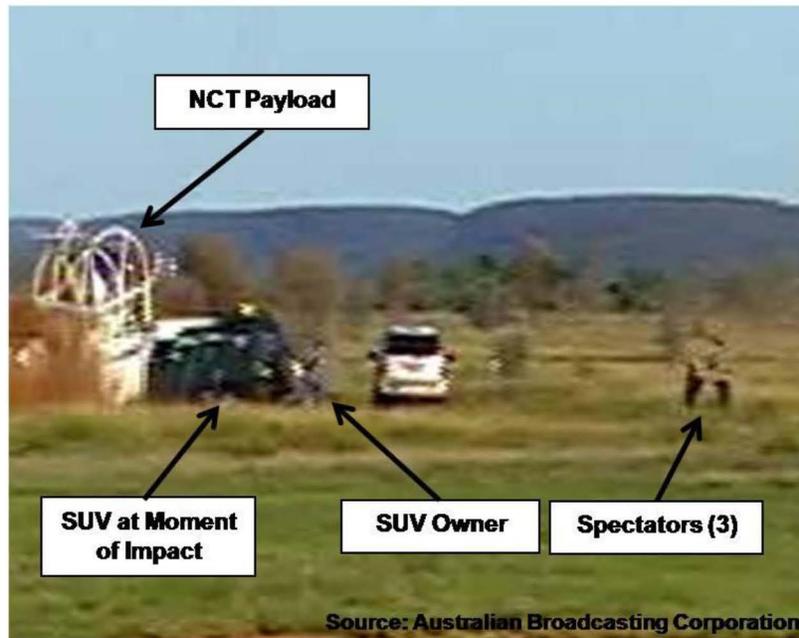
Immediately after the payload came to rest, spectators checked on the health of each other and all were found to be uninjured. The spectator that was on top of the impacted vehicle saw the danger and ran to protect himself as shown in Figure 29.

Figure 29. SUV Owner Running Just Before the SUV Was Impacted

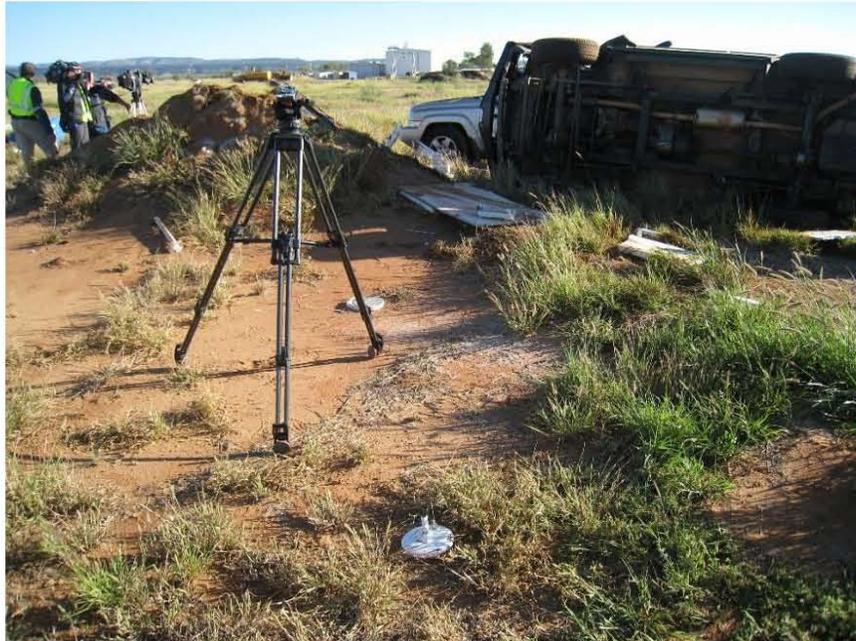
The vehicle near the impacted vehicle had two spectators inside. This vehicle suffered cosmetic damage. Within 30 seconds after the event, spectators and camera crew had approached the damaged payload shown in Figure 30.

Figure 30. Camera Crew and Spectators After the Mishap

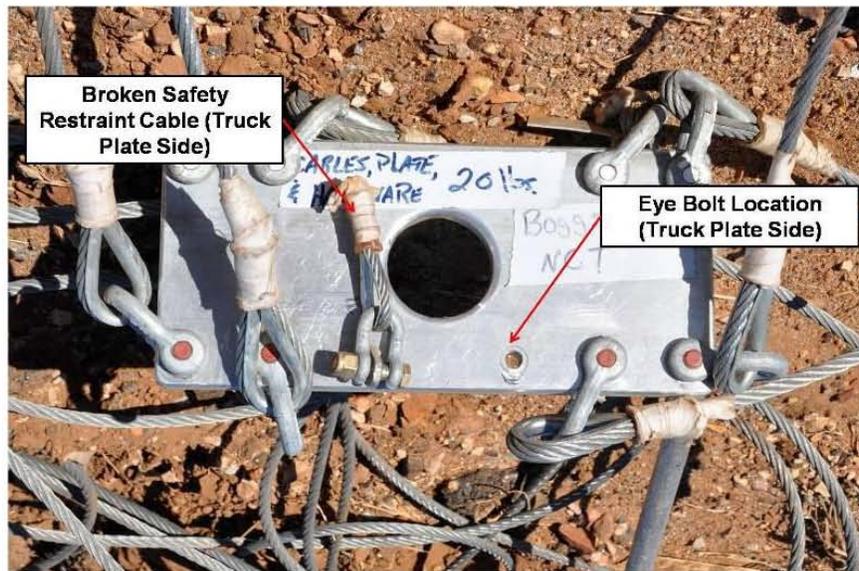
Figure 32. Truck Plate as Photographed at the at Mishap Site

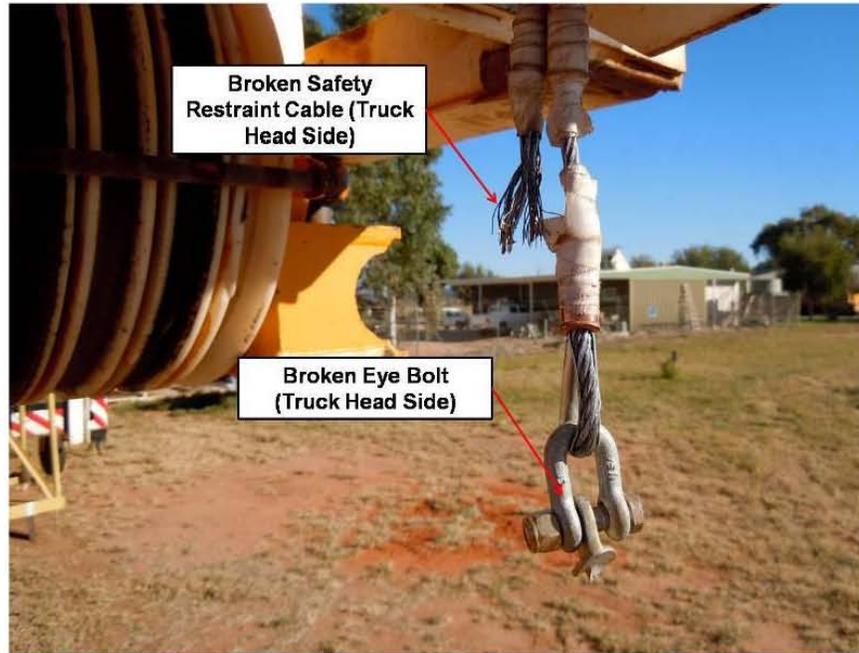
Figure 33. Broken Safety Restraint Cables on Launch Vehicle

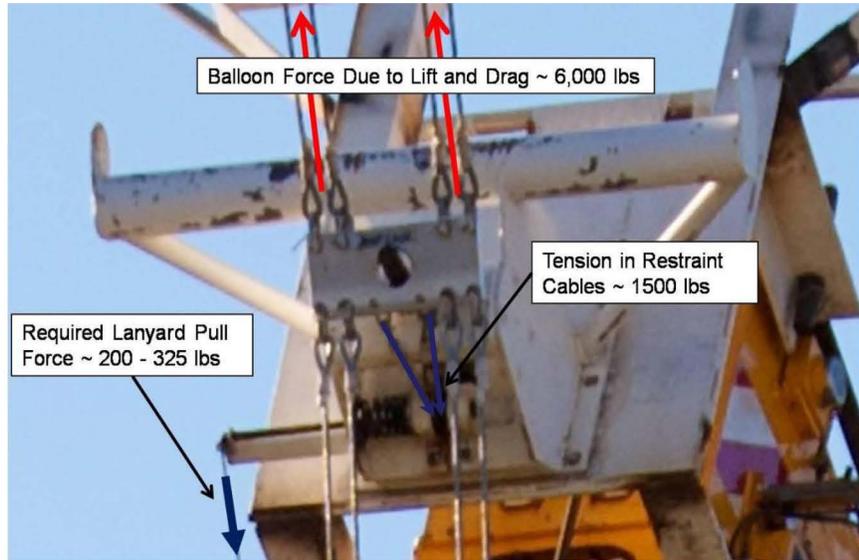
Using the data from Field Test 1, the resulting lanyard pull force would be predicted to be in excess of 300 lb (test data only covered up to 1400 lb suspended). Predicted loads on the launch mechanism and the resulting required lanyard pull force at the time of the launch attempt are shown in Figures 40 and 41.

Figure 40. Forces on Launch System at Launch Attempt Created an Unviable Condition

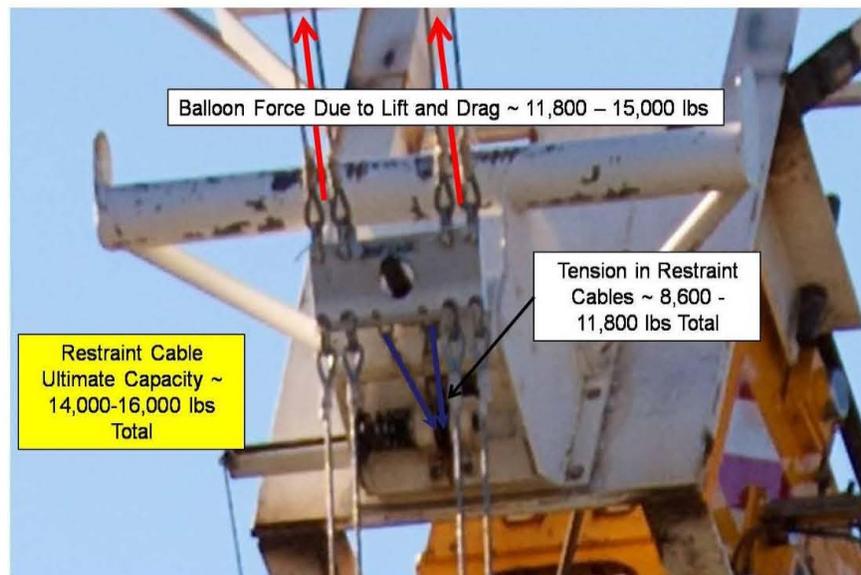
Analysis Finding: The safety restraint cables were used in a backing operation that the cables were not designed to perform. The implemented factor of safety was approximately 1.3, which is inadequate for this operation.

Figure 43. Forces on Launch System During Backing Maneuver Created Unsafe Operating Condition

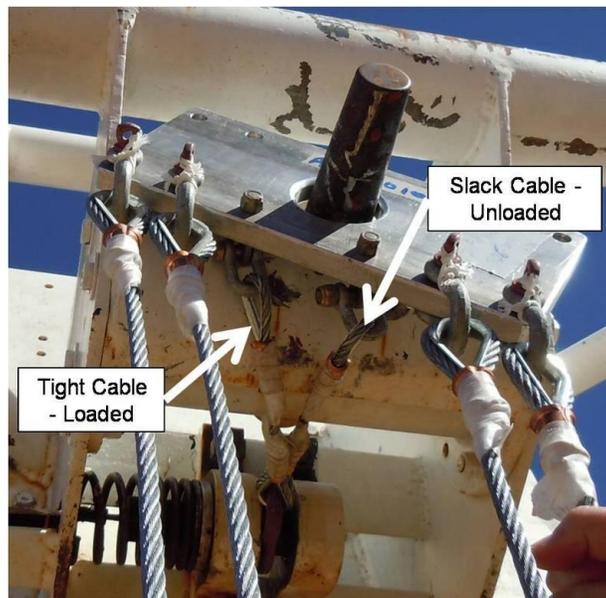
During the left turn maneuver of the launch crane, one restraint cable became off-loaded. The remaining restraint cable reacted the loads from the wind-driven balloon, which exceeded the cable's ultimate strength capability. One restraint cable ruptured, causing the unloaded cable to pick up the load. The second cable assembly also broke due to the loading condition. The load conditions and predictions of hardware behavior are consistent with hardware evidence collected in the field at Alice Springs.

Figure 44. Oblique Truck Plate Loading Off-Loads One Restraint Cable

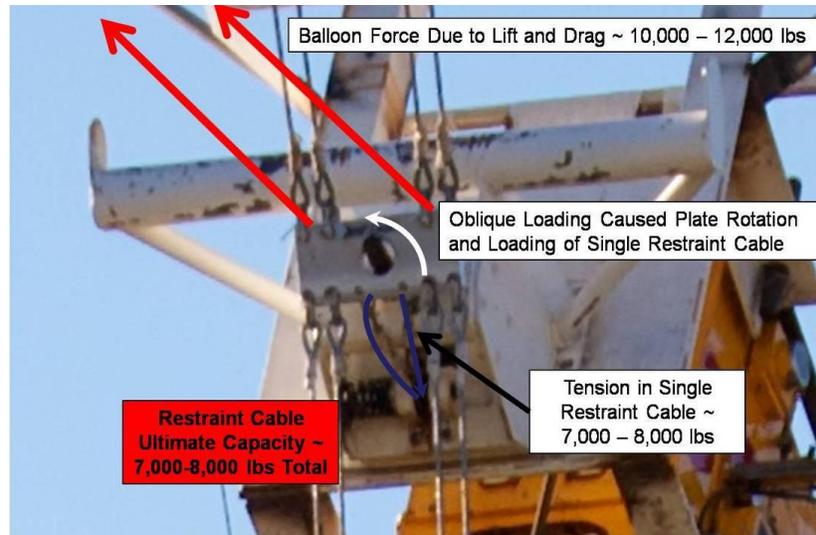
Figure 45. Forces on Launch System During Turning Maneuver Resulted in Cable Rupture (Note that there was no face-on photograph of the hardware at the time of rupture.)

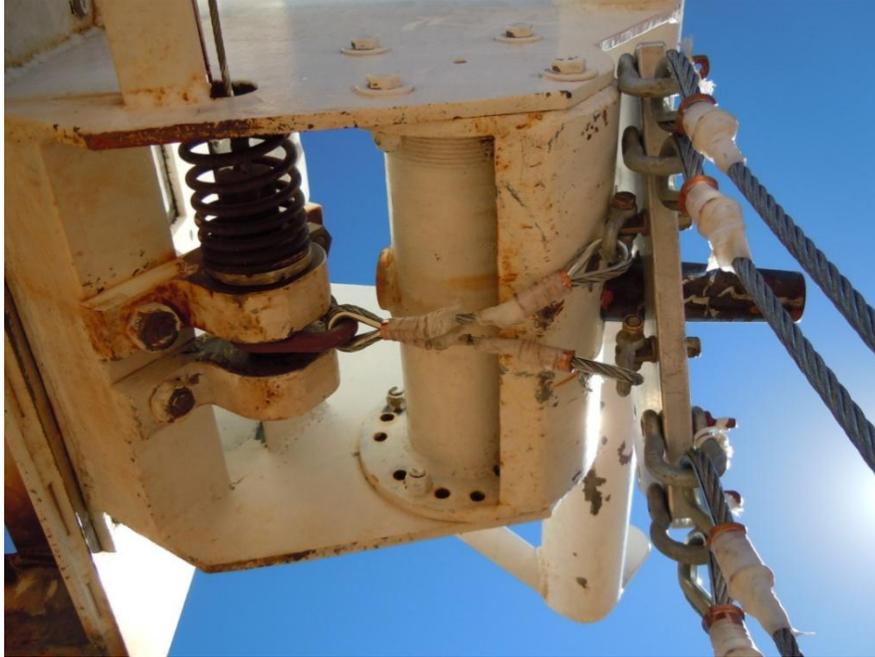
Figure C1-16. Truck Plate Twisted by a Manually Applied Force
