DART CASE STUDY EPILOGUE

DART Risk Management Case Study- Epilogue

Excerpt: Overview of the DART Mishap Investigation Results

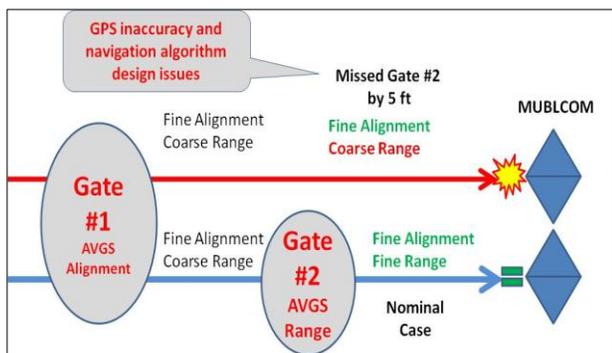
Figure 2. Final Approach Sequence

Initially, the AVGS supplied only information about MUBLCOM's azimuth (angular distance measured horizontally from the sensor boresight to MUBLCOM) and elevation relative to DART. However, as DART approached MUBLCOM, it overshot an important waypoint, or position in space, that would have triggered the final transition to full AVGS capability (see figure 1) Because it missed this critical waypoint and the pre-programmed transition

to full AVGS capability did not happen, the AVGS never supplied DART's navigation system with accurate measurements of the range to MUBLCOM. Consequently, DART was able to steer towards MUBLCOM, but it was not able to accurately determine its distance to MUBLCOM. Although DART's collision avoidance system eventually activated 1 minute and 23 seconds before the collision, the inaccurate perception of its distance and speed in relation to MUBLCOM prevented DART from taking effective action to avoid a collision.

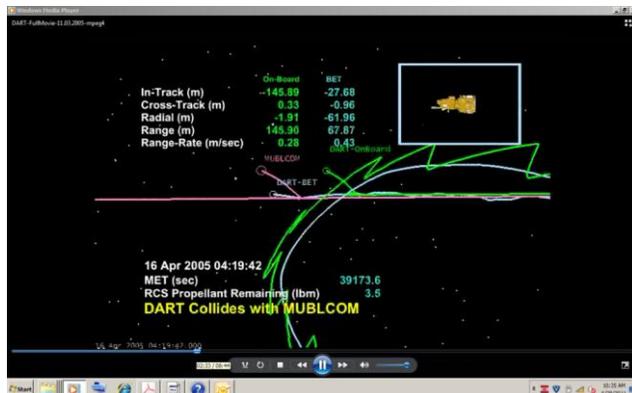
Figure 1. Telemetry of Collision

Less than 11 hours into the mission, DART collided with MUBLCOM (figure 2 shows the final telemetry leading up to the collision). MUBLCOM did not appear to experience significant damage, and the impact actually pushed it into a higher orbit. Then, shortly after the collision, DART determined that it was nearly out of maneuvering fuel, and initiated its pre-

The collision with MUBLCOM was caused by the inaccurate navigation system performance coupled with increasingly accurate azimuth and elevation information from the AVGS. This had the effect of lining MUBLCOM up in the "cross hairs" of DART's guidance system at a time when the system did not have the ability to accurately control the distance between the two spacecraft.

This condition existed because DART's pre-programmed logic for switching to AVGS distance measuring capability required the spacecraft to fly into an undersized, imaginary sphere (waypoint) along the flight path 200 meters behind MUBLCOM. The MIB's analysis of the telemetry data from the flight shows that DART missed this 6.3 meter radius spherical envelope by less than 2 meters. The reasons for this inadequately-designed logic include the unanticipated
