STS-121 Detailed Test Objective (DTO) RCC Crack Repair		
		Page 1

STS-121 Crack Repair DTO Summary

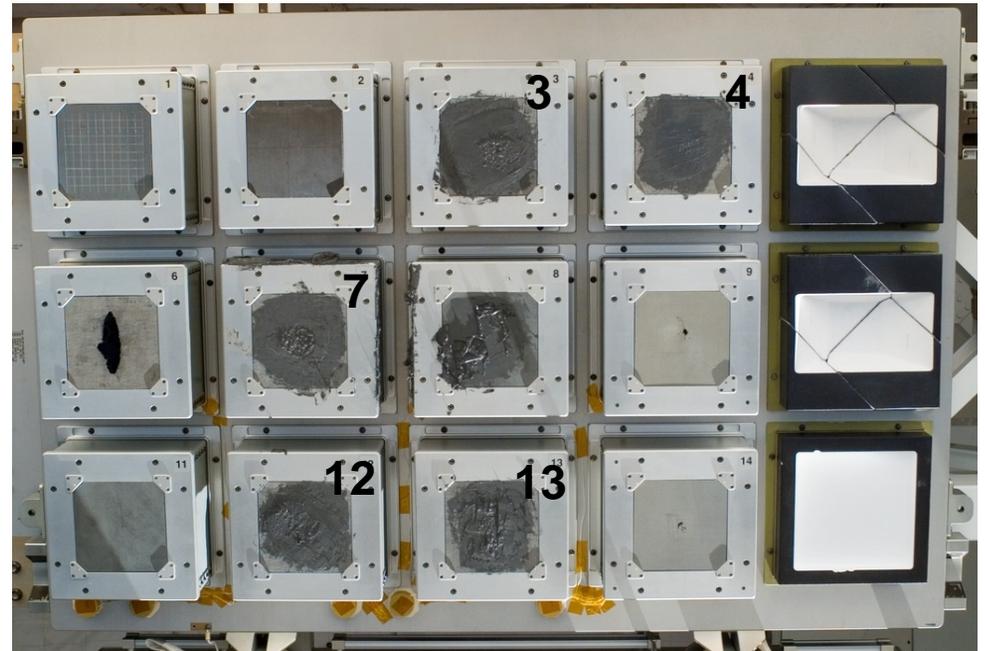
STS-121 DTO Samples – Post Repair

- **Sample 3 – Impact Crack**
 - nominal temps: 93F down to ~45F
- **Sample 4 – Impact Crack**
 - off-nominal temps: 44F down to 35F
- **Sample 7 – 2in dia spall**
 - below spec temps: ~36F and below
- **Sample 12 – 2in dia spall**
 - below spec temps: ~29F and below
- **Sample 13 – 4in x 1.2in gouge**
 - below spec temps: ~26F and below

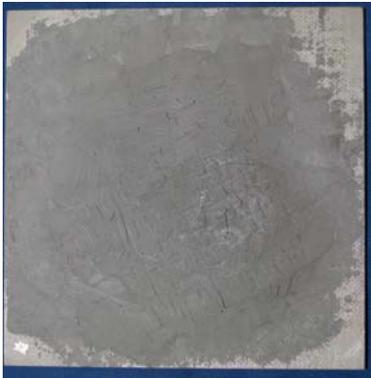
Pre-Test

DTO Sample #3

- Impact Crack

• Nominal temps:
 93F down to 45F

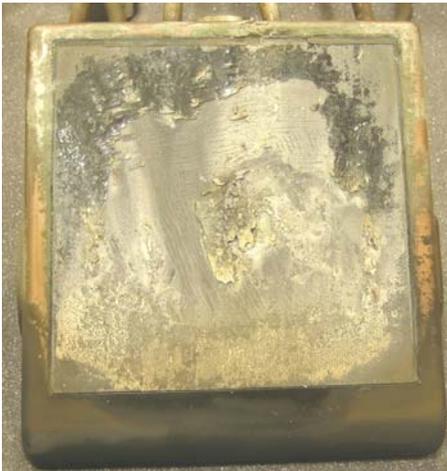
Post-Test

Arc Jet Test Conditions

- 2960 F Condition
- ~ 120 psf Surface Pressure
- 1200 Second Duration
 - Repaired area of C-C substrate not exposed
 - Sample survived entry heating profile

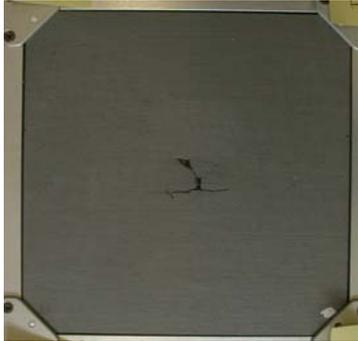
Pre-Repair

DTO Sample #4

- Impact Crack
- Off-nominal temps:
44F down to 35F

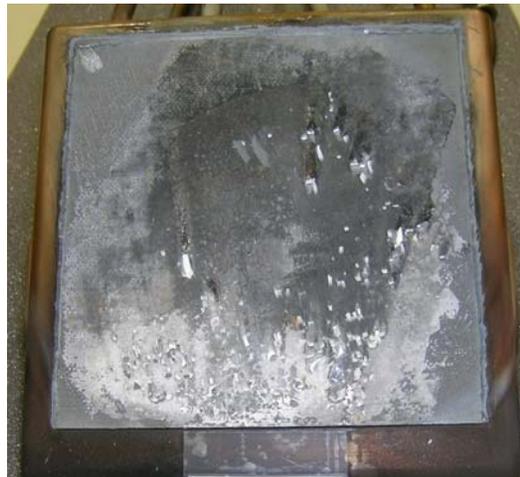
Post-Test

Arc Jet Test Conditions

- 2700 F Condition
- ~ 120 psf Surface Pressure
- 1200 Second Duration
 - Repaired area of C-C substrate not exposed
 - Sample survived entry heating profile
