NASA Engineering and Safety Center Technical Report	Document #: RP-07-13	Version: 1.0
Title: Independent Review Support for Phoenix Mars Mission Robotic Arm Brush Motor Failure			Page #: 1 of 54

**Independent Review Support for Phoenix Mars Mission
Robotic Arm Brush Motor Failure**

March 8, 2007

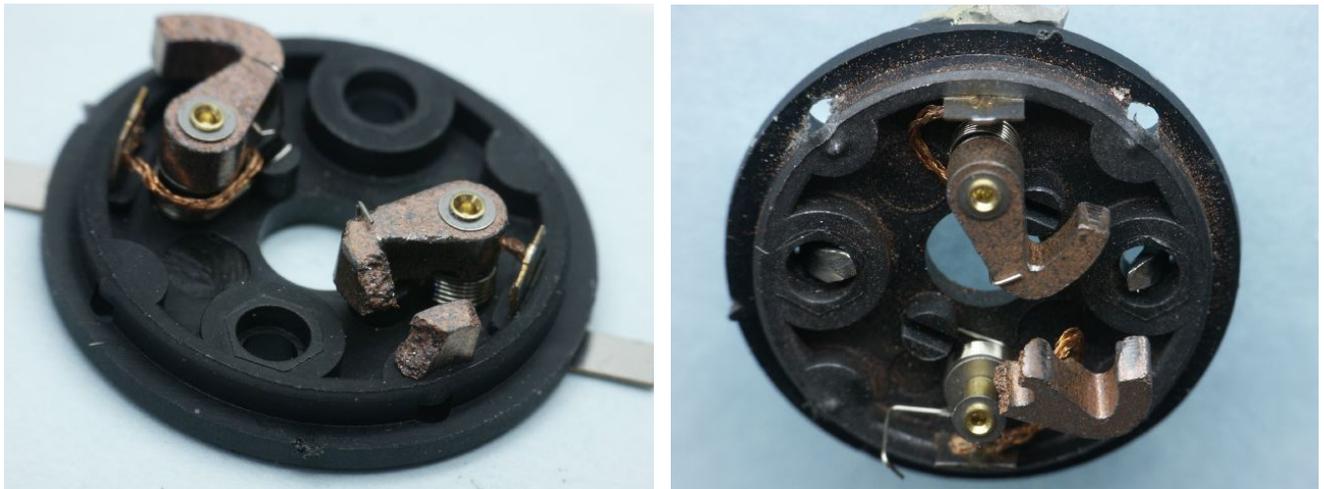
Figure 6.1-1. Motor Brush Anomalies – Tip Failure (Left) and Pivot Failure (Right)

The anomalies with these motors occur in the commutating brushes. There are two failure modes that have been identified which are a concern for mission success (shown in Figure 6.1-1).

The risk events were broken into two parts, a root break and a tip break. As discussed in more detail within this report, a brush failure at the pivot (root break) is catastrophic to the motor, but there is a high likelihood that it will be detected through motor functional and system level testing.

A tip break is less likely to be detected during functional testing; however, a tip failure can still allow motor function but with a possible reduction in torque margin and/or life. There is some concern that a tip failure is an indication of brush strength on the low end of the data scatter; however, the strength of the weakest brush tested is still greater than 3x the predicted worst case qualification loads. Because of the motor functionality with a tip failure, the consequence is listed as a 4.

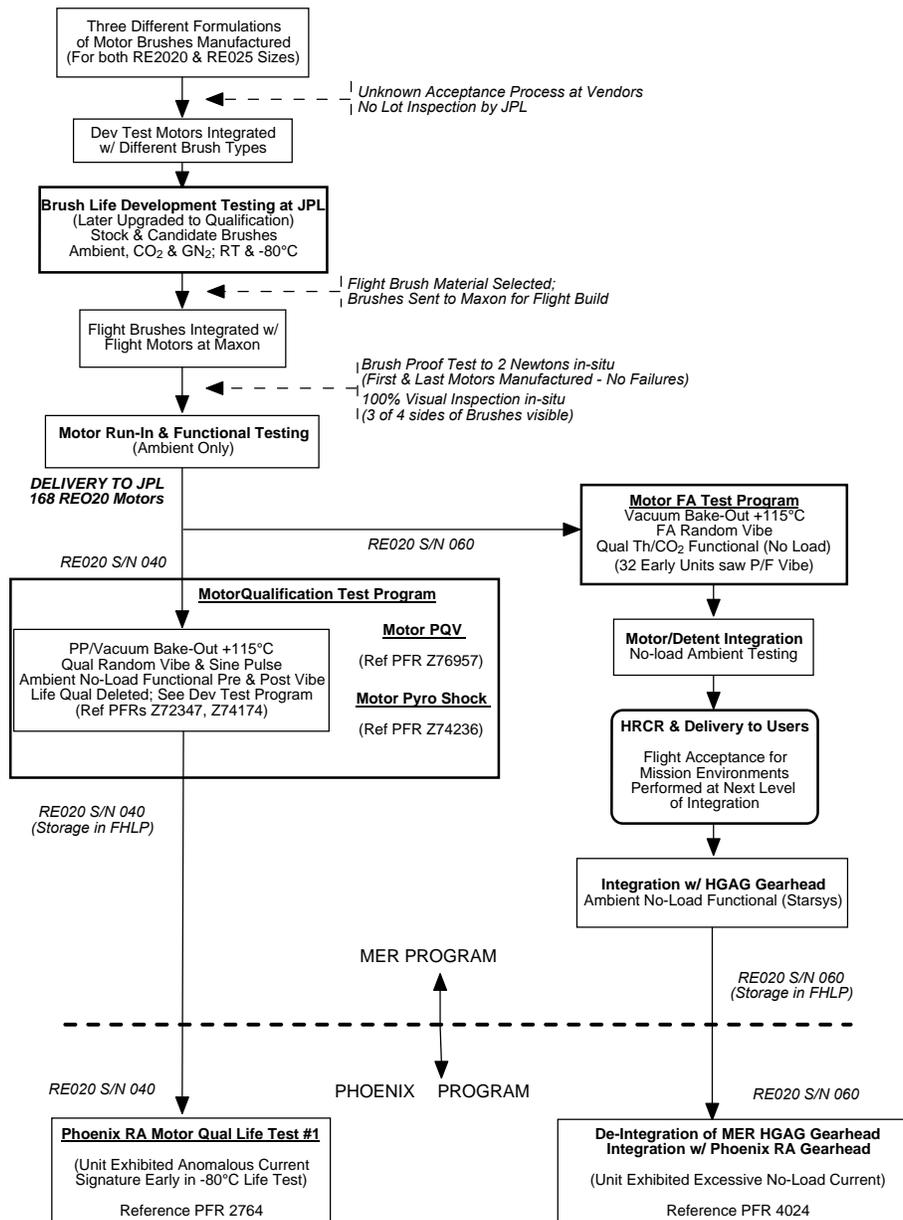
Figure 6.1-2. History of Failed Brush Motors S/N 040 and 060

In addition to the 50 RE020 units now on Mars, 17 units were used in the MER Project test bed. The remaining units were placed in storage under the Flight Hardware Logistics Program (FHLP). For the Phoenix Project, 28 of these motors were retrieved from FHLP, including serial numbers (S/Ns) 40 and 60 which were found to be defective with broken commutator brushes. Similar to other (26) motors pulled, these two motors were fully tested by the MER Project, but were not exposed to a shock environment before they were placed in FHLP. S/N 40 was one of the original four units that were part of the qualification program performed by the MER Project. S/N 60 was originally integrated into the MER Project flight spare high-gain-antenna gimbal (HGAG). S/N 60 was then de-integrated from the HGAG and assembled in the electron microscope autoradiography (EMRA) wrist. S/N 60 was replaced by S/N 101 after the motor failure was discovered during the Phoenix Project. No clear failure mechanism has been established for these two brush failures. It was suggested, but cannot be substantiated, that adverse handling may have precipitated the breakage. There appear to have been no special handling and storage procedures in place beyond the care normally exercised with flight hardware. Figure 6.1-2 illustrates the flow and processing of S/N 040 and 060.

Screening and Validation Testing of MER Brush Motors

(Ref Phoenix PFRs 2764 & 4024)

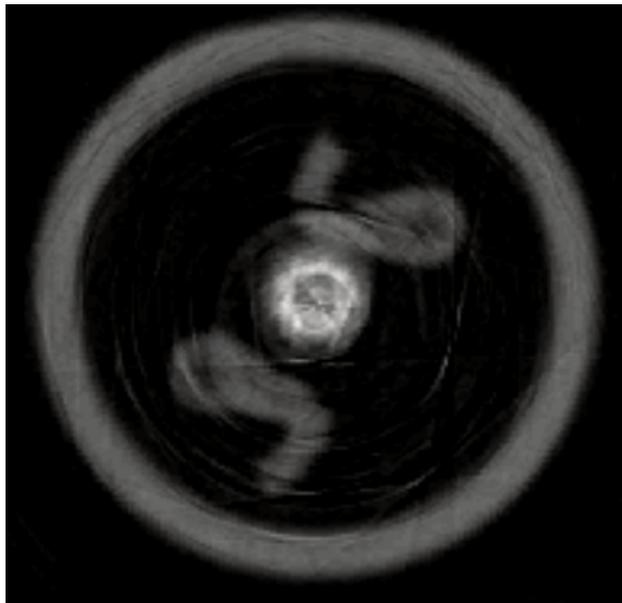
Figure 7.0-1. Image 6304 Motor N-Ray Image (Brushes Intentionally Not in Position)

Figure 7.0-1 (Image 6304) depicts the interior of a partial motor assembly (missing the encoder assembly). The brushes were intentionally installed incorrectly by not spring-preloading against the commutator. If N-ray could not detect this workmanship flaw, then it was doubtful N-ray would be beneficial as a rigorous nondestructive tool.

As Figures 7.0-1 and 7.0-2 shows, the graphite brushes are distinctive in both scans. When the images were magnified and slowly stepped through the sequential scans, some variation in the "density" of the brush was observed. This density variation however, is an artifact of the scan-and-reconstruction process. The use of N-ray beyond the detection of macroscopic breaks in the brushes would require an involved development effort to determine if flaws or pre-existing cracks could be detected.

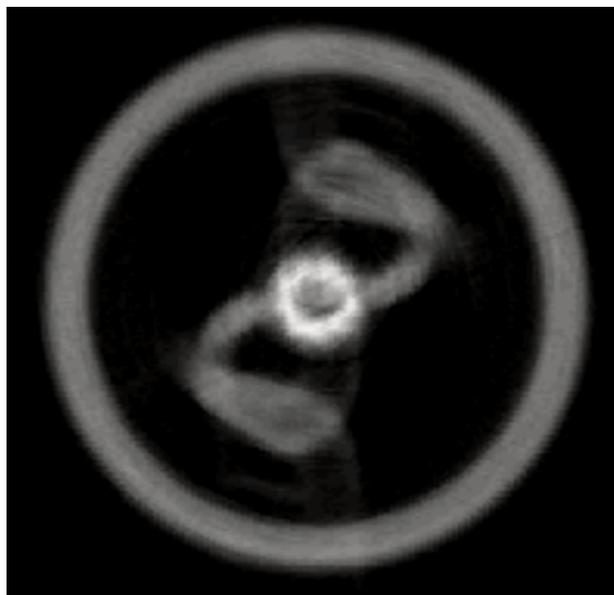
Figure 7.0-2. Image 6305 Motor N-Ray Image

Figure 7.0-2 (Image 6305) depicts a scan of a fully assembled motor with the encoder assembly included.

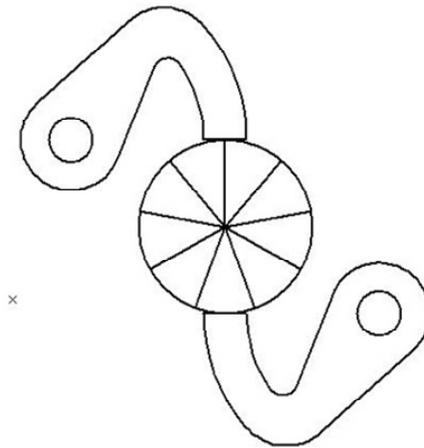
Figure 7.4-1. Brush Motor Armature/Commutator Design

operation, one brush would fail in bucking because the adhesion of the brush to the commutator was greater than the buckling strength of the cantilevered beam.

All of the Phoenix Project motors are designed for bi-directional operation. Both brush bodies are in shear/tension in one direction of rotation and in shear/compression in the other direction of rotation (assuming non-zero sliding friction). The hooked “arm” of both brushes depicted in Figure 7.4-1 is bending at the “elbow” in either direction of rotation.

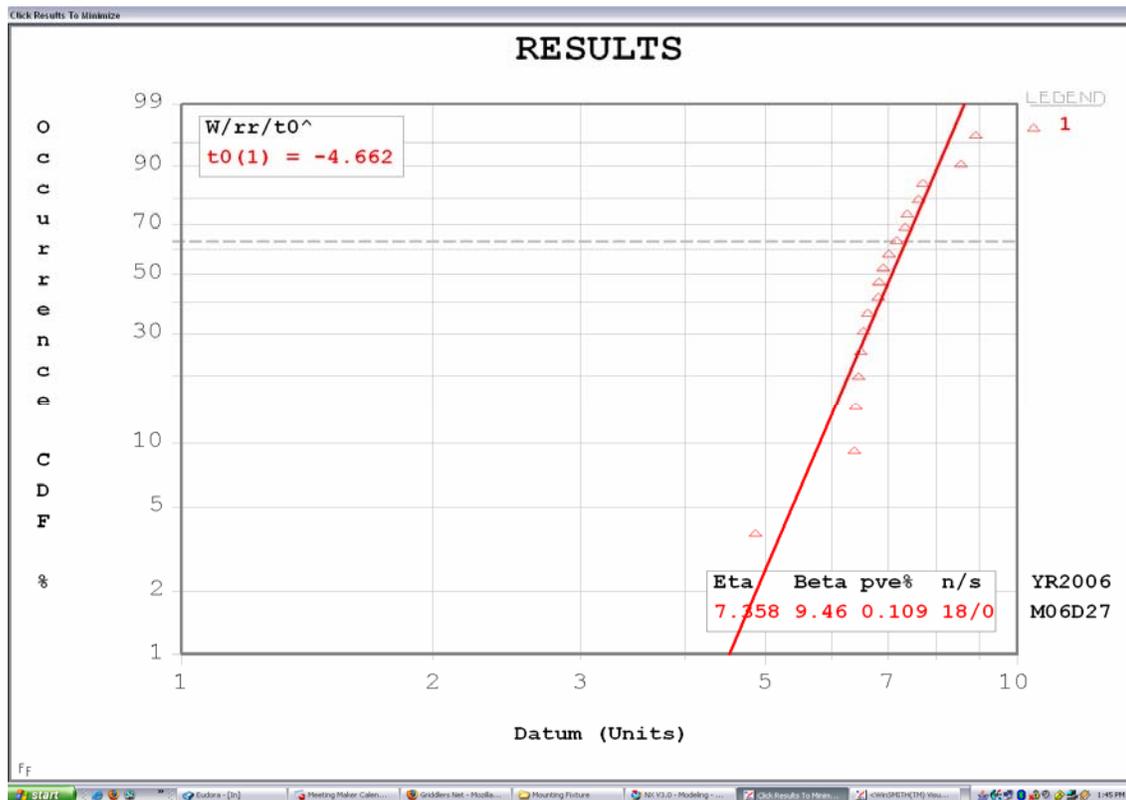
Figure 1. Three Parameter Weibull with Outlier

As shown on the plot, the data fit, defined by the pve%, is 0.190 which is not acceptable for analysis. The software package used to perform the statistical analysis (Weibull 4.0) indicated that sample number 1 of batch 1, the brush that failed at a load of 0.196 pound, was an outlier and should be discarded from the data set.

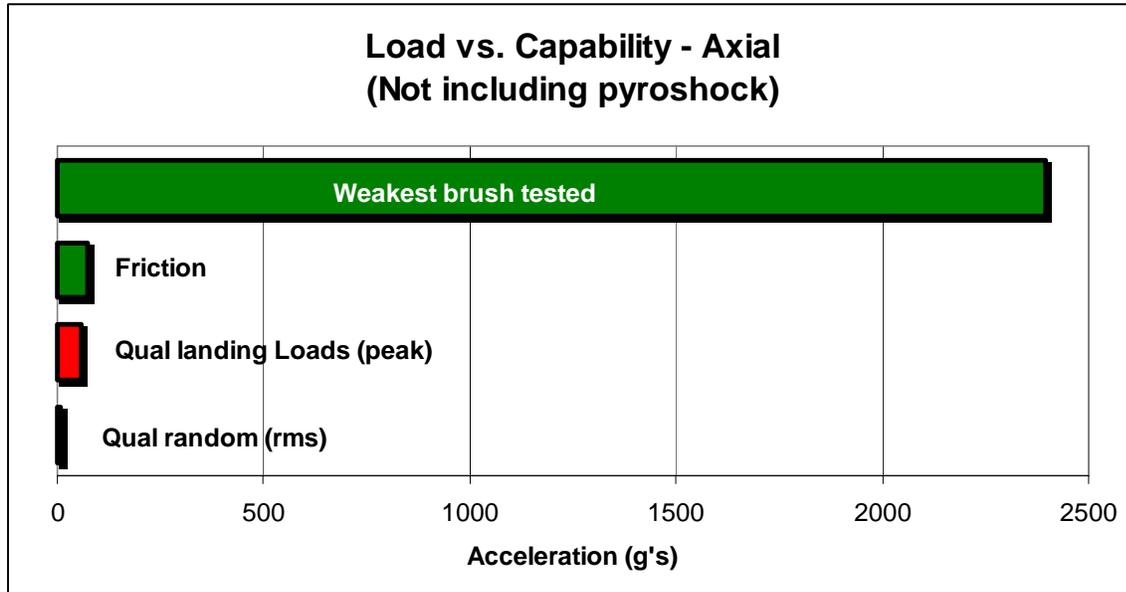
With the exception of pyroshock and other impact loads, the brush strengths measured are well in excess of any environmental loads imposed.
