# NASA Facts

February 2008

### Engine Cutoff Sensor System

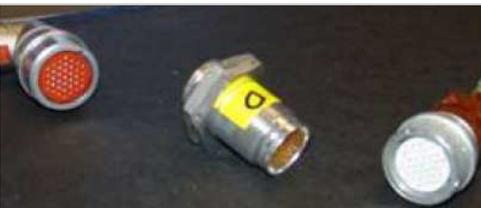
Feed Through Connector  
(1.25" dia. x 2.25" length)

A tanking, or fueling, test at Kennedy on Dec. 18, 2007, revealed that open circuits in the external tank's external electrical feed through connector were the most likely cause of false readings in the ECO sensor system during launch attempts on Dec. 6 and Dec. 9. NASA formed a combined troubleshooting team involving multiple NASA centers to find the root cause and develop plans to fix the system. A parallel team also was established to develop a forward plan of action to support the earliest possible launches STS-122 and STS-123.

All circuit anomalies experienced during testing were able to be repeated as seen during the two launch attempts and tanking test. Open circuits in the part that connects wires from the interior to the exterior of the liquid hydrogen tank, commonly known as the feed through plate, were identified as the culprit that caused false readings during two launch attempts and a tanking test in December 2007.

A modified connector was designed with the pins and sockets soldered together. A similar, but slightly redesigned connector was to be used. Both the original and modified connector configurations were subjected to temperature, pressure and vibration environments identical to those experienced during a shuttle launch. The tests verified the adequacy of the new configuration.

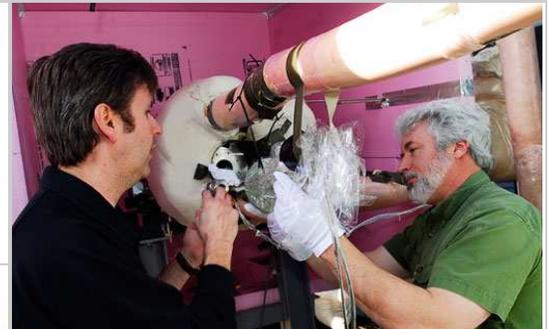
Chad Bryant, ET project manager at Marshall, and Greg Vinyard of Lockheed Martin, prepare to install ET-125's feed through connector in a pressure vessel. The ECO sensor connector is undergoing testing to determine if it was the cause of the false sensor readings.
