# **STS-107 (B1116) Flight Readiness Review**

# Columbia STS-107

### SSME Flight Readiness Review

**STS-107  
PROGRAM FLIGHT READINESS  
REVIEW**

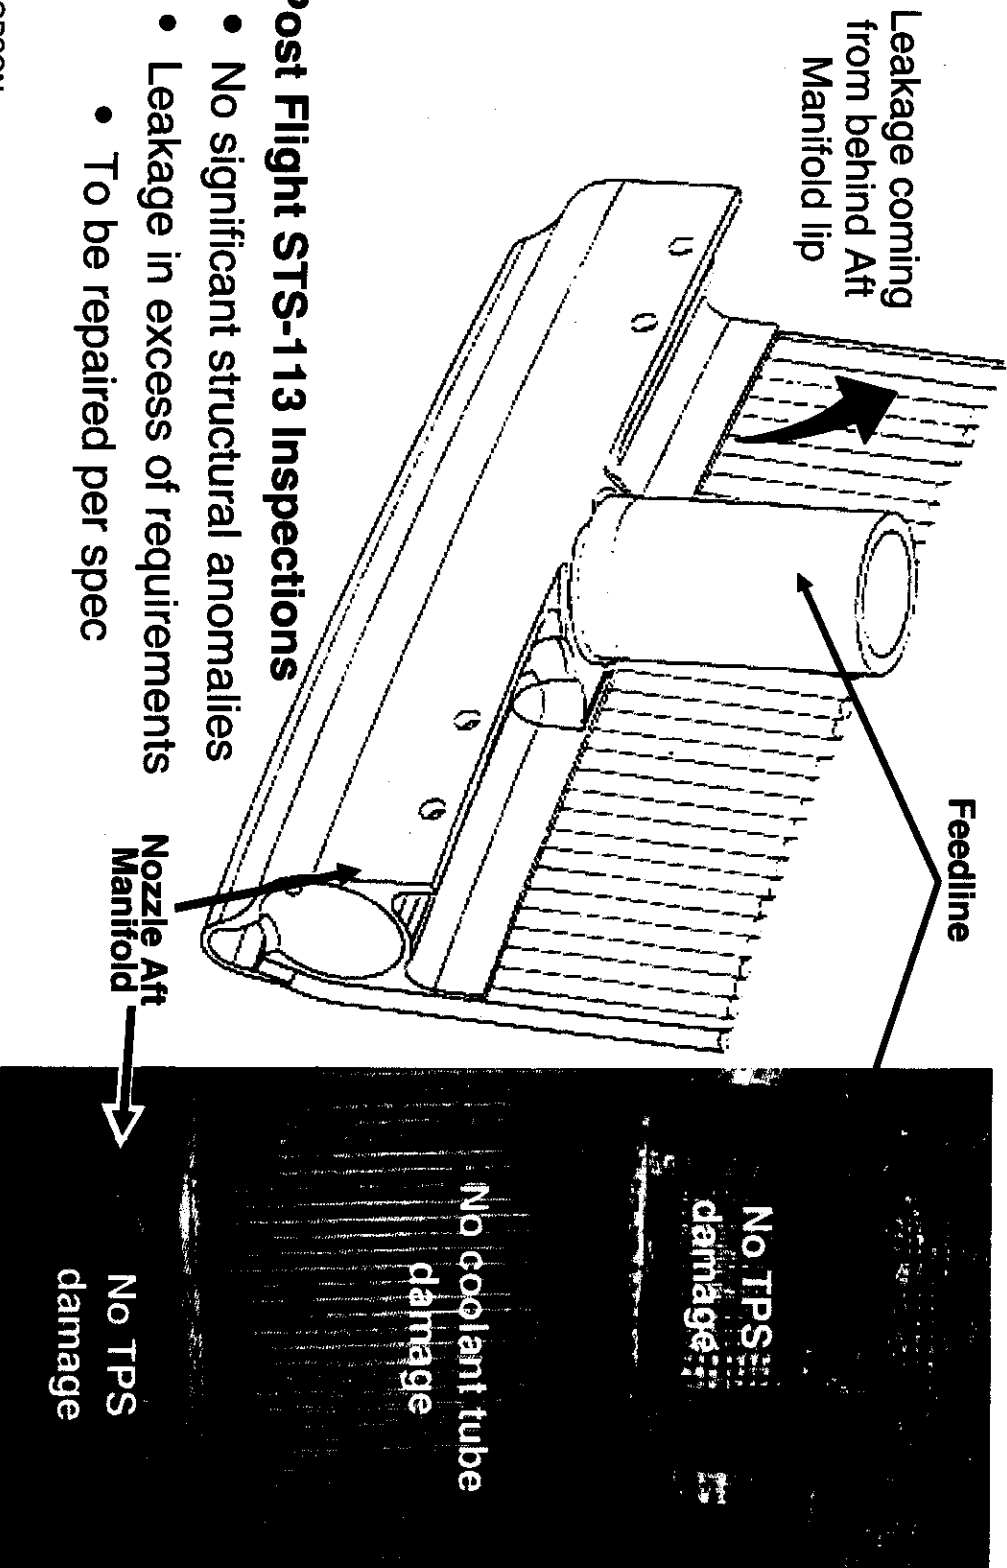
- **Post Flight STS-113 Inspections**
  - No significant structural anomalies
  - Leakage in excess of requirements
  - To be repaired per spec

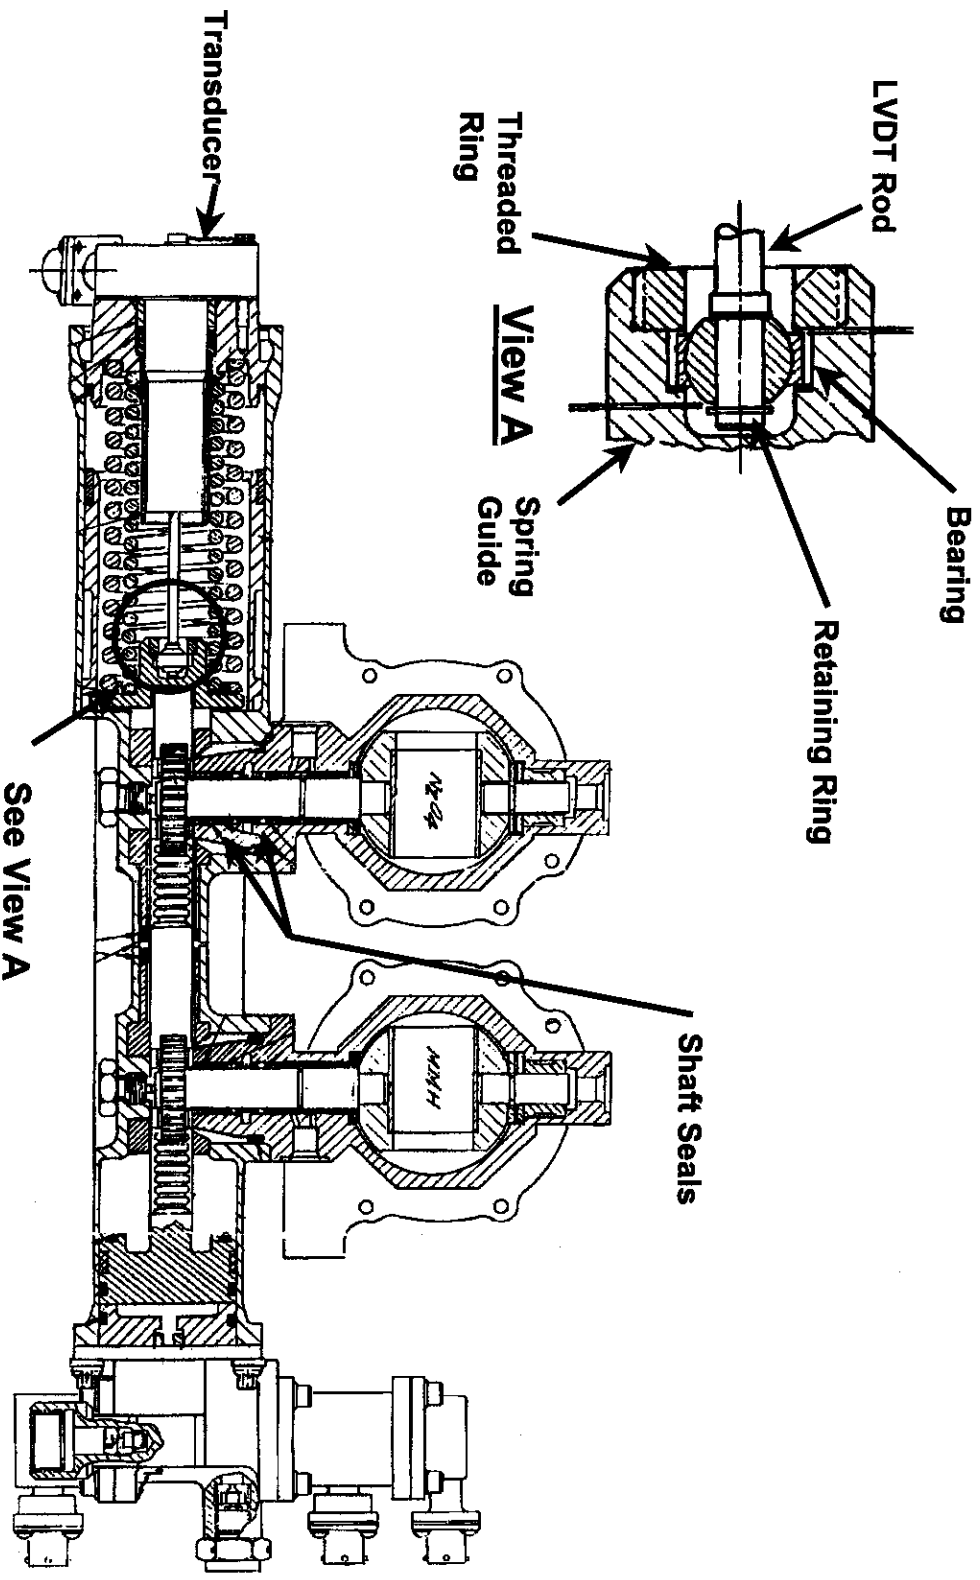
- Failed LVDT had only five flights since cleaning
  - Cleaning process (simple water flush & dry) may not be adequate for some LVDTs
  - Needs improvement to fully remove existing contamination built up over time
- Status of OV-102 OME LVDTs
  - ROME S/N 114 and LOME S/N 116 LVDTs have had only 1 flight since cleaning
    - Mitigates near-term problems
- No LVDTs have failed before 5 flights after preventative maintenance cleaning

- R&R of failed LVDT will be performed by WSTF personnel (~2/03)
  - OME removal from pod not required
  - Spare LVDT assemblies available
  - R&R of other LVDT on right OME being evaluated
- Investigating improved cleaning procedures for transducer bores
- Considering the possibility of an LVDT R&R interval (e.g. every OMDP as part of the established OME PM)
