STS-107 FLIGHT READINESS REVIEW

OV-102 MPS LH2 FEEDLINE FLOWLINER CRACKS

MPS 17" Feedline Ball Strut Tie Rod Assembly Ball Crack

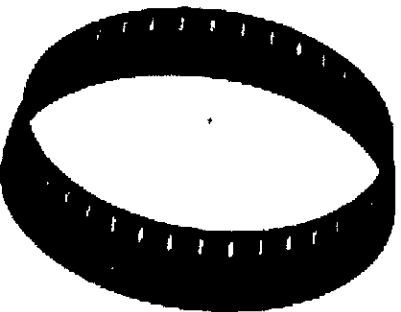
**OV-103 &
subs
Inconel 718
flowliner**

- Inspections of MPS LH2 engine feedline flowliners revealed cracks in the gimbal assembly flowliners near the SSME interface
- Inconel flowliner weld repairs previously cleared for flight on STS-112 and -113
- STS-107 is first flight of repaired CRES flowliners – similar in all details except:
 - Material is CRES 321 instead of Inconel 718
 - Roughly twice as many slots, reducing parent material in-between slots from 0.75 inches to 0.25 inches

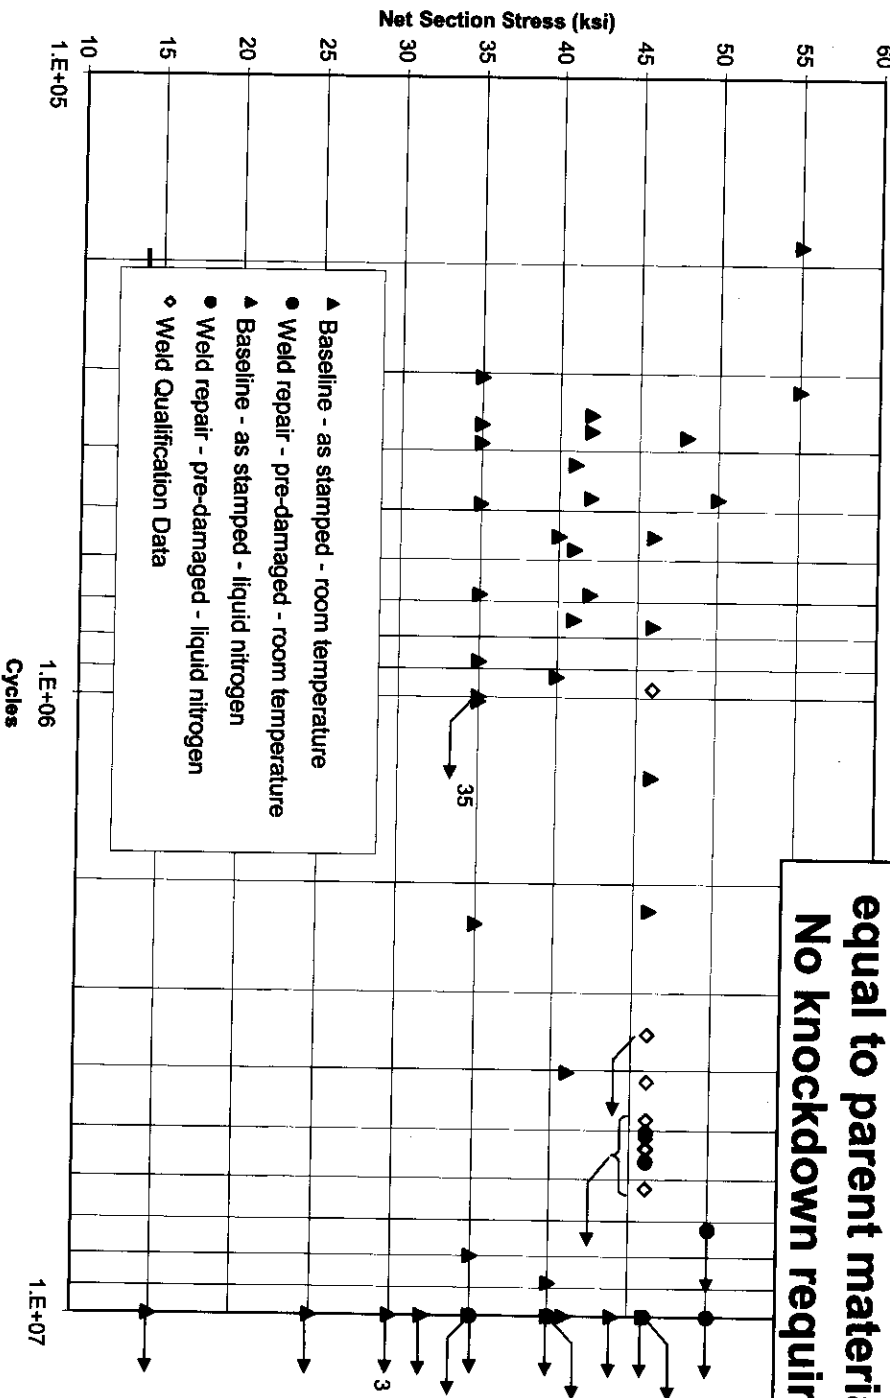
CRES 321 Baseline and Weld Repair Fatigue Test Data
Single Ligament Specimen Configuration
R = 0.1

Testing showed weld repair specimens have fatigue life equal to parent material = No knockdown required

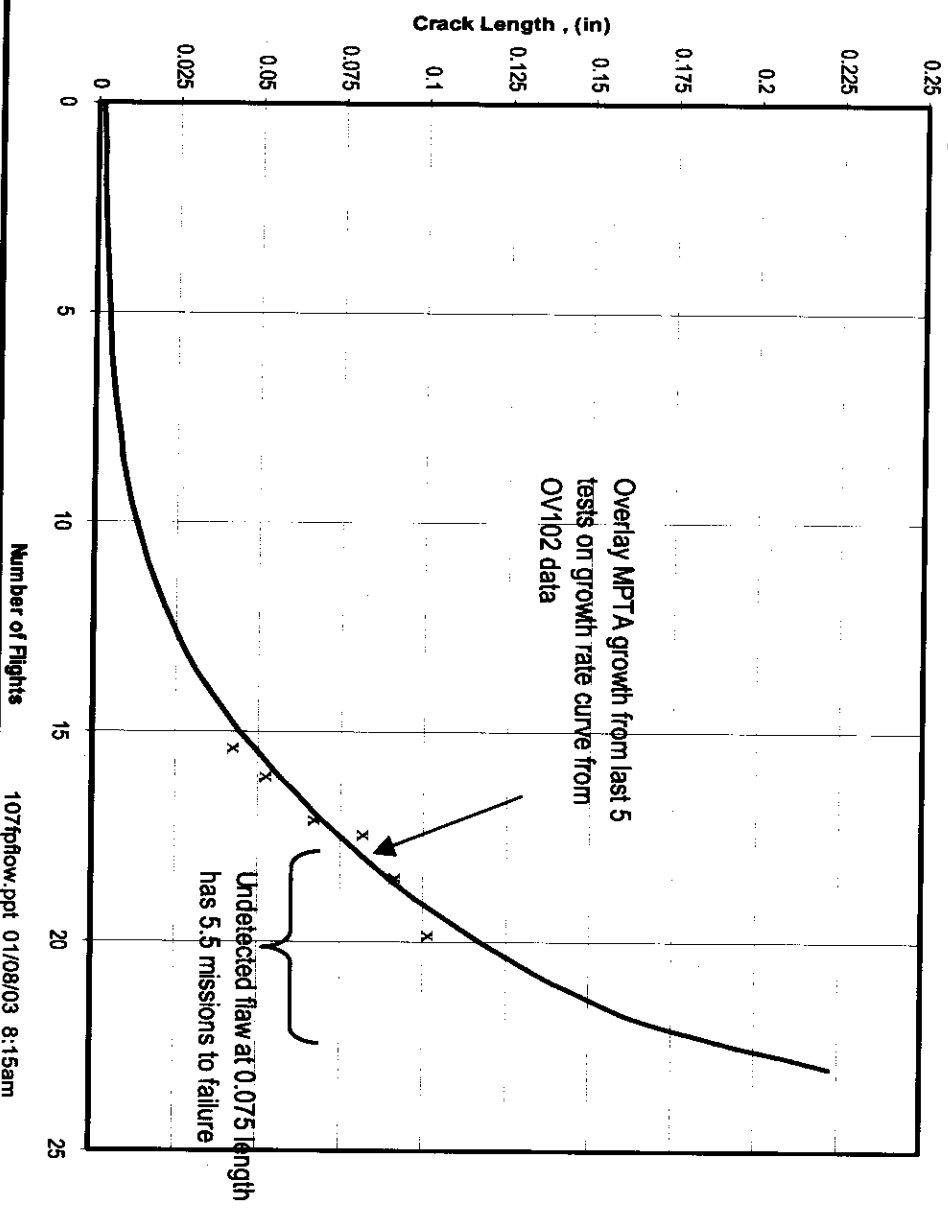
Crack growth rate curve enveloping OV-102 crack data and correlated by overlay of MPTA crack data

Weld repaired ligament has 23 missions from initiation to slot-to-slot propagation.
 An undetected crack (assumed .075 long) in parent material has 5.5 missions to slot-to-slot propagation.

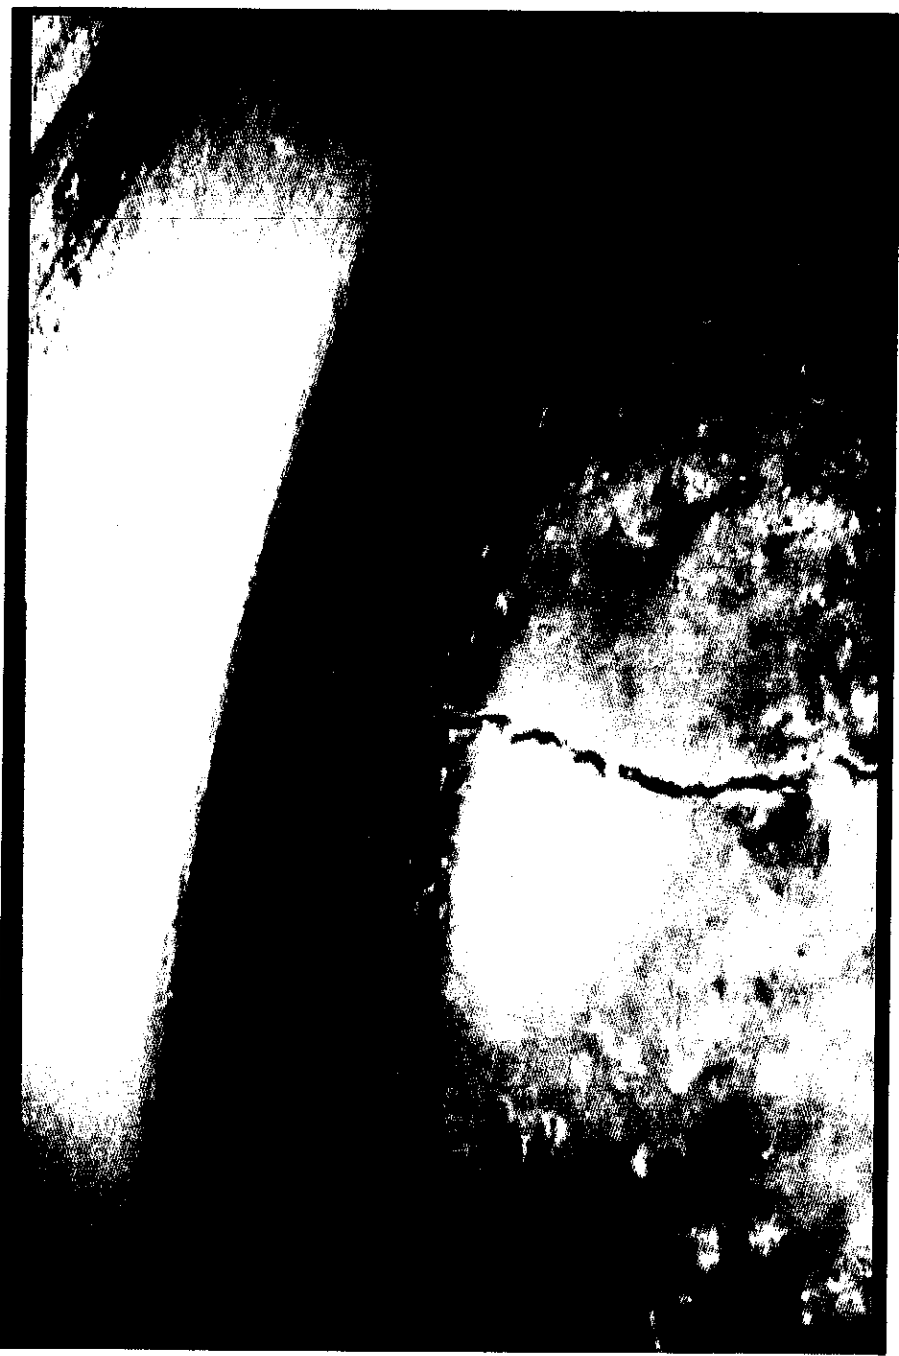
OV-103 17" BSTRA Ball Crack Indication

- OMRSD inspection of OV-103 17 inch LO2 feedline revealed a crack in the ball of the Ball Strut Tie Rod Assembly (BSTRA) nearest the LO2 manifold
- Similar design in 12 inch and 17 inch feedlines
