STS-107 FLIGHT READINESS REVIEW

Presenter:
Organization/Date: Orbiter 01-09-03

SSVEO Is Ready to Fly STS-107

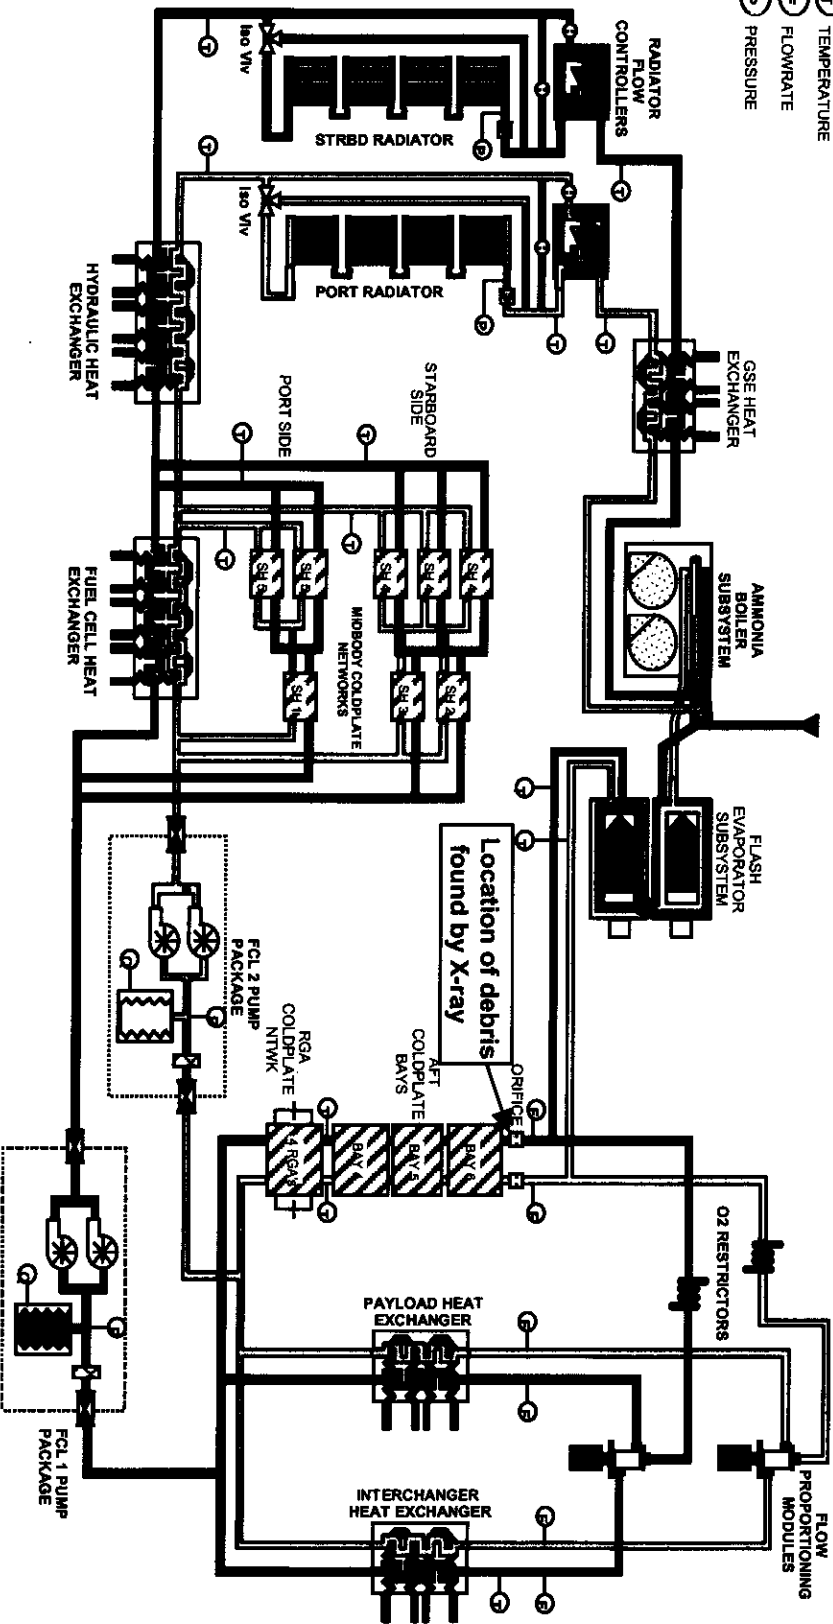
ORBITER ACTIVE THERMAL CONTROL SYSTEM (ATCS)

- Approximately ten minutes after lift-off, the FCL 1 ACP flow rate dropped from 305 lbs/hr to 225 lbs/hr, then to 195 lbs/hr when the FCL was reconfigured to rad flow
 - Data review confirmed that the flow reduction was caused by a restriction in the ACP leg
- The flow rate stabilized, and analysis determined that adequate flow would still be available to provide sufficient cooling for the remainder of STS-109

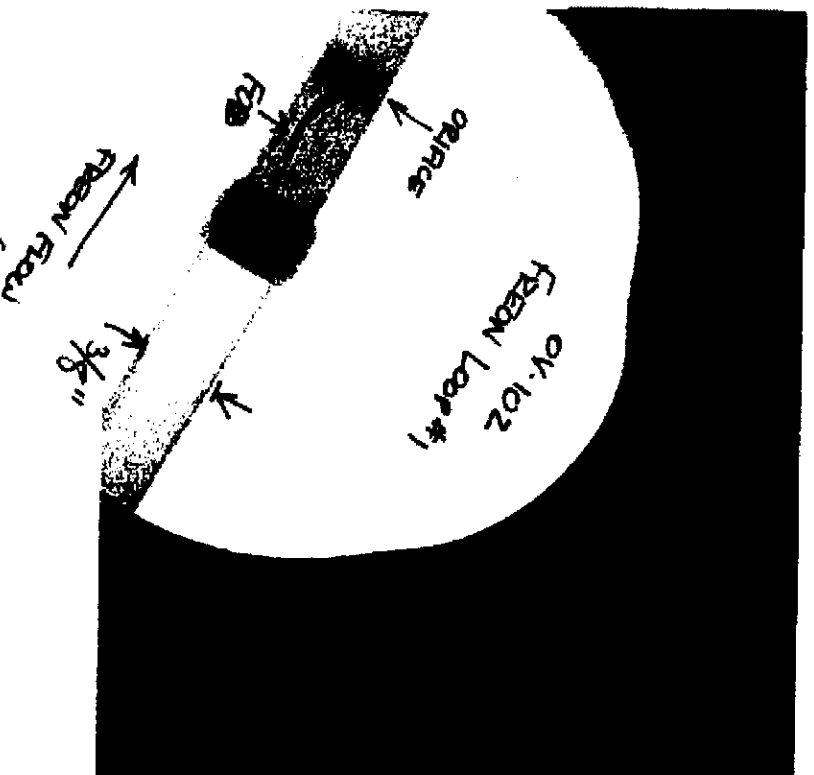
- During post-flight troubleshooting, a piece of debris was found stuck in the upstream side of the orifice between the FES and the aft coldplate network
- FCL 1 was de-serviced and de-brazed to allow extraction of the contaminant
 - Laboratory analysis confirmed that segment of braze preform became detached during brazing
- More x-rays were taken at other suspected locations after power-down to ensure no additional FOD is present in either loop 1 or 2 (see next slides)
 - Included x-rays of three potential traps in the RFCAs
- Visual inspections of FCL 1 FPM & pump inlet filters were also performed
 - FPM 1 and pump inlet filters replaced

**Braze Preform Debris Found in the Upstream Side of
the Orifice Between the FES and the Aft Coldplate
Network**

- The debris that caused the flow restriction was removed
- Additional x-rays taken at potential debris traps in both loops and visual inspection of FCL 1 FPM & pump inlet filters verified acceptable system cleanliness
 - FPM 1 and pump inlet filters replaced
- Freon systems have been verified through OMRSD testing

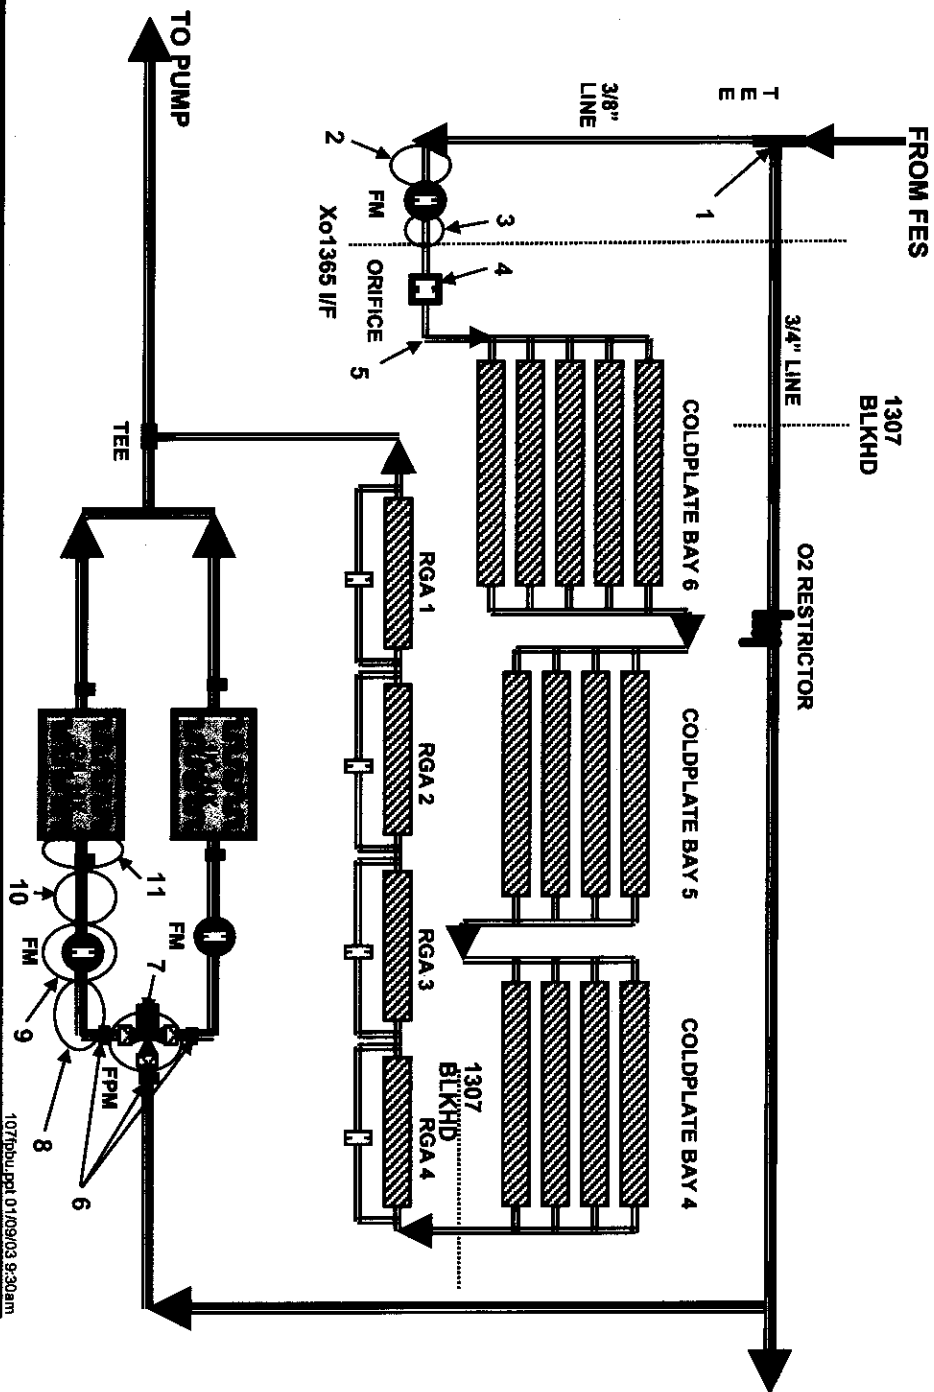
X-rayed Locations for Coldplate Network

- 1 – 3/4" – 3/8" reducer tee
- 2 – Coldplate flow sensor inlet braze/180 deg inlet tube bend
- 3 – Coldplate flow sensor outlet braze/90 deg outlet bend to X_o1365 bulkhead
- 4 – Coldplate flow orifice (debris lodged here)
- 5 – Avionics bay 6 inlet tube (90 deg bend) [FCL 1 only]
- 6 – FPM (Flow Proportioning Module) inlet/outlet brazes
- 7 – FPM inlet/outlet filters (3 each)
- 8 – FPM outlet tube bend including entire line to P/L flow sensor inlet
- 9 – Payload flow sensor including inlet/outlet brazes
- 10 – Entire line from payload flow sensor to inlet of P/L HX
- 11 – P/L HX inlet header and braze

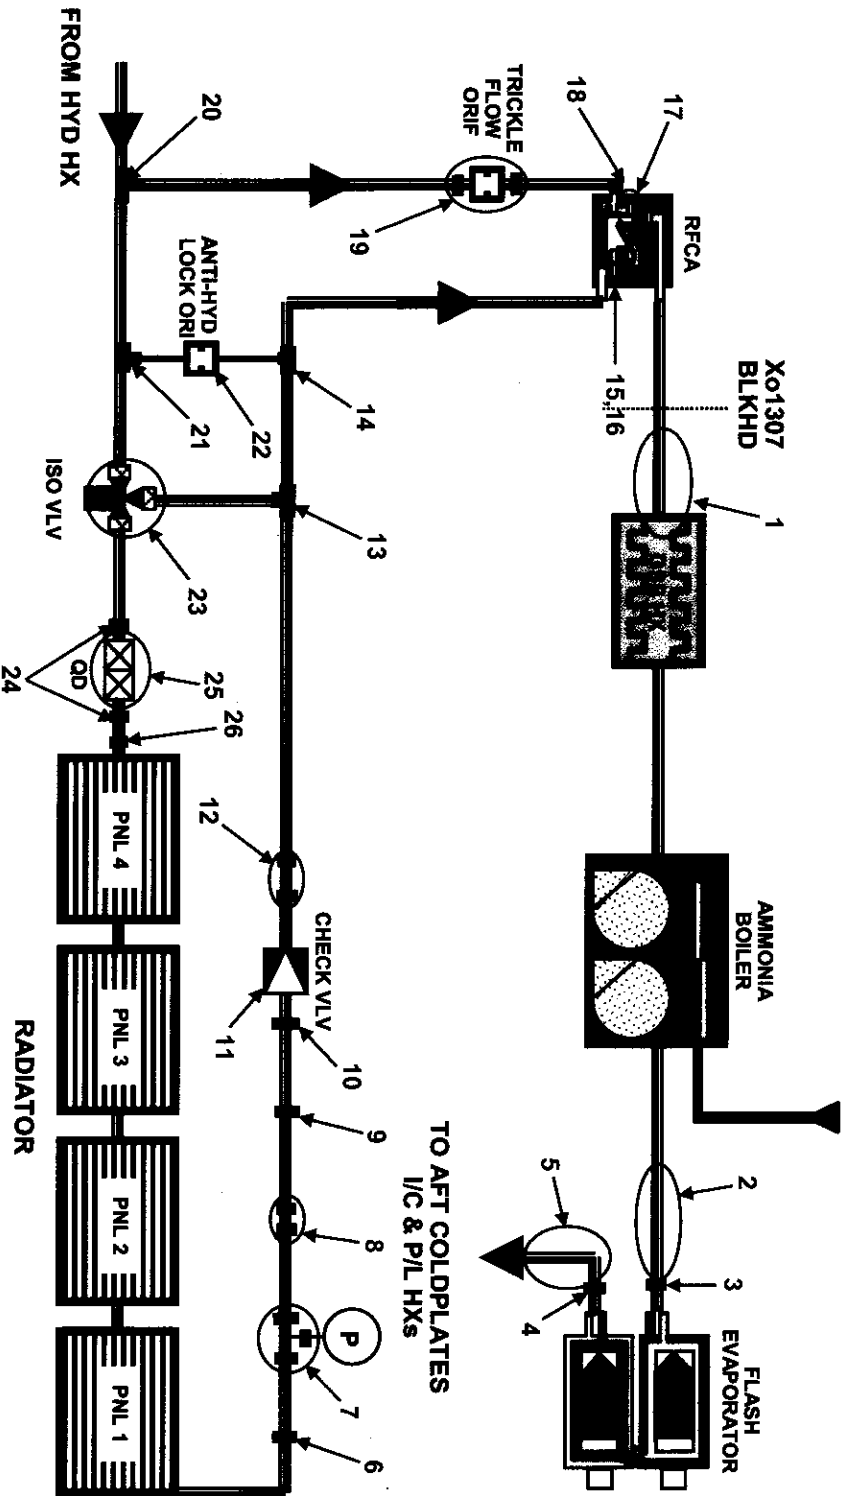
X-rayed Locations for FES, Radiator and RFCA

- 1 – GSE HX inlet header/tube run upstream to 1st clamp
- 2 – FES inlet line from 1st line clamp upstream to inlet
braze
- 3 – FES inlet braze
- 4 – FES outlet braze
- 5 – FES outlet line down to 1st clamp (including
male/female mechanical fittings)
- 6 – Tube/tube braze
- 7 – Tee (3 brazes)
- 8 – Elbow to tube/flexline (2 brazes)
- 9 – Flexline braze to tube flange support
- 10 – Tube flange support outlet braze to dynatube braze
TP231B

- 11 – Isolation check valve
 - 12 – Elbow brazes to check valve/tube*
 - 13 – Tee (3 brazes)*
 - 14 – Tee (2 brazes), brazed to item 13 tee*
 - 15 – RFCA flow control valve inlet filter (cold)
 - 16 – RFCA flow control valve inlet filter (hot)
 - 17 – RFCA bypass valve inlet filter
 - 18 – RFCA bypass leg inlet braze*
 - 19 – Bypass orifice including inlet/outlet brazes
 - 20 – Tee (3 brazes)*
 - 21 – Tee (2 brazes), brazed to item 20 tee
 - 22 – Anti-hydraulic lock up orifice*
 - 23 – Iso valve body and inlet/outlet brazes (3)
 - 24 – QD inlet braze at flexline interface/QD outlet braze*
 - 25 – QD interface male/female
 - 26 – Tube to tube braze*
- * Indicates FCL 1 only

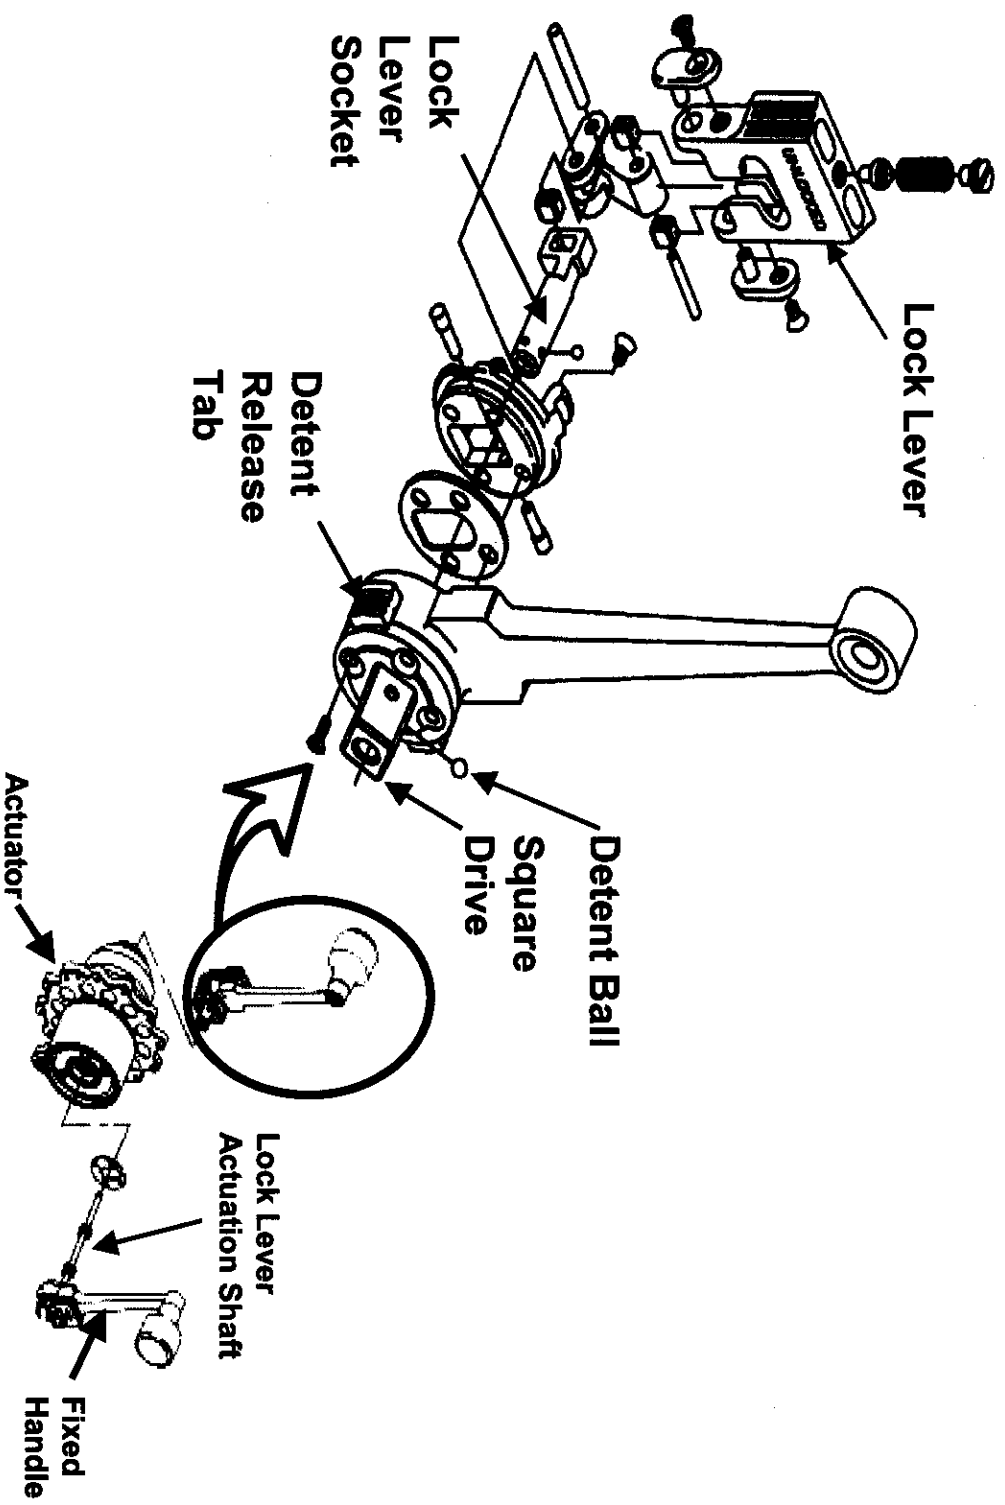
- When the crew first attempted to open the internal airlock "A" hatch during STS-109, they reported that the actuator would not unlock when the lock tab was moved to the unlocked position
- The crew noticed that the removable handle was partially disengaged from the actuator, so they reseated it and were then able to unlock and unlatch the hatch successfully

- The removable handle on the crew module side of this actuator must be fully seated in order for the lock lever socket to be properly engaged
 - With the handle unseated, lock lever can move separately from the rest of the lock mechanism
- During final hatch closeout for flight, handle was noted to be fully seated, and actuator functioned properly

- Installed the spare assembly and successfully performed functional testing
- Will re-verify proper handle engagement after platforms are removed before launch
- Will consider adding permanent OMRSD requirement to verify proper handle engagement after platforms removed

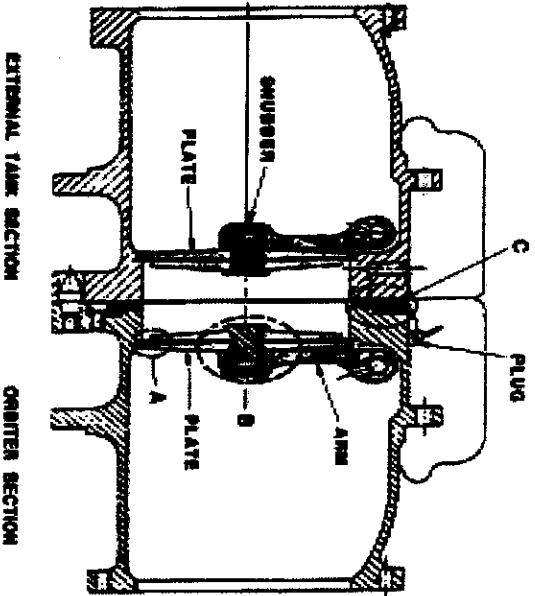
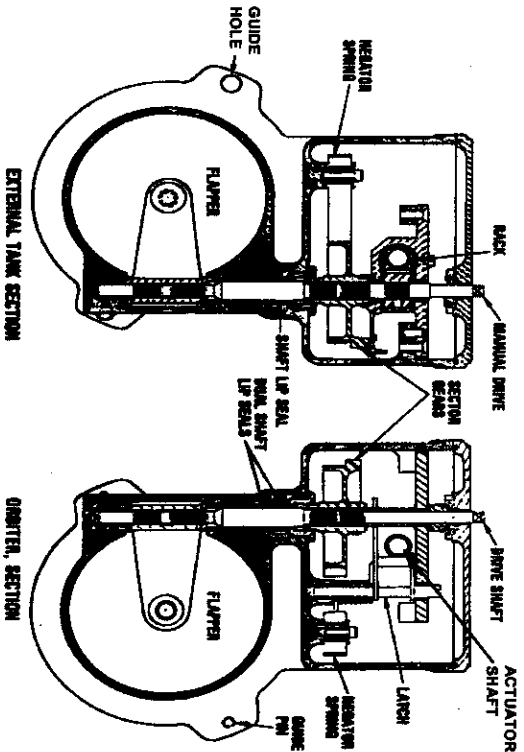
Orbiter/ET 4" Disconnect

- MPS LH2 4" disconnect failed to close pneumatically when commanded at MECO
 - Closed via back-up mechanical mode at ET/Orbiter umbilical separation

- Inspection of Orbiter disconnect post-landing for indications of failure
 - Initial runway inspection revealed nothing unusual
 - Borescope inspection found Flourogold spacer (spool which negator spring slides/rotates on) cut and bent in towards springs
 - Scuff mark found on back of housing
- Disconnect R&R complete
 - Borescoped new disconnect and verified no damage
 - Leak checks complete and good
 - Removed PD3 failure analysis to follow
 - Ambient & cryo cycle tests

- Disconnect failure to close pneumatically is only critical for uncontained SSME shutdown
 - Probability of SSME catastrophic shutdown is remote
- Borescoped new disconnect and verified no damage
- OMRS verification of disconnect function accomplished prior to propellant loading
- No history of disconnect failure to close via mechanical back-up separation mode
 - Prevents helium loss during entry

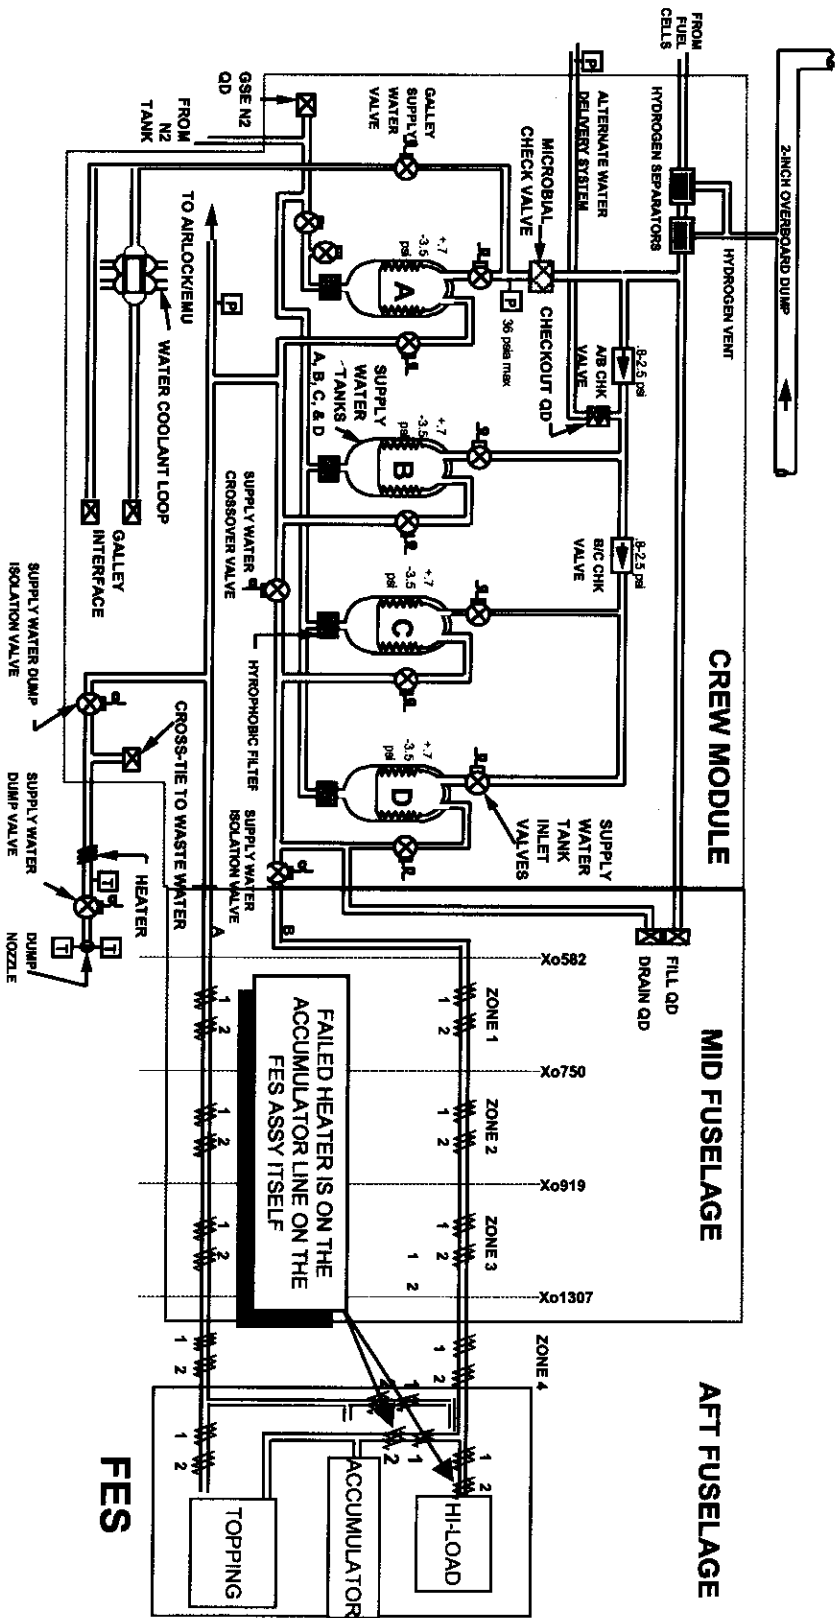
SUPPLY WATER SYSTEM

- FES accumulator/hi-load H₂O feedline B (starboard) heater system 2 zone 4 failed off

- Post-flight troubleshooting isolated the problem to a bad thermal switch
- Switch (S0V63S51) was replaced and successfully retested
- In addition, the feedline B accumulator line temp sensor (V63T1894A) was not responding during troubleshooting
 - Sensor was also replaced and successfully retested

- Problem was isolated to a bad thermal switch which has been replaced
- Post-repair verification - good results
- There are two redundant heater strings per feedline, providing temperature control to prevent freezing
- With loss of both heater strings, a contingency procedure is in place to purge the affected line to prevent freezing (safing) and allow recovery of the system for entry
- Redundant feedline (A) maintains FES capability
