# MPS 17" Feedline Ball Strut Tie Rod Assembly Ball Crack

Presenter:  
David Rigby

Date:  
Orbiter 01/14/03

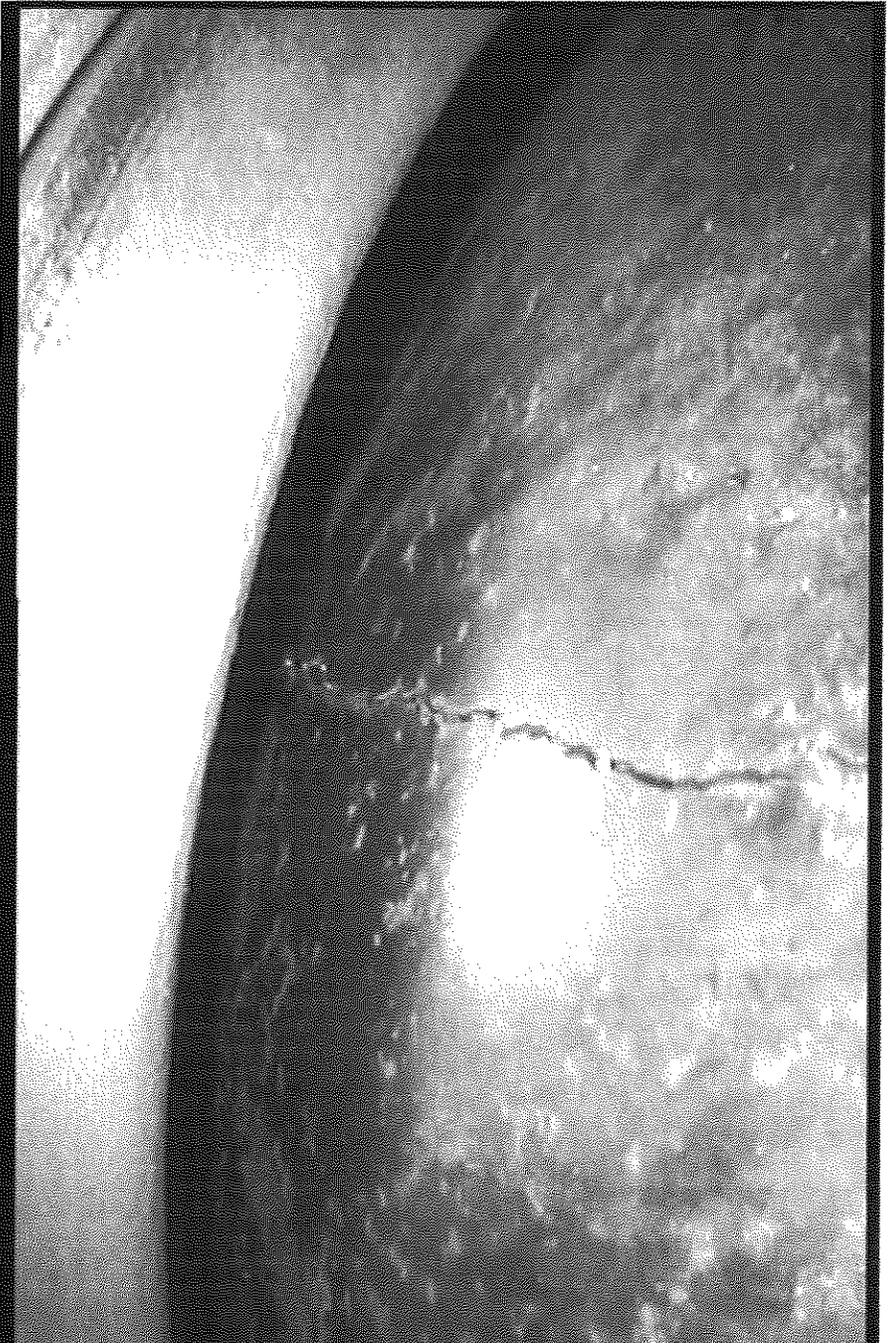
**OV-103 17" BSTRRA Ball Crack Indication**
