Hypervelocity Impact Tests
on Space Shuttle Orbiter
Using Nylon and Glass Projectiles
Thermal Protection Material

OV-102 (STS-87) TPS Damage

Presenter	R. Gatto
Date	January 6, 1998

STS-107
Launch+4 Day
Consolidated Film/Video Report
KSC, JSC, MSFC and Program Integration
Film/Video Analysis Teams

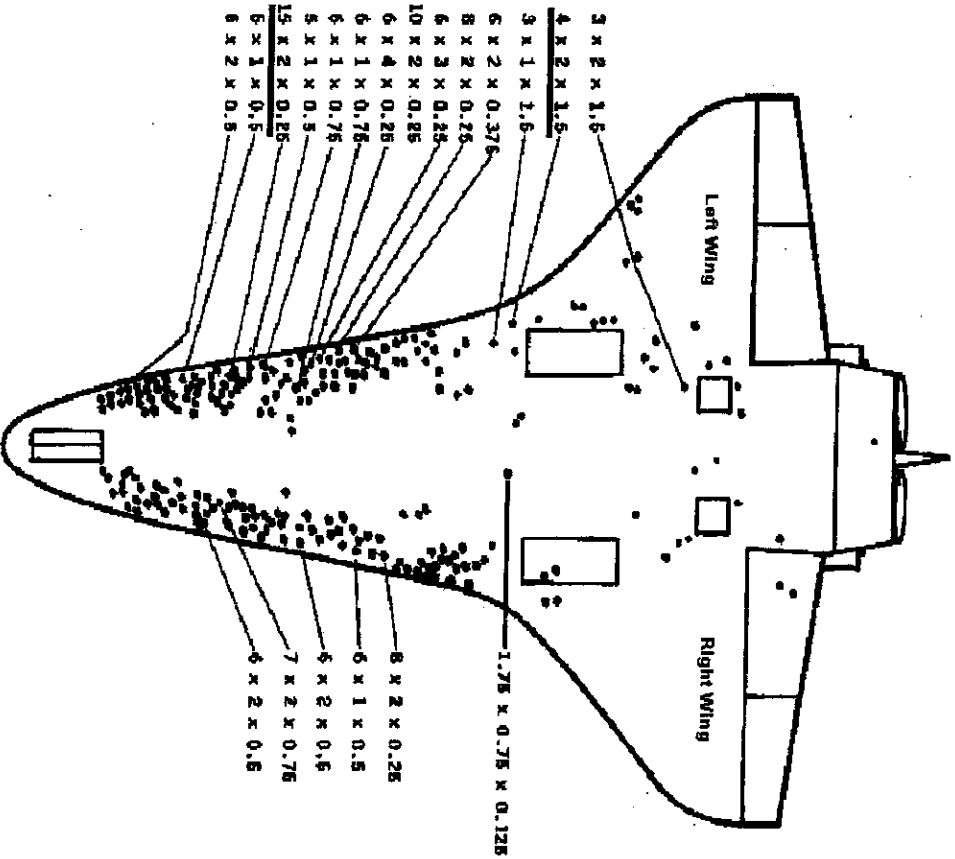
Lower Surface Tile Damage

- OV-102 TPS Sustained a Total Of 308 Hits During STS-87
 - Lower Surface had 244 Hits with 109 Hits > 1" in Length
- Major Damage Area on the Lower Surface Is Between the Nose Landing Gear and Main Landing Gear Doors
 - Largest Damage Located on the Glove Measuring 15"x 2"x.25"
 - Deepest Damage Located Forward of Left Main Gear Door Measuring 4"x 2"x1.5"

- Actual STS-87 Damage Was Determined to be Limited to TPS
 - Flight Data and Tile Removal/Inspection Found No Structural Damage
 - Analysis Simulation Indicates Damage Limited to TPS
 - Analysis Correlates with Observed TPS Surface at Damage Sites Being Near and Just Above Melting Temperatures
 - Structure Temperatures Would Not Exceed Acceptable Limits
- **101 Tiles Are Being Replaced on OV-102**

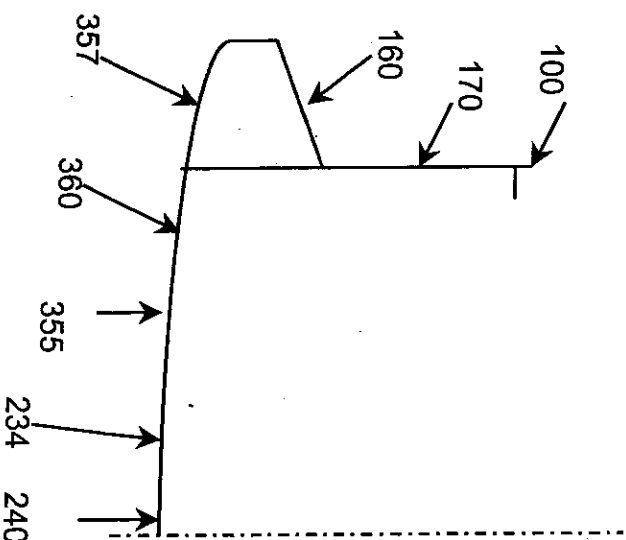
- Simulation with Damage More Severe than STS-87 Significantly Degraded Safety Margins
- 25% Decrease in Tile Thickness in Out Board Panels Gives Large Increase in In-Plane Gradients and Thermal Stresses
- Cannot Achieve Required 1.40 Factor of Safety - Approximate Contingency Capability Is:
 - TAEM - F.S. = 1.0 at 1.8 g's
 - Land - F.S. = 1.2 at 5.5 feet/sec
 - = 1.4 at 3.0 feet/sec

CONCLUDE - With Hypothesized Damage (Second Scenario), Factor of Safety Will Be Less Than 1.0

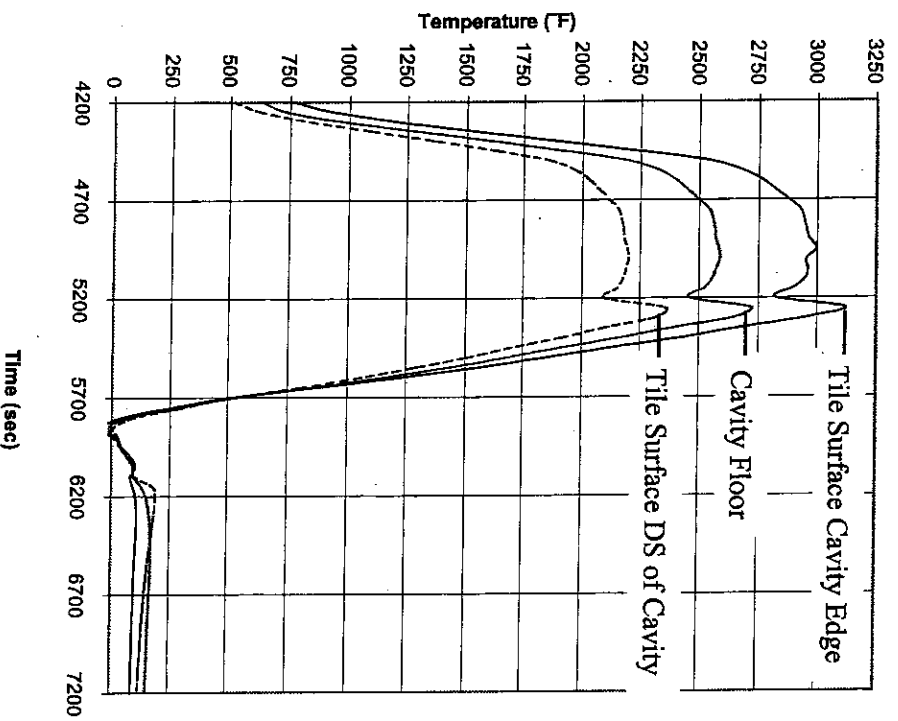
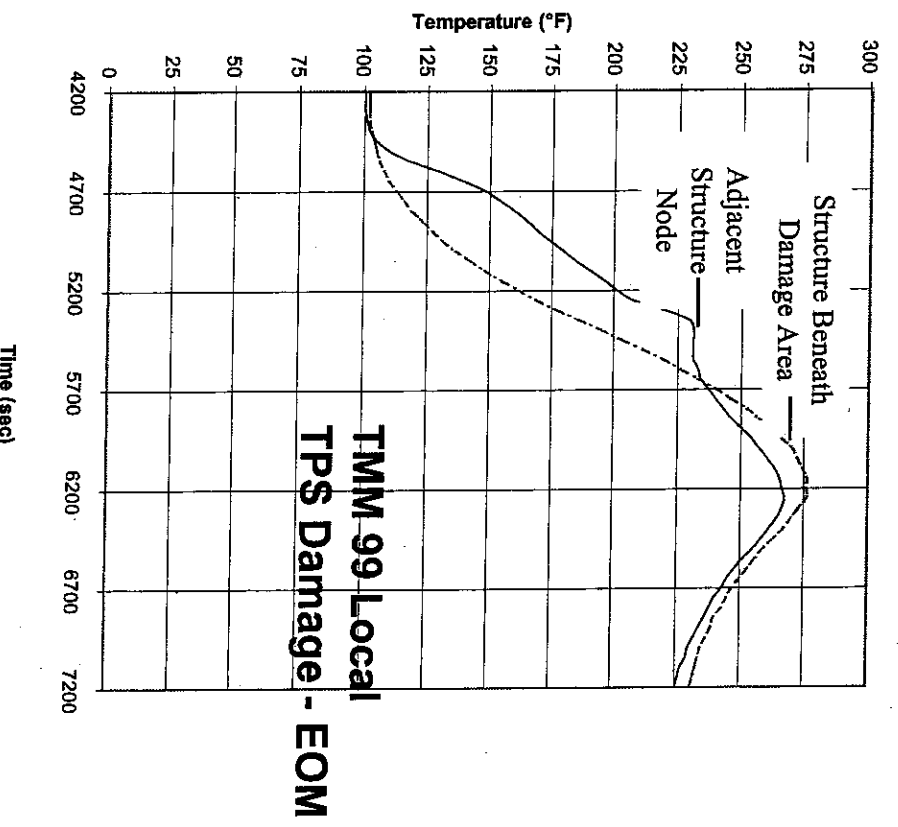
**TMM99 - Wing Glove at X_o 582
 Nodal Configuration**

Location	Tile Damage	Surface Temp	Structure Temp	Comments
TMM 99	Limited Fusing	3100°	276°	No Impact
TMM 352	Limited Fusing	2800°	309°	No Impact

Temperatures Indicate TPS Surface Damage; Structure Okay

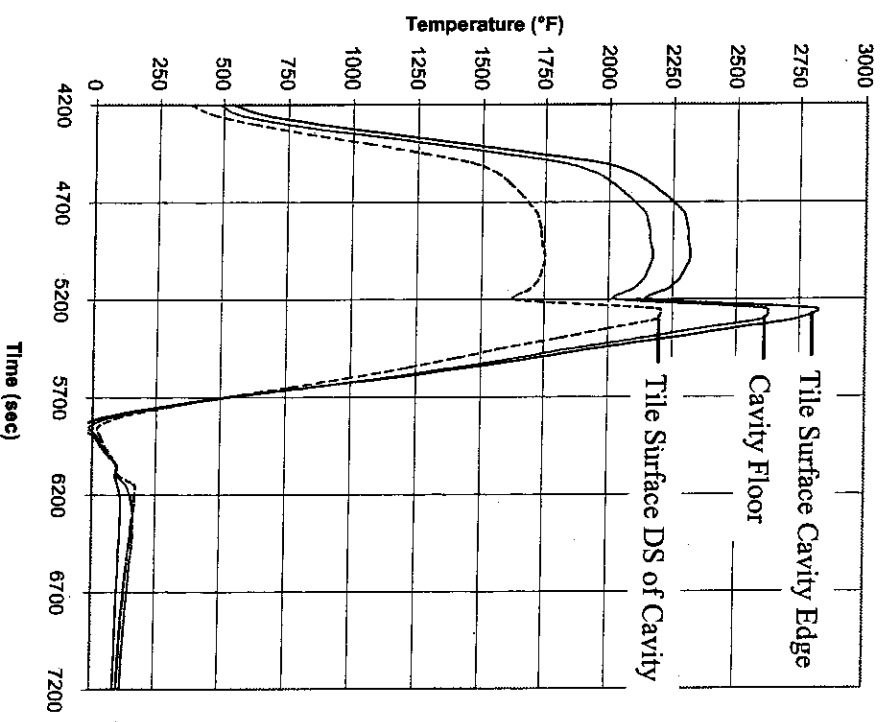
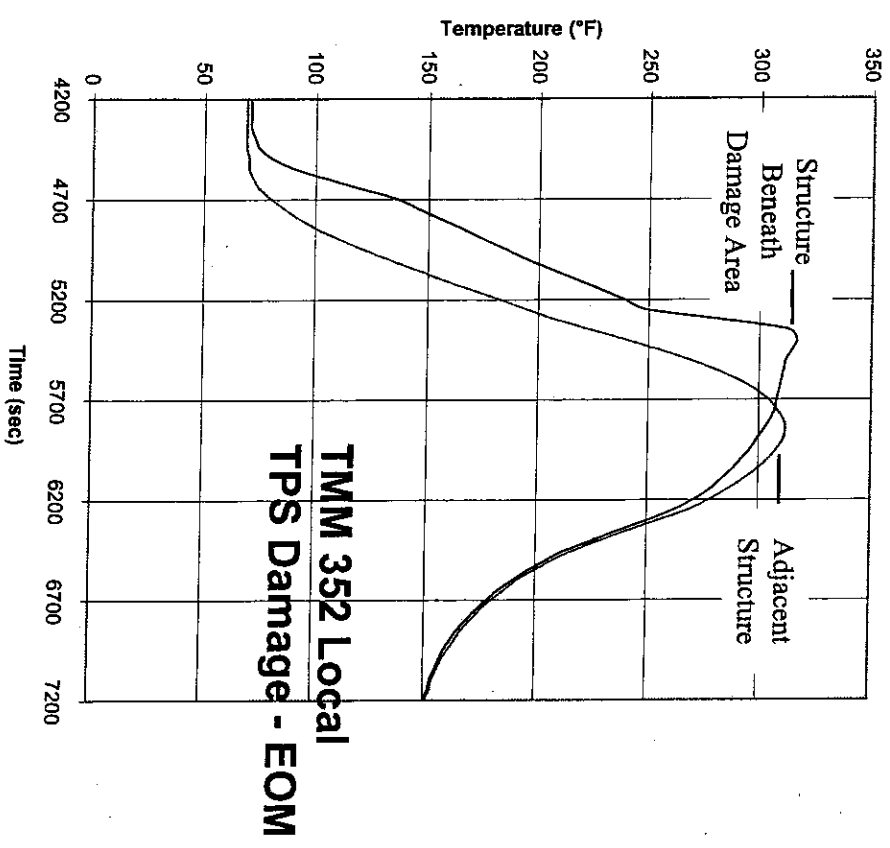
TMM 352 Configuration

Local TPS Surface Damage Expected; Structure Acceptable

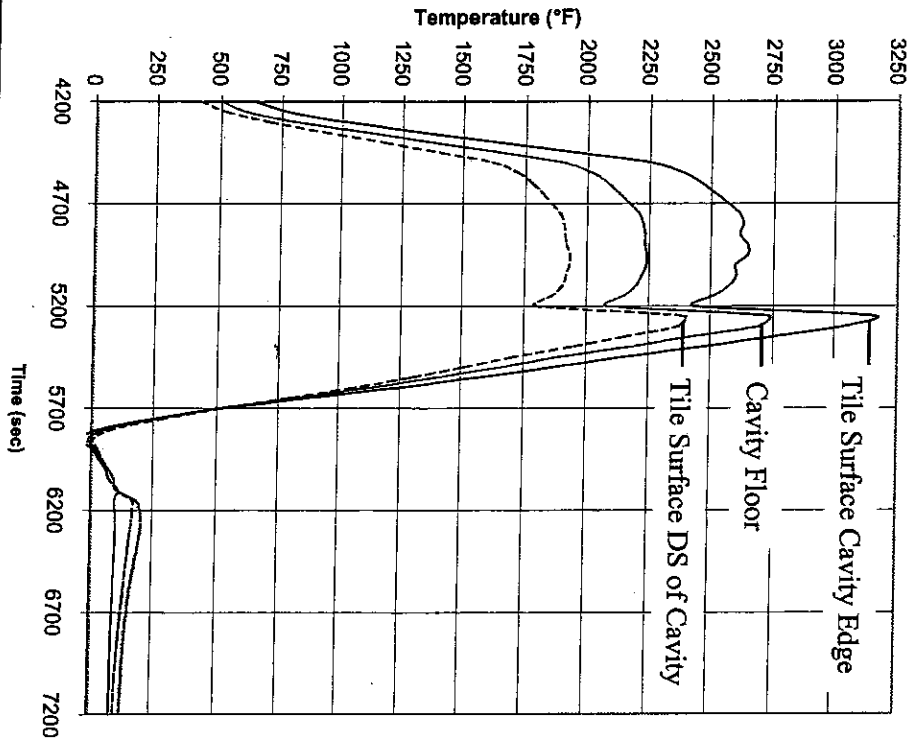
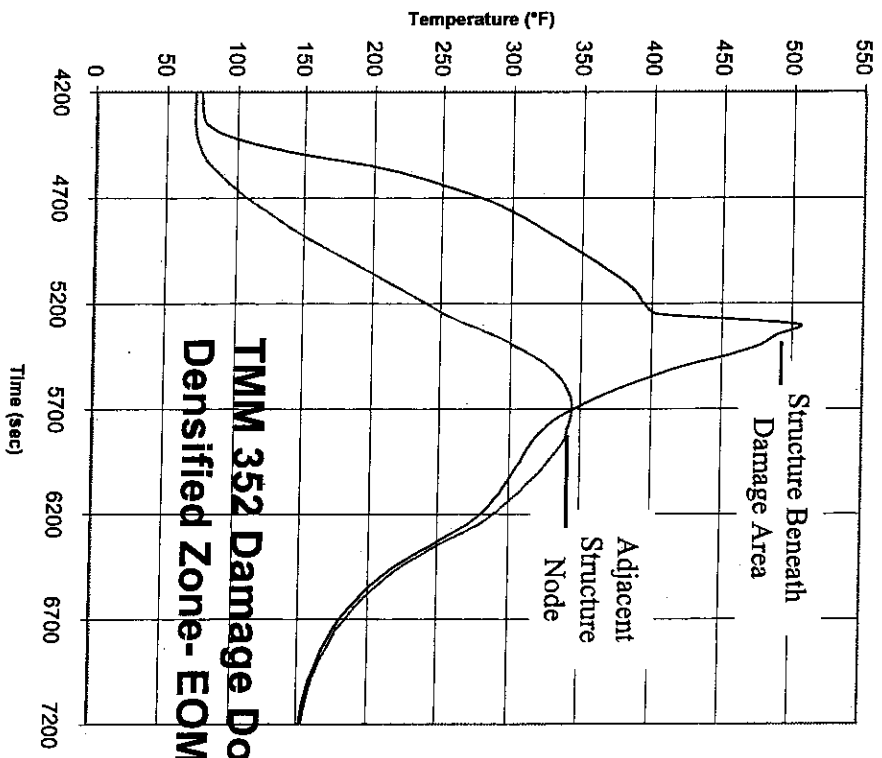
TMM 352 Damage Down to Densified Zone- EOM

Location	Tile Damage	Surface Temp °F	Structure Temp °F	Comments
EOM	TMM 99	Limited Melting	3100	272	No Issue
	TMM 352	Tile Surface Melting	2850	330	No Issue
	• 50% Loss • Loss to Densified	Tile Surface Melting	3150	506	Debond H/C
TAL	TMM 353	Minimal	2420	366	Margin Issue
	TMM 99	Tile Melting Burrowing	3300	195	No Issue
	TMM352 Densified	Minimal	2850	425	Local Structure Damage

Tile Damage to Densified Zone Produces Structural Damage
