Ares I-X 30 Day Report

*Bob Ess, Mission Manager
Marshall Smith, SE&I Chief*

December 3, 2009

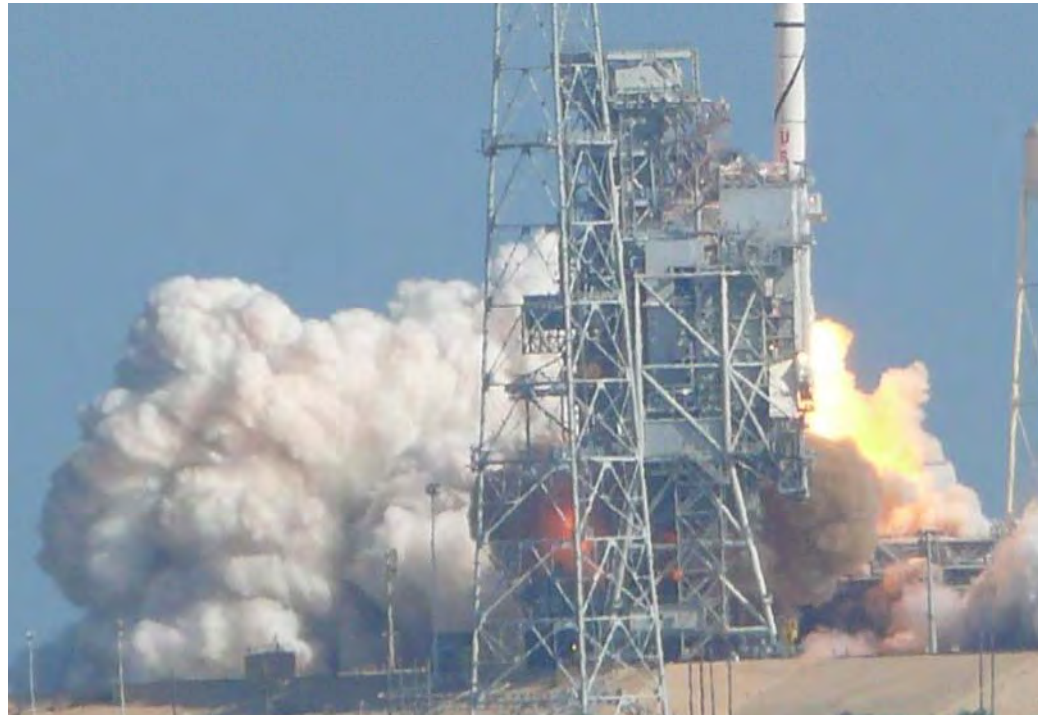
- ◆ **Completely successful Fly Away Maneuver**
 - Designed to protect higher level structures
- ◆ **Minor damage was expected at lower levels**
 - Considered acceptable
 - Shuttle has routinely causes some damage
 - Plume impingement locations were different than Shuttle that had not been hardened yet

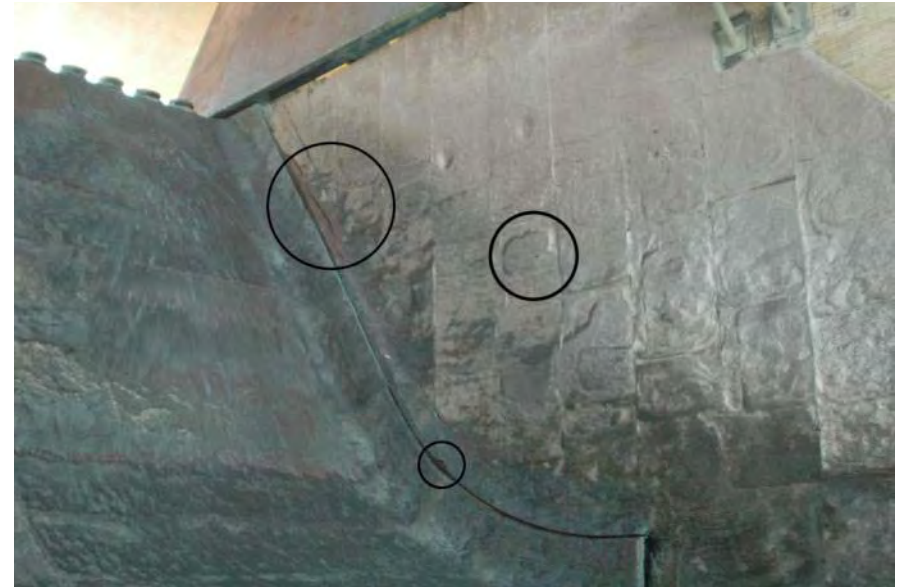
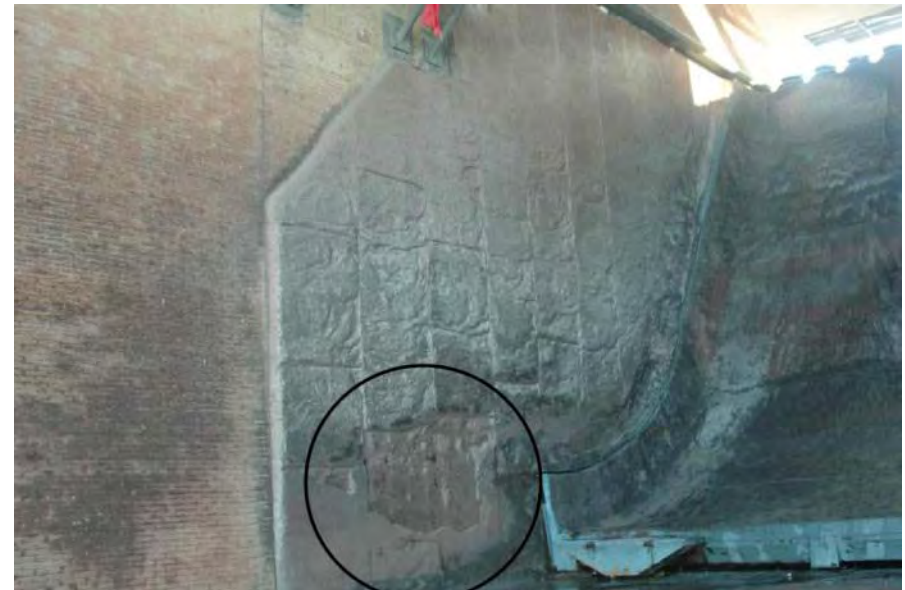
◆ **Also experienced some damage in the flame trench to the fondue fire.**

- West side wall had some damage on the flame fence wall. No obvious brick damage was observed.
- East wall damage was near a suspect location identified in the pre-launch inspection.

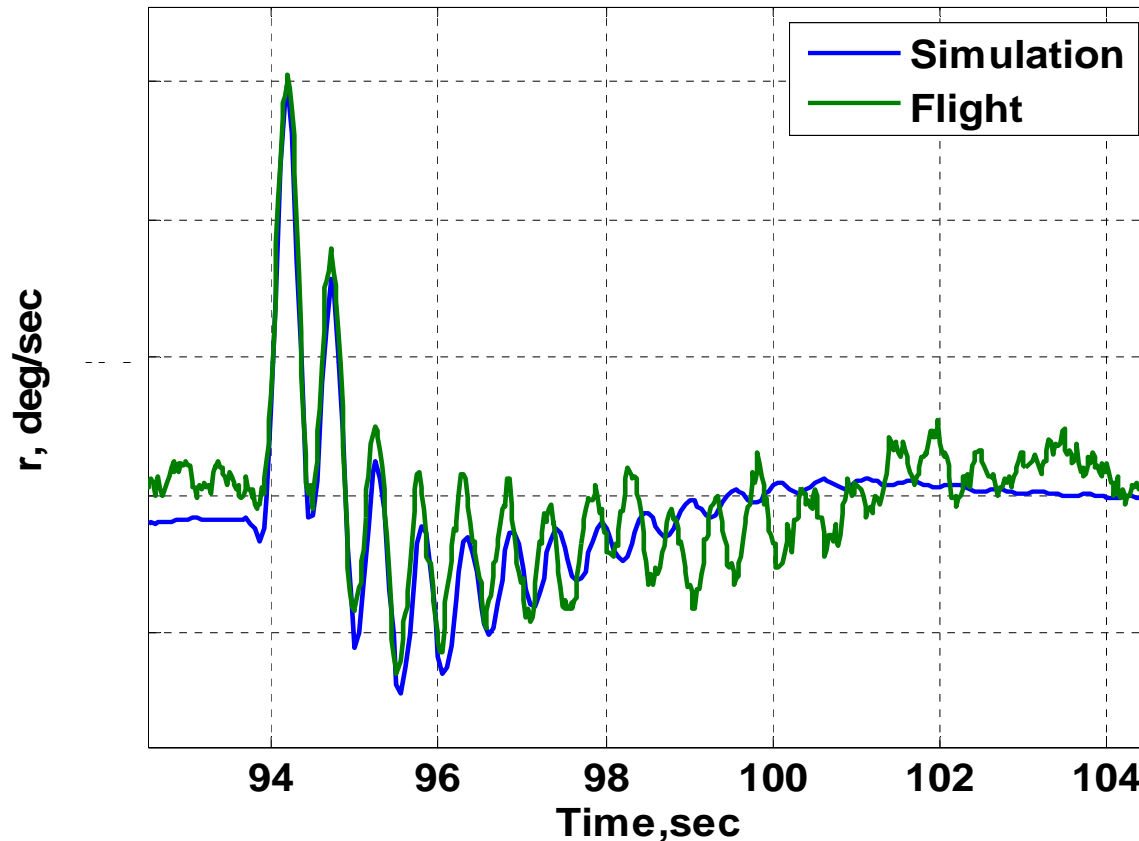
Structural Damping vs. Simulation

- ◆ Quick look shows closed-loop 1st mode flight damping about 20% lower than simulation.

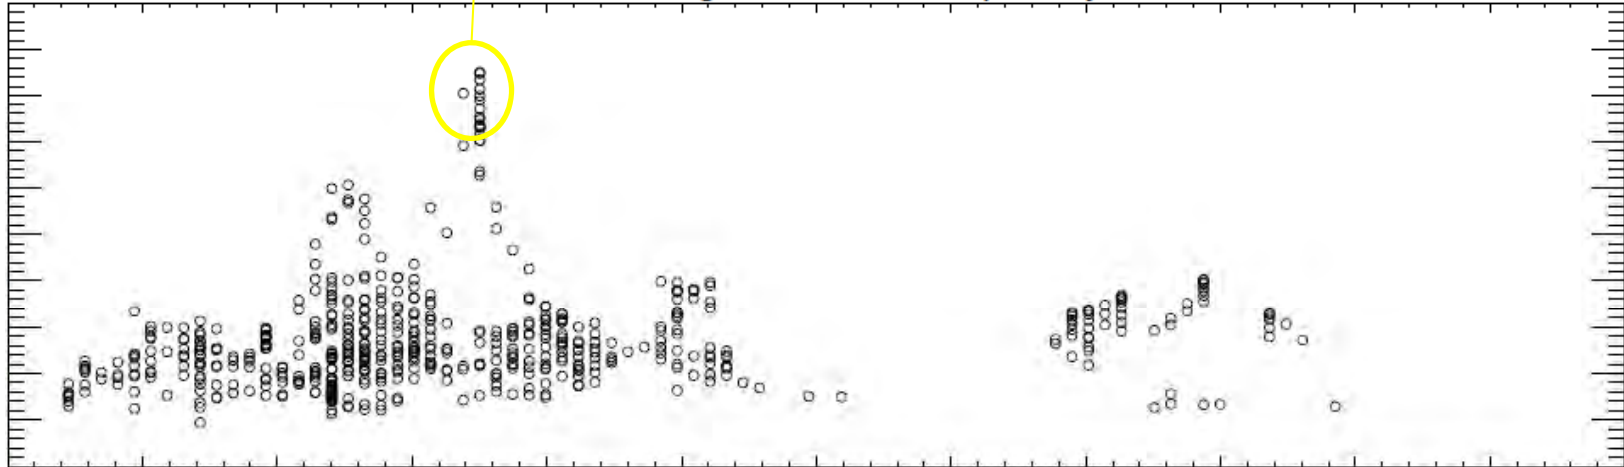
First Thrust Oscillation Mode

- ◆ 1L thrust oscillation peaked between T+77 and T+79 seconds
- ◆ Substantial margin between recommended load and actual load
 - Peak pressure was about 1/3 of the predicted value
 - Frequency was ~15 Hz

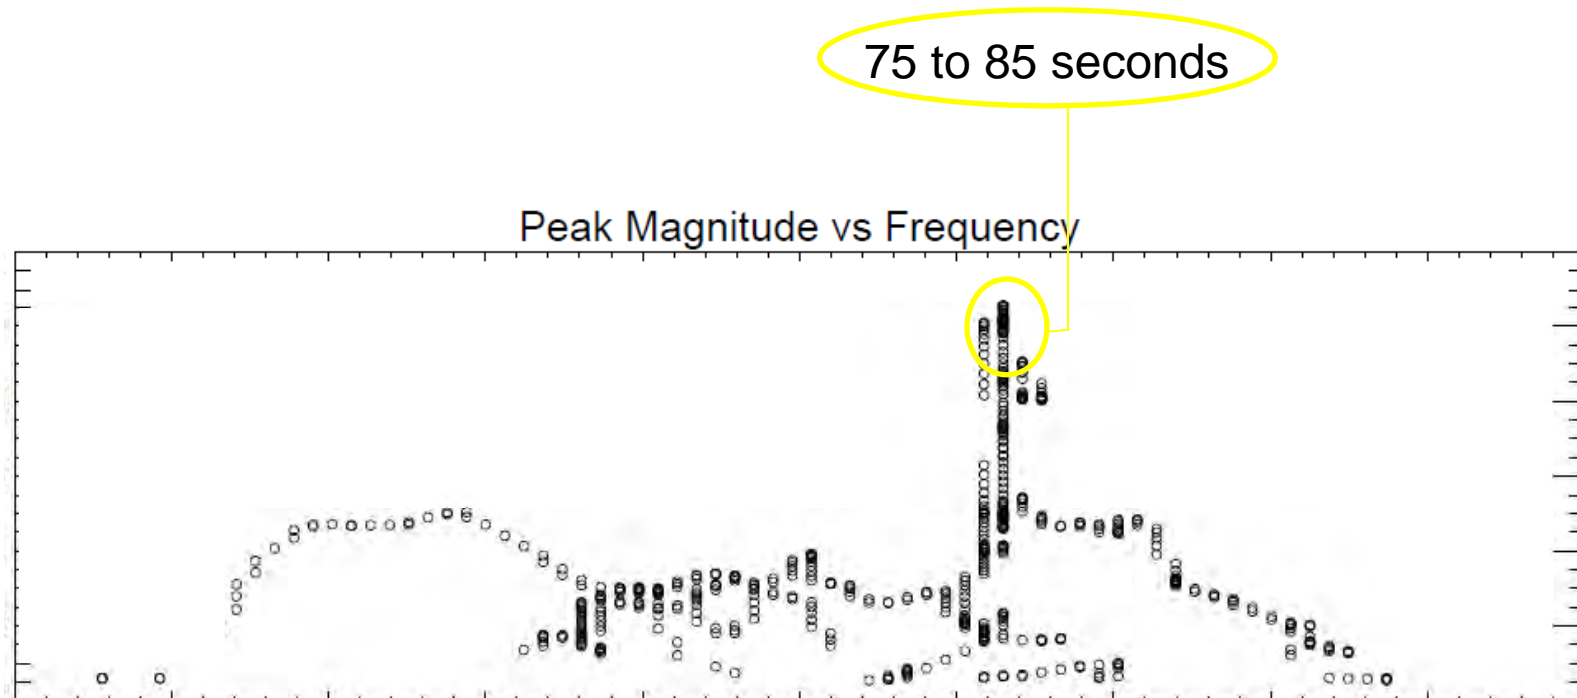
Second Thrust Oscillation Mode

- ◆ 2L thrust oscillation peaked between T+75 and T+85 seconds
- ◆ Substantial margin between recommended load and actual load
 - Peak pressure was about 1/2 of the predicted value
 - Frequency was ~ 29 Hz

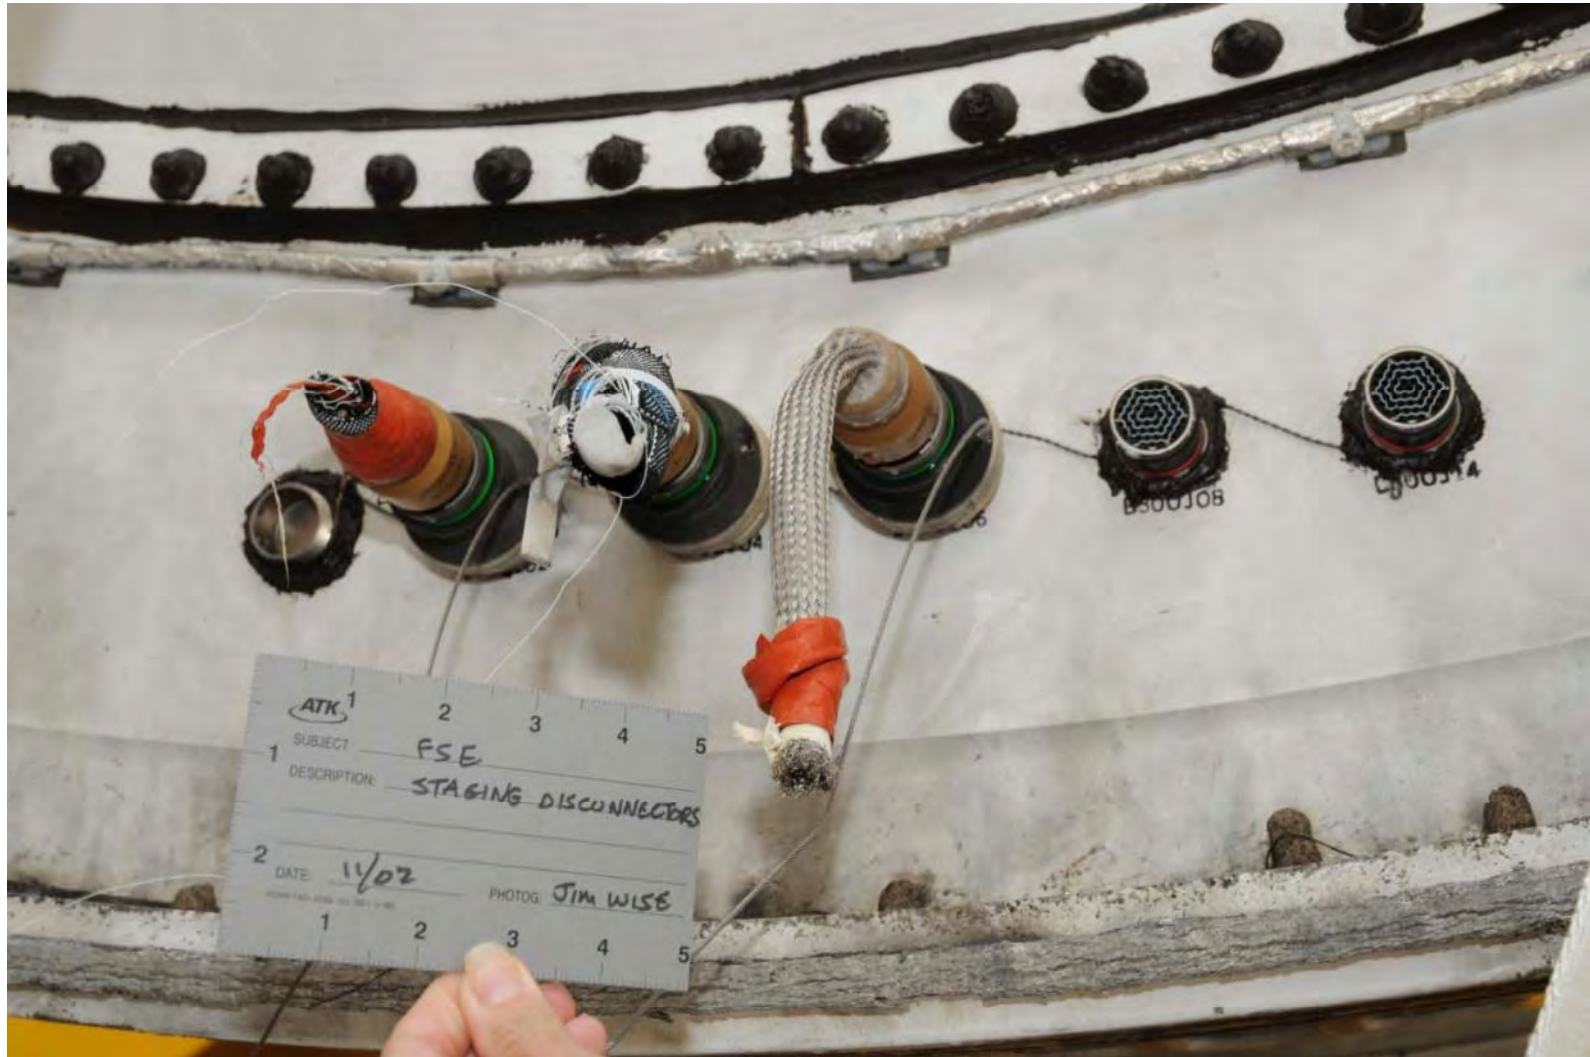
Failed Separation Connectors

- ◆ **Three separation connectors on the Forward Skirt dome did not separate**
 - Pendulum effect under the drogue chute may have caused an off center pull
 - A improper disconnect failure scenario was identified prior to launch and determined not to have any significant effects to the system
 - No loss of functionality of the connectors

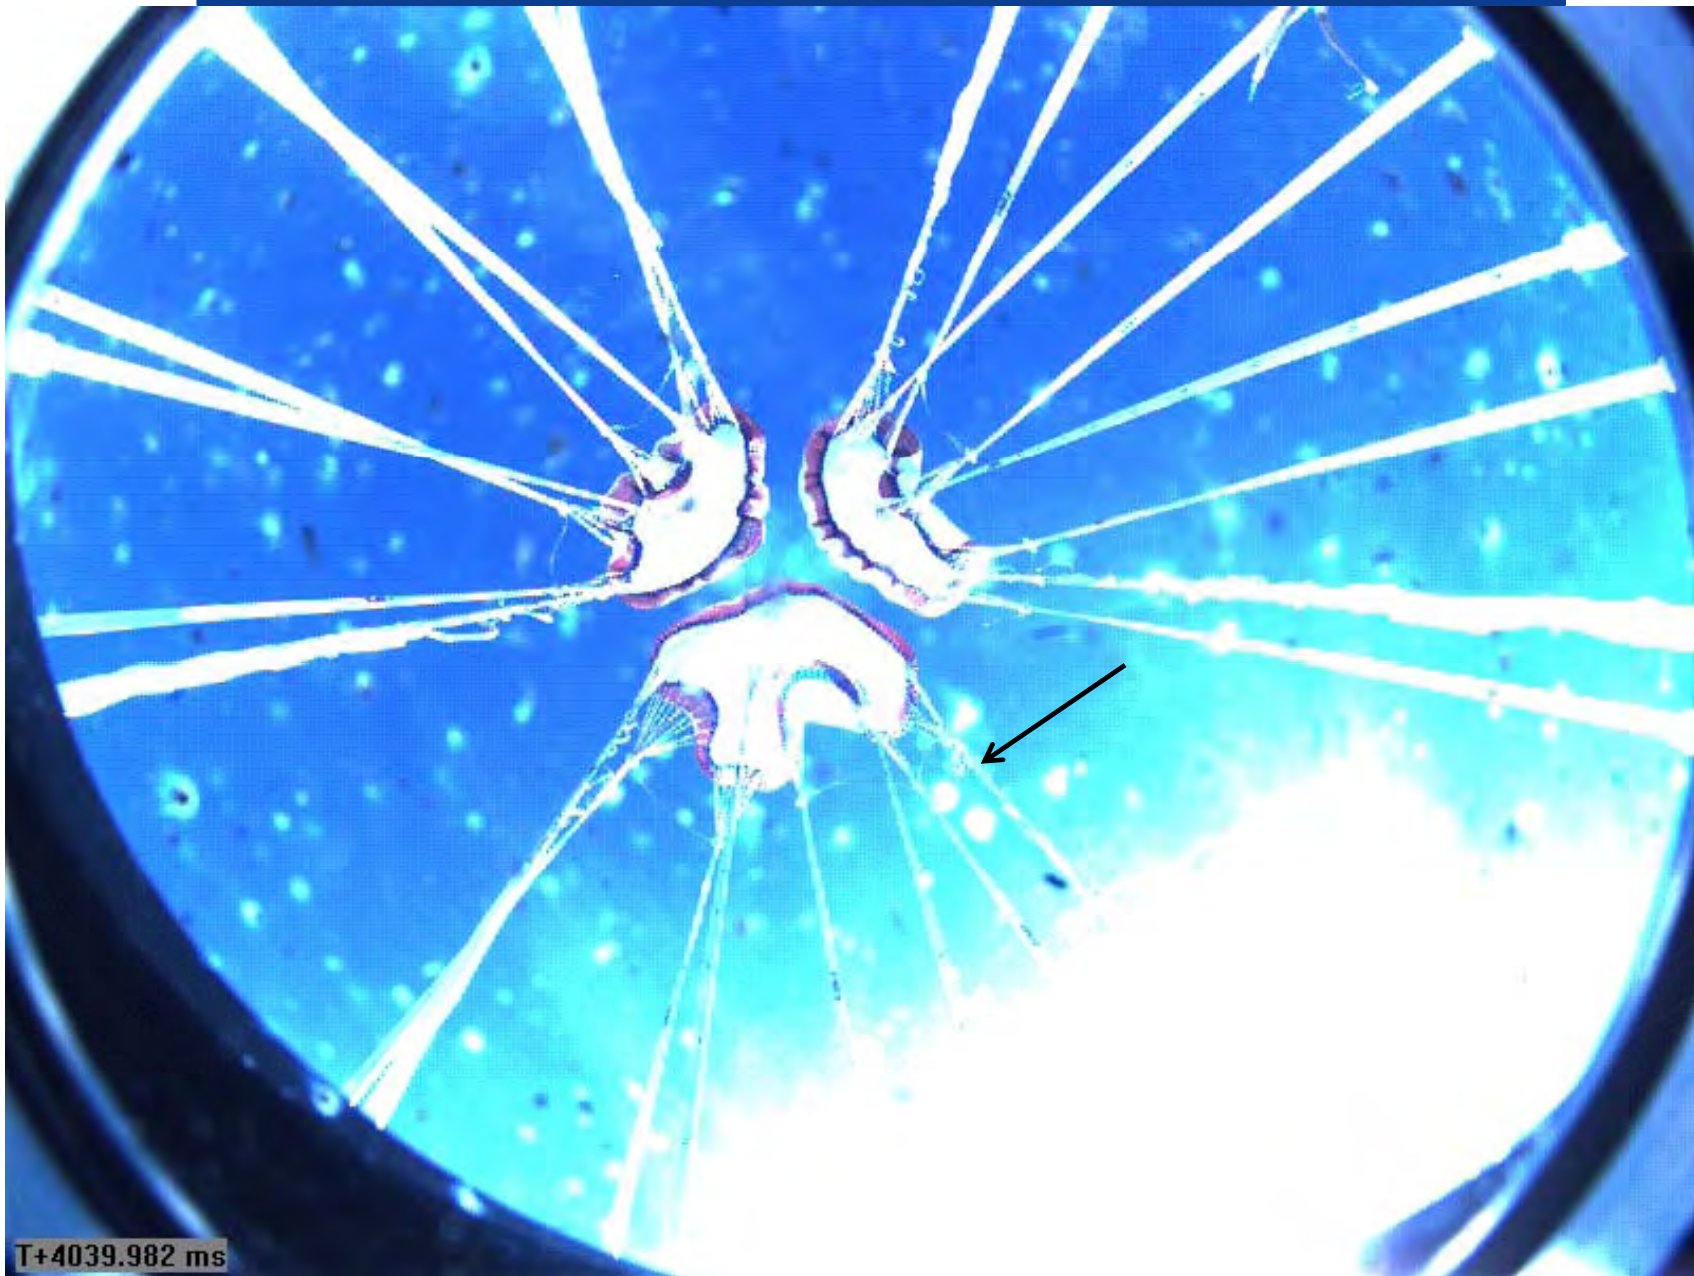
Main Parachute Failure

- ◆ **One of the main parachutes failed at initial inflation**
- ◆ **1st parachute may have “dis-reefed” prematurely allowing parachute to inflate too quickly**
 - Increased initial load on parachute and riser line system
 - Salt Water Activation Release (SWAR) hardware exhibits damage representative of an overload
- ◆ **A second parachute then partially failed**
 - Assessment underway
