So Close Yet So Far: The Jammed Airlock Hatch of STS-80

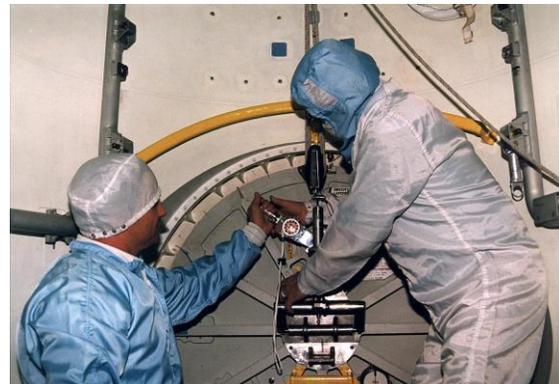
Figure 4: Engineers continue testing on the interior side of the outer airlock hatch to identify malfunctions. NASA Image

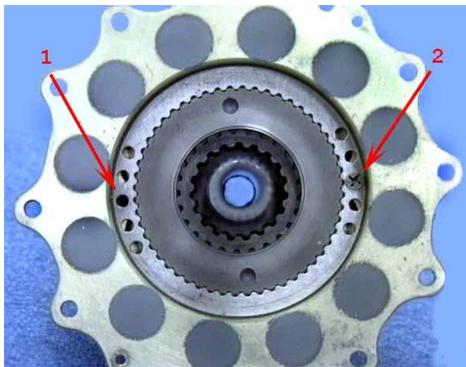
During a post-landing inspection, engineers concluded a faulty actuator assembly was to blame for the malfunction. A new actuator assembly was installed on the orbiter and worked flawlessly. Upon further inspection of the faulty actuator, engineers discovered a screw lodged in between a planetary gear and ring gear in the gearbox. The loose screw originated from a clutch assembly and most likely fell between the gears during launch or once in orbit. A second screw from the clutch assembly was found loose, but caused no operational issues with the actuator.

Engineers also concluded that improper thread inserts were used with the screws, which allowed them to loosen over time and eventually back out of the clutch assembly; non-locking thread inserts were used when design specifications called for locking thread inserts to be used. Additionally, appropriate torque values were not included in the engineering drawings of the assembly.

A detailed maintenance investigation was completed for the faulty actuator. Results determined that the screws were removed and re-installed five times without replacing the proper thread inserts. Investigations performed on the rest of the fleet identified another 12 actuators with improper inserts (some with one locking and one non-locking insert), all of which contained loose screws. As a result, all orbiters were re-fitted with the proper thread inserts and engineering drawings were updated to include torque specifications.

Figure 6: STS-80 actuator assembly showing missing and loose screws. NASA Image

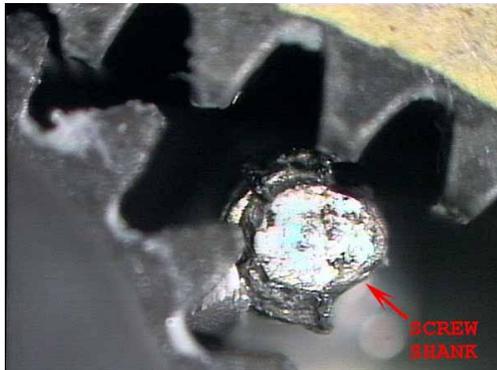
Figure 7: Close-up of jammed screw between ring and planetary gears. NASA Image

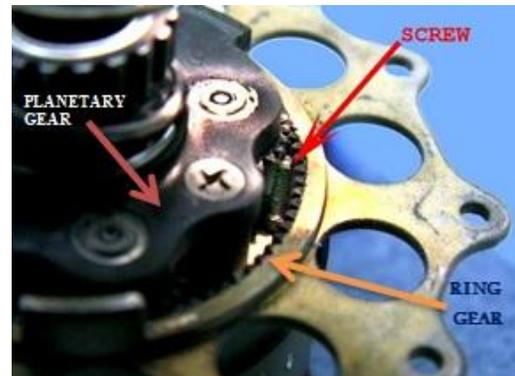
Figure 8: Screw lodged between planetary gear and ring gear. NASA Image
