## ***STS-114: Engine Cut-Off Sensors Are a No-Go***

### **Overview**

#### *Returning to Flight*

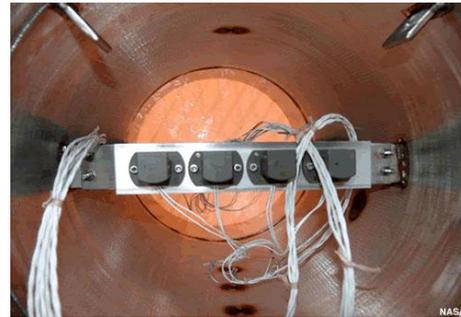
Fig.1. Engine cut-off sensors located at bottom of external tank [2].

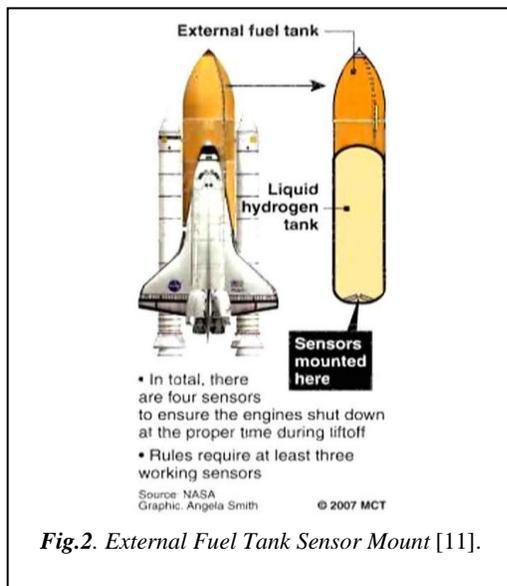
Fig.2. External Fuel Tank Sensor Mount [11].

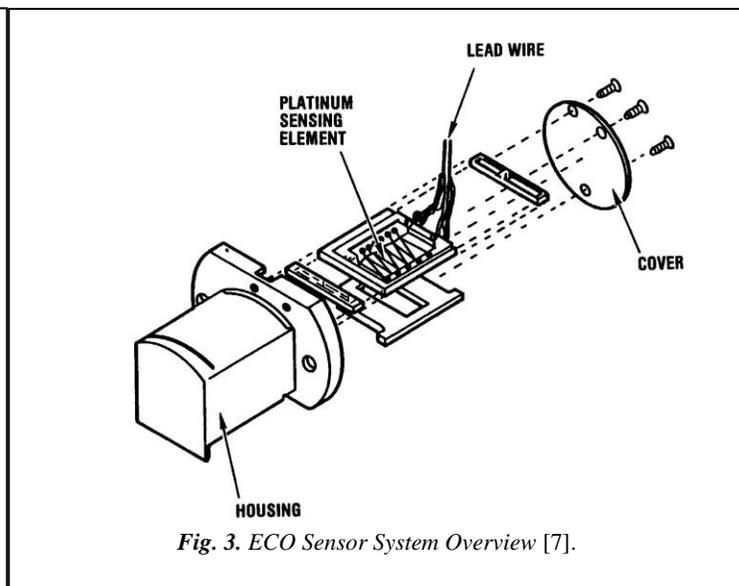
Fig. 3. ECO Sensor System Overview [7].

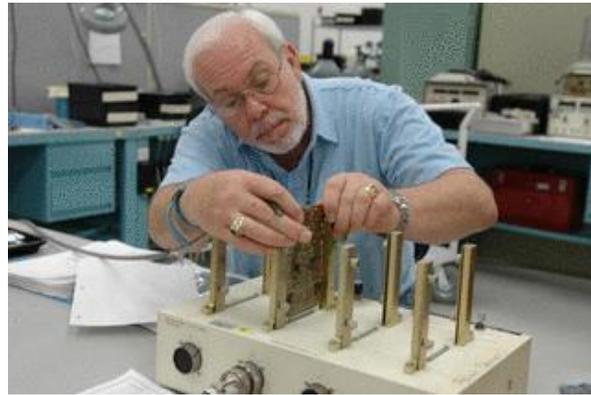
*Fig. 5. NASA test engineer Lloyd Pierce checks electronic components related to the faulty sensor readings in the LH<sub>2</sub> tank low-level fuel cut-off sensor [5].*

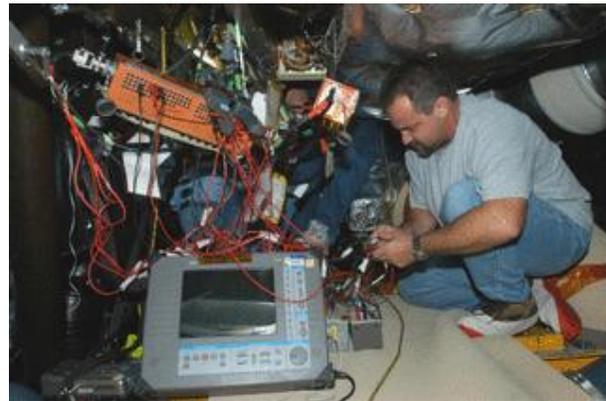
*Fig. 6. Jack Colella, with United Space Alliance, conducts electromagnetic interference and ground resistance testing on wiring in the aft engine compartment on Space Shuttle Discovery [6].*

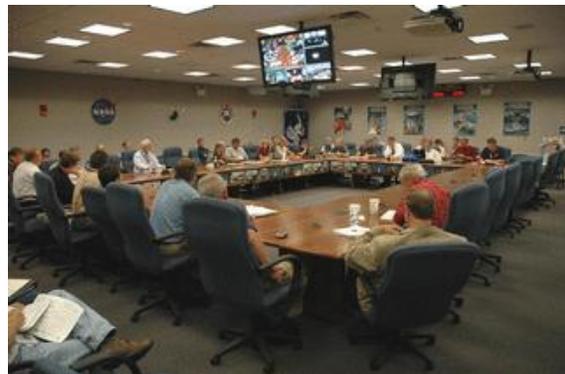
*Fig. 7. Members of the engineering team are meeting in the Launch Control Center to review data and possible troubleshooting plans for the liquid hydrogen tank low-level fuel cutoff sensor [4].*
