SHEtrak: Finding Information

Inspection Type: Construction Inspection

FWR: NNS14AA30T - B-2 Test Stand Restoration Work Package 3

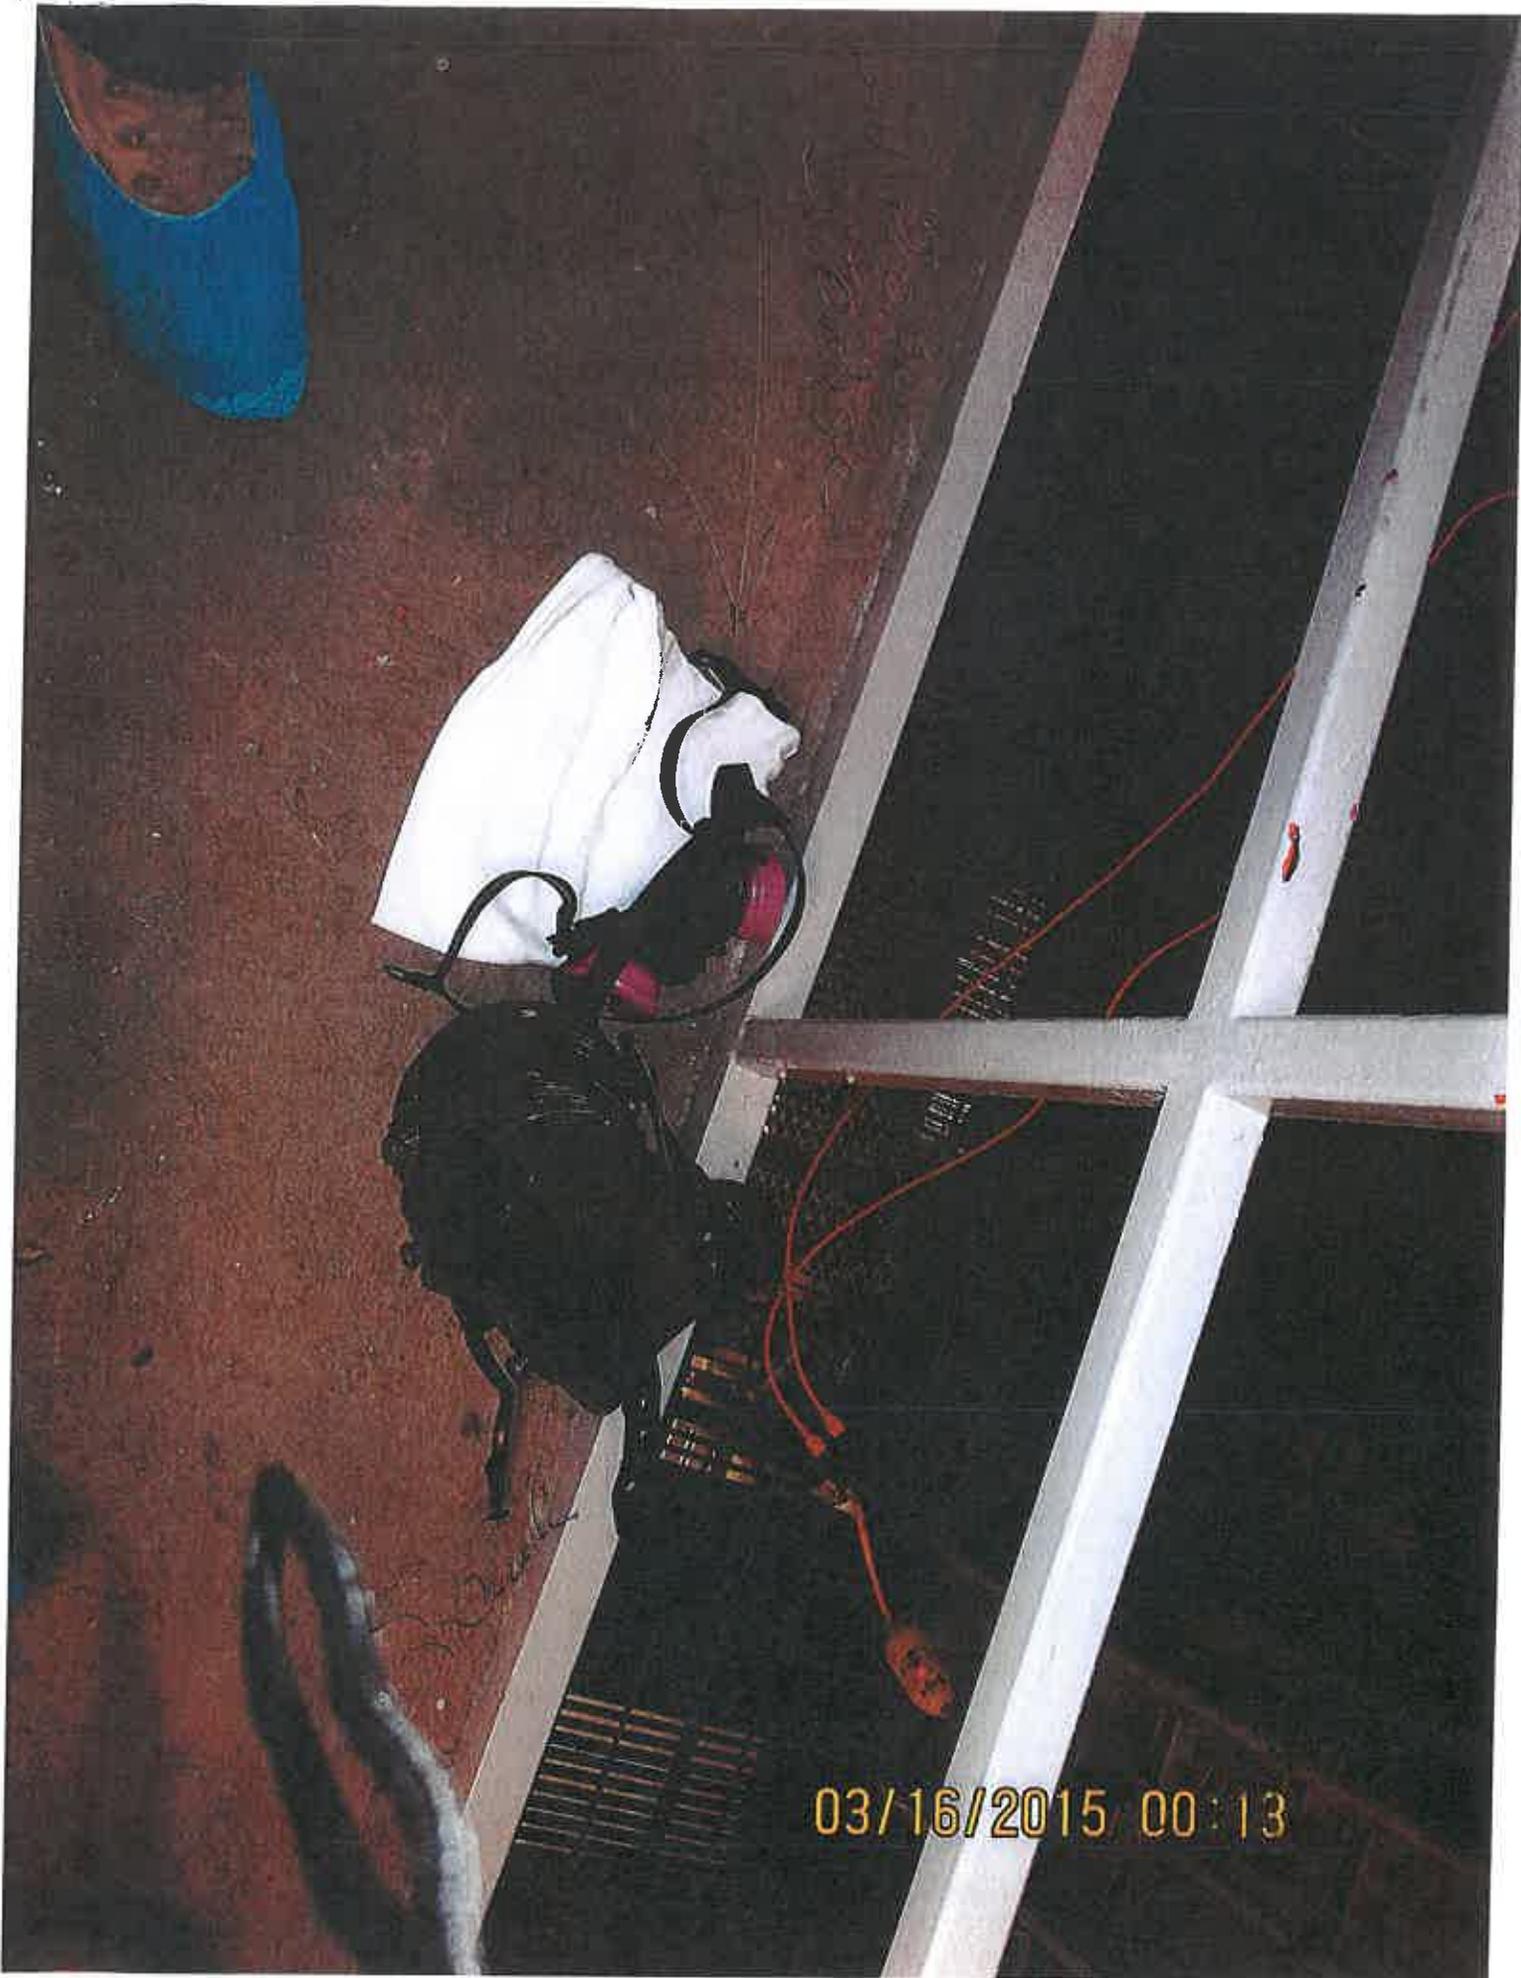
On the afternoon of 3/16/15 (b)(6) and I noticed a respirator lying on the stair landing. I contacted ADS and found the owner of the respirator, all ADS employees were called in for a Safety stand down. We discussed their training and proper storage of equipment. Employees had been provided with a clean one gallon storage bag he failed to use. In the stand down we also discussed where the respirator in the plastic bag is to be stored.

(Proper Respirator Storage.)

The employee was sent home that afternoon not completing his shift and two additional days. This employee will return to Safety office on 3/19/15 for another briefing before returning to the field. Any future safety violations with this employee may end in termination from site.
