ISS EVA 23 Mishap Investigation Board

Media Briefing – 2/26/14

Date of Mishap: 7/16/13

High Visibility Close Call - NASA IRIS Incident No. S-2013-199-00005

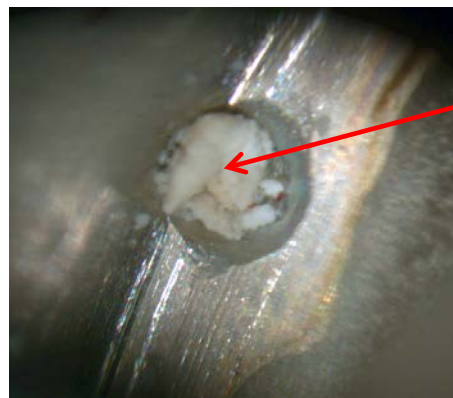
Contamination found in Fan Pump Separator

- The MIB determined that the causes for this mishap evolved from:
 - Inorganic materials causing blockage of the drum holes in the EMU water separator resulting in water spilling into the vent loop.

- **R20 (O-10):** The ISS Program should institute a systematic process of monitoring water quality and chemistry aboard ISS to track changes that can affect critical ISS systems including the EMU, crew health, and multiple ISS systems that use water and are sensitive to its chemical makeup (the oxygen generation system, the water processor assembly, the common cabin air assembly, etc.). This process should include consideration of onboard monitoring capability. It should also include return of any removed hardware to the ground for evaluation.
