## Executive Summary

# Mishaps

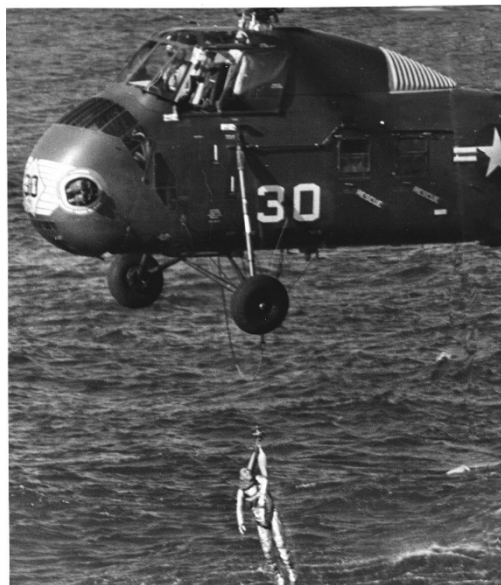
After landing, the spacecraft hatch **pyrotechnic charges prematurely fired**. The crew member was able to escape from the emergency situation, but because of waves flooding the capsule, the capsule sunk. The crew member was **nearly drowned**. The crew member was rescued after three to four minutes in the water.

- Hatch opened prematurely without command, which led to the flooding of the cabin prior to the arrival of rescue crew
- Water ingress through open valve in suit and neck dam

Virgil "Gus" Grissom during recovery following the capsule sinking

- LEA suit should be able to withstand water ingress in the event of a cabin egress during a water landing.

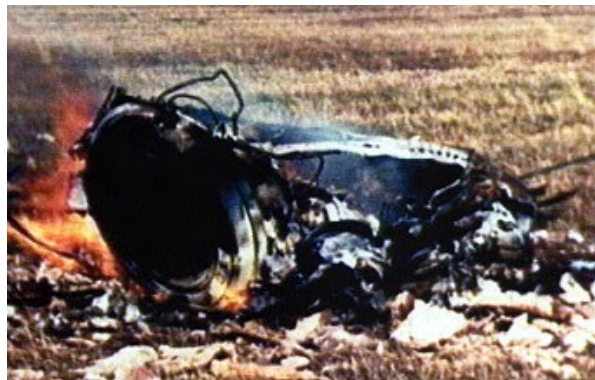
On the maiden flight of the Russian Soyuz spacecraft, the cosmonaut encountered an anomaly with the parachute system. During the descent, the drag chutes successfully deployed, but the **main chutes failed to deploy properly**. Detecting increasing speeds, the computer deployed a backup parachute. Because the drag chute was still attached and failed to release, the backup chute became tangled with the drag chute, preventing the deployment of the backup chute and resulting in a high-speed impact with the ground. **Vladimir Komarov died on impact**.

- Exhaust residue from the attitude control jets fouled the craft's ion orientation sensors, making control difficult
- Drag and main parachutes malfunctioned, entangling the backup parachute as it deployed
- Underlying issues included manufacturing oversight, external political pressures and inadequate preparation

Soyuz 1 shortly after impact

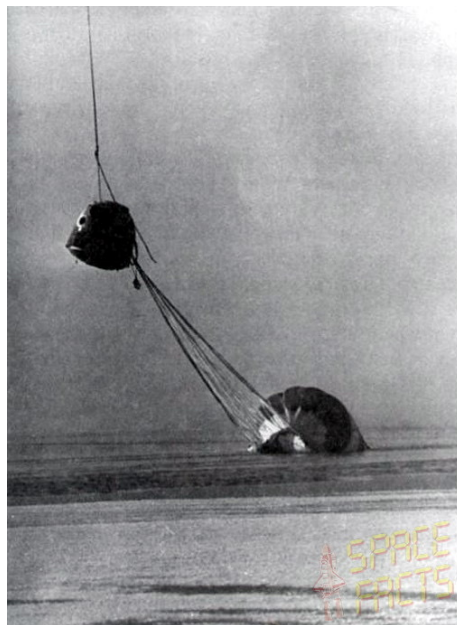
During the attempted docking with Salyut 5, the vehicle suffered an automatic docking system malfunction during final approach. The cosmonauts were ordered to return to Earth. They had less than 2 days of battery power left and had already missed the landing opportunity for that day, so they powered down systems to conserve power. On October 16, 1976 the Soyuz 23 descent module landed in Lake Tengiz, 2 kilometers from shore. The water created an electrical short which caused the reserve parachute to deploy. Parachute lines from the main and reserve parachute kept the capsule lying on its side in the water, preventing the hatch from opening and blocking the air vent.

Transmission antennas became inoperable due to submersion in the water, and the inner walls of the capsule became covered in ice.

Soyuz 23 during recovery (above) and shortly after recovery (below) from Lake Tengiz

- Manual parachute release capability
- Crew recovery operations should anticipate off-nominal landing in rough terrain or locations that could be inaccessible by vehicle or helicopter.

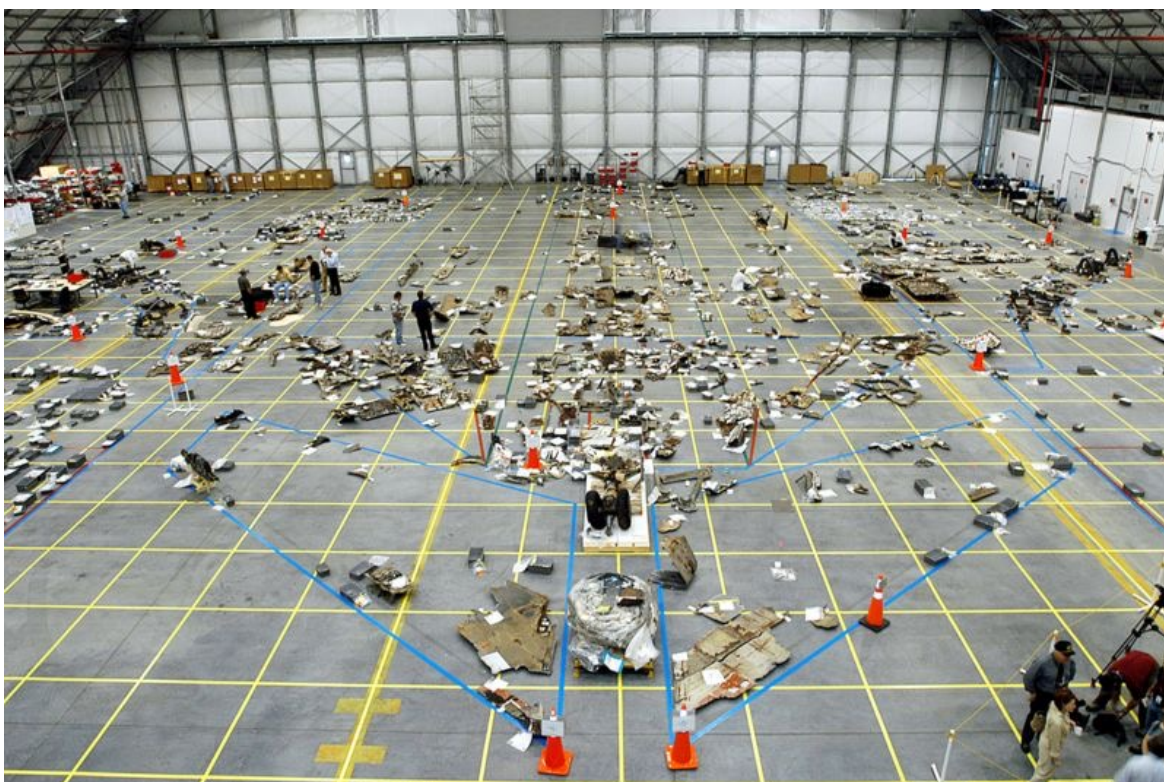
At 81.7 seconds Mission Elapsed Time a piece of foam insulation from the External Tank (ET) left bipod ramp separated from the ET and struck the orbiter left wing leading edge in the vicinity of the lower half of reinforced carbon-carbon (RCC) panel #8, causing a breach in the RCC. During re-entry this breach allowed super-heated air to penetrate through the leading-edge insulation and progressively melt the aluminum structure of the left wing, resulting in a weakening of the structure until increasing aerodynamic forces caused loss of control, failure of the wing, and break-up of the orbiter. This breakup occurred in a flight regime in which, given the design of the orbiter, there was no possibility for the crew to survive.

Hanger housing the Columbia recovery during the accident investigation.
