Industry Recommendations from Arecibo Observatory Zinc Spelter Socket Joint Failure Analysis

A structural analysis and forensic investigation concluded that the Arecibo Observatory M4N socket joint failure in August 2020 was primarily due to cumulative damage caused by initially low structural design margins and a high percentage of sustained load, resulting in zinc creep deformation, progressive internal socket wire damage, and eventual loss of joint capacity. Open spelter sockets of this type are used throughout industry in stay cables. Recommendations are proposed to prevent failures of similar socket joints, including verification of positive stress margins in socket joint wires for all failure modes, periodic visual inspections with pass/fail criteria for zinc extrusion that are tied to structural qualification, and revisiting codes/industry standards to capture lessons learned.

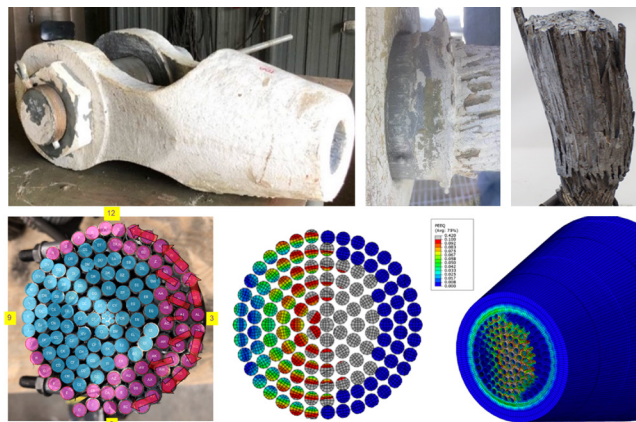
NASA structural analysis and forensic investigation concluded that the M4N Arecibo socket joint failure was primarily due to cumulative damage caused by initially low structural design margins and a high percentage of sustained load, leading to zinc creep deformation, progressive internal socket wire damage, and eventual loss of joint capacity. Visual inspections identified progressive zinc extrusion, which in hindsight was evidence of cumulative damage due to creep [1].

Finite element analysis and forensic investigation of an open conical zinc spelter socket with 1x127 cable strand showed non-uniform stress distribution across wires at half the cable breaking load, with outer wires stressed near ultimate strength but with residual elongation capability.

Analysis also showed that in applications with a high percentage of sustained (dead) load and a design factor of safety of approximately 2, there is a greater potential for zinc creep. Creep will visually manifest as zinc extrusion from the socket and was shown to further reduce wire capacity at the socket termination.

Figure 1: NASA Investigation of failed Arecibo Aux M4N cable. Top: socket (left); zinc extrusion (center); pulled out cable (right). Bottom: forensic and finite element model recreation of M4N failure progression.

1. Socket joint constituents should be verified to have positive structural margins for strength, fatigue, and creep failure modes for the service life of the socket for all design load combinations.
2. Periodic visual inspection of socket joints should include pass/fail criteria for zinc extrusion tied to a structural qualification test program that verifies the creep failure mode. Qualified processes such as cable replacement and socket joint refurbishment should then be defined to restore joint capacity in the event of failed inspection.
3. ASCE 19-10 and 19-96 codes should be revisited to ensure that the design factors consider time-dependent creep effects in dead load dominated structures, environmental conditions, and workmanship sensitivity to wire defects or brooming.
