# Investigation of Shuttle and Orion Reentry Temperature Anomalies

MIKE SQUIRE – NASA ENGINEERING AND SAFETY CENTER (NESC) SPACECRAFT ANOMALIES AND FAILURES WORKSHOP MARCH 29, 2023

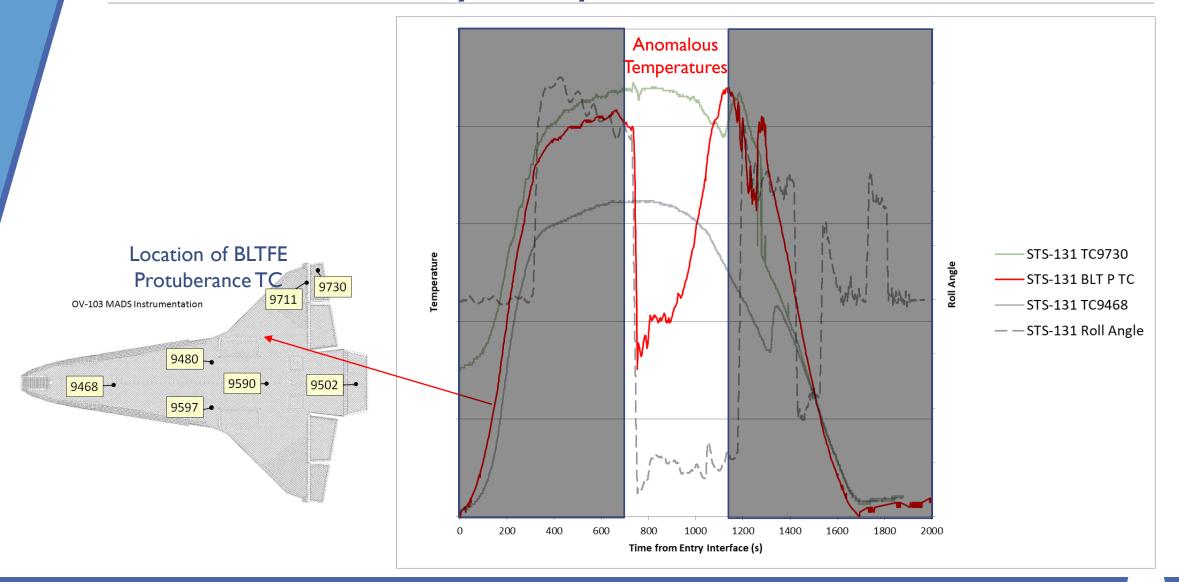
# Anomalous Entry Temperatures

Rapid apparent temperature increase or decrease coincident with first roll reversal

Occurred near peak entry heating around Mach 23-7, ~400-1200 seconds after entry interface (EI), ~76-46 km altitude

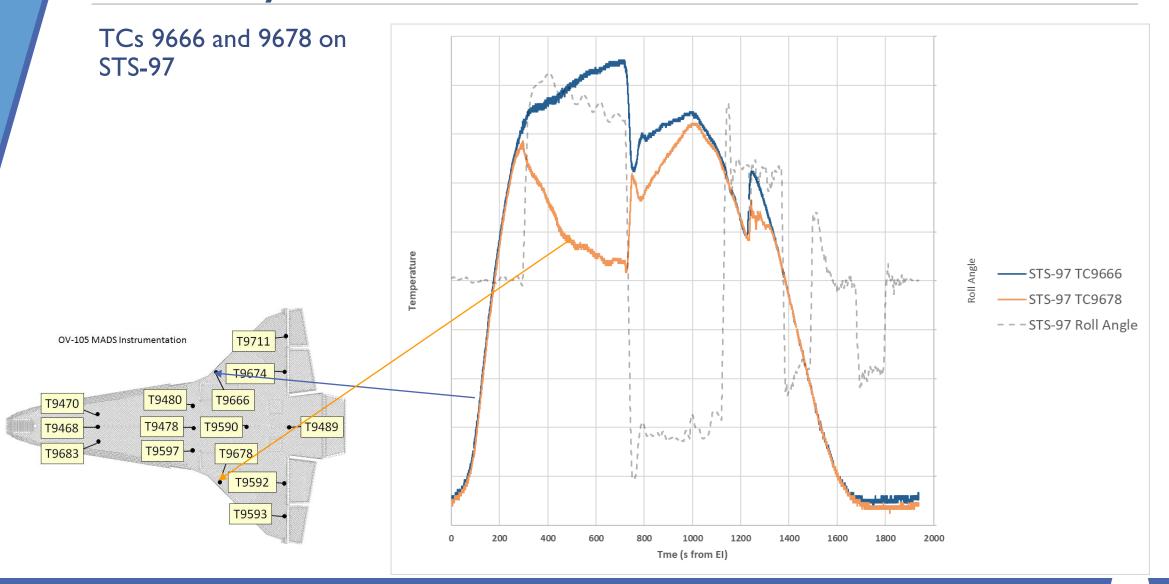
# Varies by Installation Location

Anomalies occurred on several different TCs, but not all

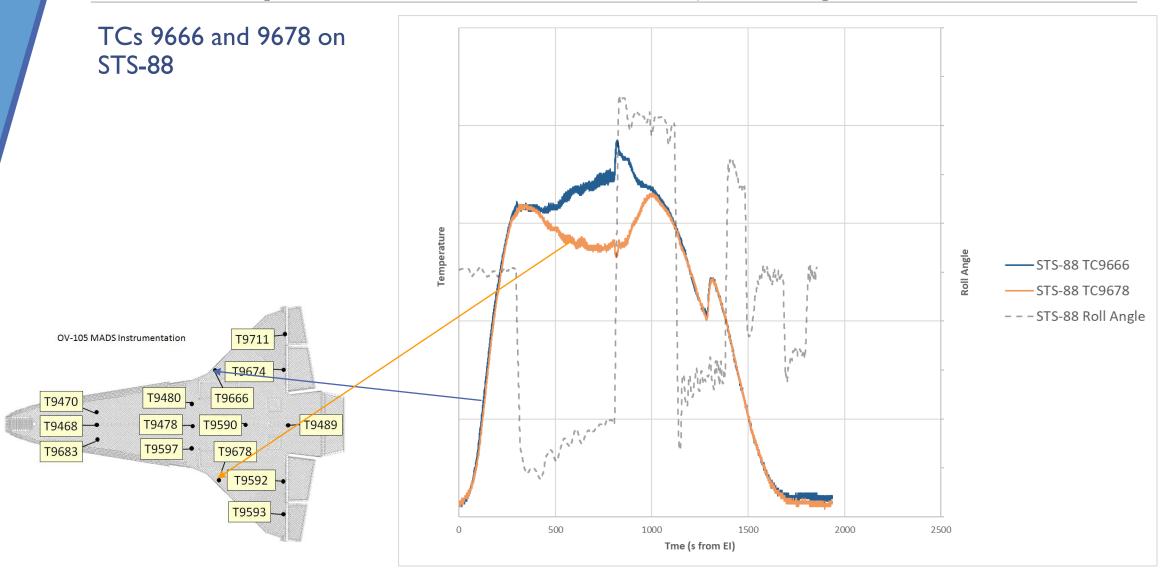
# Varies by Roll Order and Trajectory

Missions with comparable entry trajectories tend to have comparable anomaly signatures

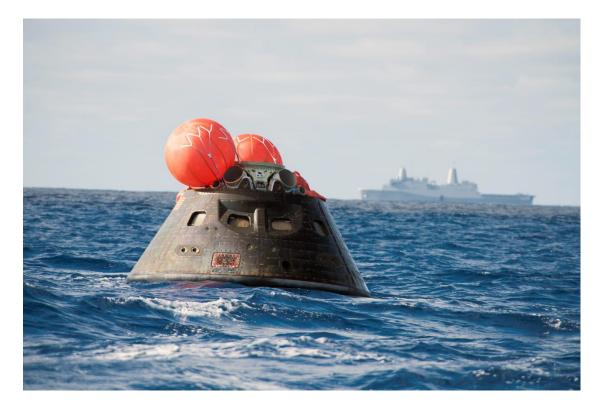
# **EFT-I** Anomaly

Temperature anomalies also on the Orion heat shield TCs for EFT-I entry

Temperature oscillations corresponding to small crew module roll oscillations

Like the Shuttle anomaly, probable cause was introduction of direct current

Mechanism driven by turbulent flow over TCs

Electrical path provided by products from heat shield ablation

TC alignment relative to flow important

Anomaly increased and decreased as vehicle oscillation brought TC in and out of turbulent regions

Align TC perpendicular to plasma flow

Electrically insulate wires as much as possible

Orient the TC loop into an "L" or "T" to cancel out anomaly
