Mishaps During Entry, Descent, and Landing

OCHMO-TB-039

Rev B

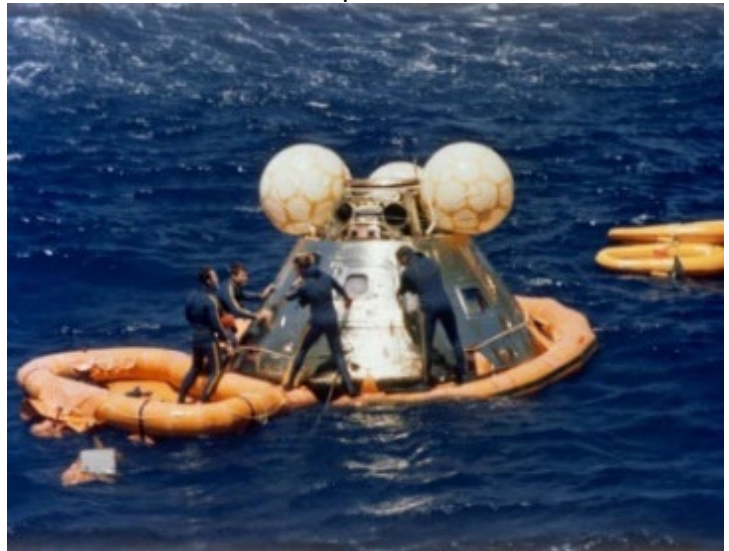
As the spacecraft descended, the commander, who was reading the checklist, failed to tell the command module pilot to move the Earth Landing System auto/manual switch to auto. The crew saw that the spacecraft was well below the deployment altitude and proceeded to manually deploy the chutes. Drogue chutes were deployed manually at 18,550 feet instead of 23,500 feet as the automatic system would have done. At 10,000 feet the commander realized that Earth Lander System (ELS) was not in AUTO and quickly switched ELS Logic and AUTO, deploying the main parachutes at 7,150 feet and disabling the Reaction Control System (RCS) instead of 10,500 feet. The RCS was not disabled manually (RCS command switch turned to “off”) at this time. It was disabled manually at 16,000 feet instead of when the checklist indicated at 24,000 feet, which was due to the alarm noise levels leading to the inability to communicate properly to initiate the command. The cabin pressure relief valve opened automatically at 24,500 feet.

During a 30-second period of high thruster activity after drogue parachute deployment, a mixture of air and propellant combustion products followed by a mixture of air and nitrogen tetroxide oxidizer (N_2O_4) vapors were sucked into the cabin. One of the positive roll thrusters is located only two feet away from the steam vent that pulls in outside air when the cabin relief valve is open. This exposed the crew to a high level of N_2O_4 since emergency oxygen masks were not available until landing. The pilot passed out, but the commander quickly put the oxygen mask on him and he was revived. The exposure resulted in a two-week hospital stay for the crew after landing.

- Failure to follow a time-critical procedure in a tightly coupled system
- The noise from an alarm caused communication difficulties between the crew and it could not be confirmed if the switch was thrown
- Nitrogen tetroxide (N_2O_4) flooded the cabin when the cabin pressure relief opened, which was due to the closure of the propellant isolation valves from crew not activating the ELS at the correct altitude – cabin pressure relief valve was located two feet from the positive RCS roll thrusters

Rescue team with ASTP Apollo command module during recovery

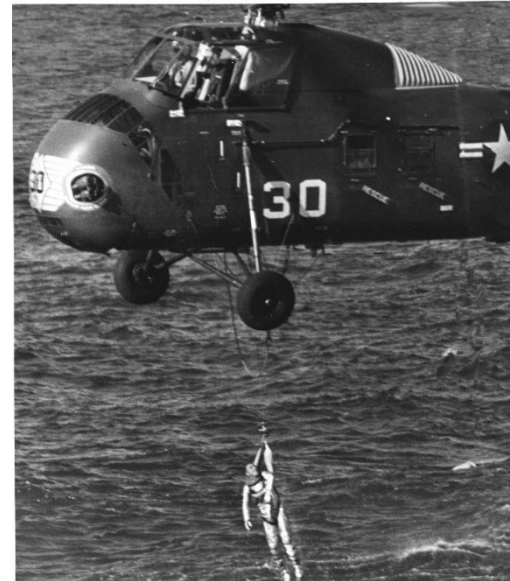
After landing, the spacecraft hatch pyrotechnic charges prematurely fired. The crewmember was able to escape from the emergency situation, but because of waves flooding the capsule, the capsule sunk and the crew member was nearly drowned. The crewmember was rescued after three to four minutes in the water.

- Hatch opened prematurely without command, which led to the flooding of the cabin prior to the arrival of rescue crew
- Water ingress through open valve in suit and neck dam

Virgil "Gus" Grissom during recovery following the capsule sinking

- LEA suit should be able to withstand water ingress in the event of a cabin egress during a water landing.

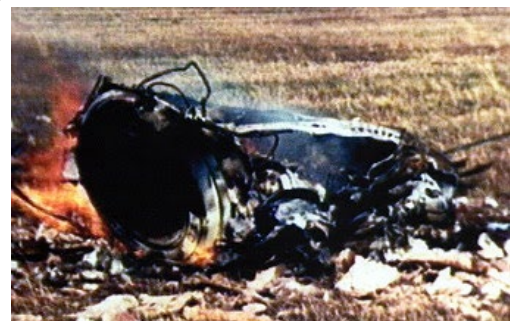
On the maiden flight of the Russian Soyuz spacecraft, the cosmonaut encountered an anomaly with the parachute system. During the descent, the drag chutes successfully deployed, but the main chutes failed to deploy properly. Detecting increasing speeds, the computer deployed a backup parachute. Because the drag chute was still attached and failed to release, the backup chute became tangled with the drag chute, preventing the deployment of the backup chute and resulting in a high-speed impact with the ground. Vladimir Komarov died on impact.

- Exhaust residue from the attitude control jets fouled the craft's ion orientation sensors, making control difficult
- Drag and main parachutes malfunctioned, entangling the backup parachute as it deployed
- Underlying issues included manufacturing oversight, external political pressures and inadequate preparation

Soyuz 1 shortly after impact

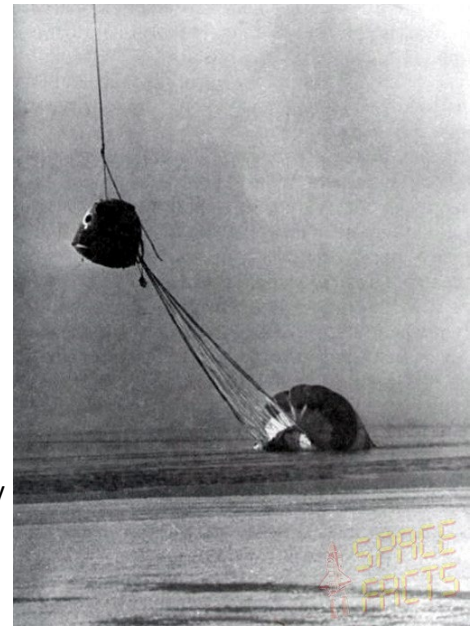
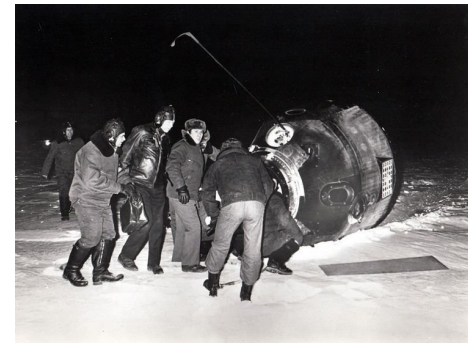
During the attempted docking with Salyut 5, the vehicle suffered an automatic docking system malfunction during final approach. The cosmonauts were ordered to return to Earth. They had less than 2 days of battery power left and had already missed the landing opportunity for that day, so they powered down systems to conserve power. On October 16, 1976 the Soyuz 23 descent module landed in Lake Tengiz, 2 kilometers from shore. The water created an electrical short which caused the reserve parachute to deploy. Parachute lines from the main and reserve parachute kept the capsule lying on its side in the water, preventing the hatch from opening and blocking the air vent. Transmission antennas became inoperable due to submersion in the water, and the inner walls of the capsule became covered in ice.

The crew removed their pressure suits during this time to don their flight suits, however this took an hour and a half and required the use of a knife to cut themselves out. Attempts to recover the crew were not only thwarted by the icy waters of the lake, but also the bogs and marshes in the area. Due to the lack of light, the rescue had to be delayed further until daylight, leaving the crew in the capsule for 11 hours post-landing. The recovery team assumed the crew was dead due to the lack of communication, which was actually due to the crew losing consciousness from high levels of carbon dioxide in the cabin. They towed the capsule for 45-minutes back to the shore to await a special team to remove the bodies. After eleven hours in the capsule the crew finally opened the hatch from the inside.

Soyuz 23 during recovery (above) and shortly after recovery (below) from Lake Tengiz

- Manual parachute release capability
- Crew recovery operations should anticipate off-nominal landing in rough terrain or locations that could be inaccessible by vehicle or helicopter.

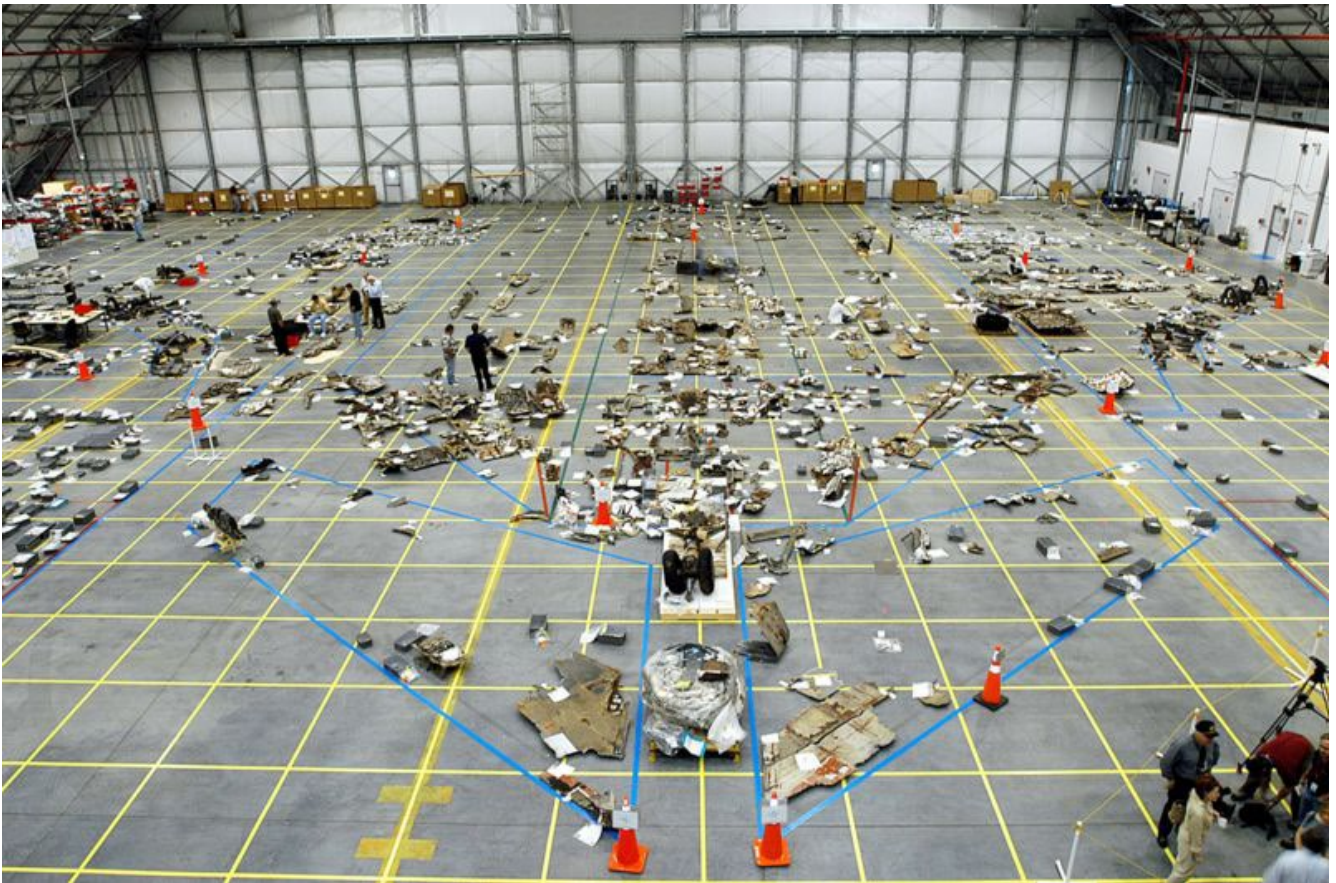
Damage to the Thermal Protection System from a debris strike on ascent resulted in the loss of crew and vehicle on entry.

At 81.7 seconds Mission Elapsed Time a piece of foam insulation from the External Tank (ET) left bipod ramp separated from the ET and struck the orbiter left wing leading edge in the vicinity of the lower half of reinforced carbon-carbon (RCC) panel #8, causing a breach in the RCC. During re-entry this breach allowed super-heated air to penetrate through the leading-edge insulation and progressively melt the aluminum structure of the left wing, resulting in a weakening of the structure until increasing aerodynamic forces caused loss of control, failure of the wing, and break-up of the orbiter. This breakup occurred in a flight regime in which, given the design of the orbiter, there was no possibility for the crew to survive.

Hanger housing the Columbia recovery during the accident investigation.
