# **Space Shuttle Independent Assessment Team**

Report to Associate Administrator  
Office of Space Flight

October - December 1999

March 7, 2000

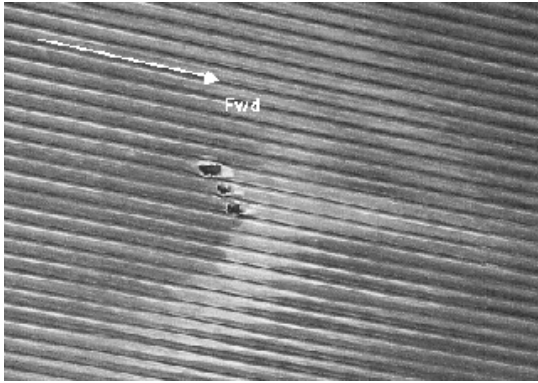
New engines are acceptance tested to full mission duration before flight eligibility. Individual components which are new or have been overhauled are likewise tested (Green Run) on a development (non-flight) engine prior to use in the flight inventory. "Standard Repairs" such as liquid oxygen post deactivation are not necessarily tested before flight. The SIAT finds that there was pervasive evidence that liquid oxygen post pin insertion required a hot-fire verification. Of 19 pins ejected during ground testing, all but one were ejected during the first engine firing. The SIAT recommends comprehensive re-examination of maintenance and repair actions, for adequate verification requirements (i.e., visual, proof test, or green run) which require a pre-flight green run. Specifically, the SIAT feels that green run criteria need to be revised to increase mission safety and avoid future incidents such as the liquid oxygen post pin impact damage of the chamber wall tubes.

Figure 10 -- Ruptured Tubes, a

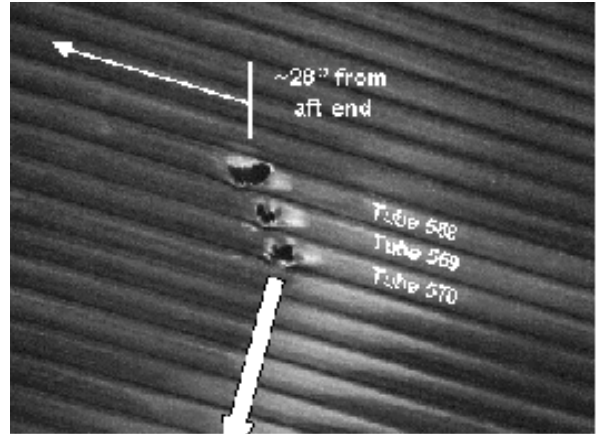
Figure 11 -- Ruptured Tubes, b

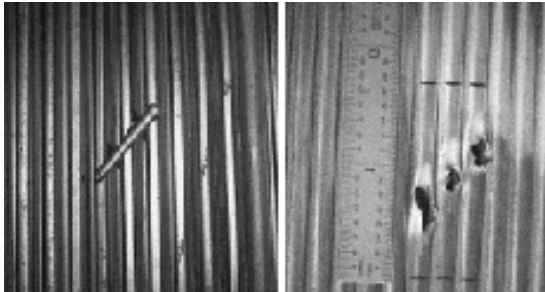
Figure 12 -- Ruptured Tubes, c

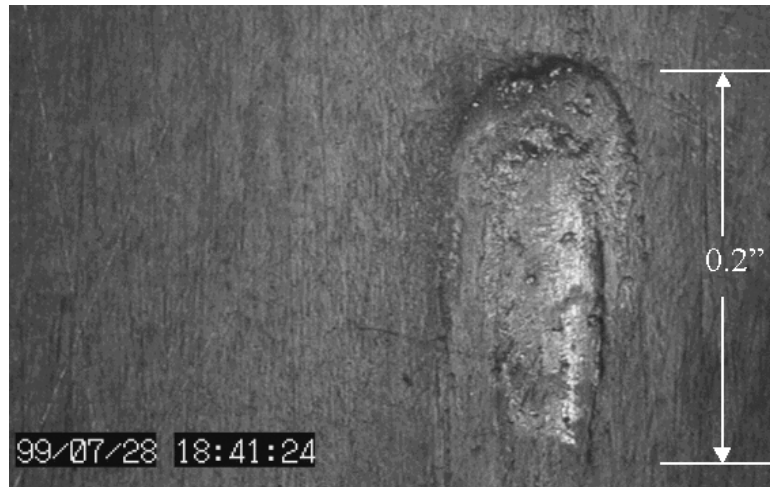
Figure 13 -- Main Combustion Chamber Ding

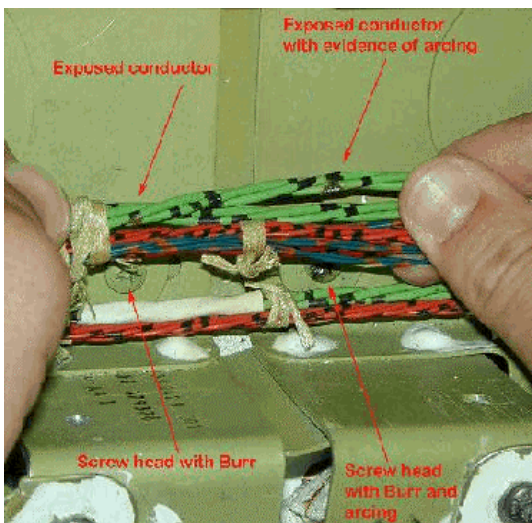
The SIAT was briefed on an in-flight anomaly wiring failure that occurred during the STS-93 mission of OV102 Columbia. Five seconds after the STS-93 launch, a primary and back-up main engine controller on separate engines dropped offline. Controllers were automatically dropped off line when a power fluctuation was detected. This left single engine controllers on two of the three engines (each main Shuttle engine has double redundant controllers). The mission continued uneventfully and after the mission, inspection revealed a single 14 ga. polyimide wire had arced to a burred screw head (*Figure 17* and *Figure 18*). The wire was located in the aft left-hand mid-body bay #11 lower wire tray. A single three amp circuit breaker had tripped, with no electrical damage to adjacent wiring. The wire provided 115 VAC power to each of the controllers that were dropped off line.

Technicians noted a 10 ohm short between the wire electrical ground through the structure of the vehicle. Inspection of the wires in the adjacent area revealed insulation and conductor damage at the short location (*Figure 18*). An expanded inspection of all mid-body wires revealed varying degrees and types of wire insulation damage. All four vehicles exhibited extensive and varying degrees of wire insulation damage from exposed conductors to minor abrasion (*Figure 19*, *Figure 20*, and *Figure 21*). The SIAT was briefed on the Shuttle program analysis of the in-flight anomaly, the results of inspection and repair of wiring on all vehicles, and corrective actions taken to mitigate future wiring failures. In the course of the SIAT's fact-finding process, we reviewed maintenance practices and representative vehicles at the Kennedy Space Center Shuttle processing facility and the Palmdale Shuttle depot facility.

Figure 17 -- Shorted Wire in OV102: Arc Damage & Mechanical Damage

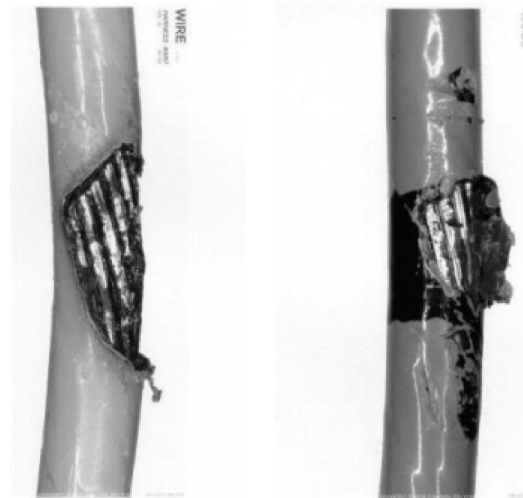
Figure 18 -- Carbonized Insulation Due to Arc Damage

The following is an assessment of the wire incident or mishap based on presentations given by NASA and on NASA laboratory data. The material transfer and welding present provide evidence of arcing; gouges in the conductor were also noted. Surface analysis revealed oxides in the wire strand gouge sites that suggest the damage might have occurred several years earlier. The wiring in the mid-body payload bay is normally covered and records did not indicate the cover had been removed since the last Orbiter Maintenance Down Period (OMDP) that occurred four years earlier at the Palmdale depot facility. Secondary damage caused by the arcing has destroyed most of the insulation and wire damage that was present before the arcing began at the primary failure site. Circumstantial evidence surrounding the failure suggests the wire may have initially been damaged by an impact and subsequent chafing/vibration may have led to the electrical failure. There was no evidence of arc propagation into adjacent wiring.

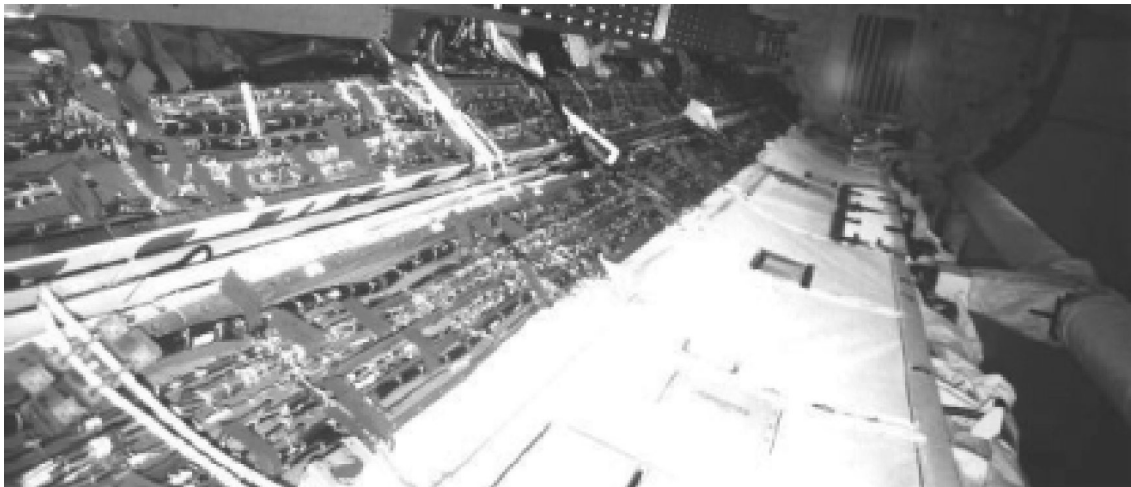
Figure 19 -- Red Tag Anomalies in OV103 Left Mid-Body

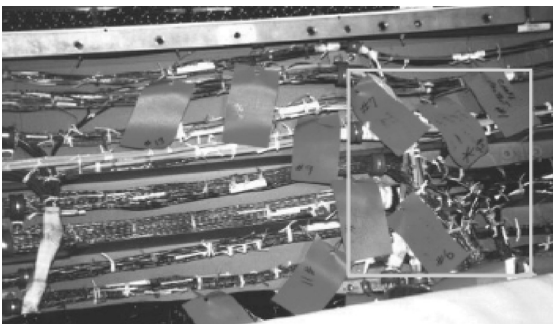
Figure 20 -- Close-up OV103 Mid-Body: Compromised Redundancies, Possible Chafing

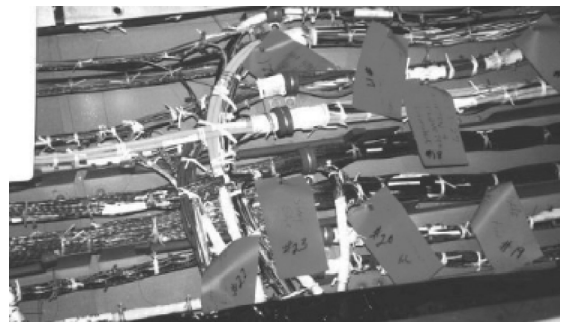
Figure 21 -- OV103 Mid-Body: Intersecting Wire Bundles

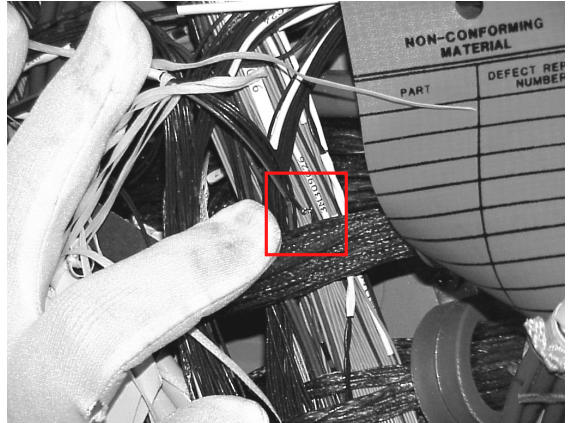
Figure 23 -- OV103 Mid-Body: Strand Damage

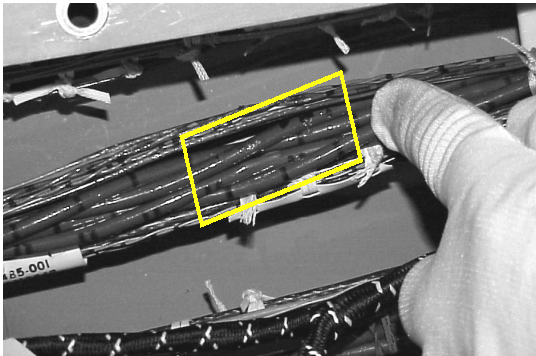
Figure 24 -- Surface Damage Inside Bundle

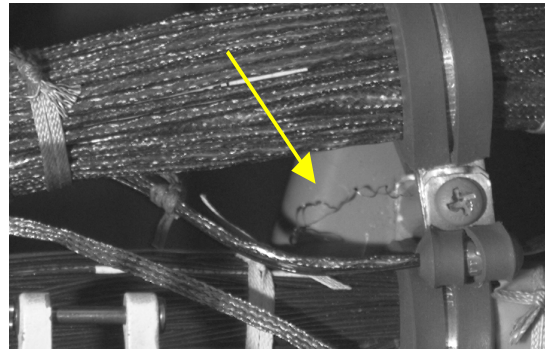
Figure 25 -- OV102: FOD, Metal Shaving

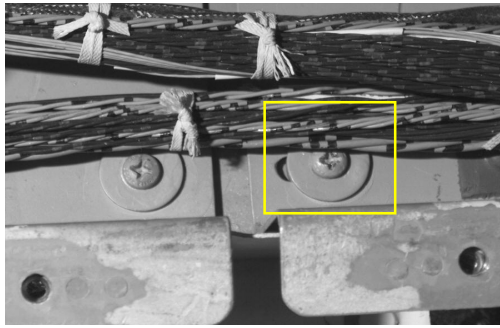
Figure 27 -- Potential Chafe in Mid-Body

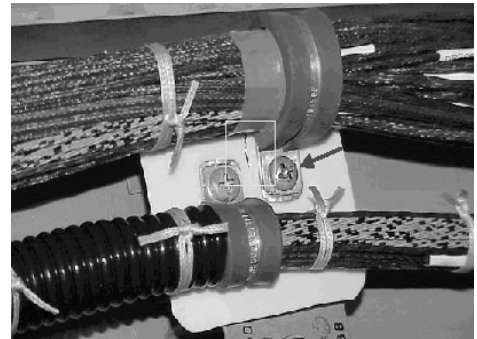
Figure 28 -- Metal Shaving (FOD), Burred Screw, Convoluted Tubing

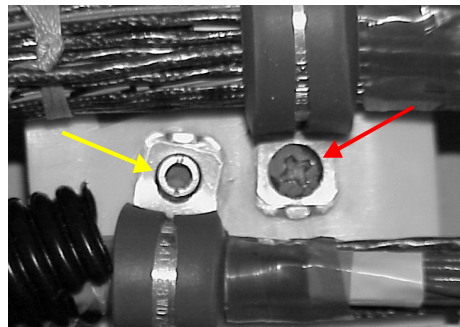
Figure 29 -- Burred Screw, Hex Head Screw
