**Michoud Assembly Facility**  
**Rigging Crane Rails Employee Injury**  
**Type B Mishap**  
**NMIS Case Number: 23-101175**

**Date of Mishap: September 22, 2023**

**Date of Report: November 17, 2023**

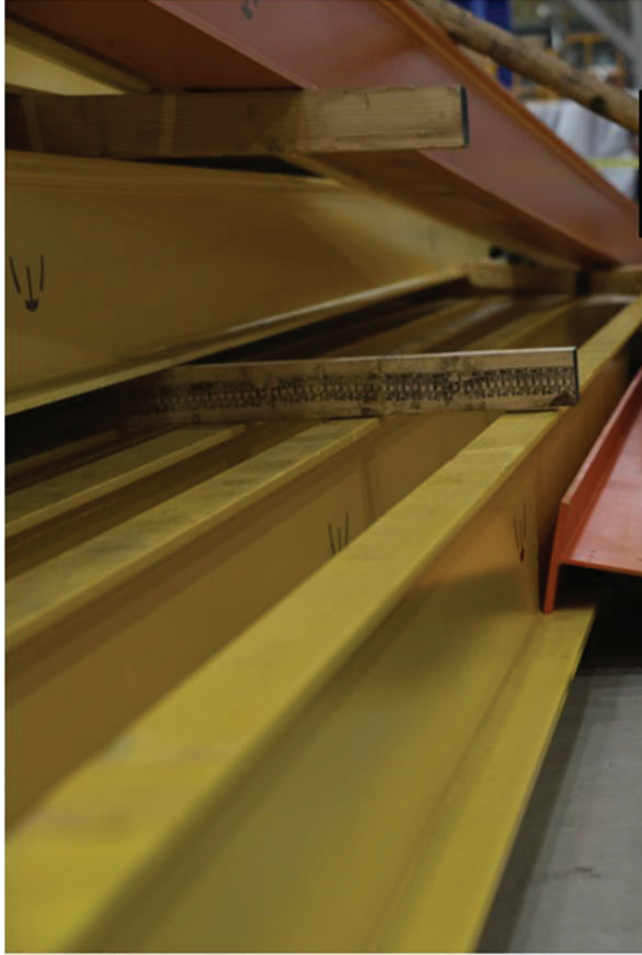
Dunnage are 4”x4” wood beams that were repurposed following their use in transportation of the steel beams to MAF (Figure 3); the wood beams are used to separate each level in the stacks of steel beams. Dunnage has a height of 3.5 inches. Beams are always stacked with dunnage placed under them starting at the floor level.

*Figure 3: Dunnage between beam stacks.*

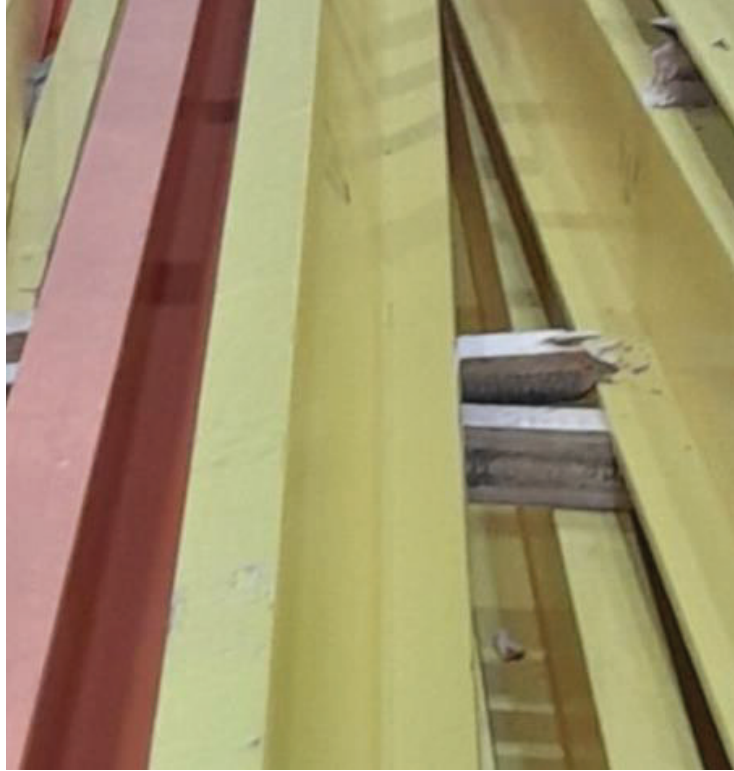
At approximately 8:53 a.m., IP climbed the stack of beams to level 4, which is approximately 64 inches above the floor, and began rigging the next beam on level 5 (~6'8"). At 8:54:03 a.m., the forklift driver lifted a beam from level 5 and lowered the beam to the floor. At 8:54:16 a.m., the IP exited down the stack of beams from the side instead of walking to the end of the beams, which was the normal procedure to exit the beam. When exiting down the stack of beams, IP stepped on dunnage to get to the next level, but the dunnage broke and IP fell to the floor. The IP can be seen in the video footage falling from the stack of beams with the beams rolling off the stack. Interviews indicated IP stepped down onto the dunnage with their right foot, and the dunnage broke and gave way (Figure 8).

*Figure 8: View of broken dunnage under beam.*

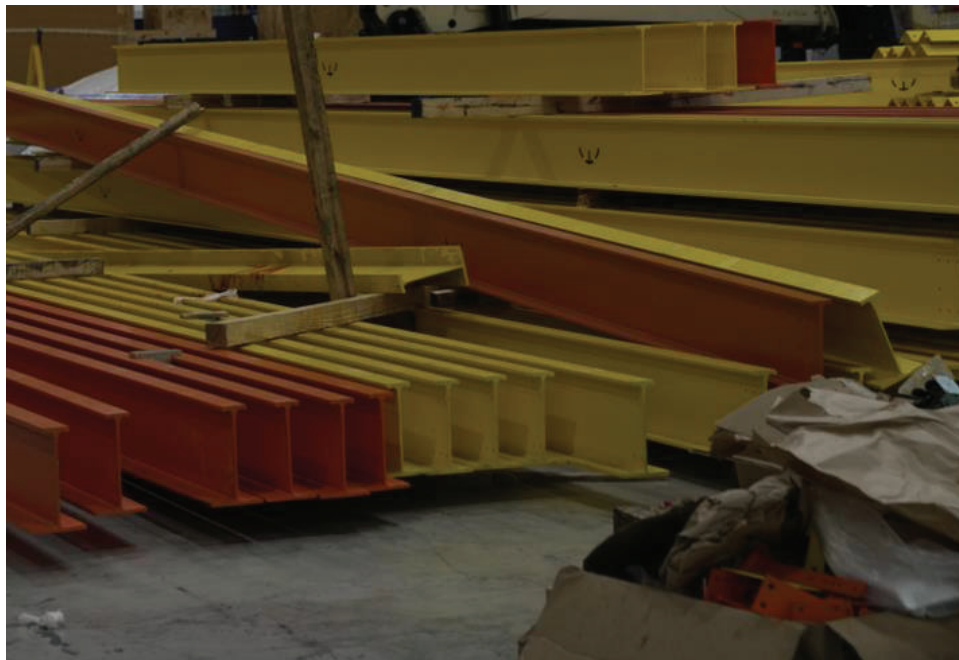
The steel supported by the dunnage on the fourth level plummeted, and in the act of falling, the IP's left foot contacted the steel beam on the fifth level, causing it to fall into another beam and roll off the stack (Figure 9).

*Figure 9: View of collapsed beams.*

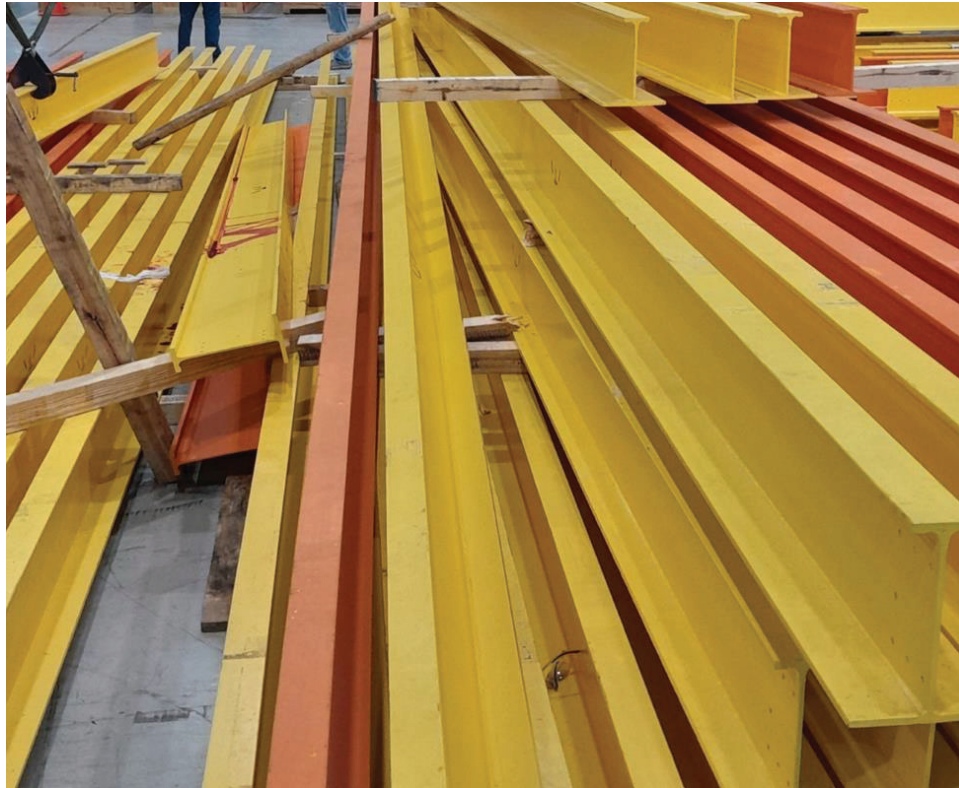
*Figure 10: View of collapsed beams and broken dunnage.*

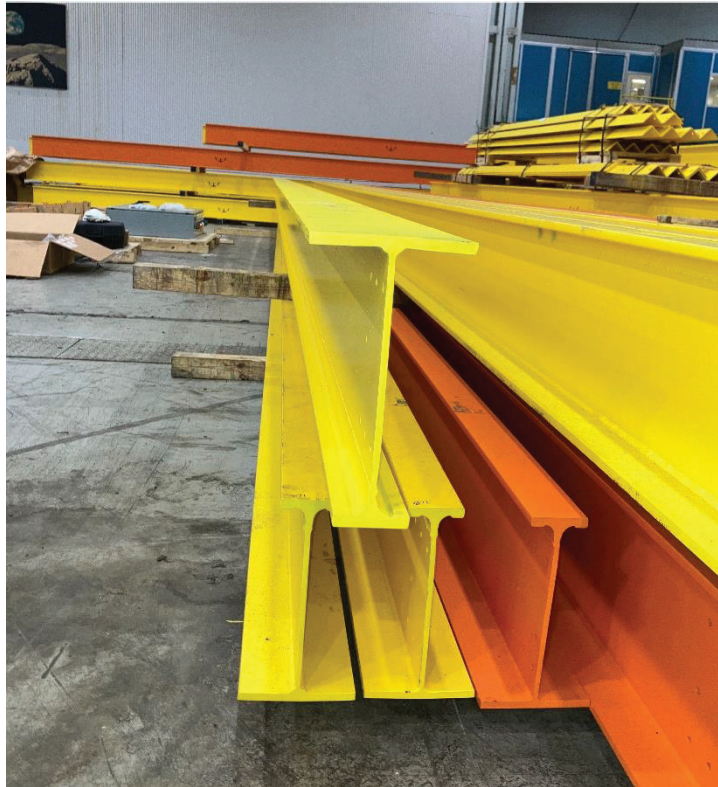
During the site visit, after the mishap site was safed, the MIT and MAF's Safety and Health Manager identified that a beam was stacked incorrectly or upside down with the narrow portion on the bottom (Figure 14), and this was brought to the attention of the subcontractor safety officer for them to remedy this situation to keep the work area safe. The correct stacking of the beams is with the wide edge down.

*Figure 14: Beam upside down in stack.*

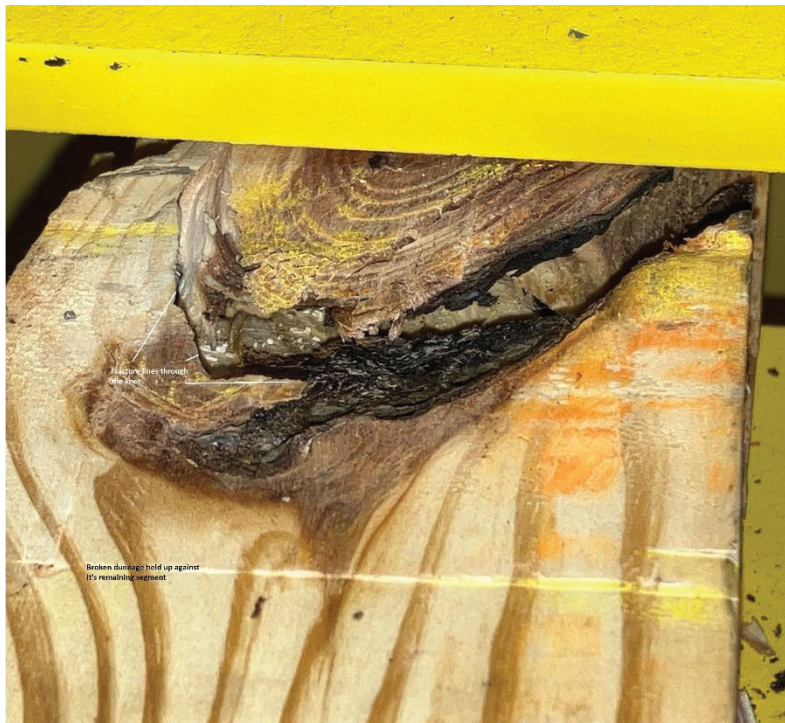
Figure 15: Fractured dunnage to show the extensive knot and fracture pattern along the knot.

For this case, the knot was significant in size, encompassing almost the entirety of the width and greater than 50% of the depth of wood dunnage. In addition, it is unknown what forces this dunnage was subjected to previously, such as from being ratcheted down for transport. Thus, in addition to the data from the literature showing that this dunnage was at risk for breaking due to the size of the knot, it is not known what additional stress factors or cracks may have occurred as a result of the dunnage being subjected to previous forces when loaded and used for transport and then subsequent reuse.

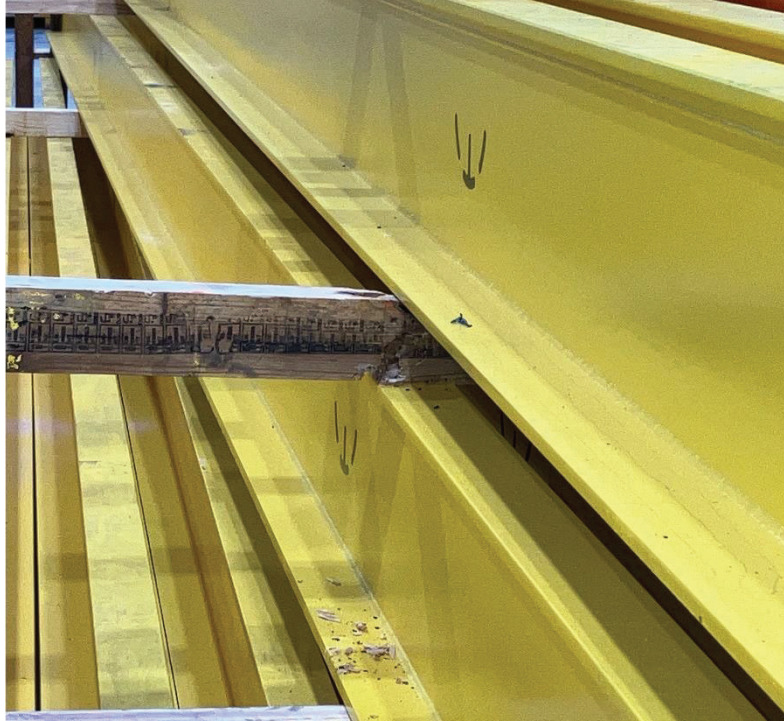
In addition, the dunnage was inspected, and the broken/fractured piece of dunnage was married to its remaining part to show the exact position of the dunnage when the accident occurred. The large knot, with the fracture pattern along the knot, was also photographed and evaluated. Greater than 85% of the width of the dunnage was encompassed by the knot, and the depth of the knot extended well beyond 50% of the 4"x4" board. The fracture pattern of the wood was along the knot line as indicated in the figures below (Figure 15 and Figure 16). In addition, from interviews, it was found that it was common to reuse dunnage that had been used to secure the load on the delivery truck. When using dunnage on the delivery truck, the load is typically ratcheted down for transport, which may in turn cause additional wear and tear on the dunnage. The dunnage was also not lined up vertically in the stack to dissipate the weight load and avoid potential issues from cantilevering.

*Figure 16: Fractured dunnage is re-mated to show position and fracture site.*

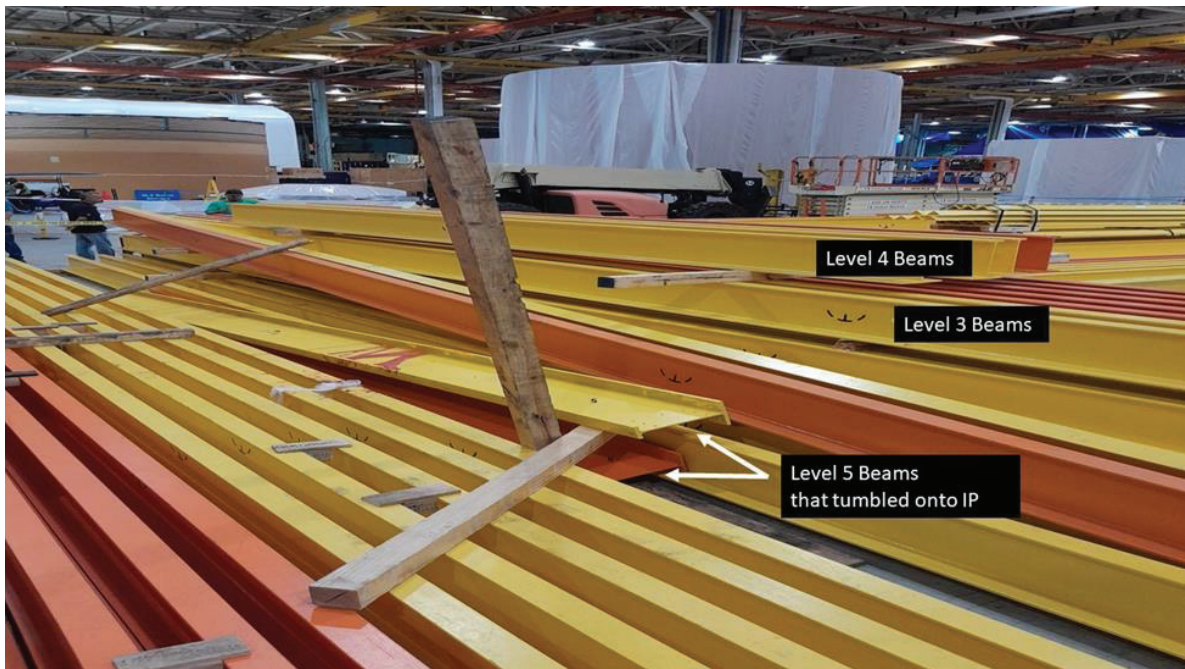
**Supporting Evidence:** Interviews indicated IP made contact with the beams either with their hands and/or foot, which may have contributed to the beams tumbling. MIT also learned from video footage and a visit to the mishap site that when IP stepped on dunnage, the beams began to tumble. Several factors contributed to the beams tumbling, such as contact with beams, misalignment of beams and dunnage, and dunnage breaking.

Figure 19: Beams from level 5 that tumbled onto IP, and beams that collapsed with breakage of dunnage.

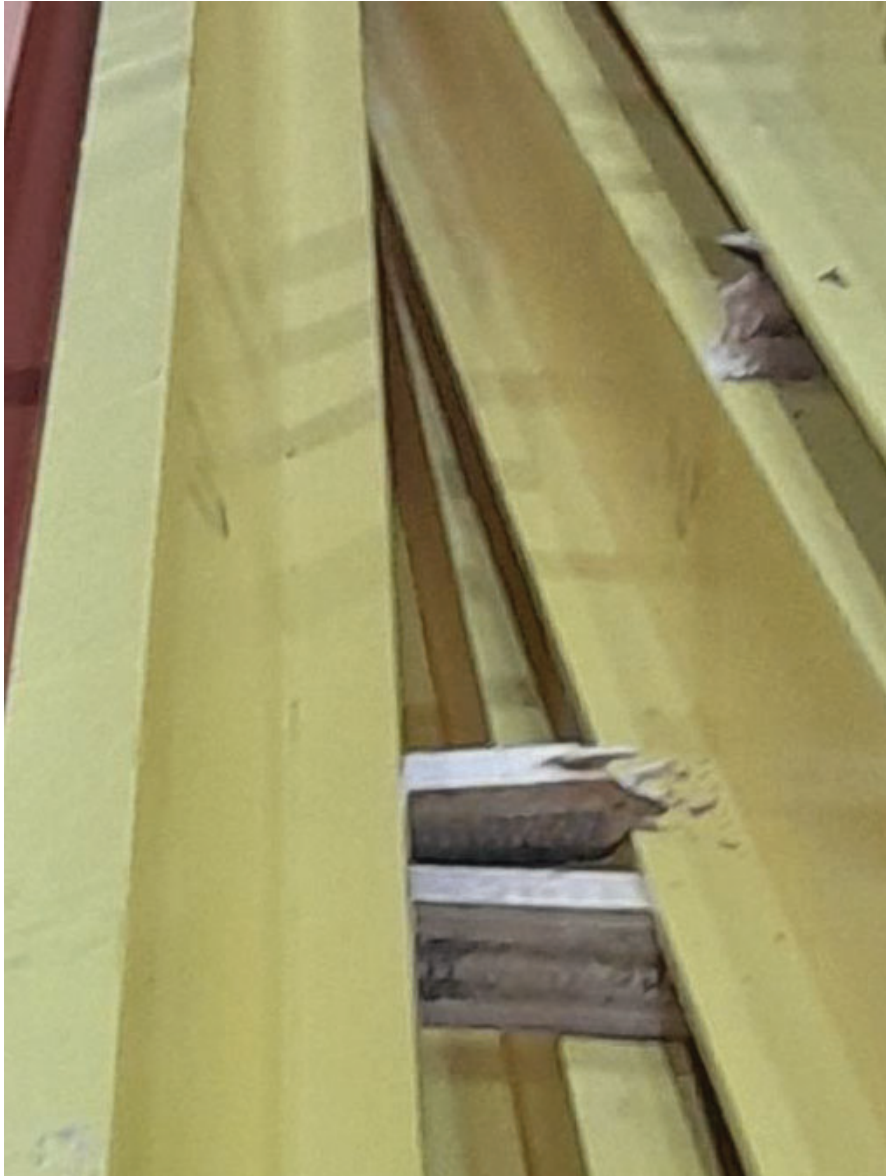
For this case, the knot was significant in size, encompassing almost the entirety of the width and greater than 50% of the depth of the 4"x4" wood dunnage. In addition, it is unknown what forces this dunnage was subjected to previously, such as from being ratcheted down for transport. Thus, in addition to the data from the literature showing that this dunnage was at risk for breaking due to the size of the knot, it is not known what additional stress factors or cracks may have occurred as a result of the dunnage being subjected to previous forces when loaded and used for transport and then subsequent reuse.

*Figure 22: Broken dunnage and one of two beams that it supported.*

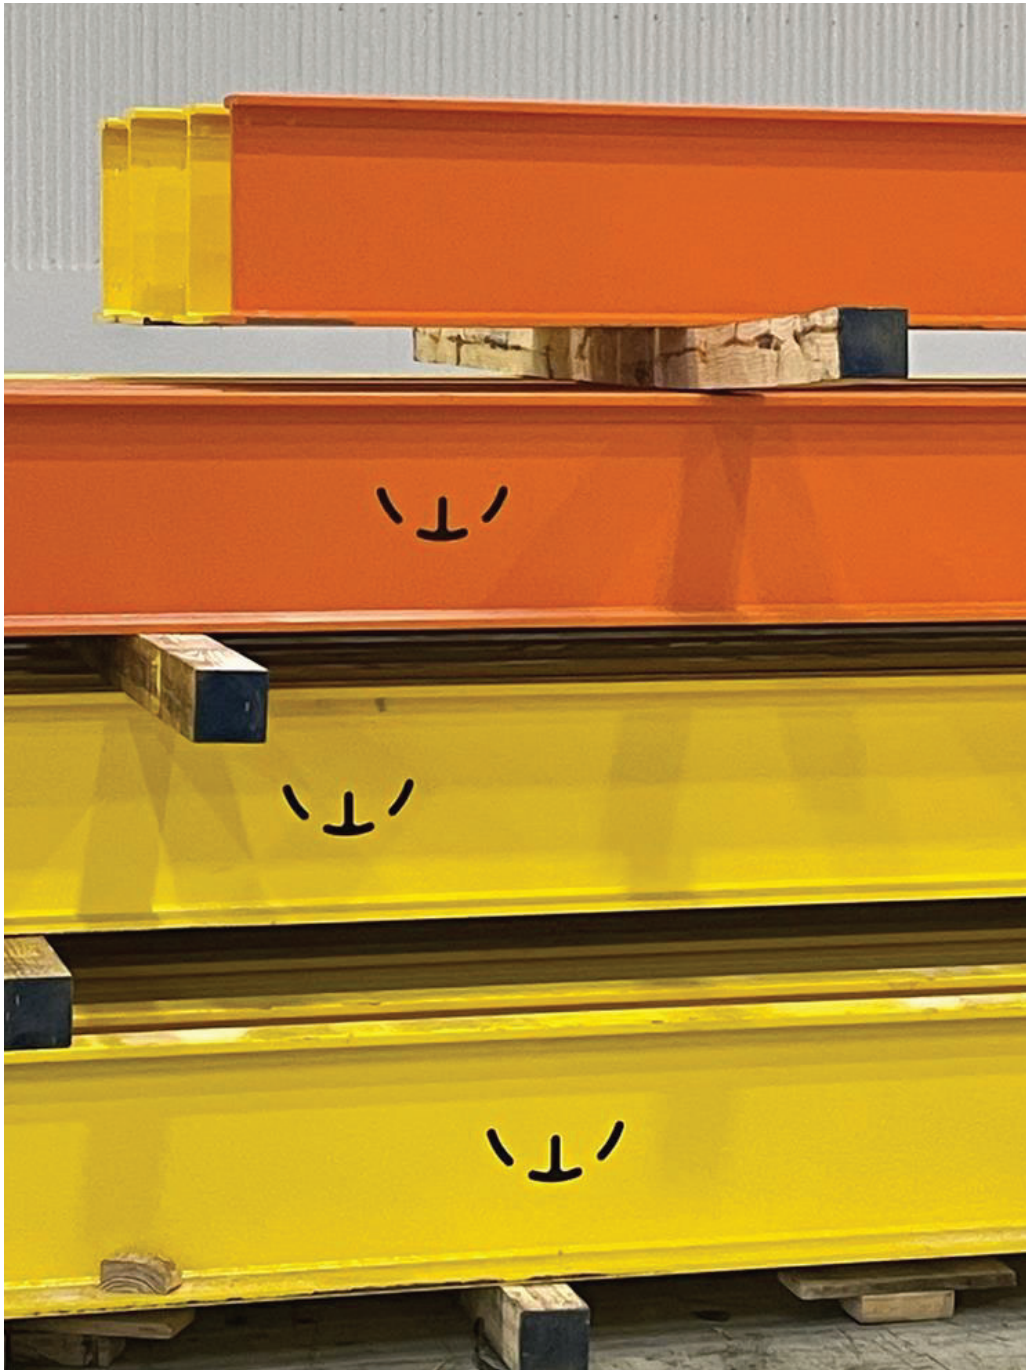
**Supporting Evidence:** MIT learned from the timeline that on May 30, 2023, all beams were received for the installation of the castellated beam project. MIT witnessed that the dunnage was aligned in a staggered fashion when visiting the mishap site. Pictures of the dunnage misalignment were provided to the MIT for evidence.

*Figure 24: Misaligned dunnage supporting steel beams.*
