LEAD BASED PAINT SURVEY REPORT

BACHELOR'S ENLISTED QUARTERS (ID: Building 512A)

NASA-AMES

Benchmark Environmental Engineering
August 17, 2001
Project Number: E01-448w-L-SU

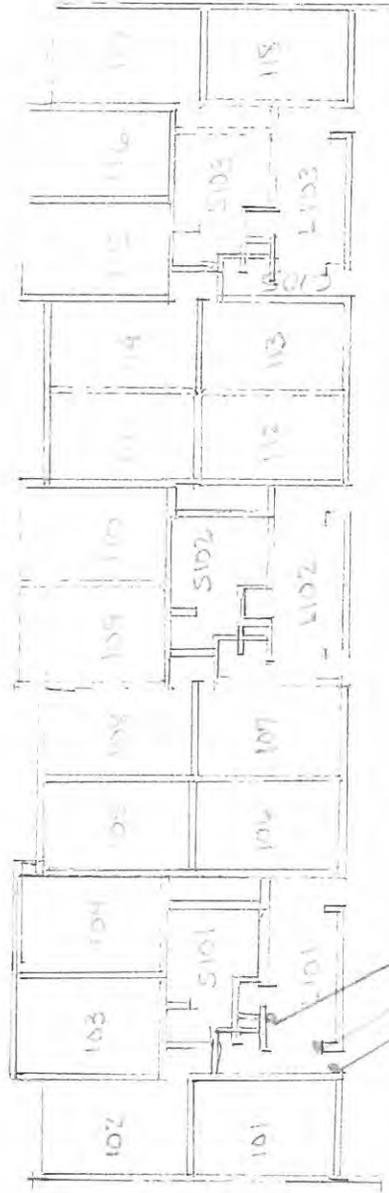
1 ST FLOOR

01-4849-S101A

01-4848-S102A

01-4847-S103A

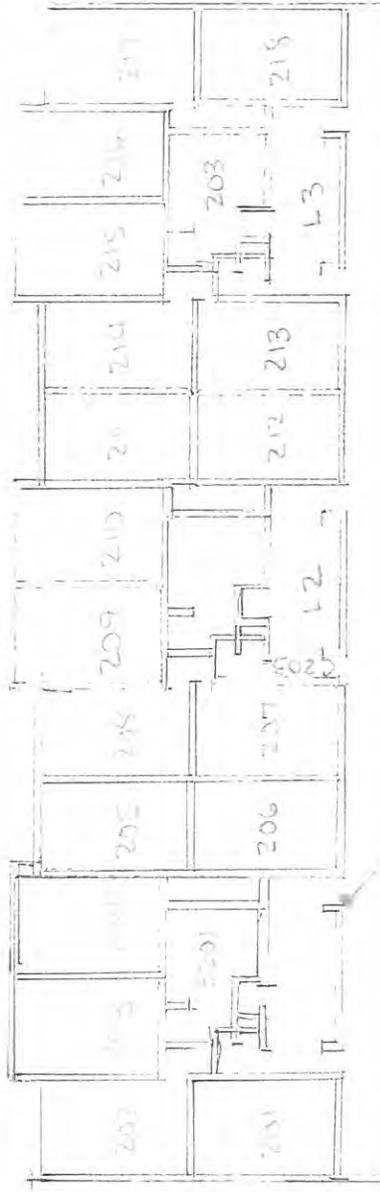
2ND FLOOR

21-4850-512A-4
