ASBESTOS SURVEY REPORT

Community Storage (ID: Building 82)

NASA-AMES
Moffett Field
Mt. View, CA 94035

Prepared by:
Benchmark Environmental Engineering
November 8, 2001
Project Number: **E01-448-A-SU**

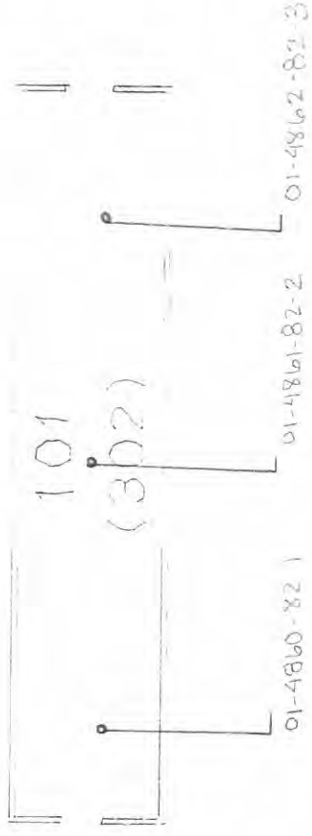
DRAFT PERSON:	WLB	DATE:	10/30	DWG. No.	1
PROJECT NAME:			PROJECT No.		
PARCEL 5 BUILDING 82 NASA-AMES			E01-448-AL-510

<i>Sample ID(s)</i>	<i>Sample Location(s)</i>	<i>Floor</i>	<i>Analyzed</i>	<i>Overall Result</i>	<i>Layer(s) Reported by Lab</i>	<i>Results by Layer</i>
RM-1-01-4860-82-1	Exterior West		Yes	35%	1) Roofing material 2) 3)	35 % Chrysotile
RM-1-01-4861-82-2	Exterior Middle		Yes	35%	1) Roofing material 2) 3)	35 % Chrysotile
RM-1-01-4862-82-3	Exterior East		Yes	35%	1) Roofing material 2) 3)	35 % Chrysotile

<i>General Condition</i>	<i>Damage Category</i>	<i>Overall Material Assessment</i>	<i>Recommended Response</i>
		Not Assessed under AHERA	Abate Prior to Demolition
