NOAA-17 Breakup Engineering Investigation

Spacecraft Anomalies and Failures (SCAF) Workshop 2024

March 27th, 2024

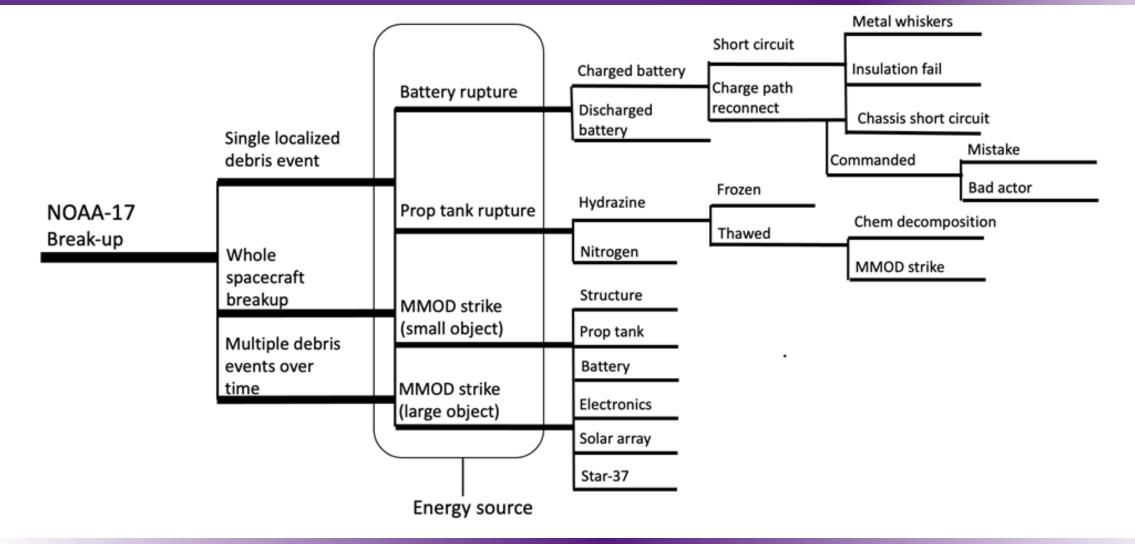
- No clear cause 'jumped out' based on the evidence
- Fault Tree used to associate potential causes with the observed breakup
 - Evidence, observations, and logic used to categorize potential root causes as Impossible, Unlikely, Possible, or Probable

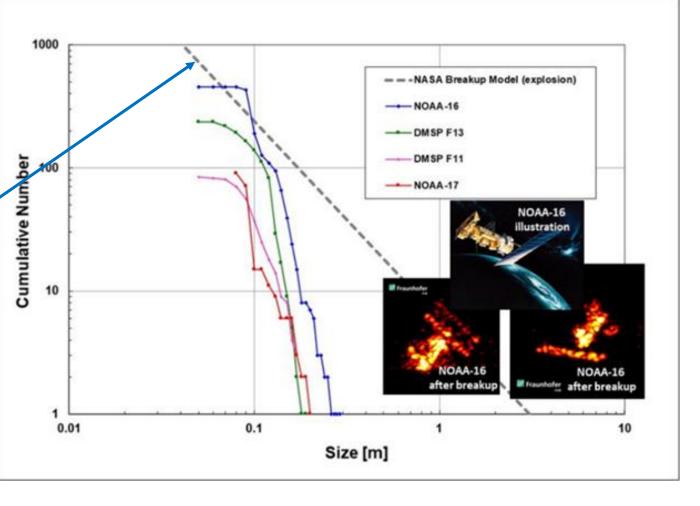
Investigating the Likely Source of the Debris: Debris Size Distribution

- NASA radar Size Estimation Model used along with the Radar Cross-section to determine debris characteristic length distribution
- Compared to the standard distribution for a complete spacecraft explosion: <u>not</u> consistent with an explosion
- Compared to the three similar breakups: same trends

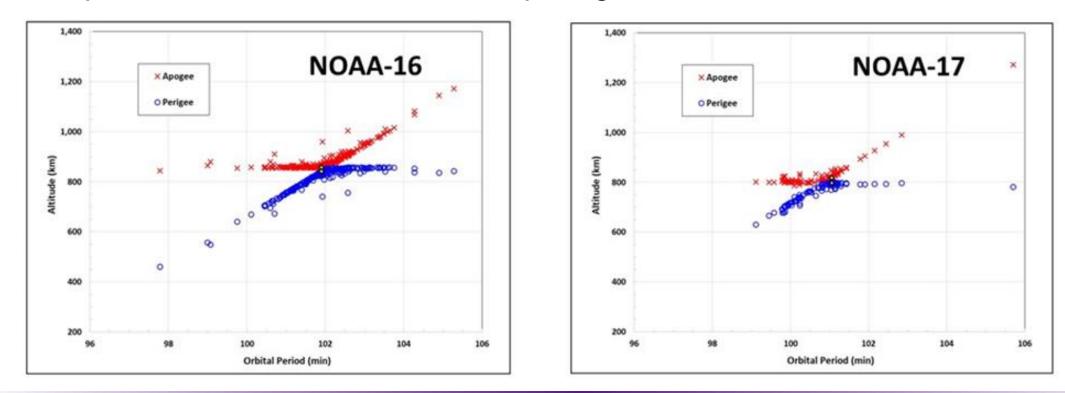
Investigating the Likely Source of the Debris: Debris Distribution in Orbit

- Gabbard diagrams illustrate the altitudes of perigee and apogee vs orbital period
- Suggests that the nature and the intensity of the NOAA-16 and NOAA-17 breakups were similar. DMSP breakup diagrams also looked similar to those

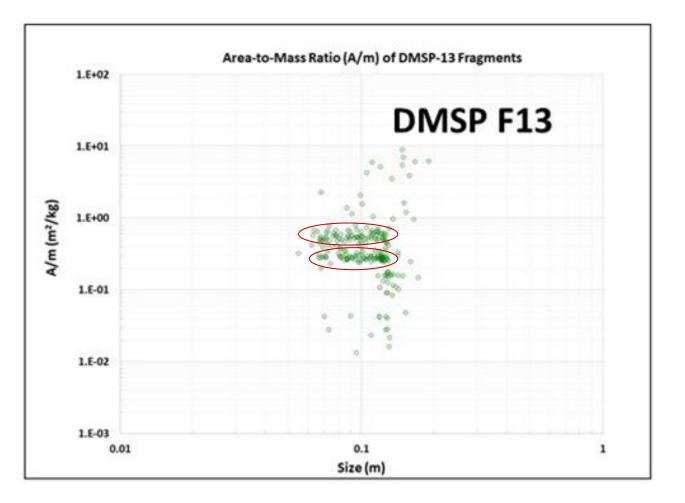
Investigating the Likely Source of the Debris: Debris AMR (1 of 3)

- Area to Mass Ratio (AMR) is a key driver for long-term orbit decay
- Orbit decay history over days to weeks was used to imply an AMR for each tracked object
- Two peaks were evident for all four breakups
 - ~0.3 m²/kg ~0.4 m²/kg

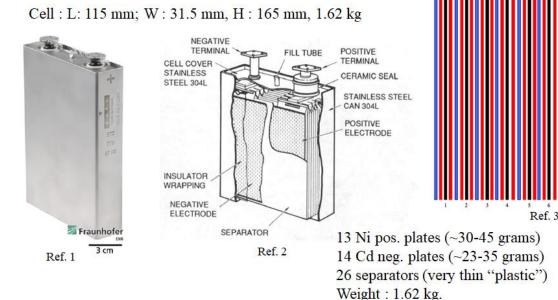
Investigating the Likely Source of the Debris: Debris AMR (3 of 3)

tickel plaque surface as seen under the scan

- Each battery cell contains 13 Ni and 14 Cd plates
- Battery packs (6 per spacecraft) contain either 8 or 9 cells
- NOAA-17 produced
 114 tracked debris
 (just over 4 cells)

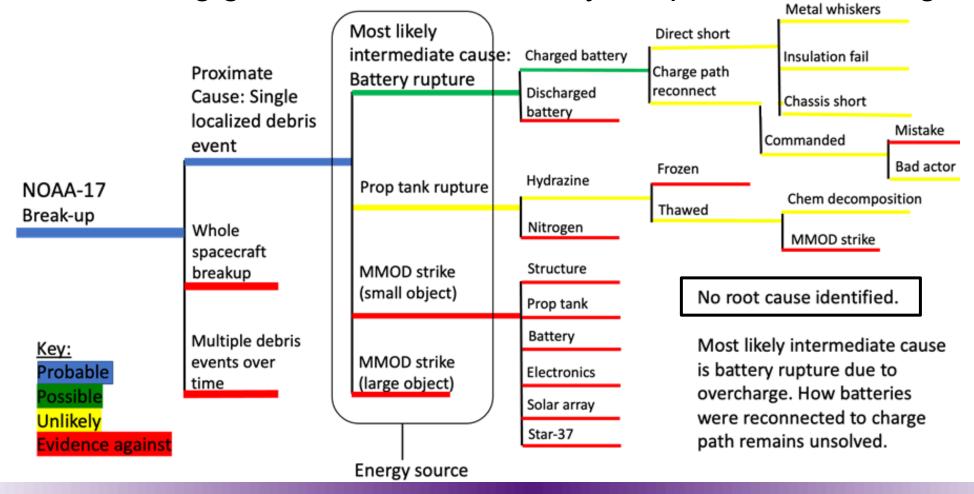
No clear 'smoking gun', but several unlikely but potential initiating events
