# FLIGHT READINESS STATEMENT STS-70/ET-71 AND STS-69/ET-72 Δ EXTERNAL TANK PROJECT REVIEW

# STS-69/ET-72 Flight Readiness Review

# **STS-70/ET-71 STS-69/ET-72 Flight Readiness Review**

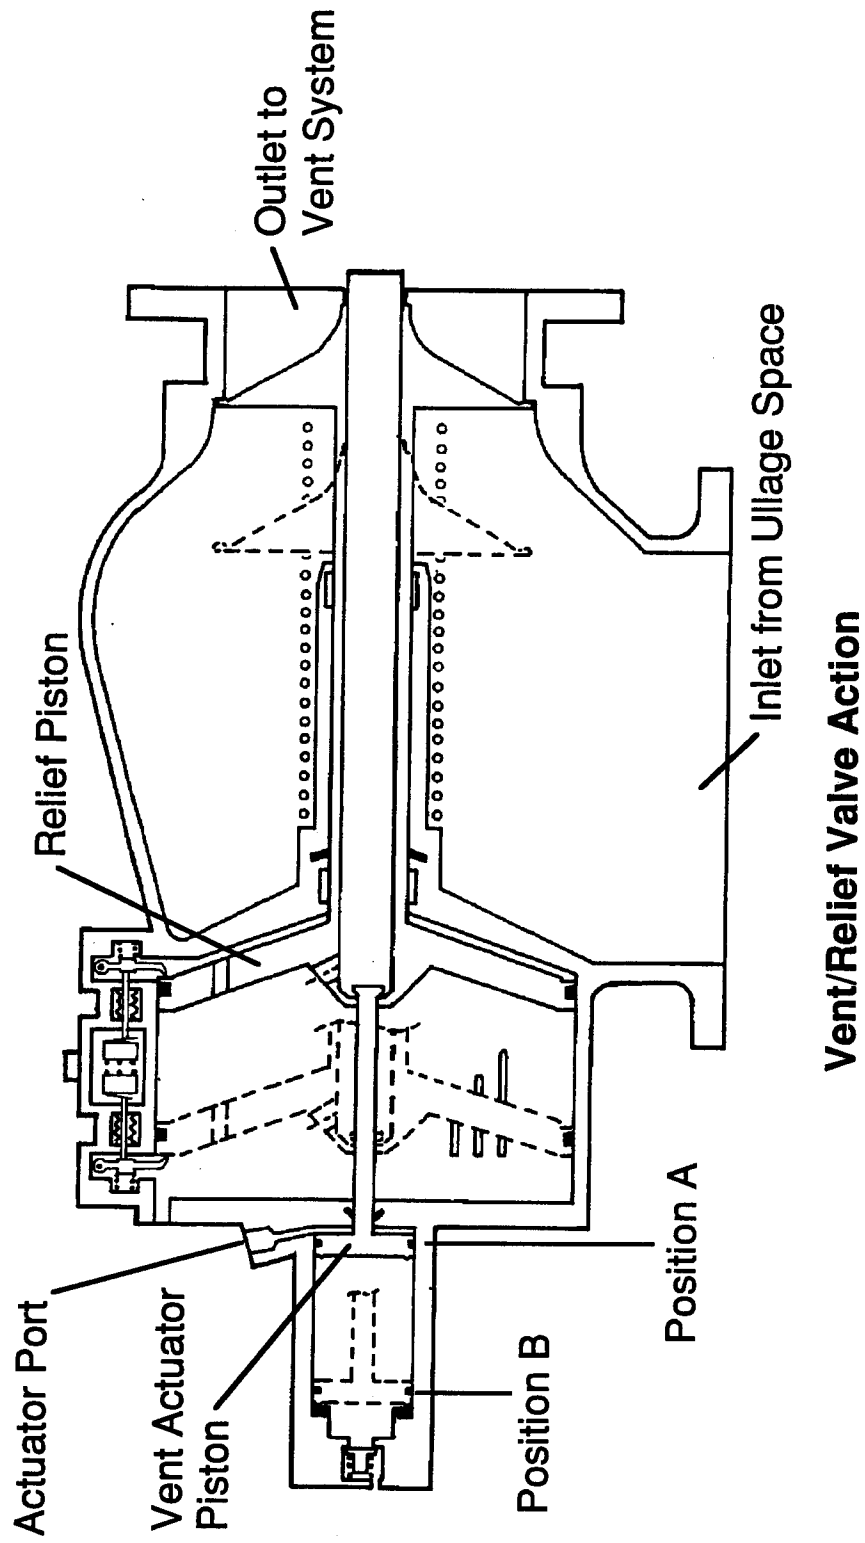
ET-4

# Anomalous GH2 V/R Valve Position Indication

- ET-72 (S/N 202)
  - During H2 blank-off plate installation IPR-69V-066 was generated as a result of anomalous position indication
  - IPR investigation revealed that closed position indicator failed to show "on" on 2 occasions
  - Investigation also showed one cycle with simultaneous indications of open and closed
  - Several instances of intermittent "off/on" indications occurred with valve in closed position
- No anomalies noted for S/N 202 during vendor ATP, MAF test/checkout and KSC valve timing checks and pad validation
  - No leakage during 9 months storage period at MAF
- Vent/relief valve failure history
  - ET-43 position indicator switch exhibited simultaneous open/closed electrical indications during checkout at MAF
  - Failure investigation concluded that damage to the switch case of the open position micro switch was responsible for failure

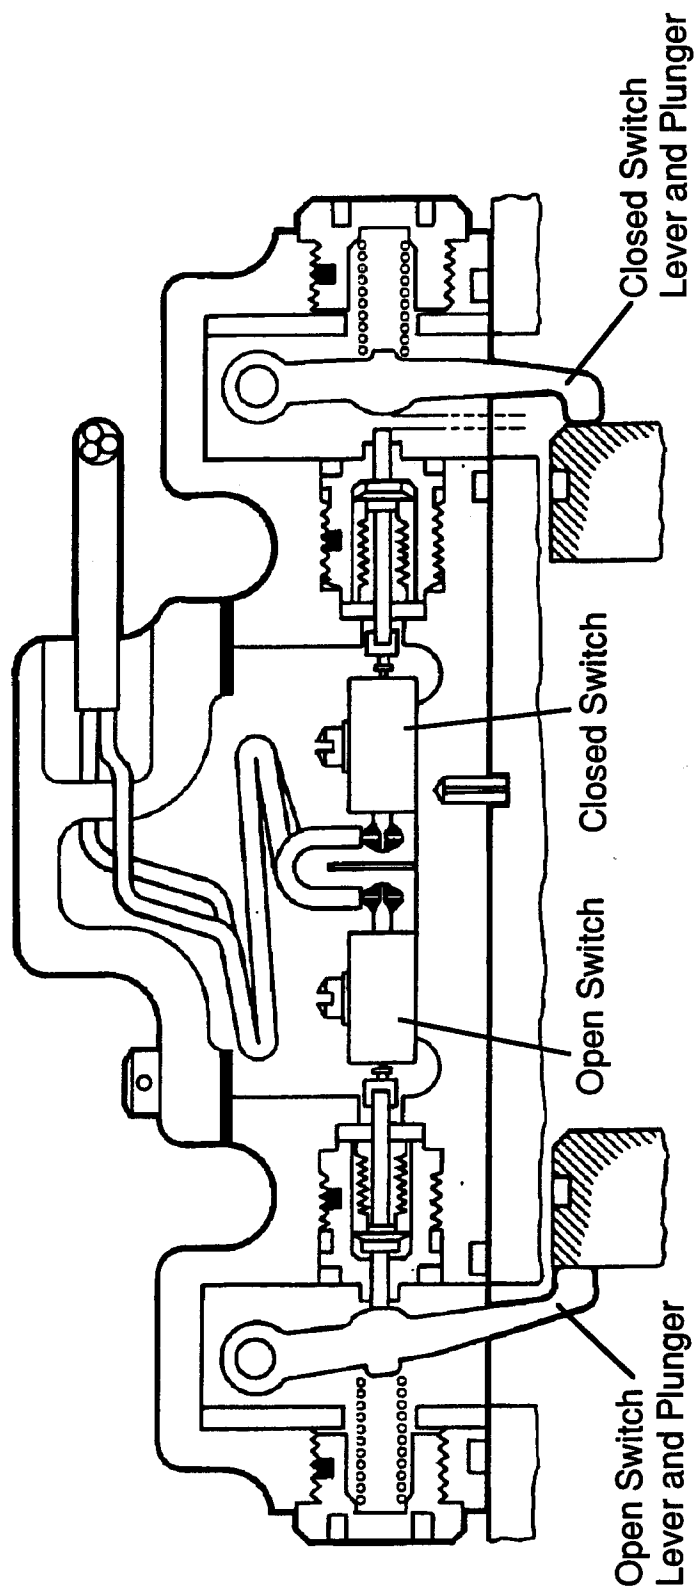
Vent/Relief Valve Switch Assembly

ET-5

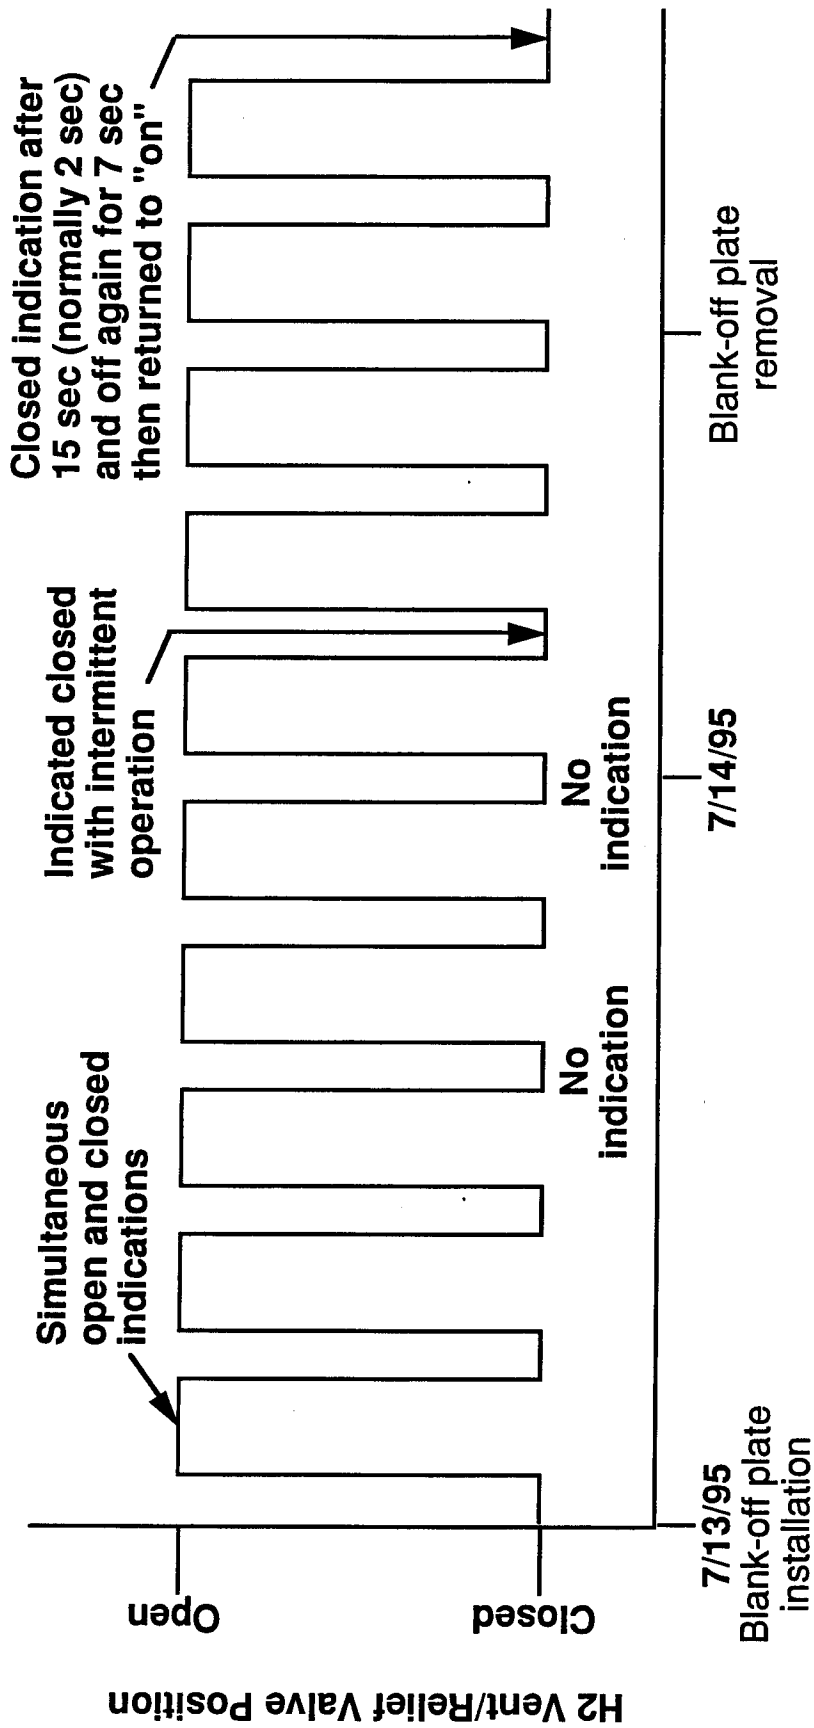
## H2 Valve Cycling Closed Indication Anomaly

- Anomaly isolated to vent/relief valve closed position indicator assembly/circuit
  - Simultaneous indications of open and closed
  - With valve closed closed indicator exhibited intermittent "off/on" conditions
  - With valve closed all other instrumentation functioned normally
- Vent/relief valve closed indicator
  - OMRSD requirements:
    - Vent valve open/closed timing checks completed - Nominal
    - Verify closed indicator "on" at initiation of pre-press (S00FM0.400)
    - Verify closed indicator "on" for contingency restart of cavitating recirc pumps (S00E00.576)
  - Not critical (Crit 3)
  - Not monitored nor used in any LCC
  - Not used for propellant loading control
  - Not used in GLS

- LCC (ET-04, Pre-pressurization cycle anomaly) provides protection from excessive H2 leakage in flight (ref Hazard Report S.10)
- ET-72 acceptable for flight with existing vent valve (S/N 202)
  - Exception to OMRSD (S00FM0.400 and S00E00.576) in process

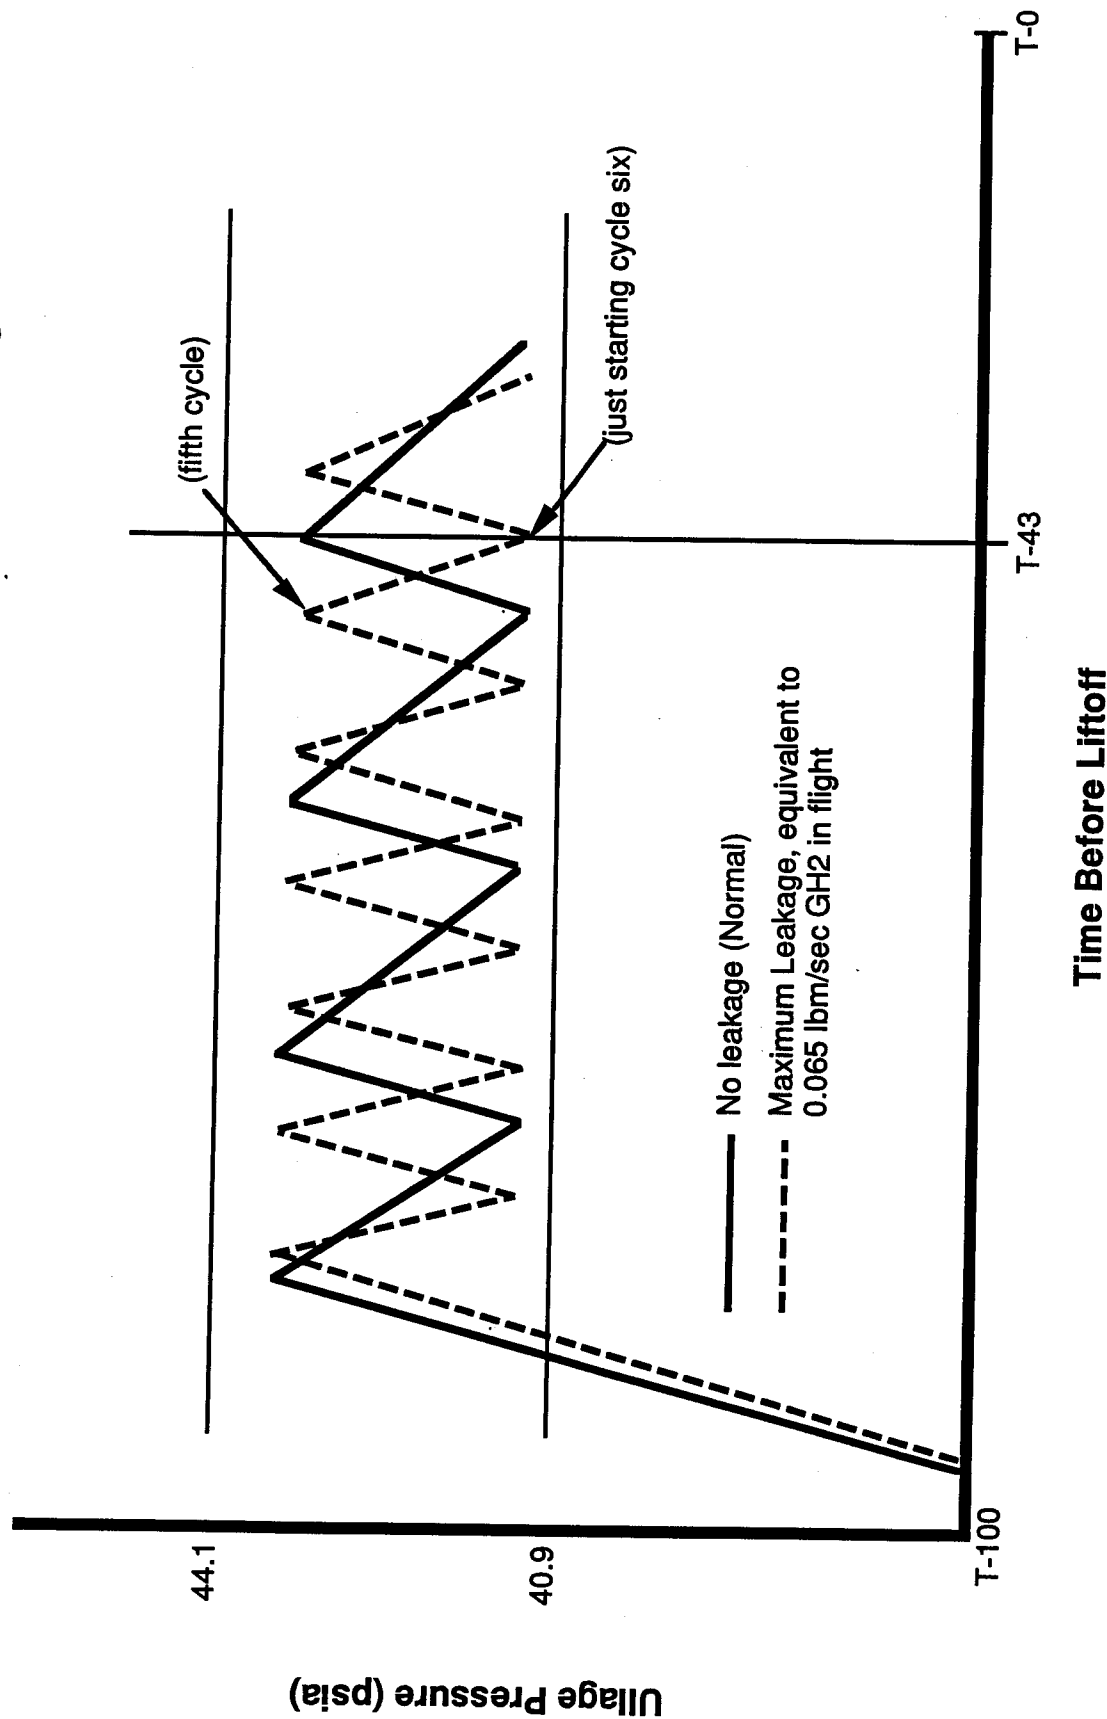
BU ET-2

*Pre-press ullage pressure - No leakage vs Worst Case Acceptable Using LCC ET04*

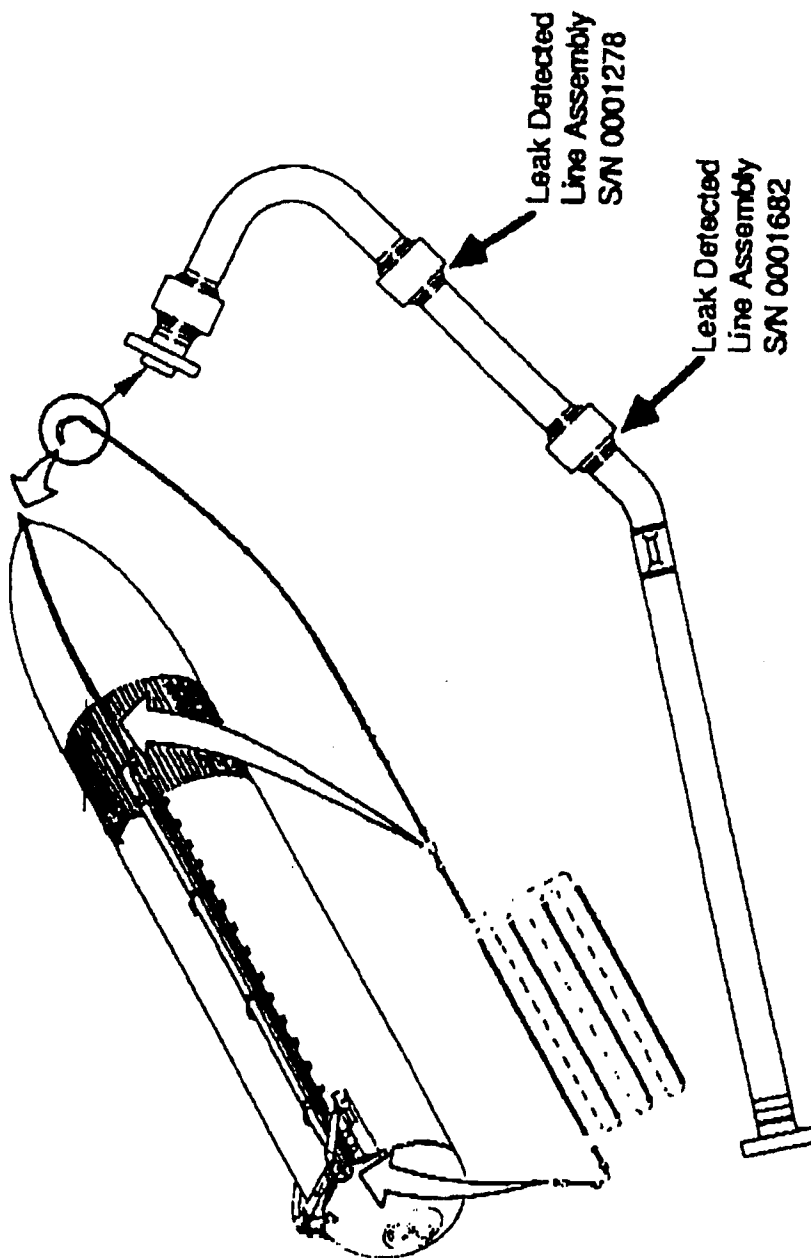
# GO2 Pressure Line Leak (CAPS P-078)

- GO2 forward pressure lines failed ATP for leakage
  - Line S/N 0001278 leak detected at weld #4
  - Line S/N 0001682 leak detected at weld #6

- Line S/N 0001278 at weld #4
  - Leaked during hydrostatic pressurization for the 600 psig deflection test
  - Leak subsequently verified by the GN2 leak test (noticeable at 25 psig)
  - Prior to deflection test, a drop of water was seen by operator following the 1500 psig proof test (source unknown)
  - Leak caused by a 0.030" long x 0.003" wide crack
    - Critical flaw size for weld #4 is 1.76"
    - Crack not detectable by X-ray and smaller than Probability of Detection (POD) for penetrant inspection
- Line S/N 0001682 at weld #6
  - Leaked during the 1500 psig proof test
  - Leak confirmed by a second 1500 psig proof test
  - Leak caused by a 0.025" long crack (unable to determine width)
    - Critical flaw size for weld #6 is 1.76"
    - Crack smaller than Probability of Detection (POD) for penetrant inspection

- ET-71 and up - All units successfully passed ATP
- ATP is designed to catch this type of failure

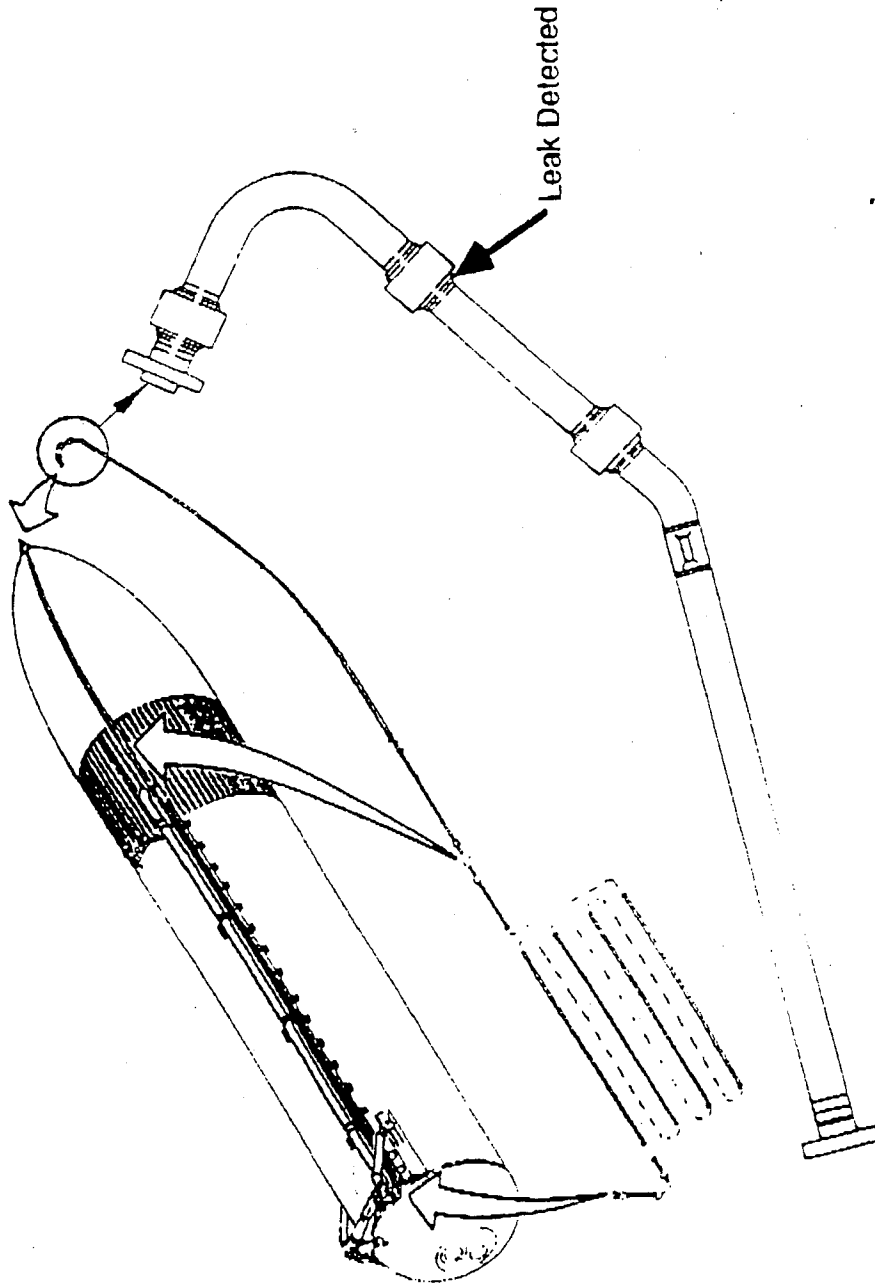
# GO2 Pressure Line Leak (CAPS P-078)

- GO2 forward pressure line leak detected during ATP

- Pressure line assembly tests:
  - 1500 psig hydrostatic proof test
- Deflection tests
  - Two motions unpressurized
  - Two motions with line hydrostatically pressurized to 600 psig
- Line is dried and leak tested using GN2
- Initial proof test resulted in a drop of H2O viewed on weld #4
- Leak was confirmed during pressurization for deflection testing

- ATP is designed to catch this type of failure

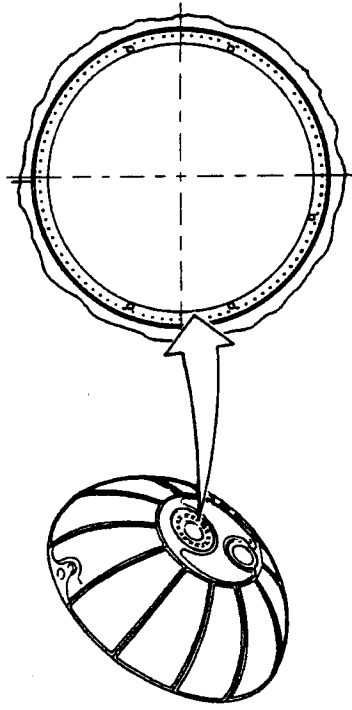
LH2 siphon manhole cover

- ET-80 LH2 siphon cover joint leak test failed ATP

- During the dual seal cavity leak check in Final Assembly, a 472 sccm leak was detected (requirement = sccm maximum)
- Flange uses a Teflon coated Inconel Naflex seal
- No test equipment malfunction found during investigation
- Upon joint disassembly inspection of seal found the following:
  - Area on the primary seal lip, where no evidence of seal to flange contact was present (no witness mark)
  - Dished area with no disruption or damage to the Teflon coating
- Seal returned to supplier for failure investigation

- ET-80 joint reworked and successfully retested
- All others - No issue
- Problems of this nature are screened during leak test

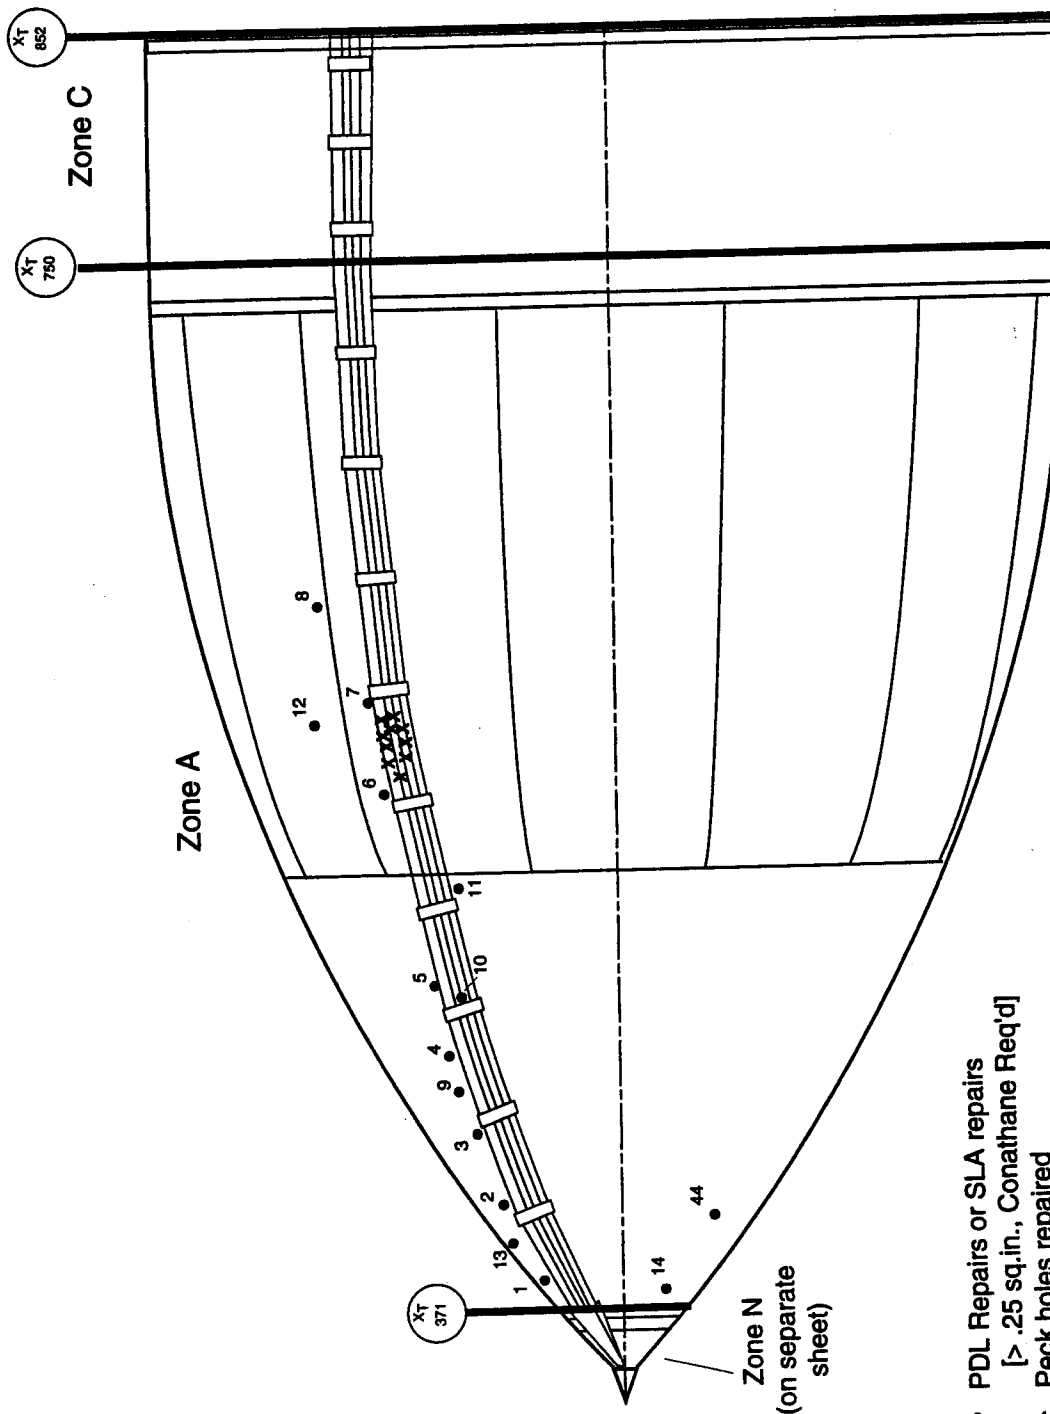
## LO2 Tank C/T Run View

- Inspection of ET-71 TPS surface revealed numerous (216) areas of damaged foam caused by woodpecker while at Pad B

- Detail mapping of damaged areas revealed 216 damage locations
- All areas to be repaired or dispositioned as acceptable for flight
- STS-70 returned to VAB to accomplish repairs
  - 175 areas repaired:
    - Nose cone 8
    - LH2 barrel 19
    - Aft hard point 1
    - LO2 ogive cable tray 14
    - LO2 ogive and barrel 58
    - LO2 feedline 1
    - Intertank 63
    - Aft dome 11
  - 41 peck holes < 0.125" in diameter not repaired
- Concern related to ice formation, structural integrity and ET disposal footprint
- All areas repaired or dispositioned as acceptable for flight
