Starliner Propulsion System Anomalies during the Crewed Flight Test - Investigation Report

02/05/2026

Executive Summary

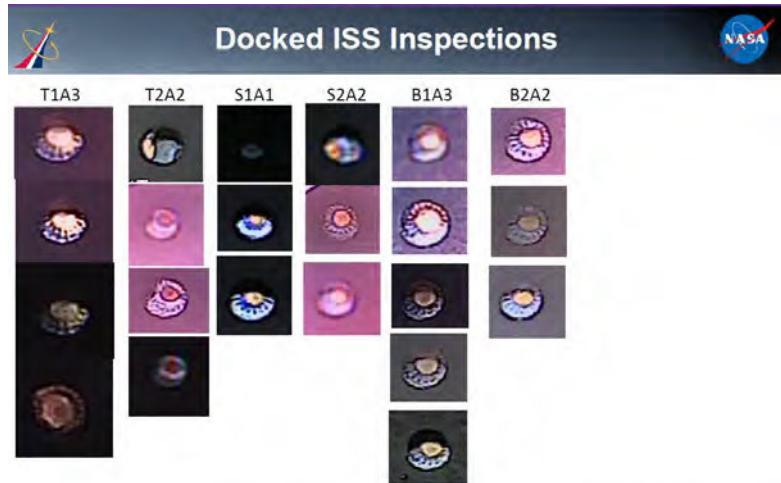
Figure 25: On-Orbit Inspections of Thruster Chambers

show any damage, though image resolution is limited. The borescope images from the ground, during WSTF inspections, are of much higher fidelity than the images taken on orbit. The borescope images were positioned in the throat itself, while the cameras on orbit were hovering on the outside of the nozzle. The data from docked firings demonstrated that the thrusters had somewhat recovered, which would not have occurred in a failed and/or degraded thruster chamber. The combustion chamber is not considered to be a cause or contributor.
