National Aeronautics and Space Administration

Deep Space Station 14 (DSS-14) Azimuth Over-Rotation Mishap

Mishap Classification: Mishap Type A

Date of Mishap: September 16, 2025

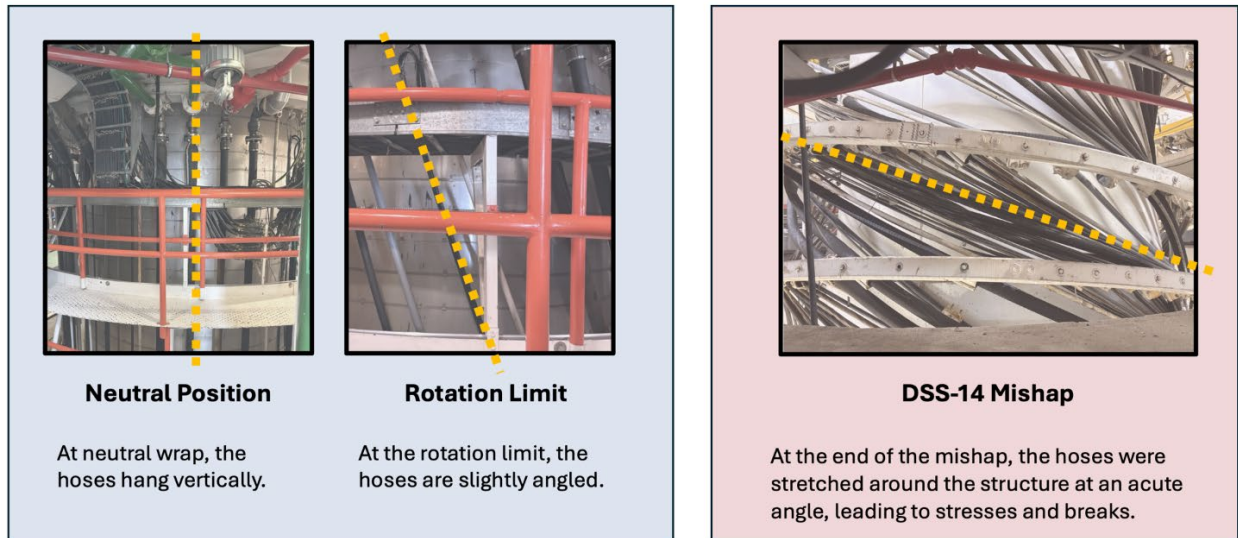
Figure 4: DSS-14 Rotation Limit Photographs

The images in Figure 4 show the wrap as “neutral” at the clockwise rotation design limit, and in the over-wrap state observed in the mishap.

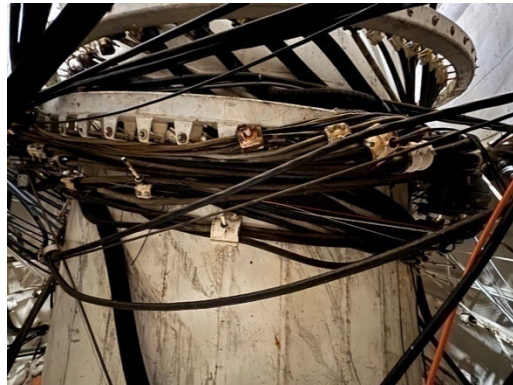
Figure 5: Cable Wrap Damage

For this investigation, the cable wrap is composed of fluid hoses, power and data cables, and other structural elements. These structural elements include large steel rings connected by steel support rods and wire cables acting as tension members. Each ring carries fairleads that support and guide the hoses and cables. Figure 5 shows hoses, cables, and structural elements — including steel rings, support rods, and several fairleads — in various states of damage.

Eleven hoses were present in the wrap at the time of the mishap, and all 11 will require replacement. One hundred twenty-five cables were present in the wrap at the time of the mishap. Of these, 11 are obsolete and do not need to be replaced. Of the remaining 114, the damage assessment indicated at least 85 were clearly broken; any cables not clearly broken will require inspection and recertification prior to reuse.

There are seven rings — two outer rings at the top of the rotating structure and five inner rings that are suspended down into the stationary antenna base — requiring 56 connecting rods, all rods will require replacement. The rings themselves do not need to be replaced.

Wire cables maintain tension between the inner and outer rings, and these wire cables will also require replacement. At least 30 of the 2,688 fairleads used to guide cables and hoses along the rings will require replacement, while the remaining fairleads will require inspection and recertification. Each ring has a set of casters and brackets that guide the ring as it rotates, and all seven sets of casters and brackets will require replacement.

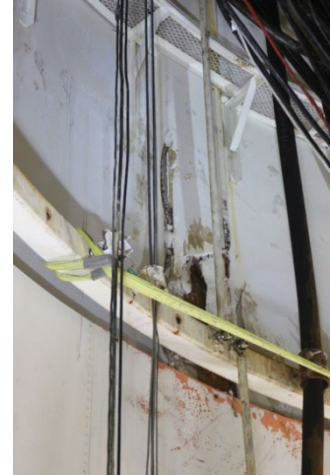
Figure 6: Structure Damage

Structural and mechanical systems outside of the cable wrap also were damaged. Walls surrounding the cable wrap were damaged by the wrap's structural components, while other walls were damaged by flooding. Drywall affected by the damage and flooding tested positive for asbestos, requiring abatement. The fall protection systems used to ensure worker safety when operating on the cable wrap from the alidade were damaged and require replacement and requalification. Several hooks, cable grips, and trays used to support cables and hoses either before or after they enter the wrap were damaged and require replacement. Fire protection systems also will require inspection and repair.
