REPORT OF APOLLO 204 REVIEW BOARD

APPENDIX D
PANEL 5

**REPORT OF PANEL 5
ORIGIN AND PROPAGATION OF FIRE
APPENDIX D-5
TO
FINAL REPORT OF
APOLLO 204 REVIEW BOARD**

ORIGIN AND PROPAGATION OF FIRE

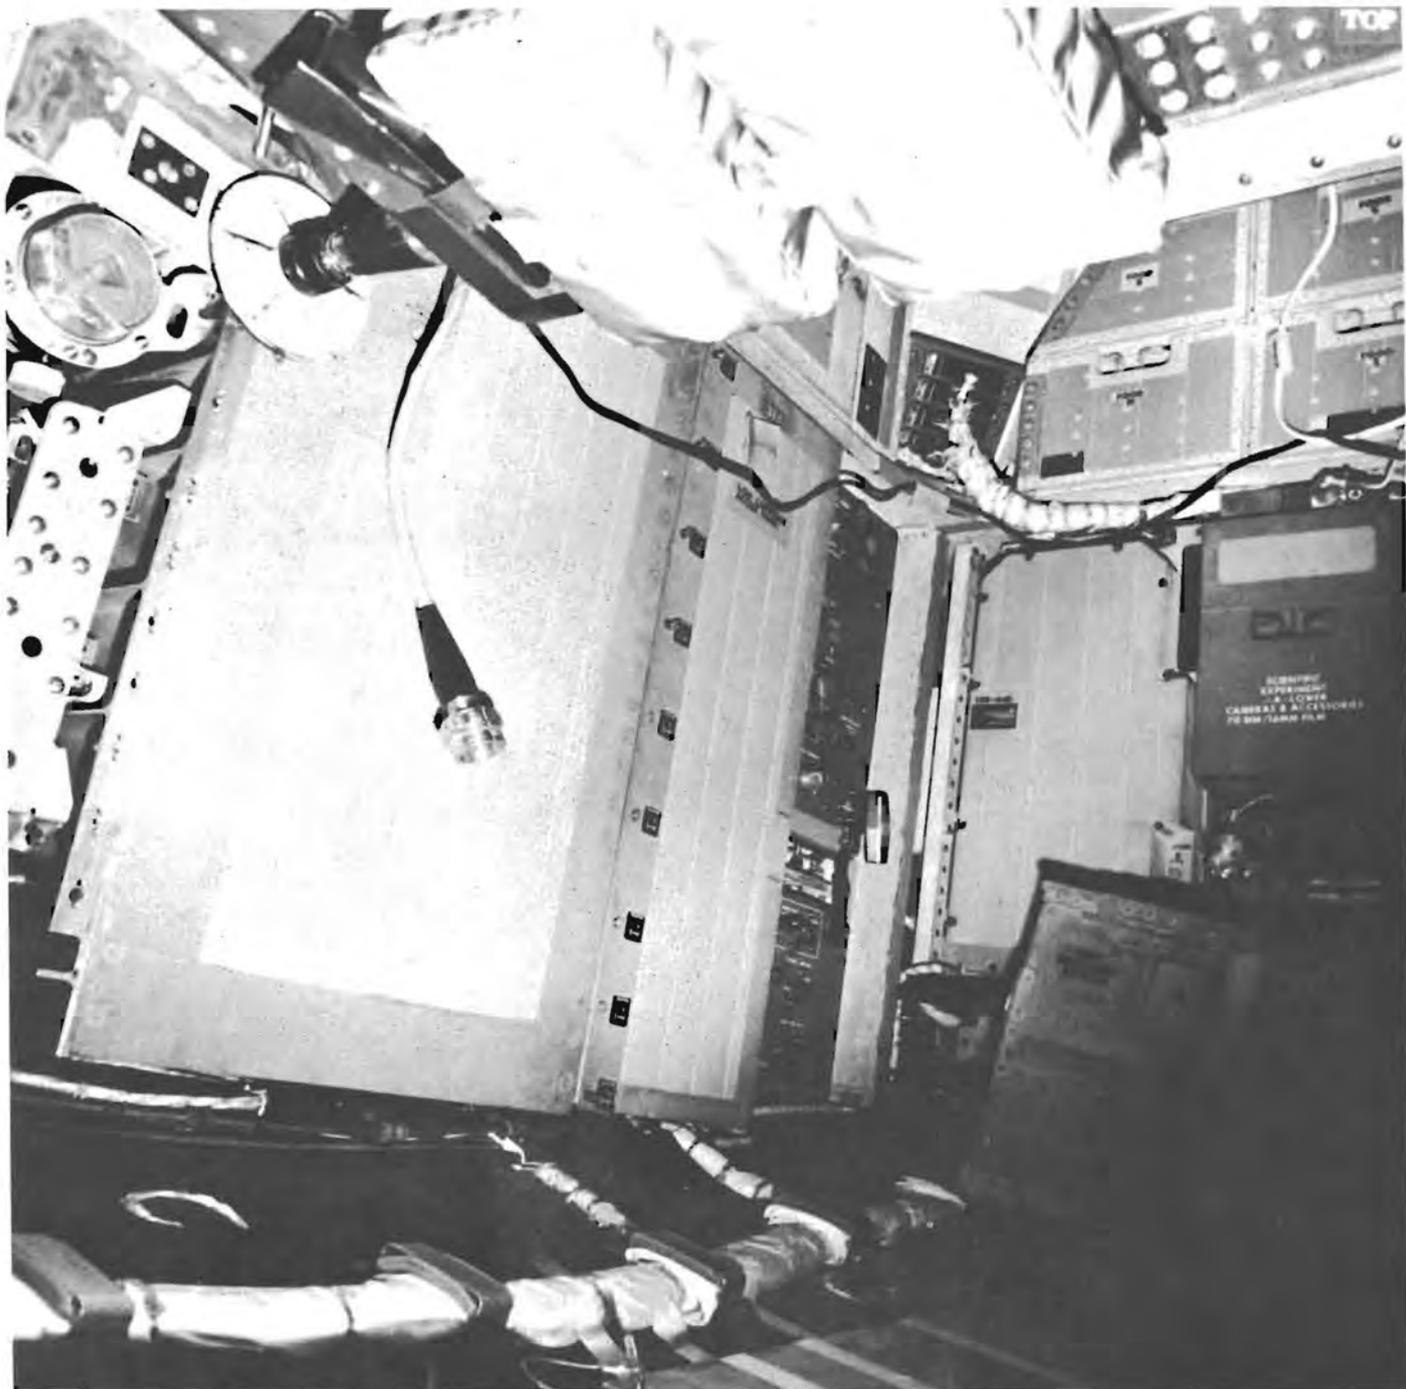
ENCLOSURE 5-2

f. One example of wire insulation damage that may have preceded the fire is illustrated by photograph (Enclosure 5-2). The circled area in the figure shows a wire bundle which lies over a bare stainless steel tube that is a waste management line. This tube lies below the aluminum access door to the carbon dioxide and odor absorber compartment of the Environmental Control Unit (ECU). When the door was opened and closed, its lower edge may have chafed the wires of this bundle. There was no chafing guard for the Teflon insulation on these wires; this made them vulnerable to damage. Teflon is particularly vulnerable to cold flow and mechanical damage. Wire splices close by increased the susceptibility of the insulation to chafing damage. Careful investigation showed that the splices were too far from the chafing point to matter. Combustibles in the form of polyurethane foam and nylon netting lay close to the electrical arcs and sparks that would occur if the Teflon insulation were defeated. The same wires damaged by fire are shown encircled in photograph (Enclosure 5-3).

WIRING UNDER CO₂ ABSORBER ACCESS DOOR

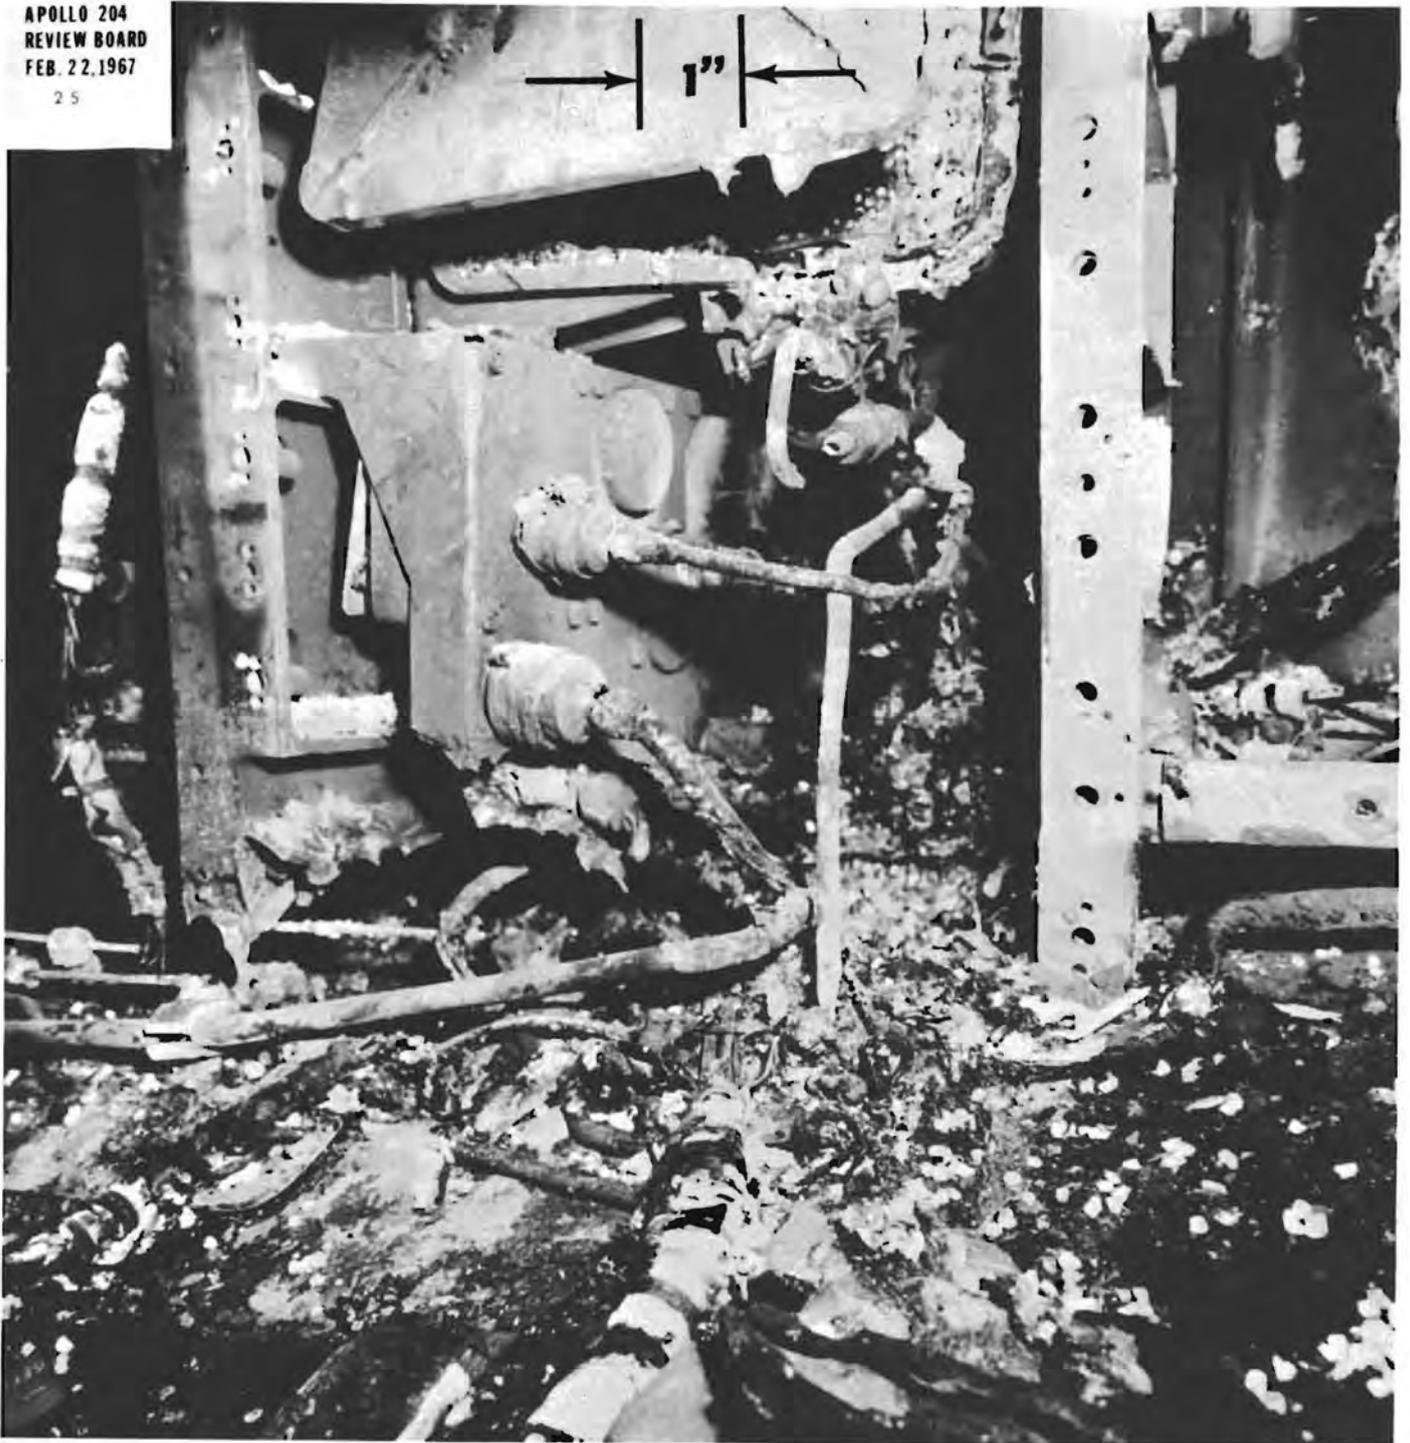
DAMAGED WIRING UNDER ACCESS DOOR

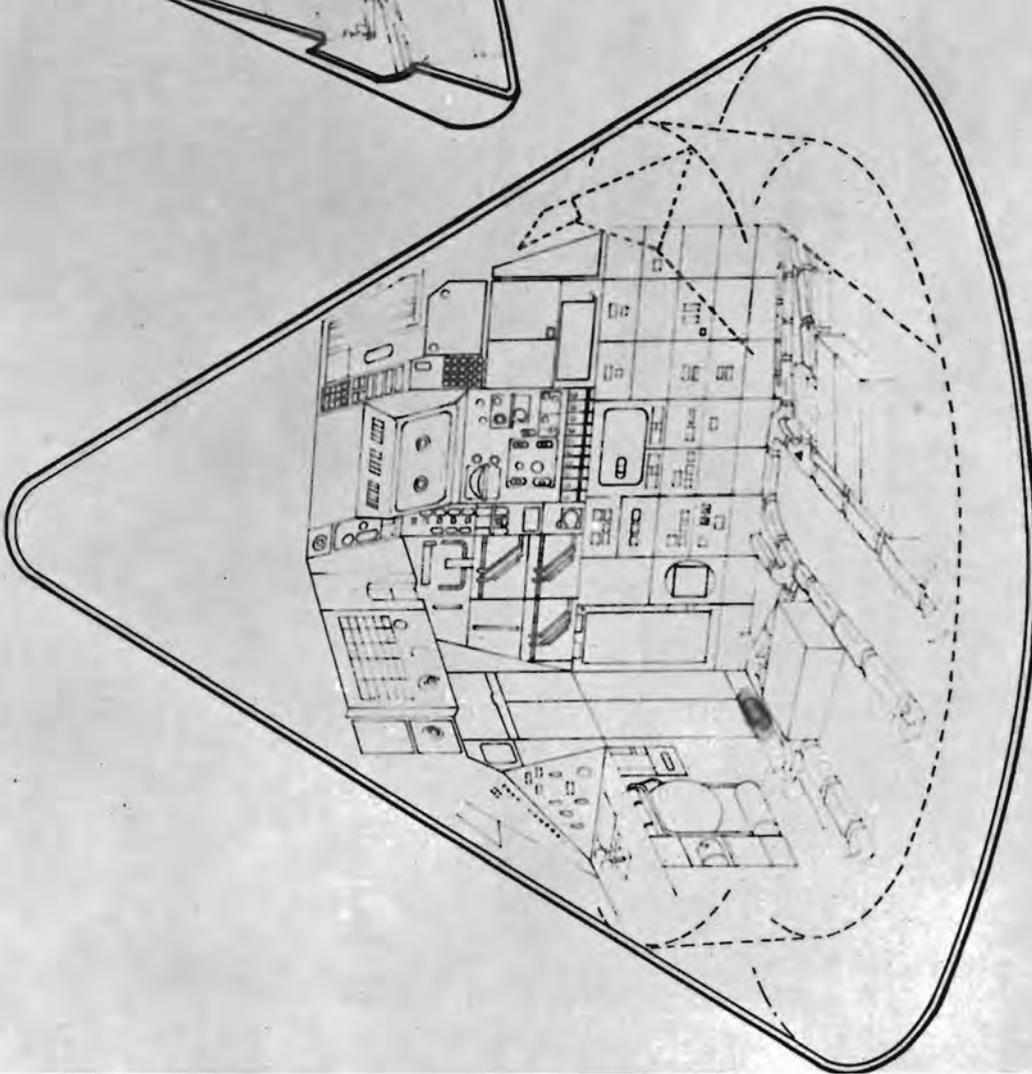
b. From observations of post-fire damage and witness statements, the fire first appeared to be at the lower portion of the left side of the C/M, presumably near the lower left corner (Enclosure 5-7). The slow rate of rise of recorded cabin pressure caused by the heat released by the fire suggests that the fire was not intense until about 23:31:12 GMT (Enclosure 5-8). This slow rate of pressure rise is consistent with the view that the early fire was either located in a zone containing little combustible or one containing much bare aluminum structure which could absorb an appreciable portion of the heat. The first significant indication of pressure rise was shown by telemetry data at 23:31:08.4 GMT.

VIEW OF LOWER LEFT HAND CORNER

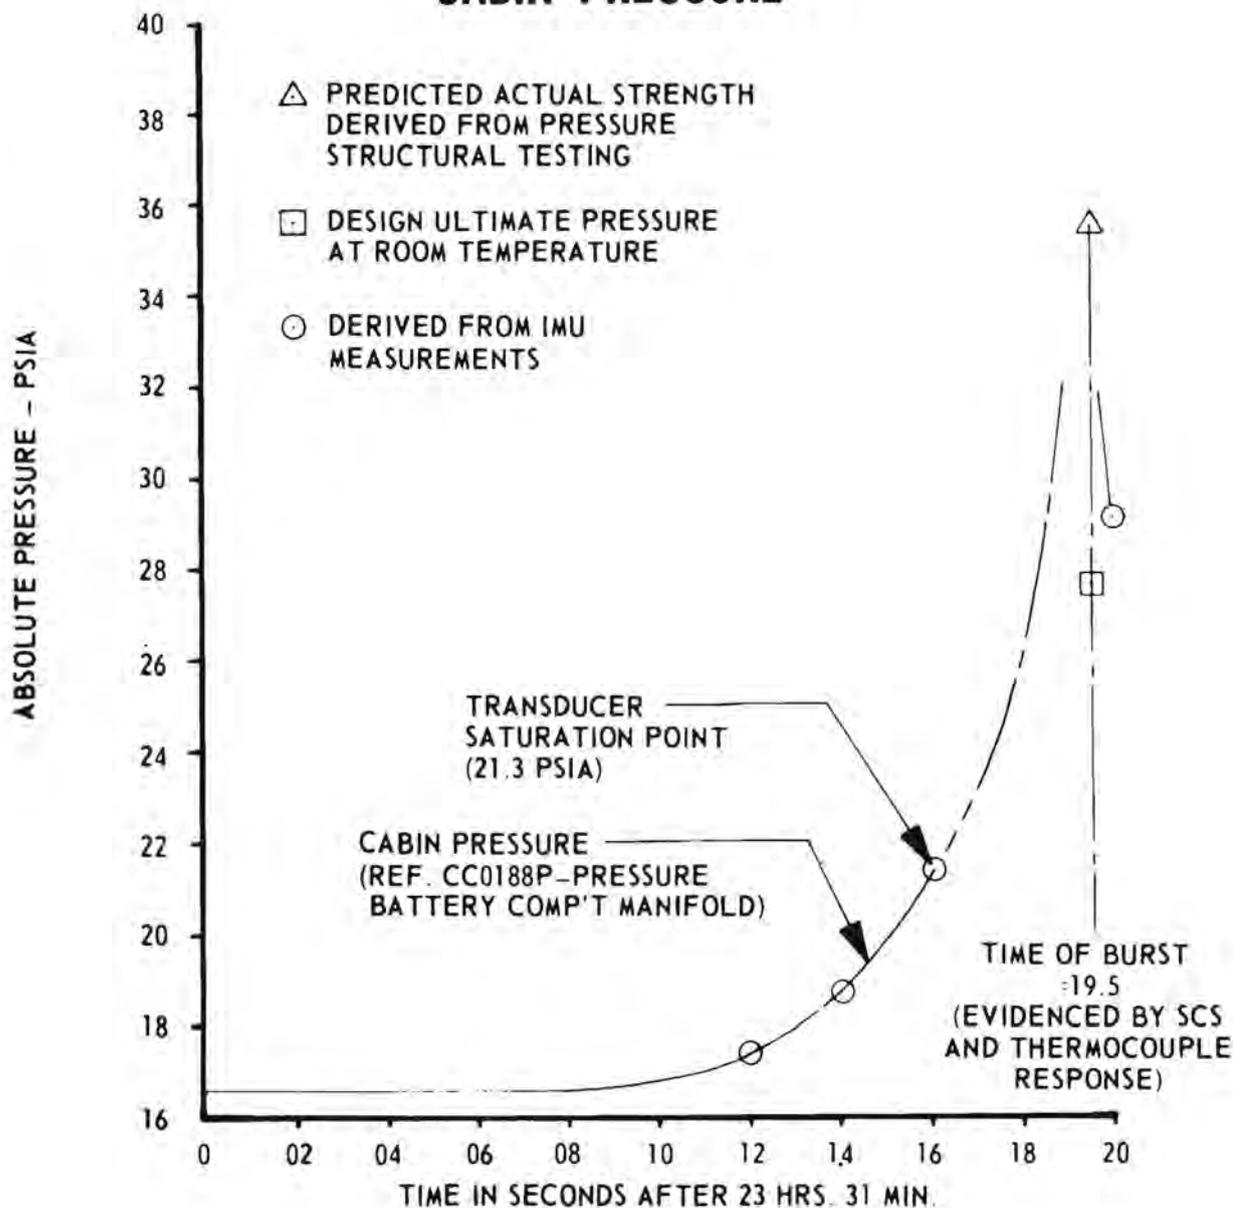
CABIN PRESSURE CHART

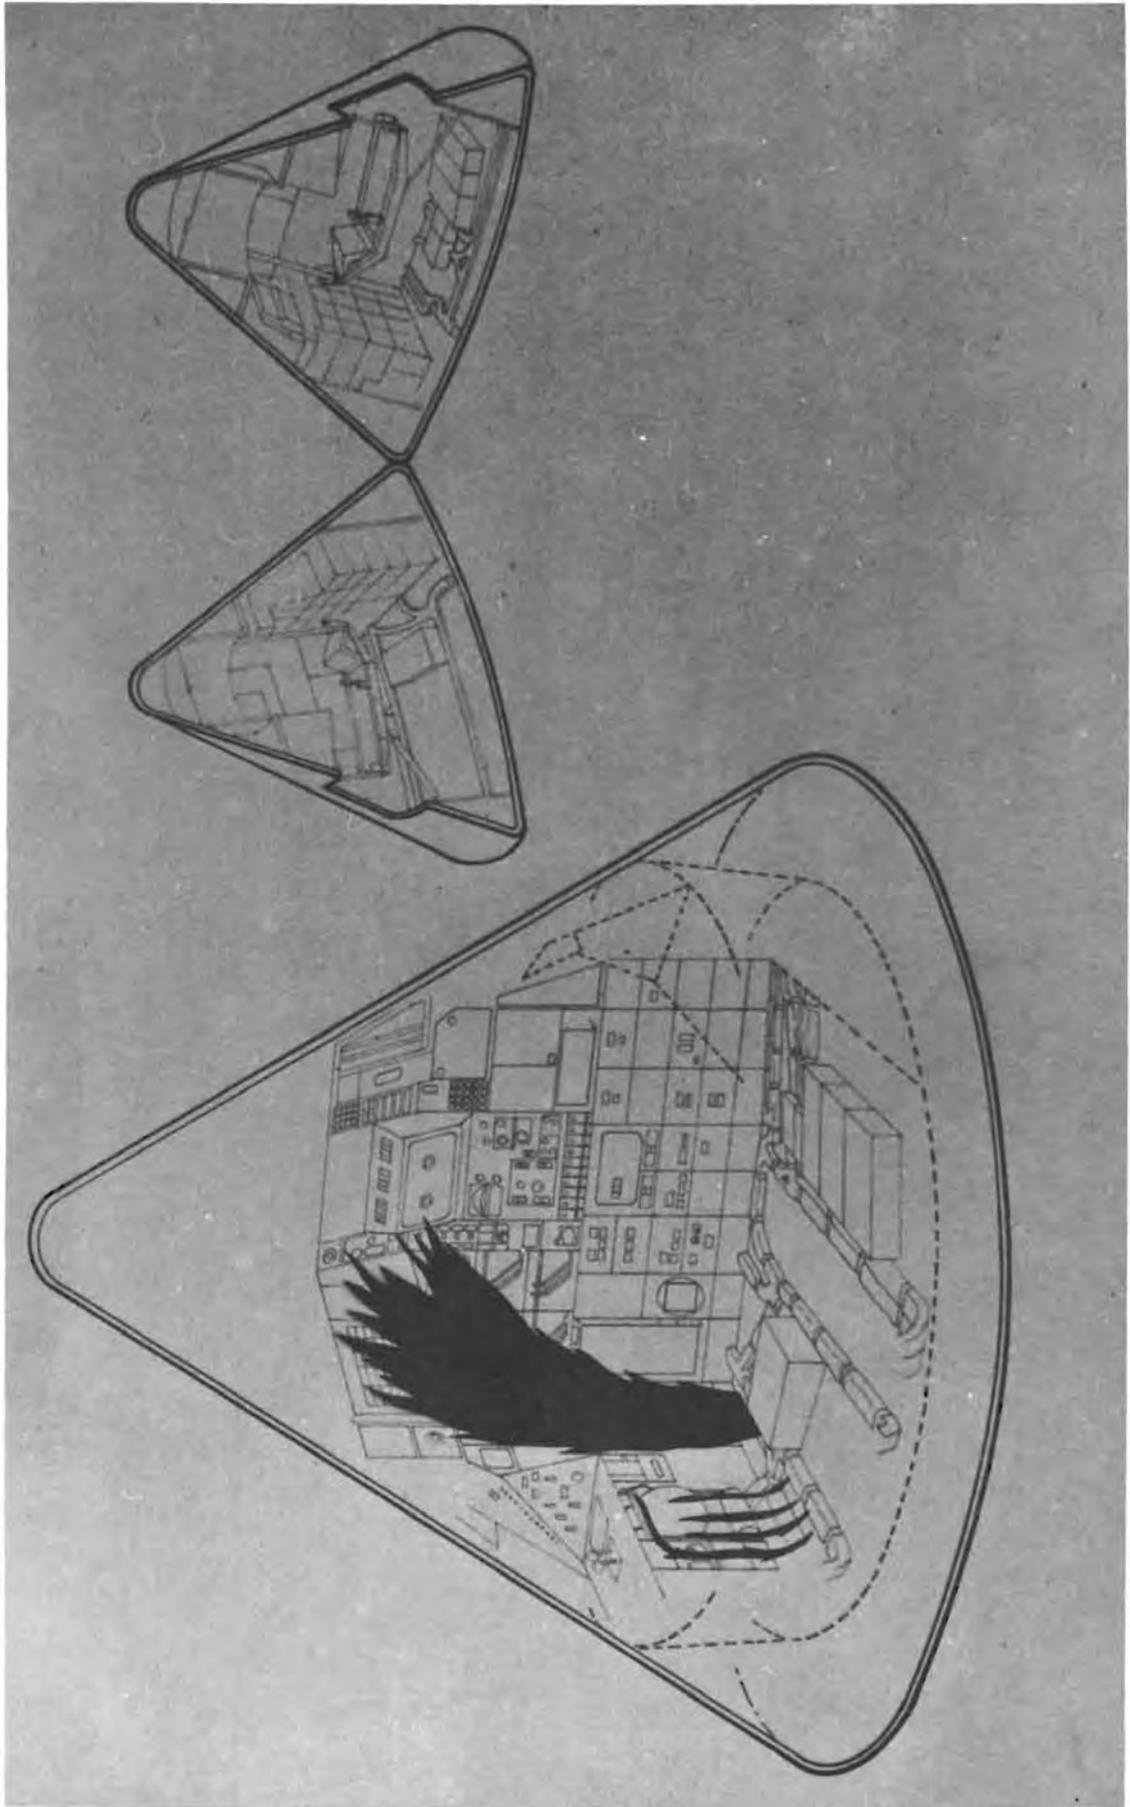
Stage 1 - Stage 1 began when the fire started, probably some seconds before the astronaut's first verbal indication of the fire at 23:31:04.7 GMT (6:31:04.7 pm EST). This inference is based upon several anomalies in the telemetry data. Stage 1 concluded at about 23:31:19.4 GMT when the internal pressure ruptured the pressure vessel.

FIRST PHASE OF FIRE

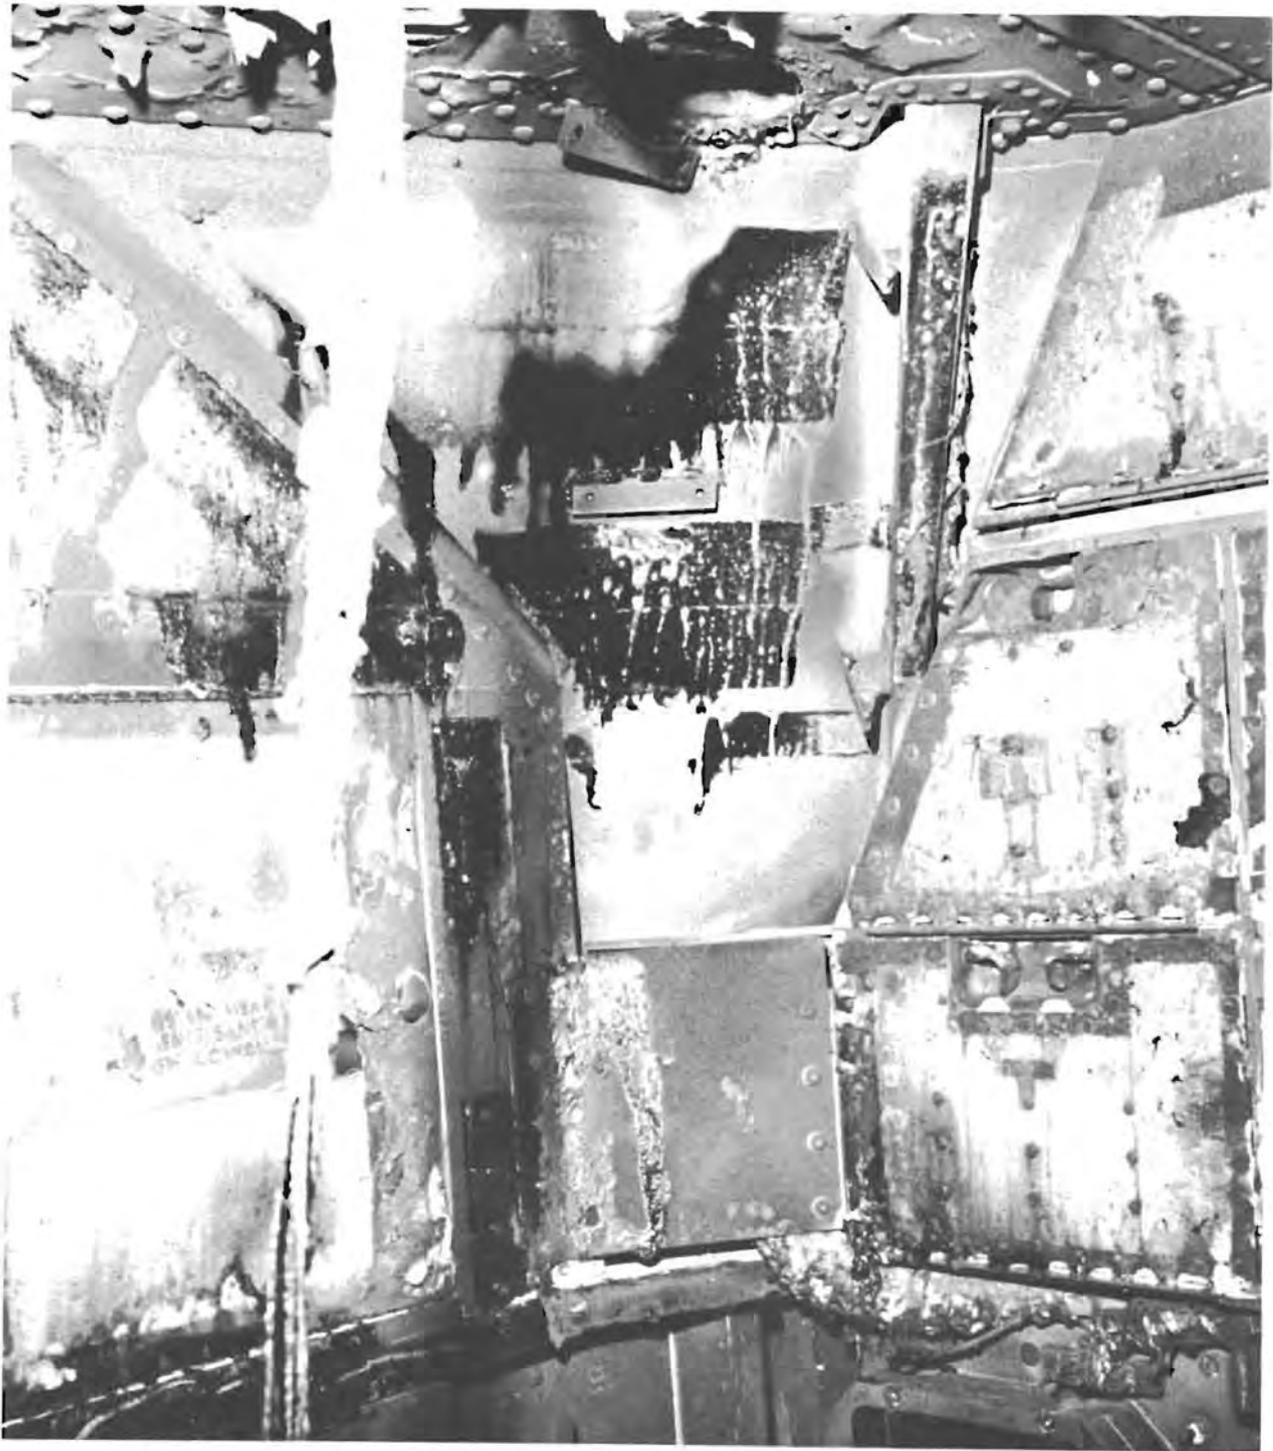
ENCLOSURE 5-10

EXTREME UPPER LEFT HAND CORNER BETWEEN LOWER EQUIPMENT BAY
AND LEFT HAND EQUIPMENT BAY

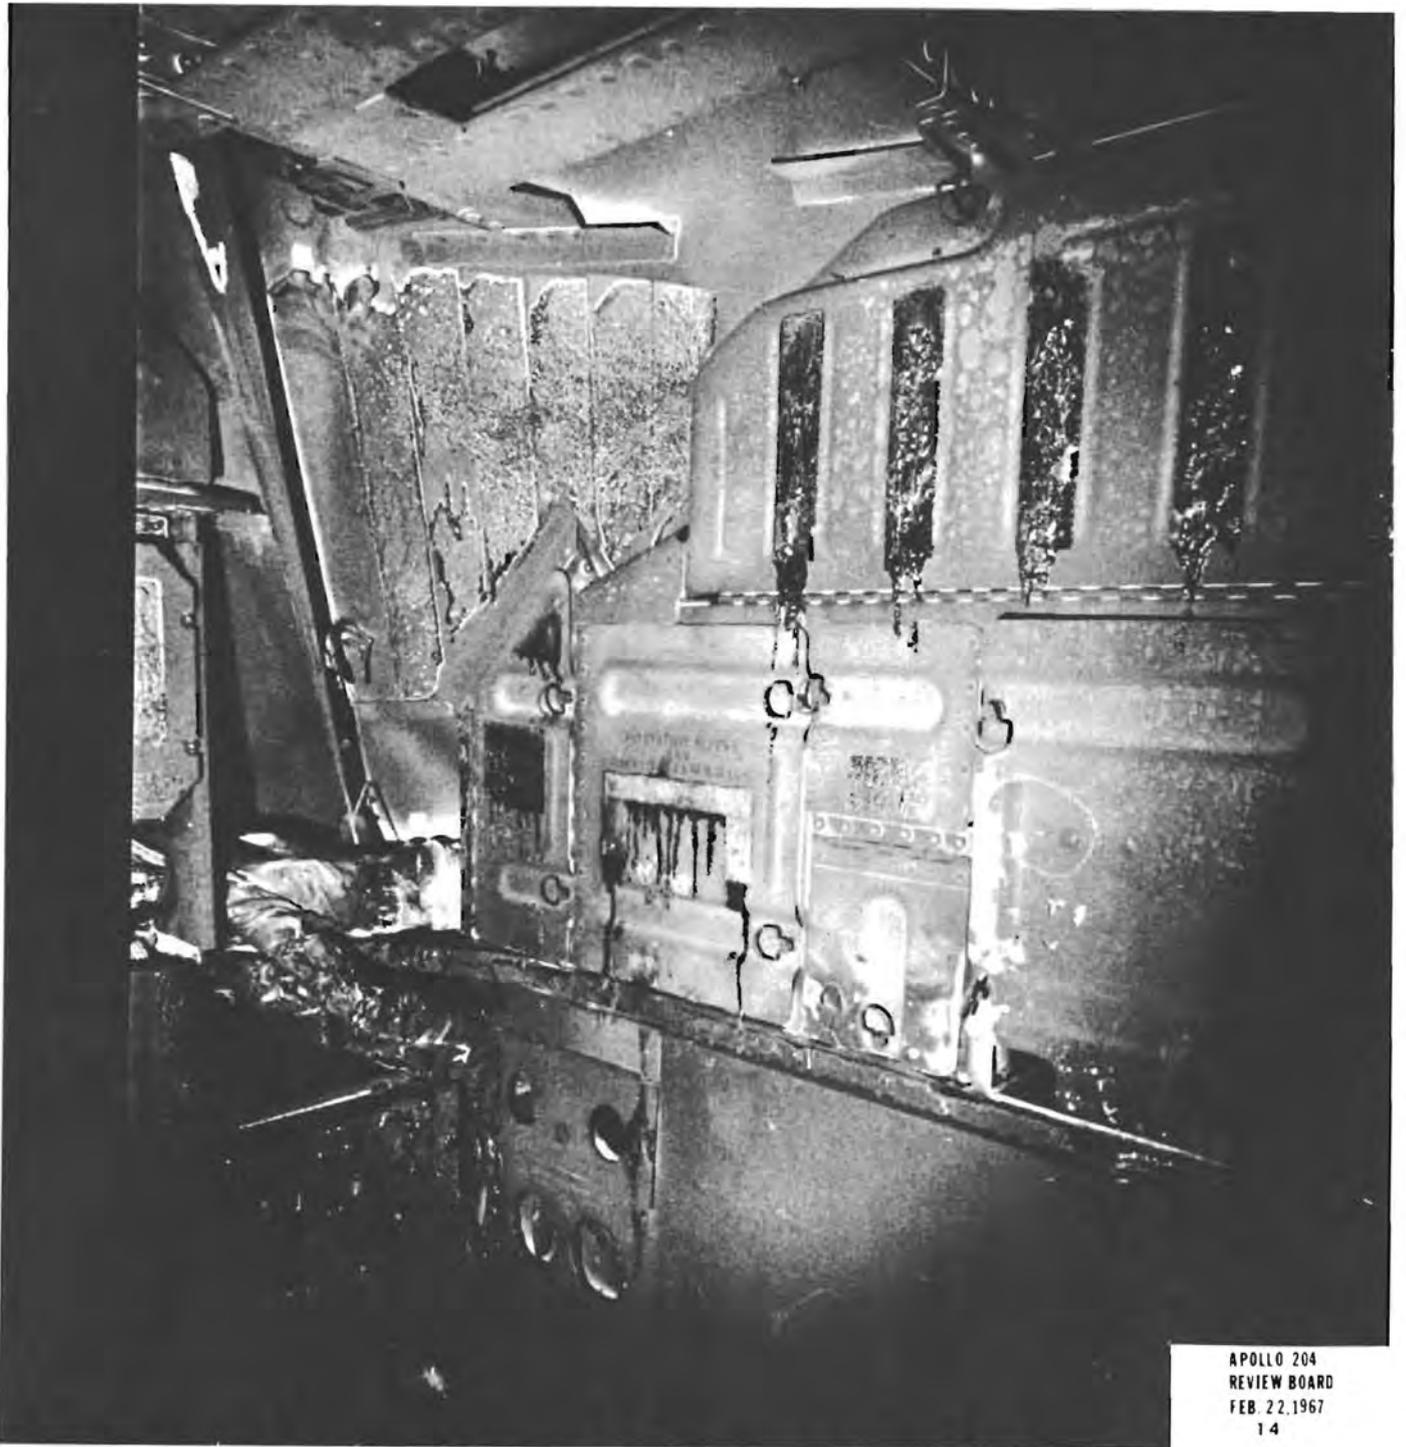
d. Because there had been a history of electric arcs from the Pyro Battery to adjacent structure at the aft bulkhead level in the right front corner, this area was reviewed carefully as a possible site of the fire origin. The main combustible here is the nylon debris trap (Raschel Net) that extends from floor to ceiling. The extensive melting of this net (Enclosure 5-11), visible as fused yellow plastic adhering to C/M components in the corner indicates that the oxygen concentration at the time of its ignition was too low to burn it to completion. For this reason the right front corner is not regarded as the location of the origin of the fire.

EXTREME RIGHT HAND CORNER ABOVE LOWER EQUIPMENT BAY AND RIGHT HAND EQUIPMENT BAY

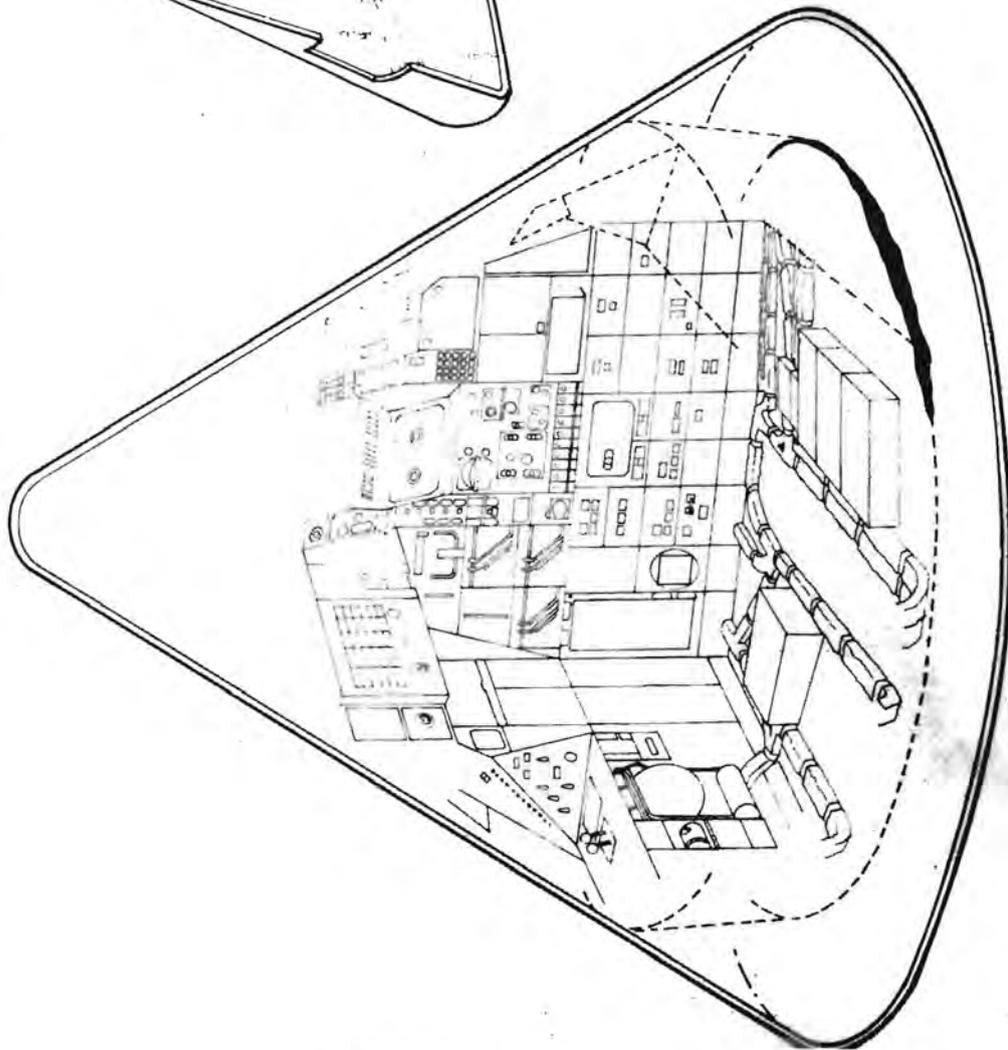
f. A major failure in the aft bulkhead occurred at the junction of the wall and aft bulkhead in the vicinity of the umbilical (Enclosure 5-12). Cabin gases and flame flowed in the direction of the break in the floor. The flames, debris, and oxygen flowed into the toroidal space between the pressure shell and the heat shield where the thermocouples registered rapidly rising temperature at 23:31:20 GMT. Flames in the toroidal space burned and melted components of the Reaction Control System and the insulation and honeycomb structure of the aft heat shield. These flames also poured from access hatches in the crew compartment heat shield and set fire to combustibles situated on and around the spacecraft at levels A-8 and A-7. These fires endangered pad personnel and impeded rescue.

FIRST PRESSURE VESSEL FAILURE

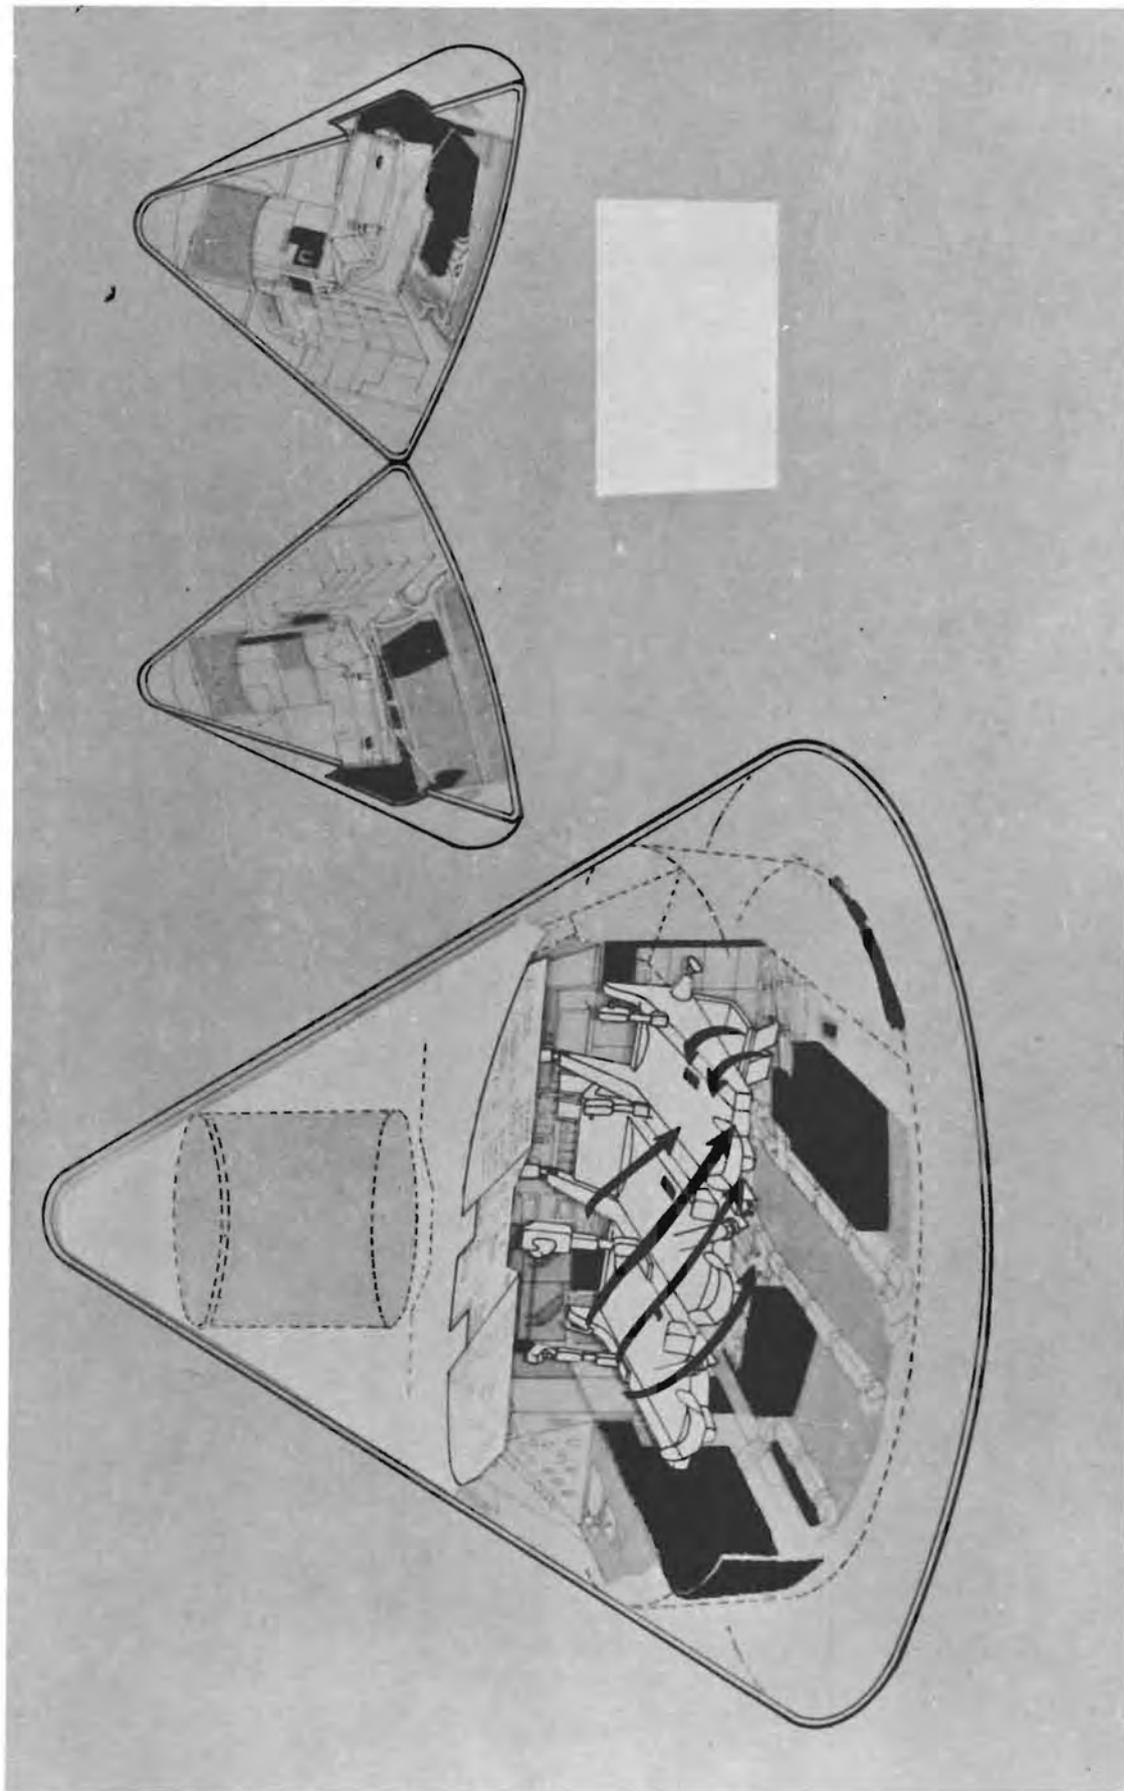
g. After cabin failure, the gas flowing toward the floor break swept the flames to other combustibles and increased the rate of fire spread markedly. Flames rising above the couches were directed into a horizontal plane to spread the fire over the couches. Examination of the couches and astronauts' suits after the fire indicates the movement of these flames in the manner indicated in Enclosure 5-13. Flame damage to the suits, harness, and helmet visors show that it was most severe for the Command Pilot and least for the Pilot. Witnesses at monitors of the television camera mounted outside the cabin hatch view port reported movement of flame from left to right inside the cabin.

SECOND FIRE PHASE OVER COUCHES

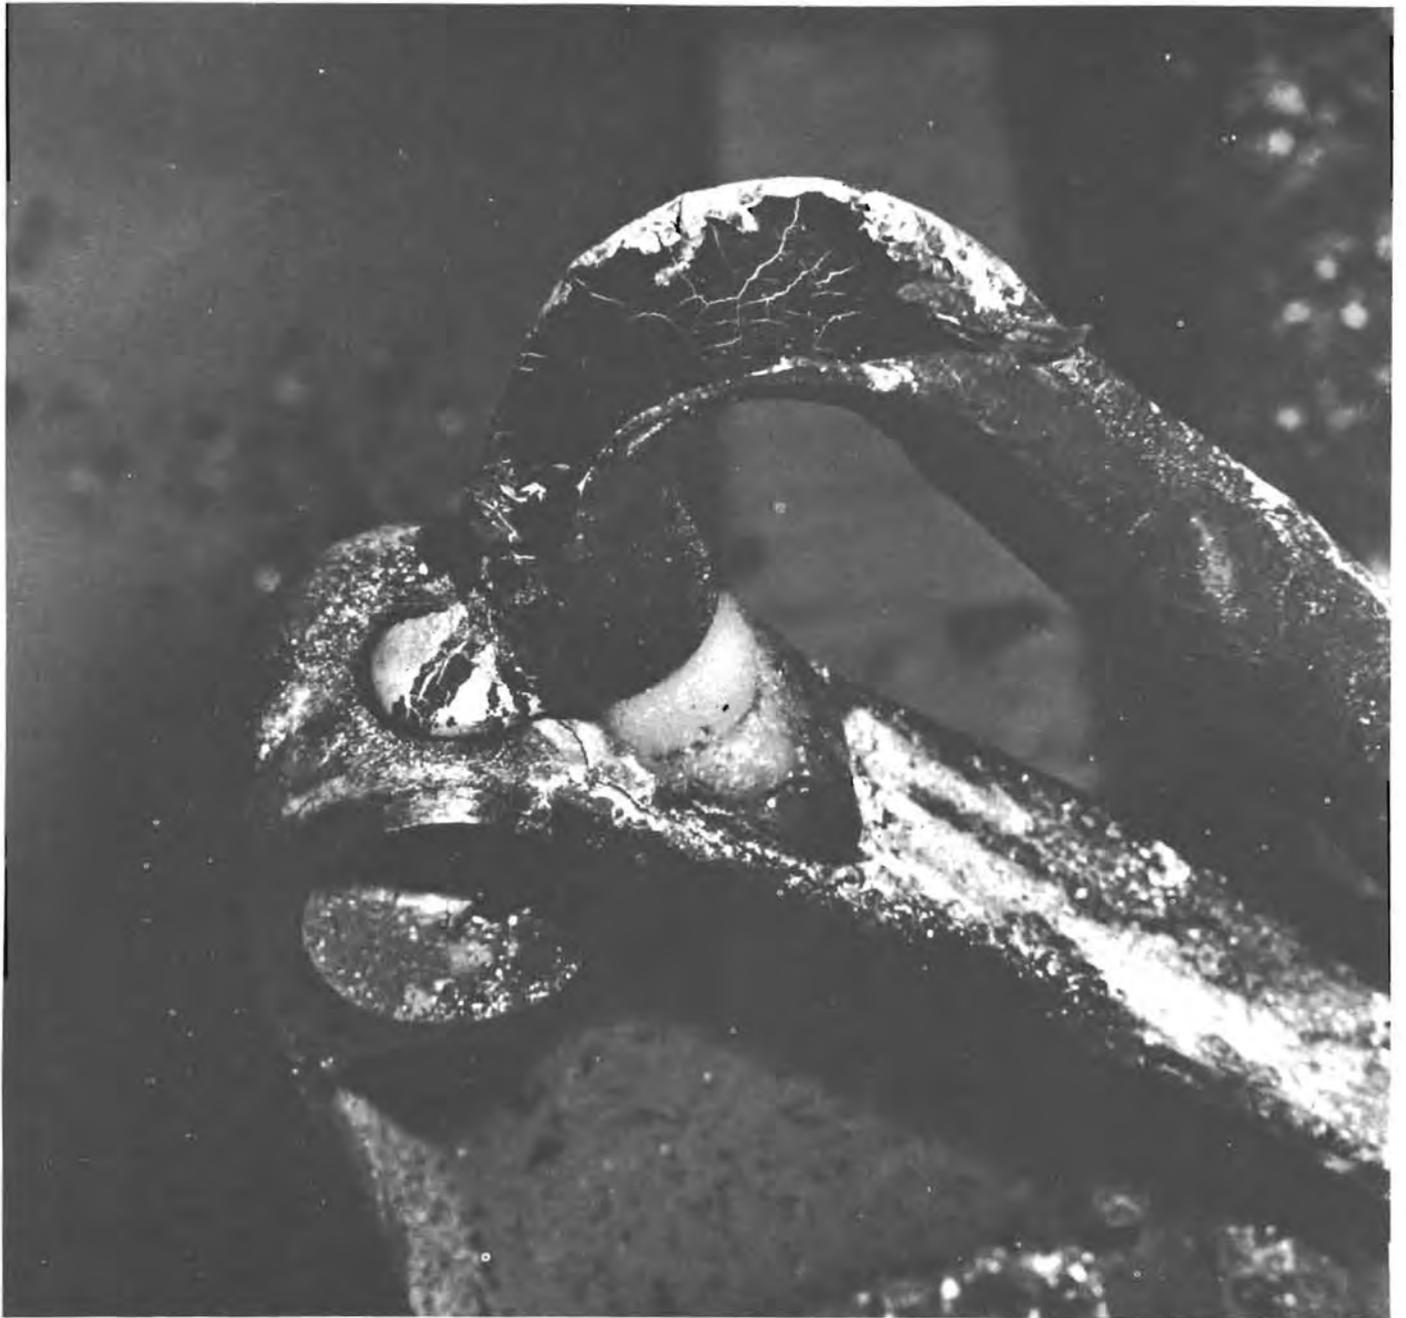
ENCLOSURE 5-14

i. Further evidence that fire crossed the couches from left to right is given by the melting and burning of the leg rest control handle on the left side of the left couch. This handle is formed from aluminum tubing. Tongues of flame flowing over the handle melted and burned its left side where heat transfer would be greatest. The result was a softened and deformed ledge of aluminum on the right side where the heat transfer was less (Enclosure 5-14). A plastic button at the base of the handle shows little deformation and no burning. An aluminum ingot deposited by molten metal from the handle lies adjacent to the plastic button.

LEG REST CONTROL HANDLE

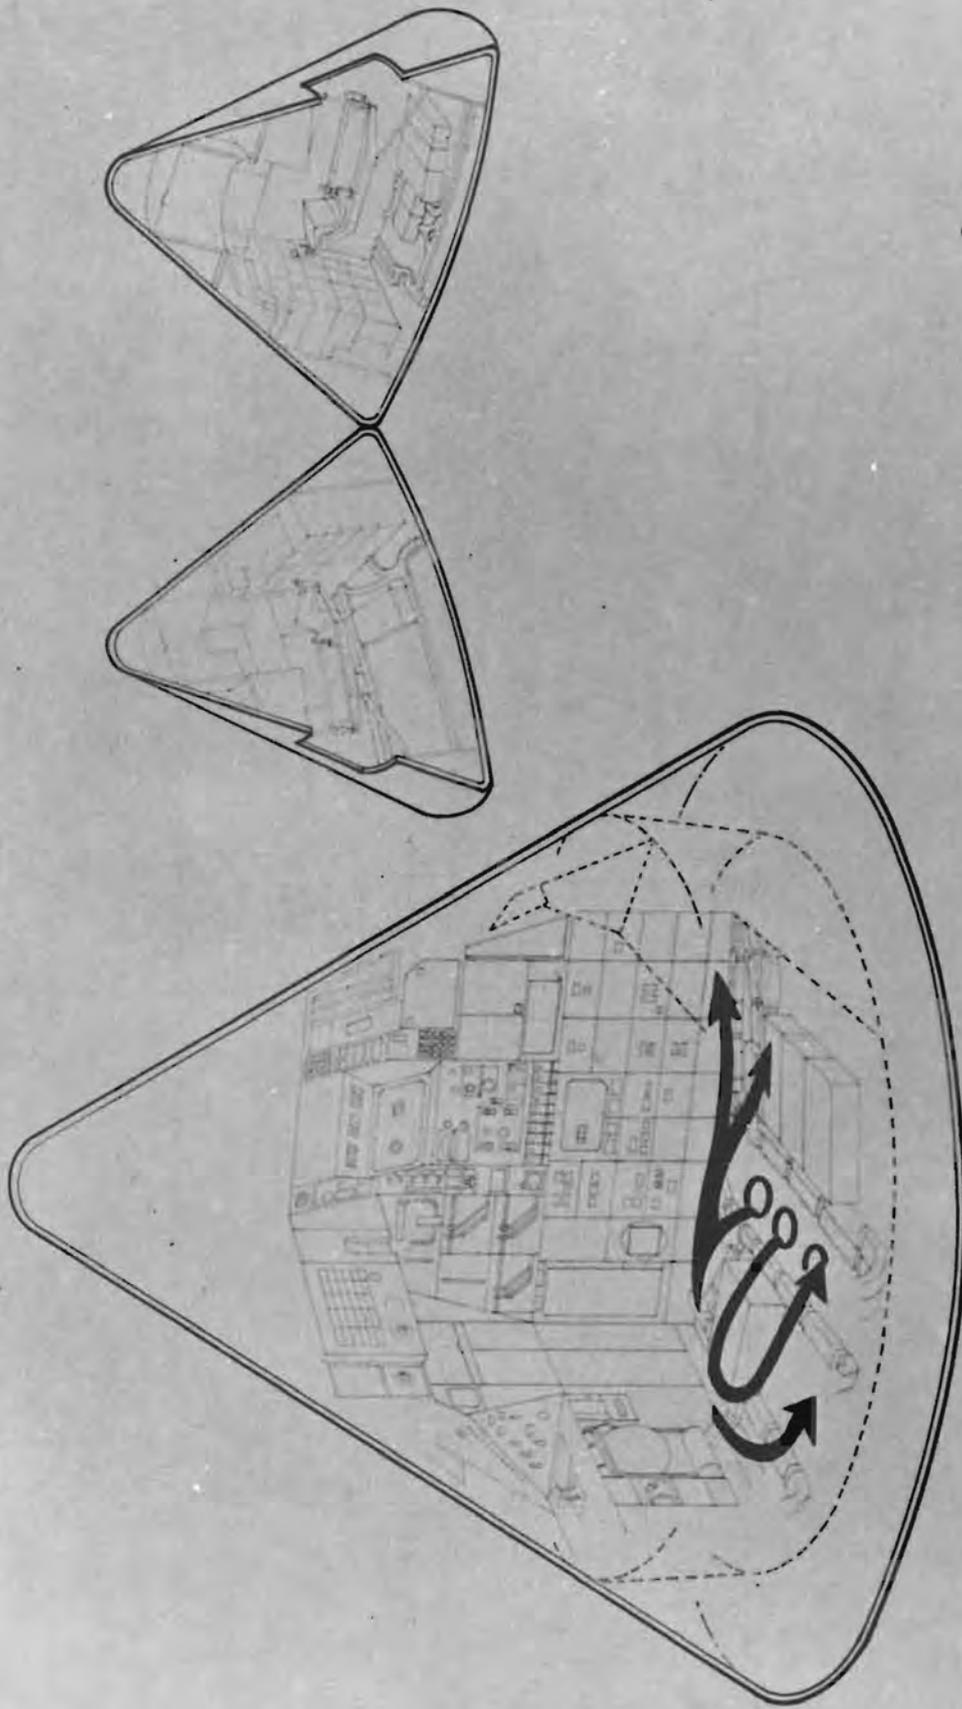
j. Some of the fire below the couch also swept in the direction of the floor break (Enclosure 5-15). Fire damage to the three helmet covers lying on the floor below the Senior Pilot's (middle) couch indicated that some of this flame spread around the lithium hydroxide (LiOH) canister storage box to the left of the helmet covers (Enclosure 5-16). Fire damage to these covers is greatest on their left sides where the flames impinged. The fire damage to the helmet covers, shown in this photograph, is consistent with this view of the path taken by the flames at this location. Enclosure 5-17 is a view of the helmet cover which lies closest to the hatch. Because the camera faces the hatch, the left side of the C/M is on the viewer's right.

SECOND PHASE OF FIRE -- ON THE FLOOR
