REPORT OF APOLLO 204 REVIEW BOARD

APPENDIX D
PANEL 5

**REPORT OF PANEL 5
ORIGIN AND PROPAGATION OF FIRE
APPENDIX D-5
TO
FINAL REPORT OF
APOLLO 204 REVIEW BOARD**

ORIGIN AND PROPAGATION OF FIRE

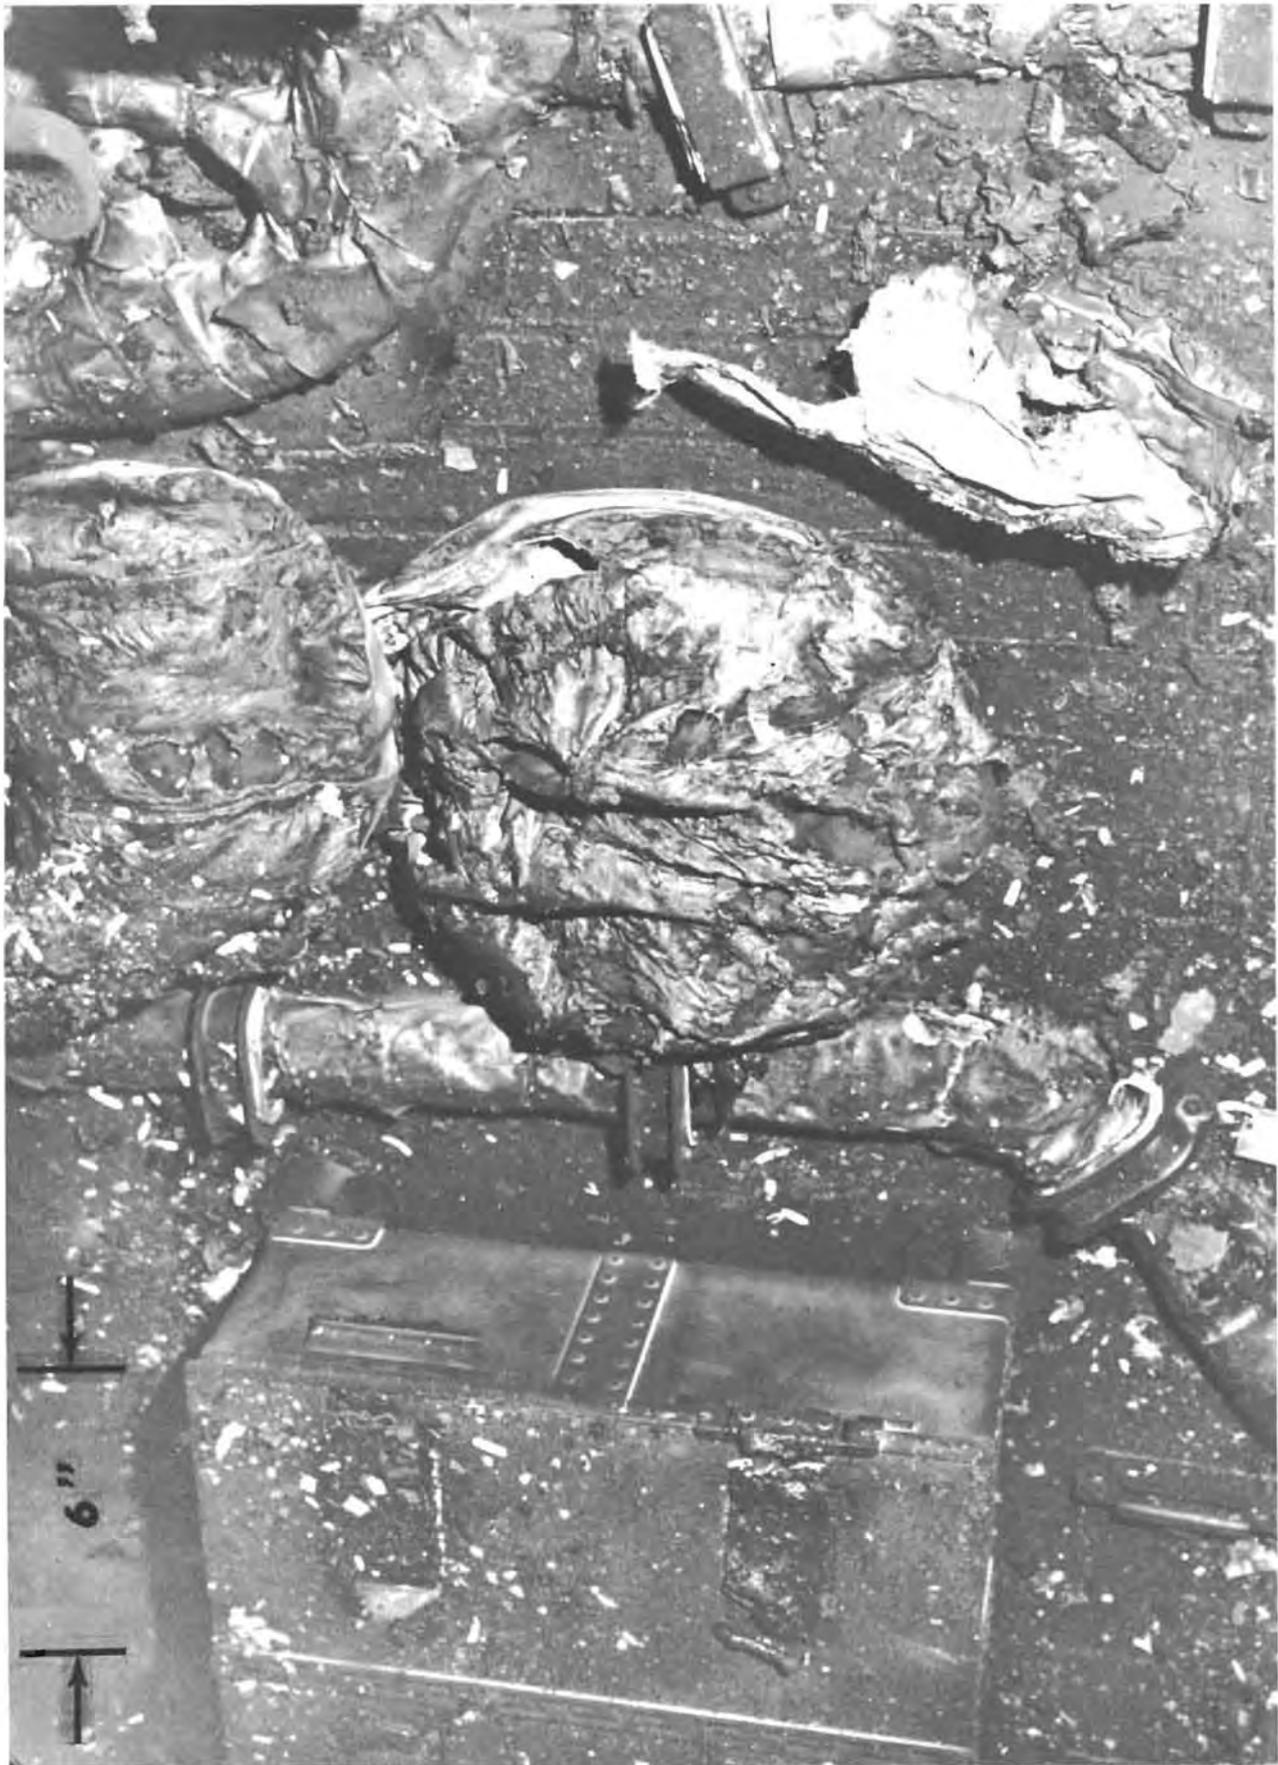
j. Some of the fire below the couch also swept in the direction of the floor break (Enclosure 5-15). Fire damage to the three helmet covers lying on the floor below the Senior Pilot's (middle) couch indicated that some of this flame spread around the lithium hydroxide (LiOH) canister storage box to the left of the helmet covers (Enclosure 5-16). Fire damage to these covers is greatest on their left sides where the flames impinged. The fire damage to the helmet covers, shown in this photograph, is consistent with this view of the path taken by the flames at this location. Enclosure 5-17 is a view of the helmet cover which lies closest to the hatch. Because the camera faces the hatch, the left side of the C/M is on the viewer's right.

VIEW OF HELMET COVERS

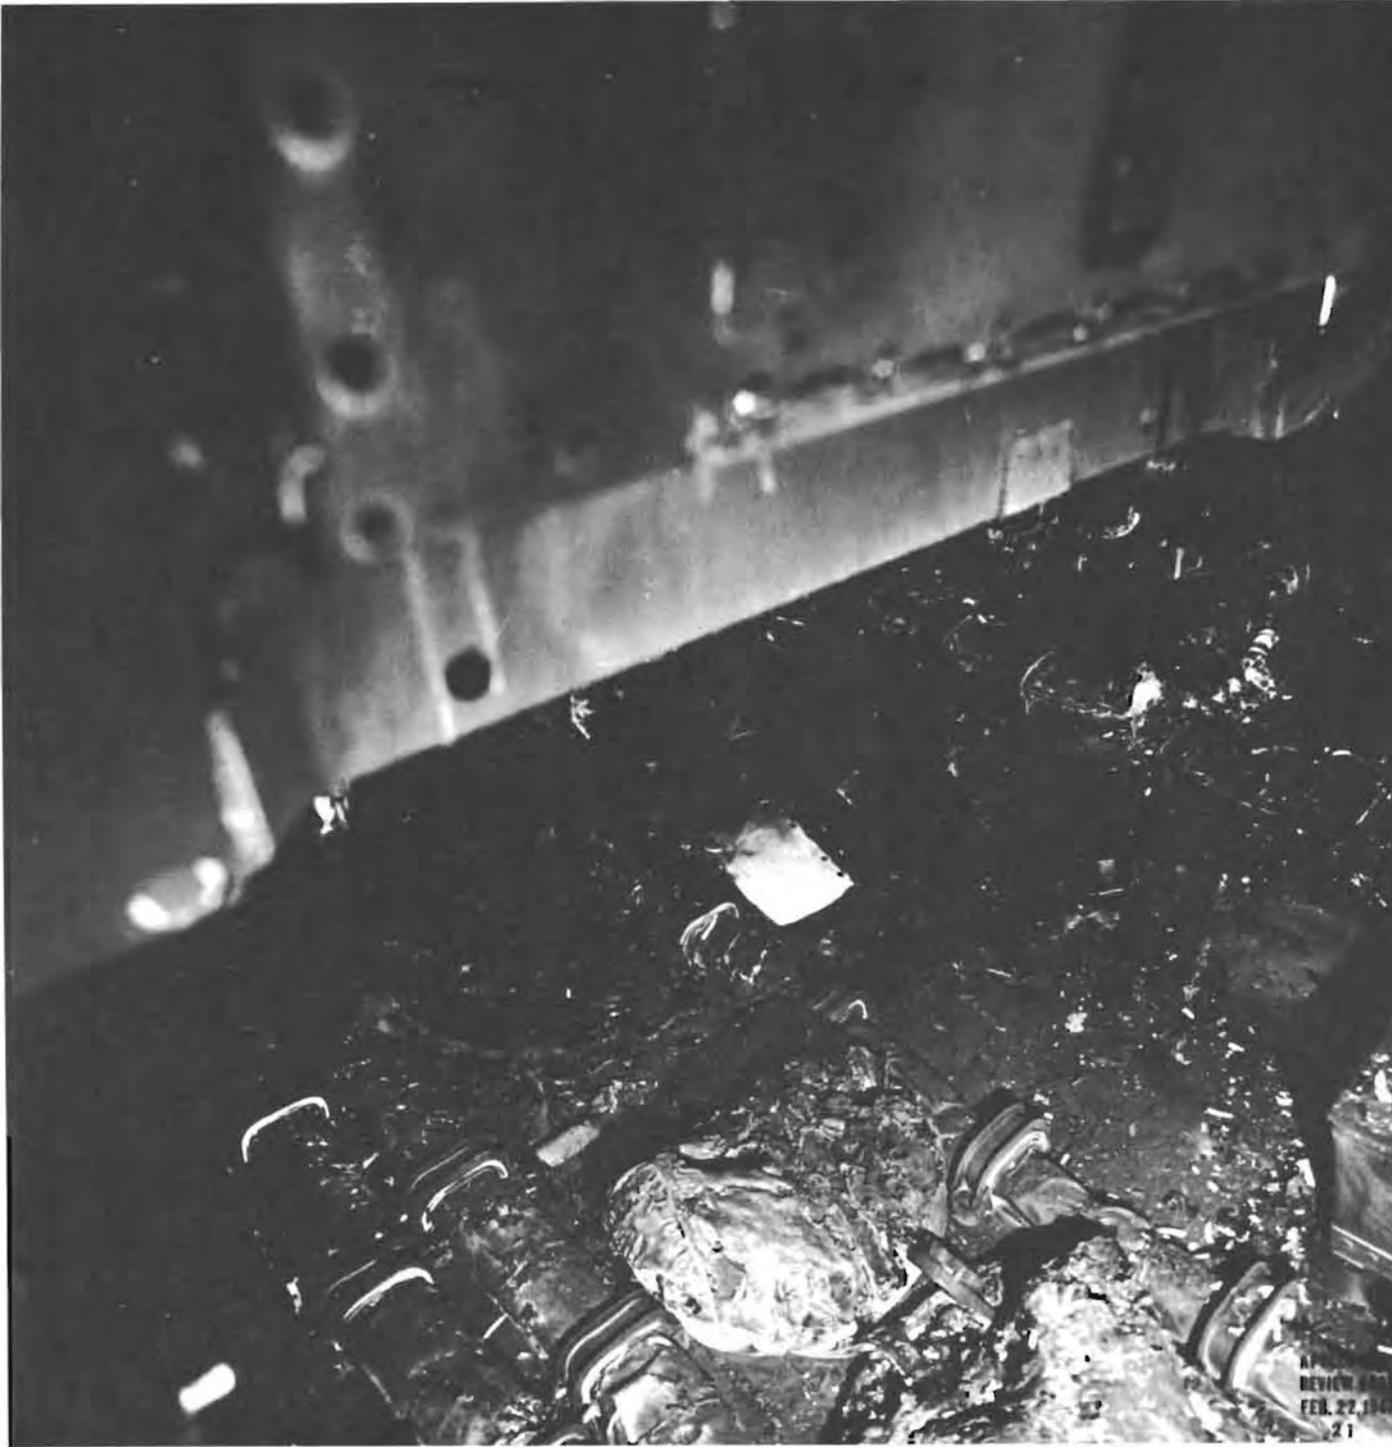
k. Absence of substantial heat damage to the LiOH canister storage box and the clean underside of the couch above the helmet covers indicates that these flames lasted for only a few seconds. Discrete damage to wire bundles at floor level along the right side of the C/M indicates part of these flames reached completely across the floor.

VIEW OF HELMET COVERS

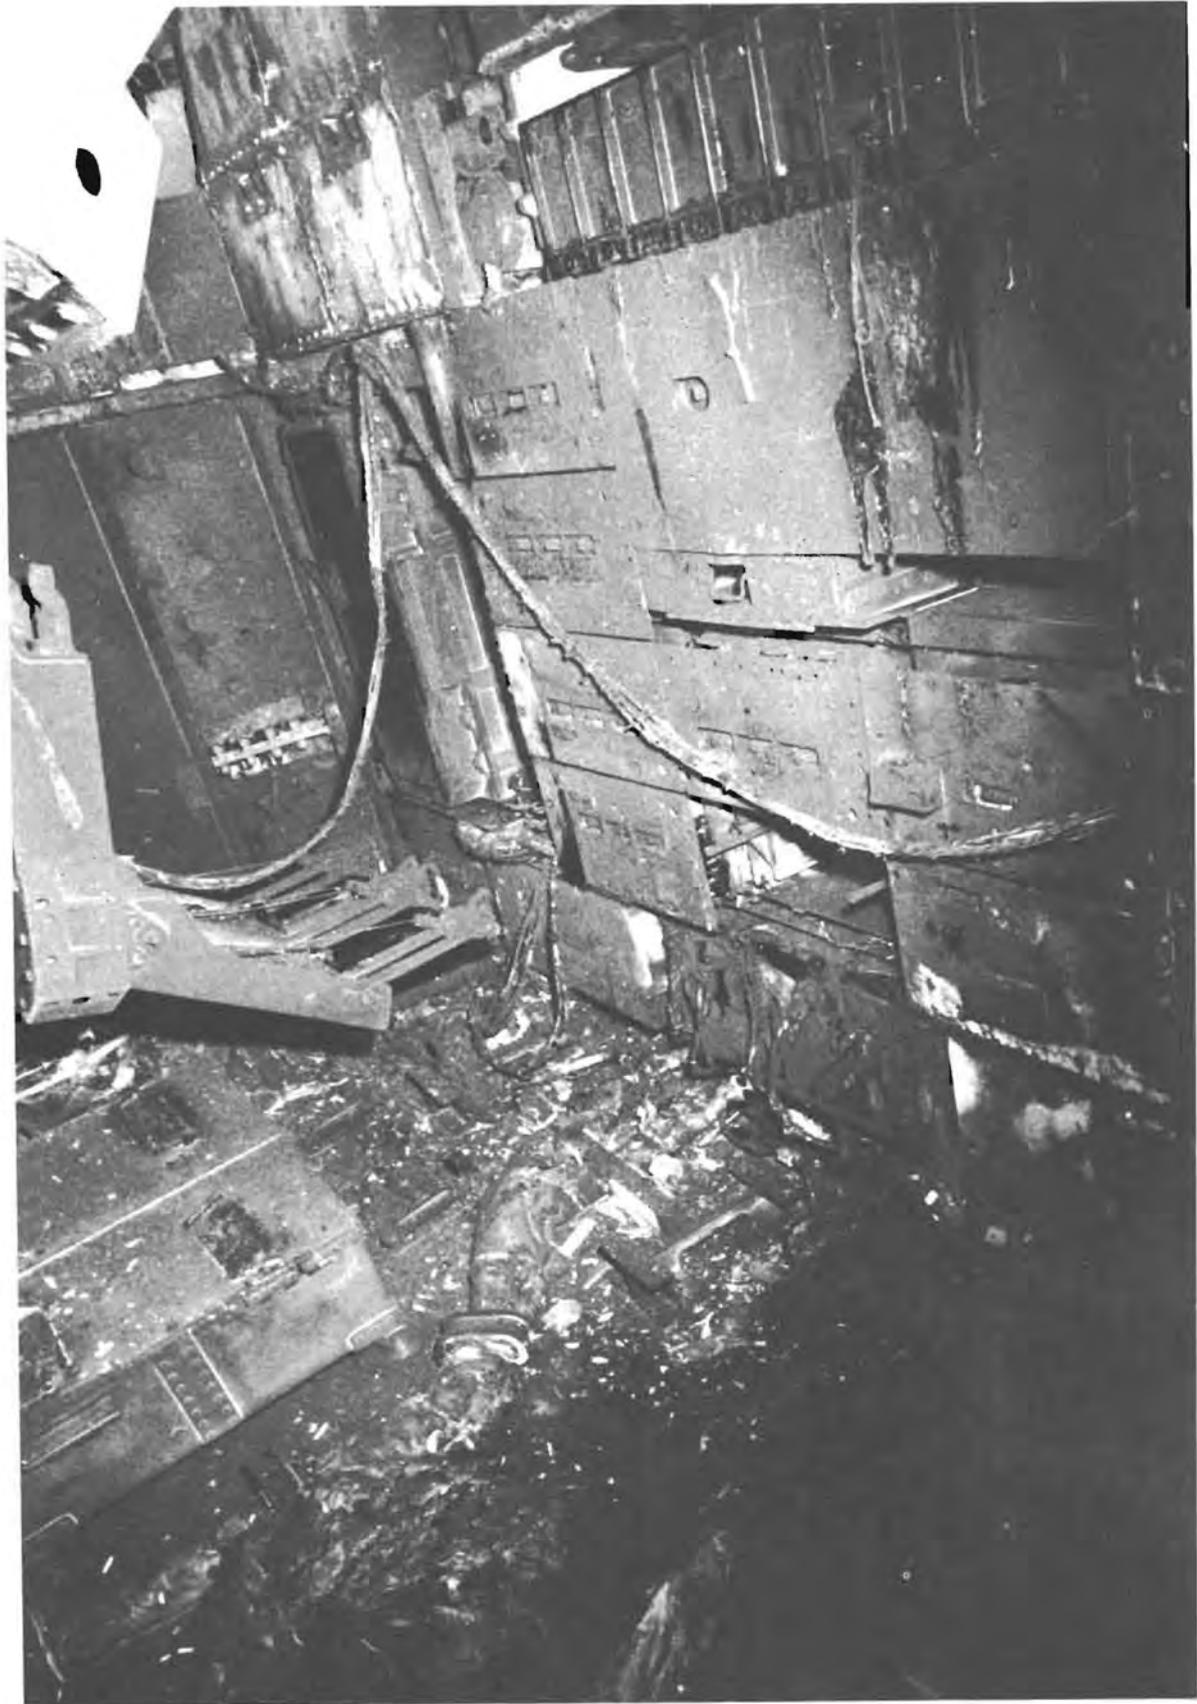
ENCLOSURE 5-18

l. Flames also moved from left to right along the front panel at slightly above floor level. With reference to Enclosures 5-18 and 5-19, which show a portion of the floor in front of this panel, the damage to wire bundles where fire impinged is shown to be greater than to those which lie to their right, as indicated by the arrows on the photograph. The same relative fire damage is apparent on the metal clamp covering the wire bundles, being greatest on the left and least at the right.

VIEW OF FLOOR BELOW LOWER EQUIPMENT BAY

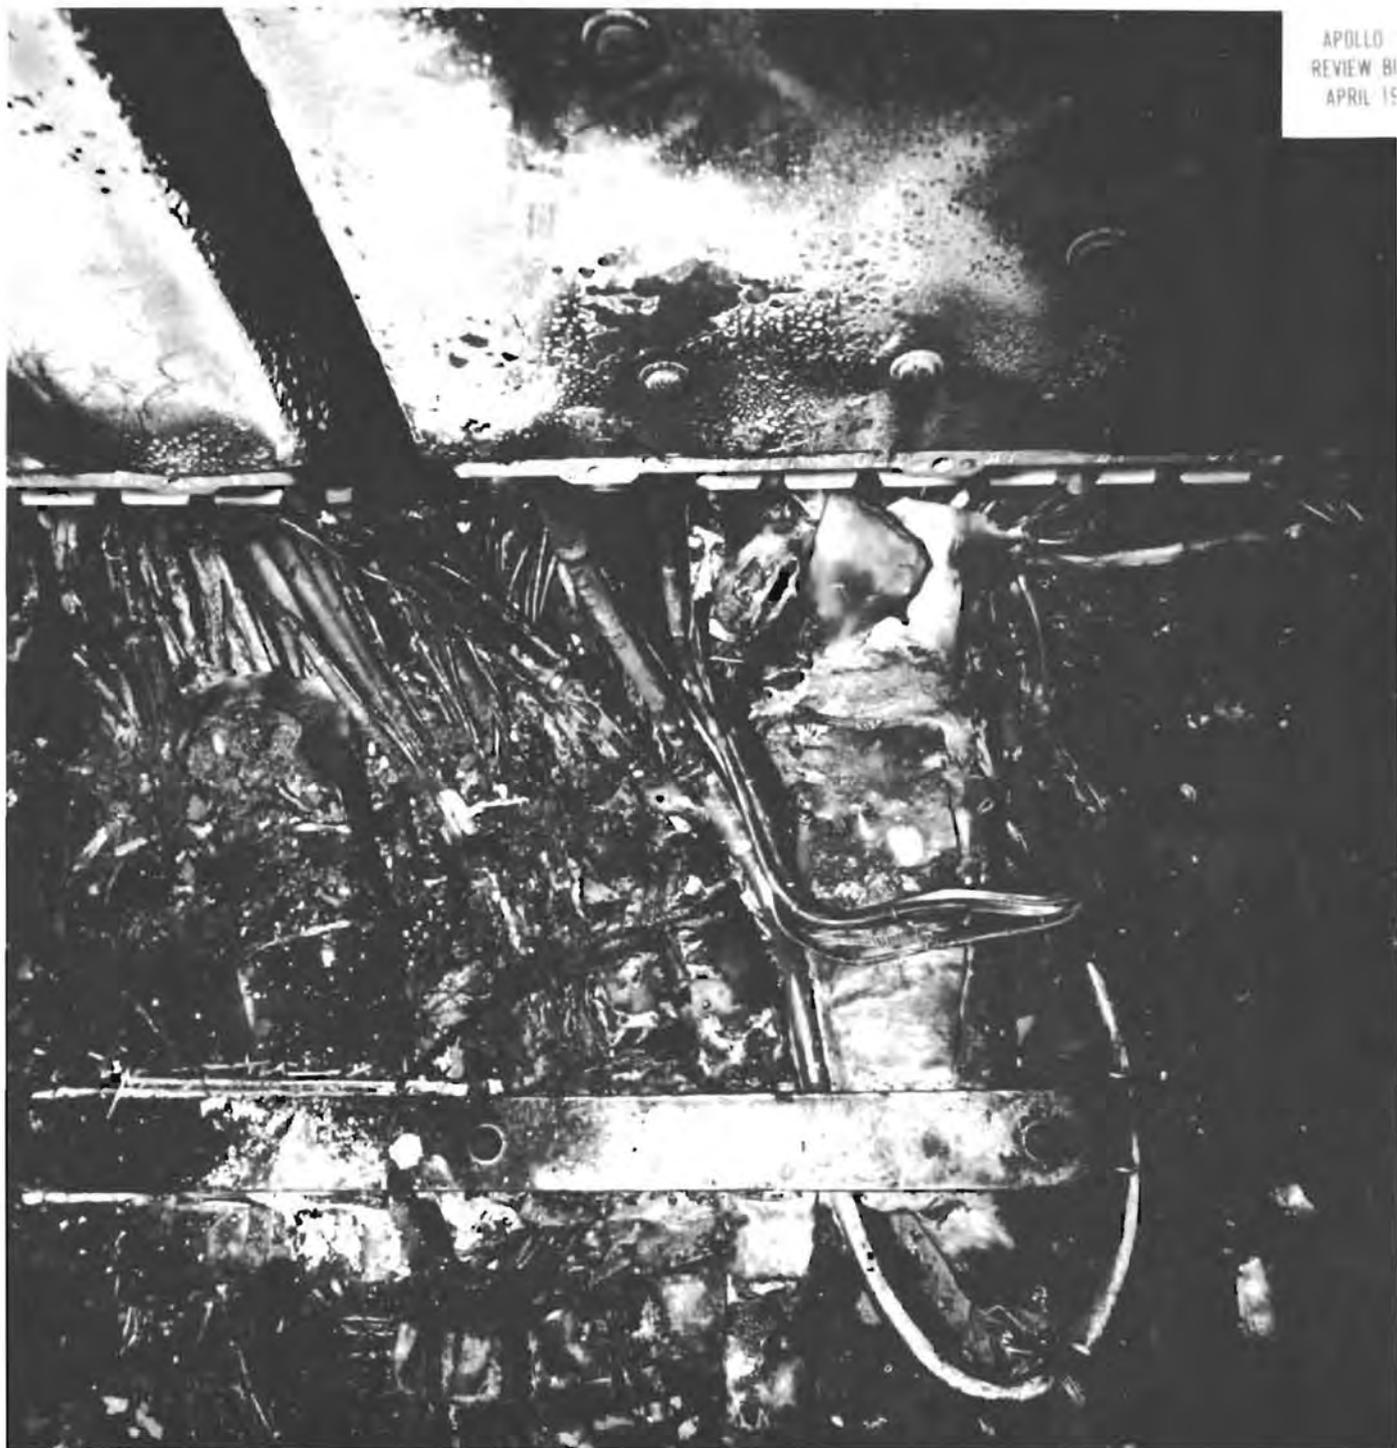
VIEW OF AFT BULKHEAD WIRING BELOW INVERTERS

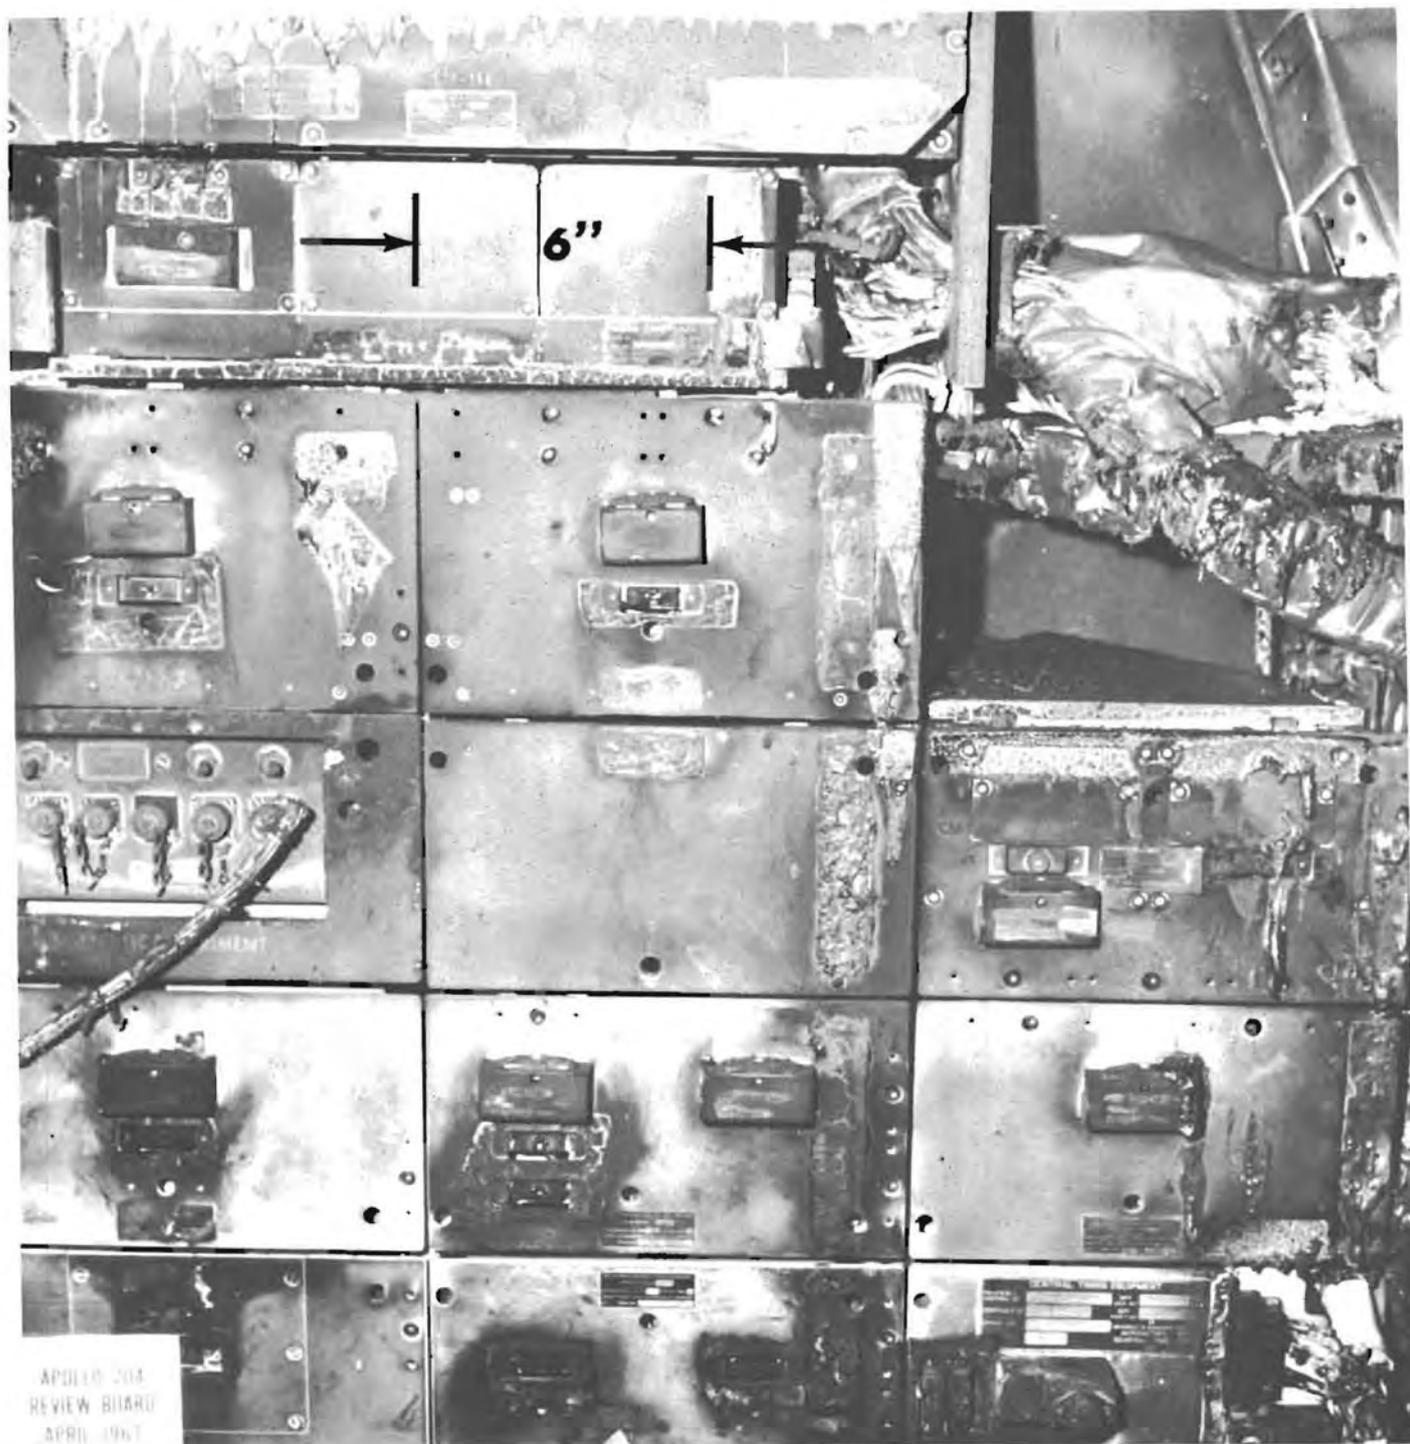
m. Substantial fire damage to paint and wiring insulation appears along the front panel, particularly above the batteries, and inverters as shown in Enclosure 5-20.

n. Fire damage lessens with displacement from left to right across the front panel above the floor. The modest damage to paint on the upper right section of the front panel shown in the above enclosure demonstrates this point. Soot marks on the panels around the rectangular protuberances indicate the passage of a smoky flame moving upward and from left to right. Some of this smoky flame was provided by small local patches of Velcro which burned incompletely. A tongue of flame extended momentarily to the two wire bundles in the corner to do the localized damage visible in the photograph.

INSTRUMENTATION ABOVE INVERTERS

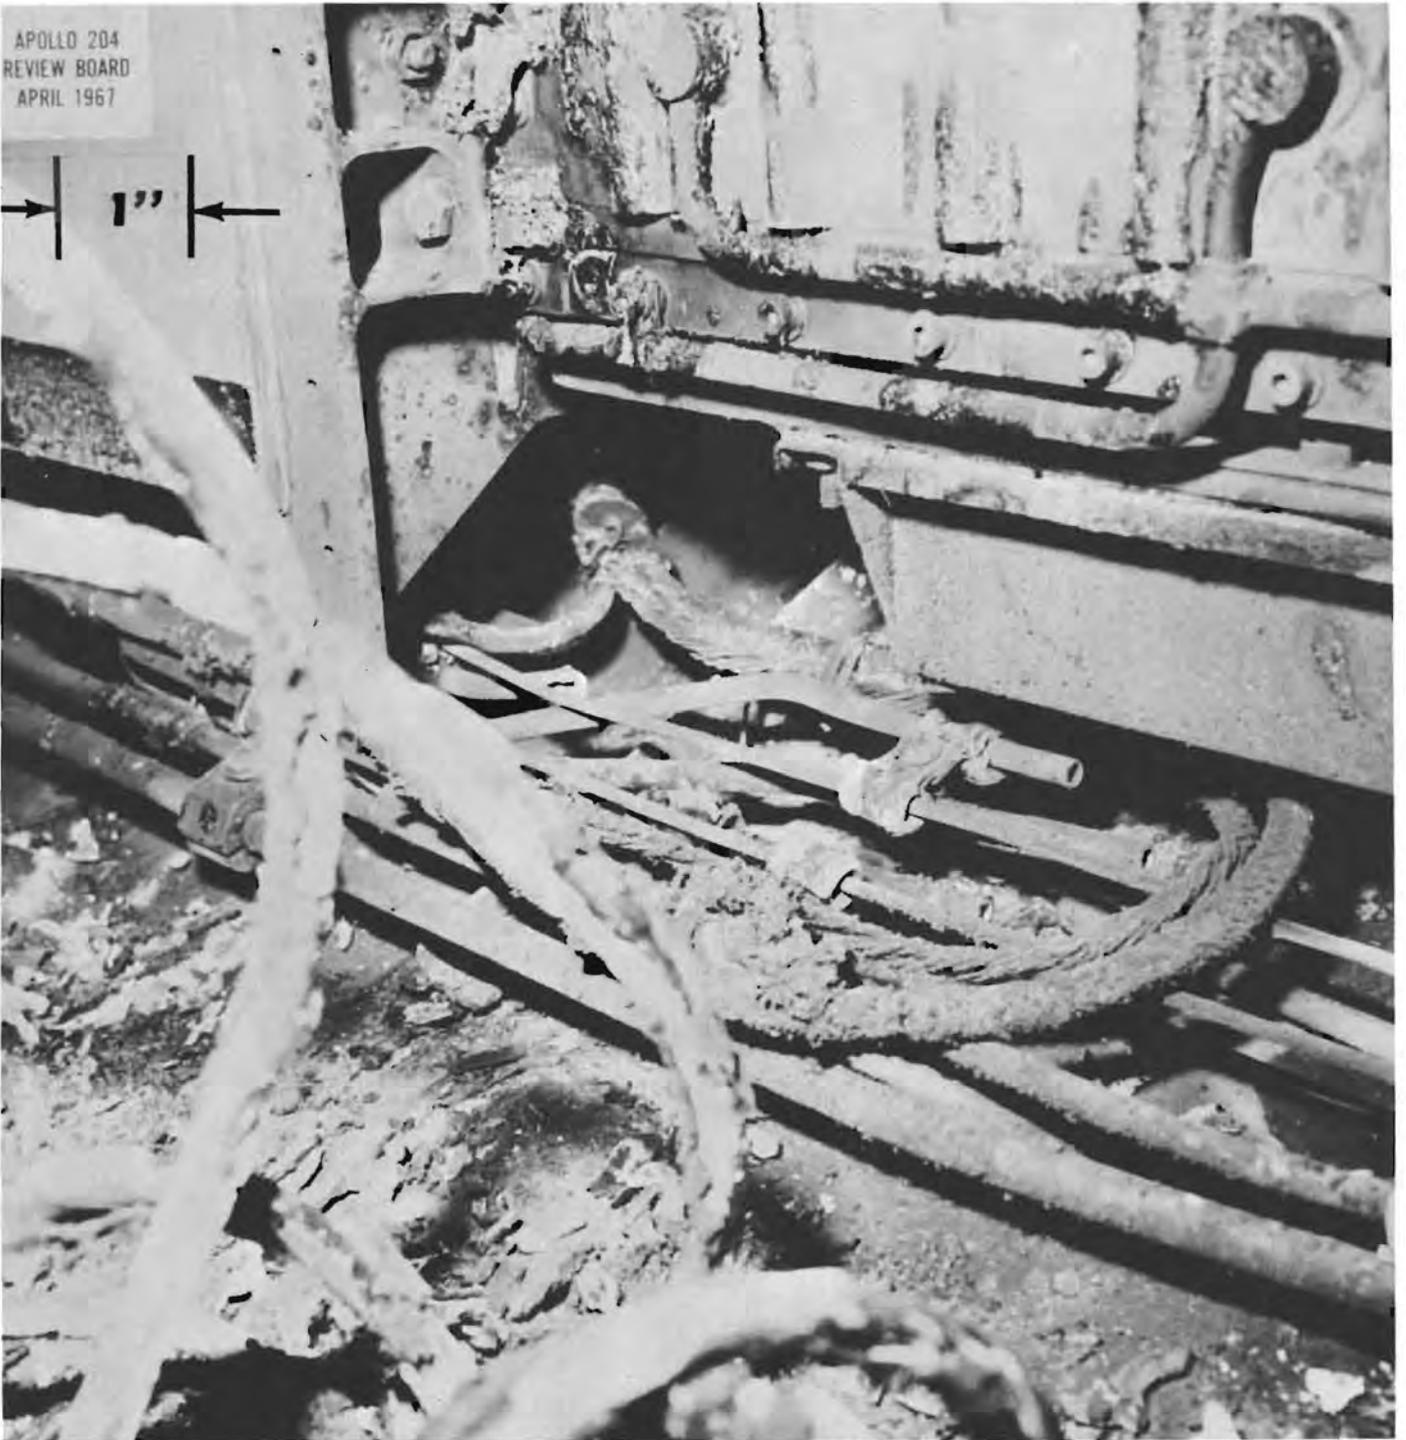
p. Some of the failed 100 and 900 psia oxygen tubing below the Environmental Control Unit are shown in Enclosure 5-21. This photograph shows separated solder joints and burst aluminum tubing running near floor level below the suit circuit heat exchanger. The adjacent portion of the ECU, which contains the LiOH canisters shown in Enclosure 5-3, revealed broken coolant tubing (upper circle), more failed oxygen lines in the oxygen control panel area, and holes burned through the aft bulkhead and pressure vessel wall. The container for the LiOH canisters and adjacent structure show severe damage from a hot, sustained fire.

TUBING BELOW ENVIRONMENTAL CONTROL UNIT HEATING EXCHANGER

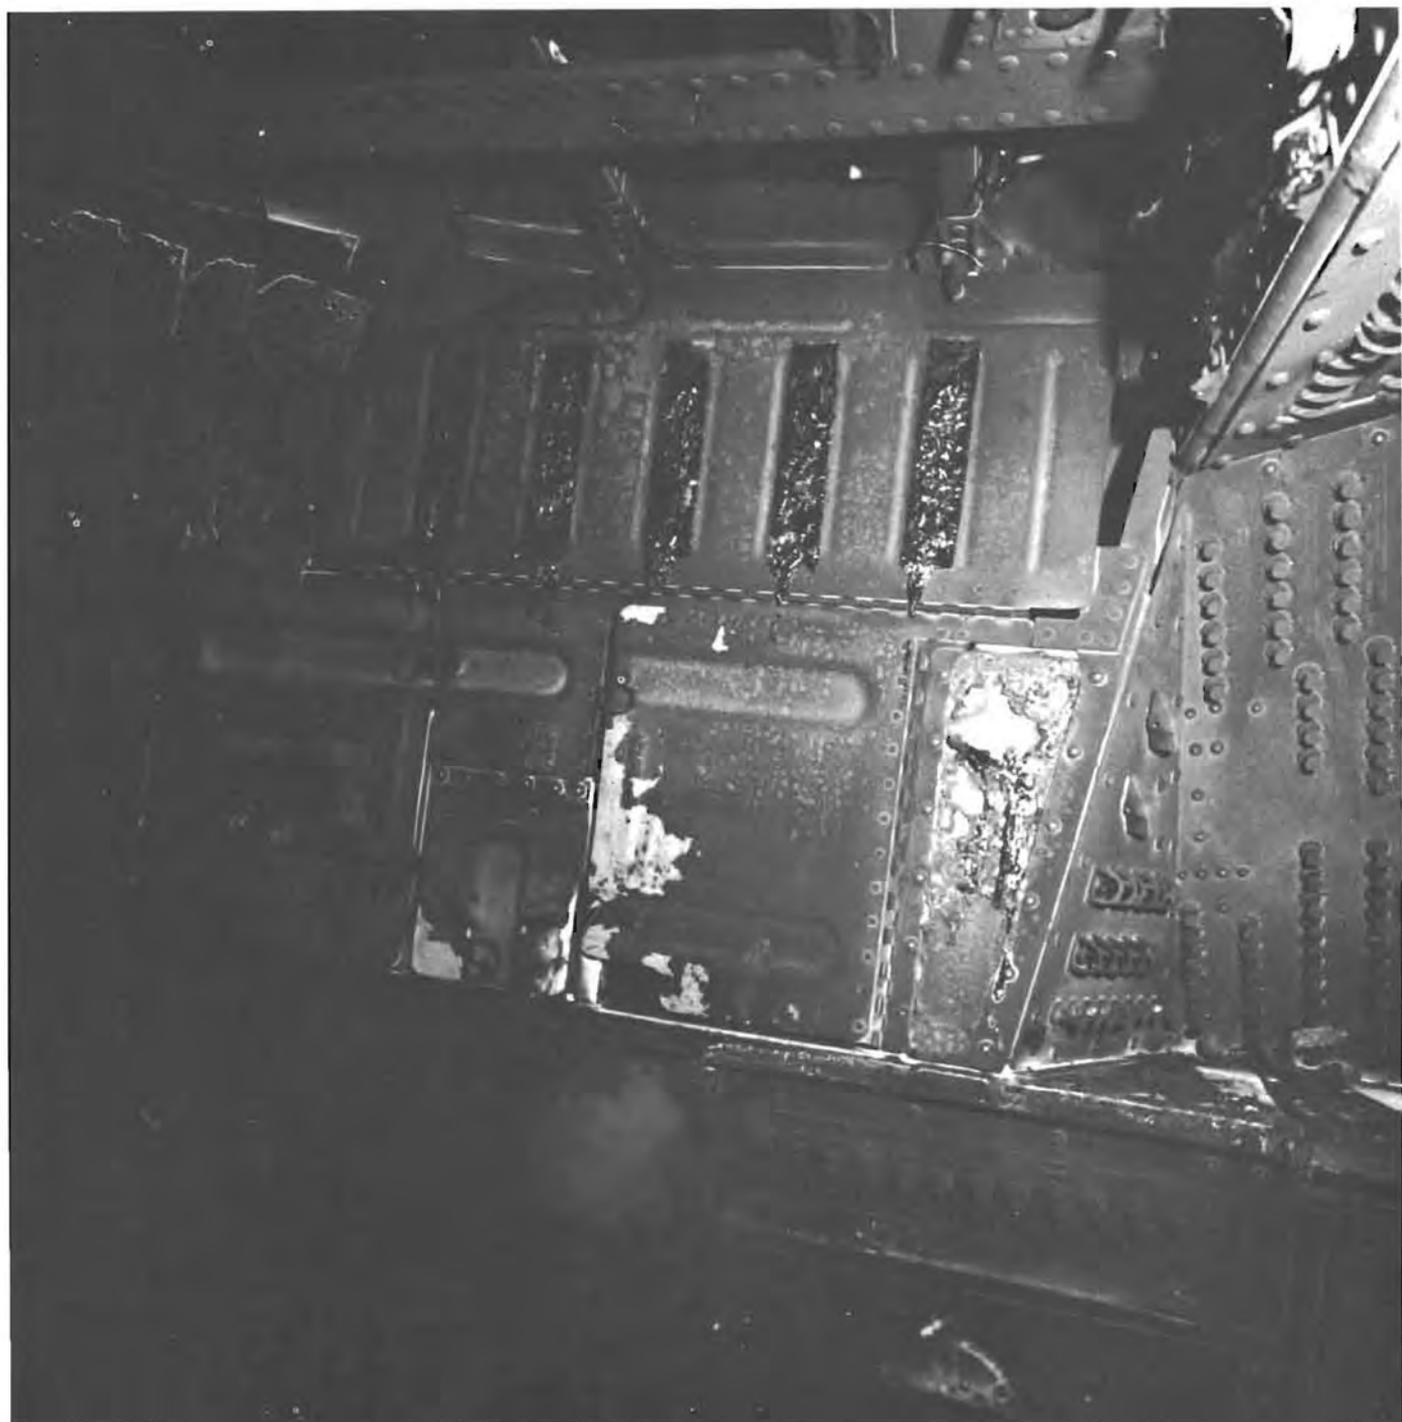
The conditions observed in the Right Hand Forward Equipment Bay showed only minimal fire damage (Enclosure 5-28 and 5-29). However, in the Left Hand Forward Equipment Bay (LHFEB) some of the bottom panels received very severe damage due to localized flame impingement originating from the Left Hand Equipment Bay. Heavy sooting in this area occurred during

RIGHT HAND FORWARD EQUIPMENT BAY

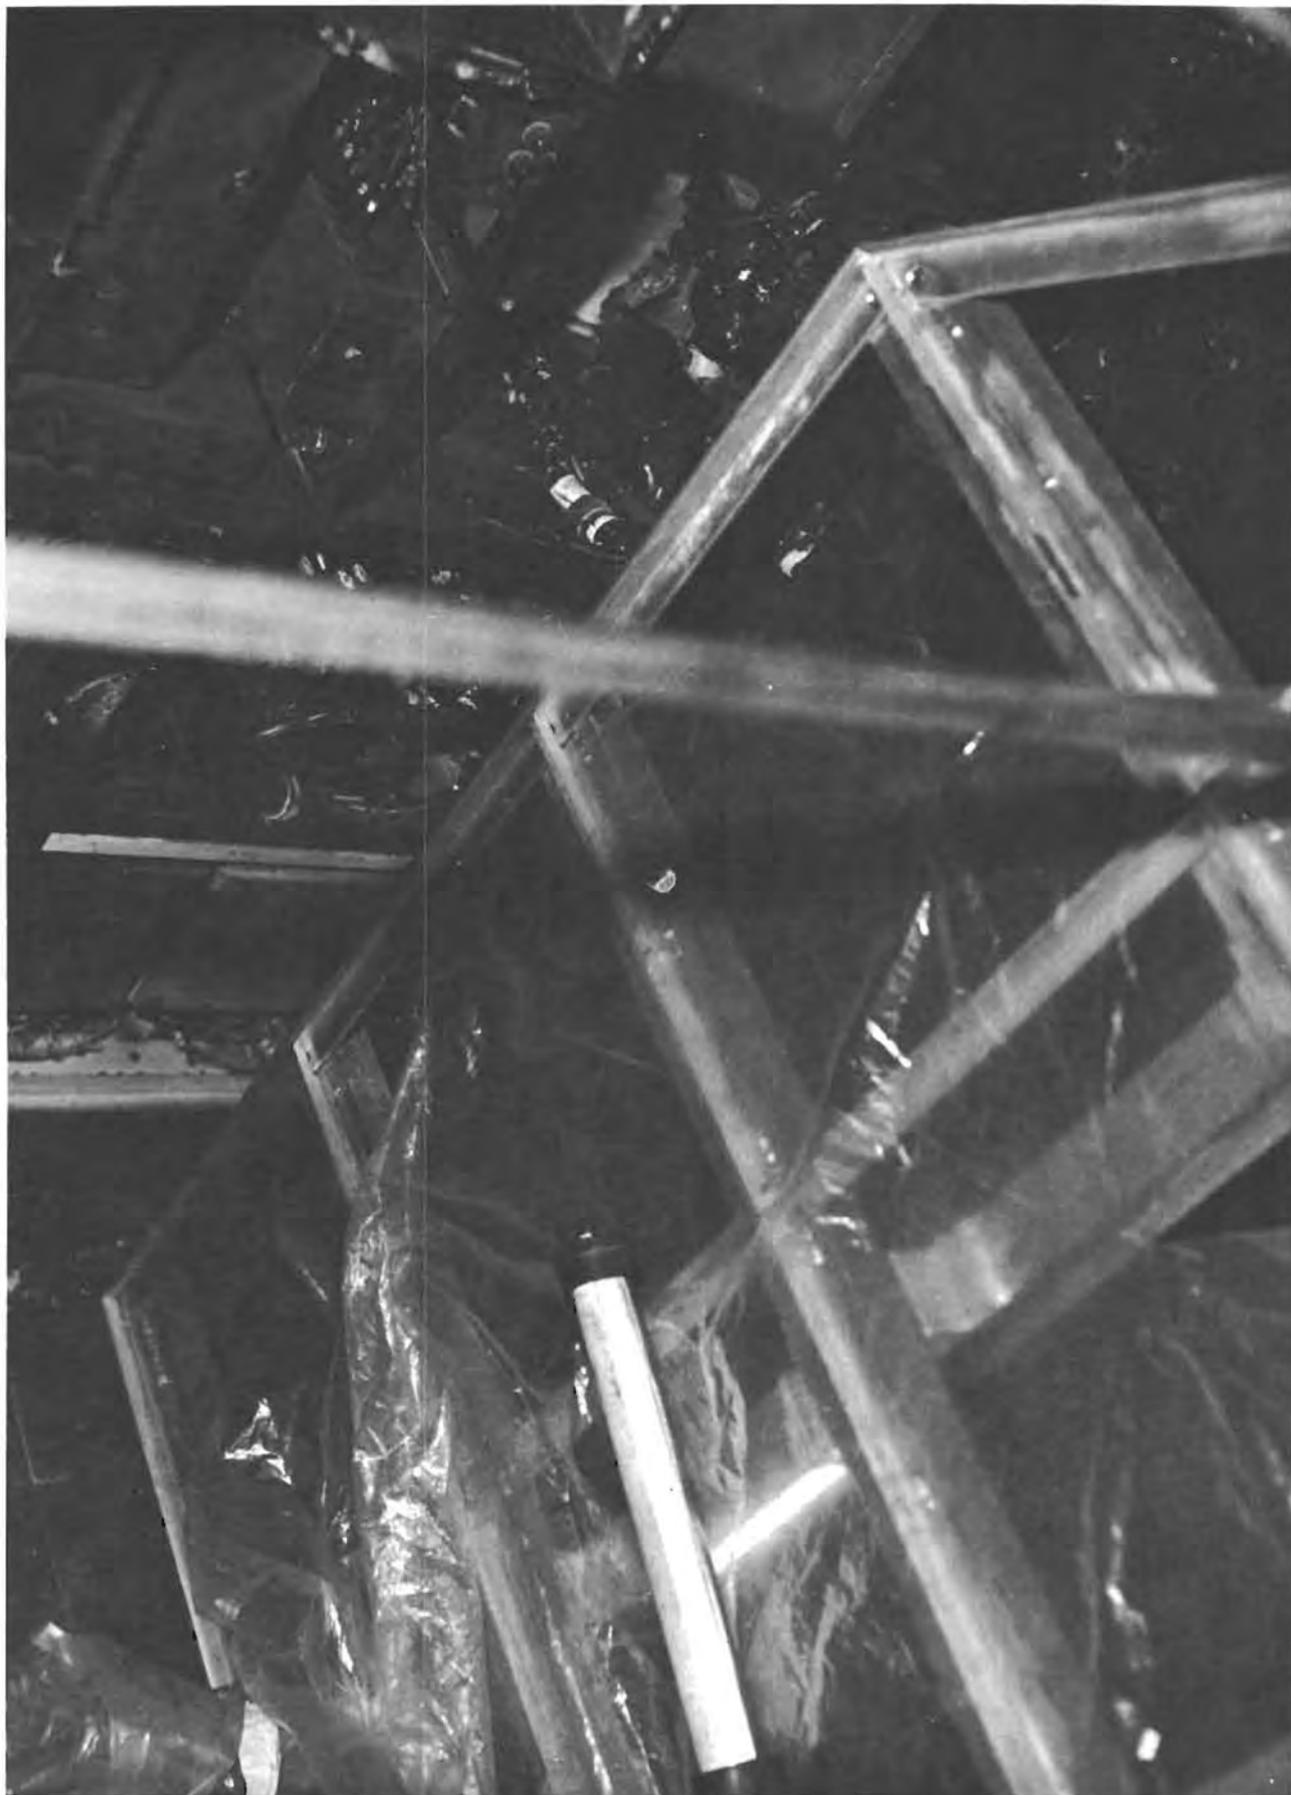
The instrumentation, wiring, panels, and rear pressure vessel wall were sooted and fire damage was slight. Some debris resulting from fire damage was found on the aft bulkhead in the open areas. The compartment floor under the Earth Landing Sequencer and Circuit Interrupter areas showed moderate fire damage which was probably due to fire sweeping under these compartments to the break in the aft bulkhead. None of this fire damage is indicative of a fire source. Enclosures 5-24, 5-25, and 5-26 visually show the subject area and Enclosure 5-27 is a detailed tabulation of findings.

Based upon visual observations of the extent of damage and condition of equipment, the Right Hand Equipment Bay cannot be considered as the ignition source area even though the combustible materials in this area provided fuel.

PARTIAL VIEW OF RIGHT HAND EQUIPMENT BAY

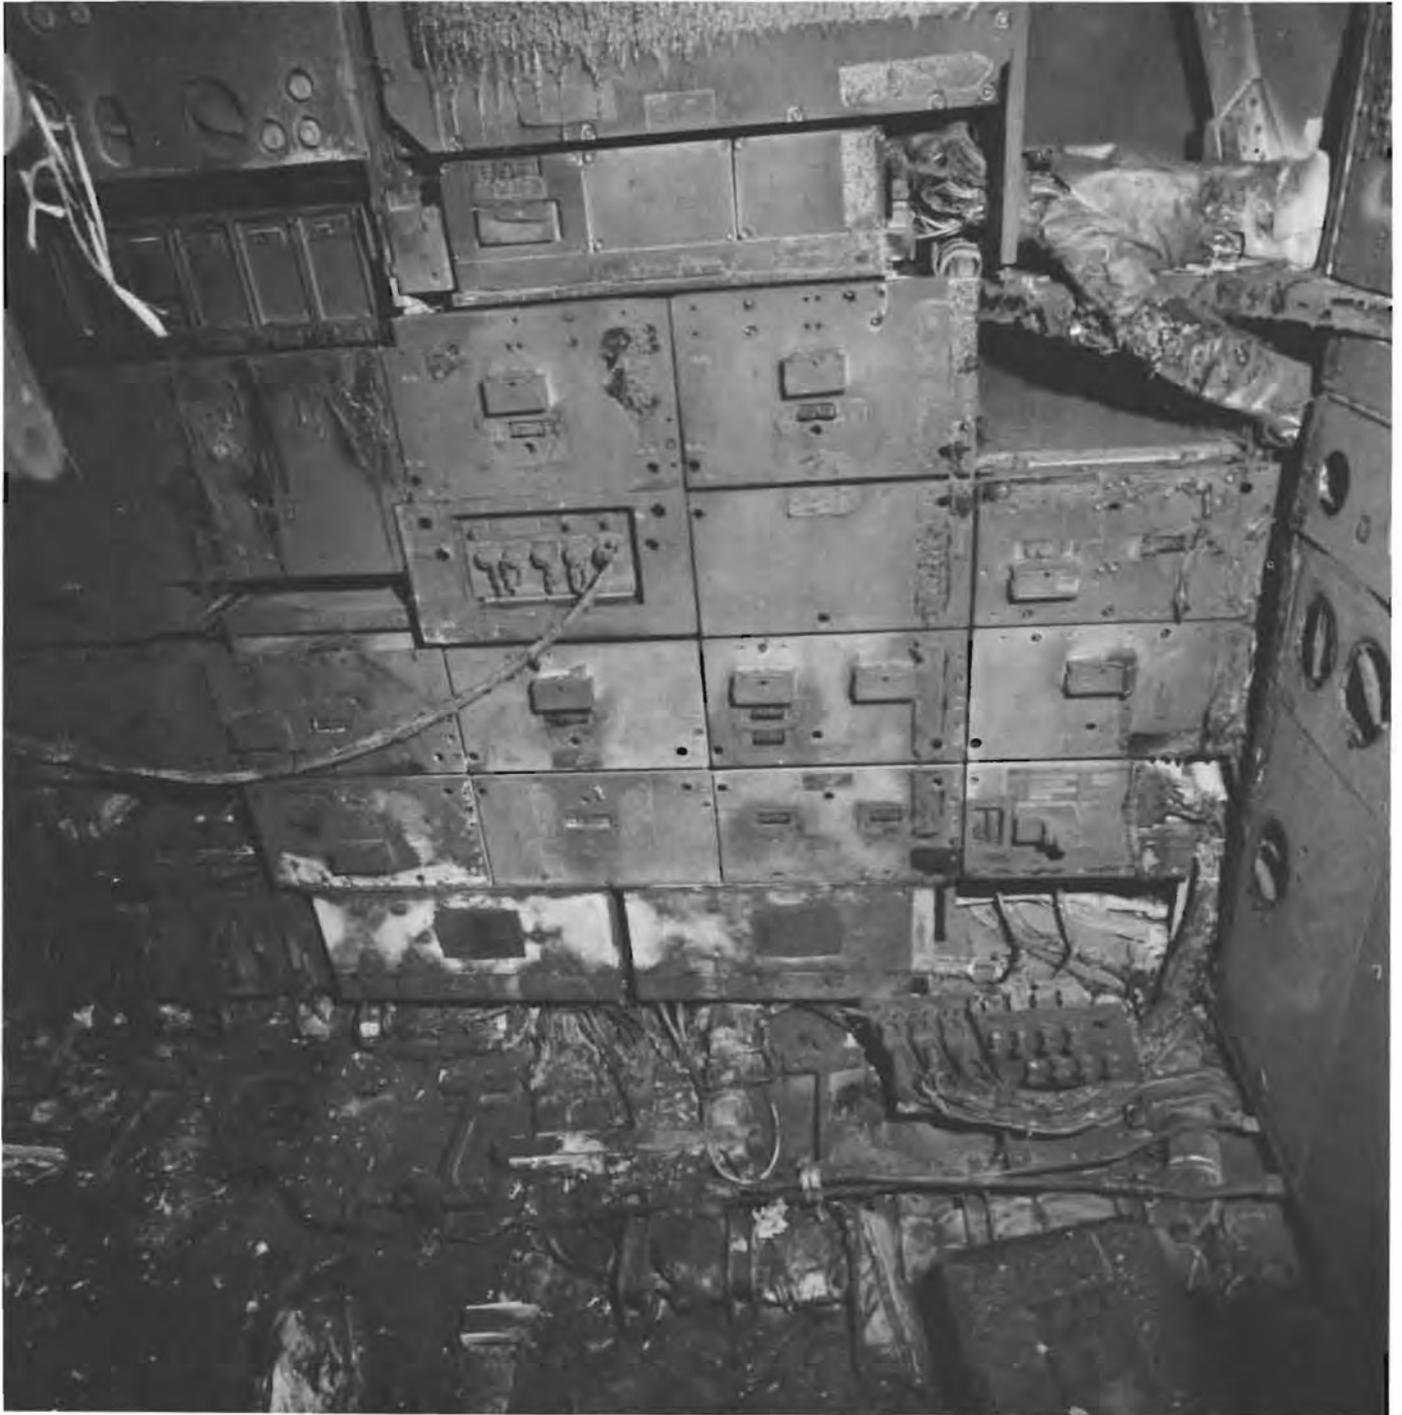
RIGHT HAND SECTION OF LOWER EQUIPMENT BAY

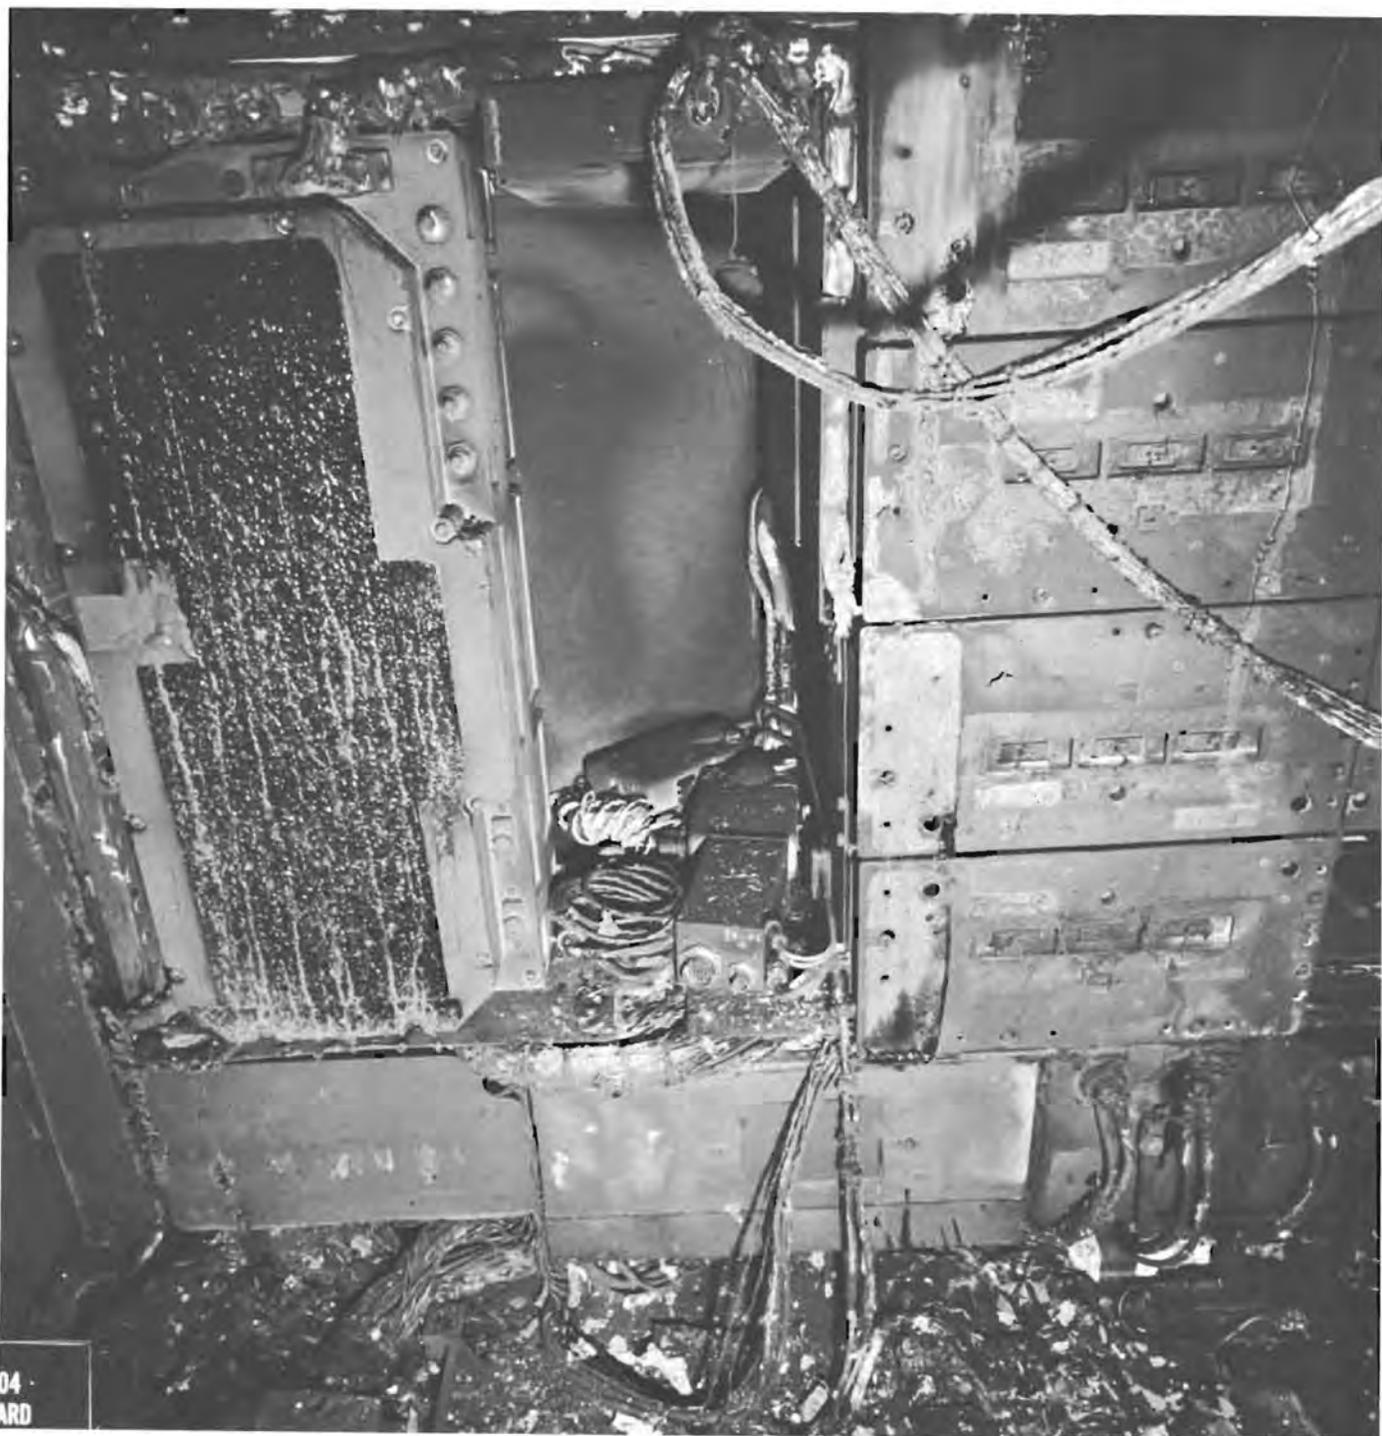
ENCLOSURE 5-31

LOWER LEFT HAND SECTION OF LOWER EQUIPMENT BAY
