REPORT OF APOLLO 204 REVIEW BOARD

APPENDIX D
PANEL 5

**REPORT OF PANEL 5
ORIGIN AND PROPAGATION OF FIRE
APPENDIX D-5
TO
FINAL REPORT OF
APOLLO 204 REVIEW BOARD**

ORIGIN AND PROPAGATION OF FIRE

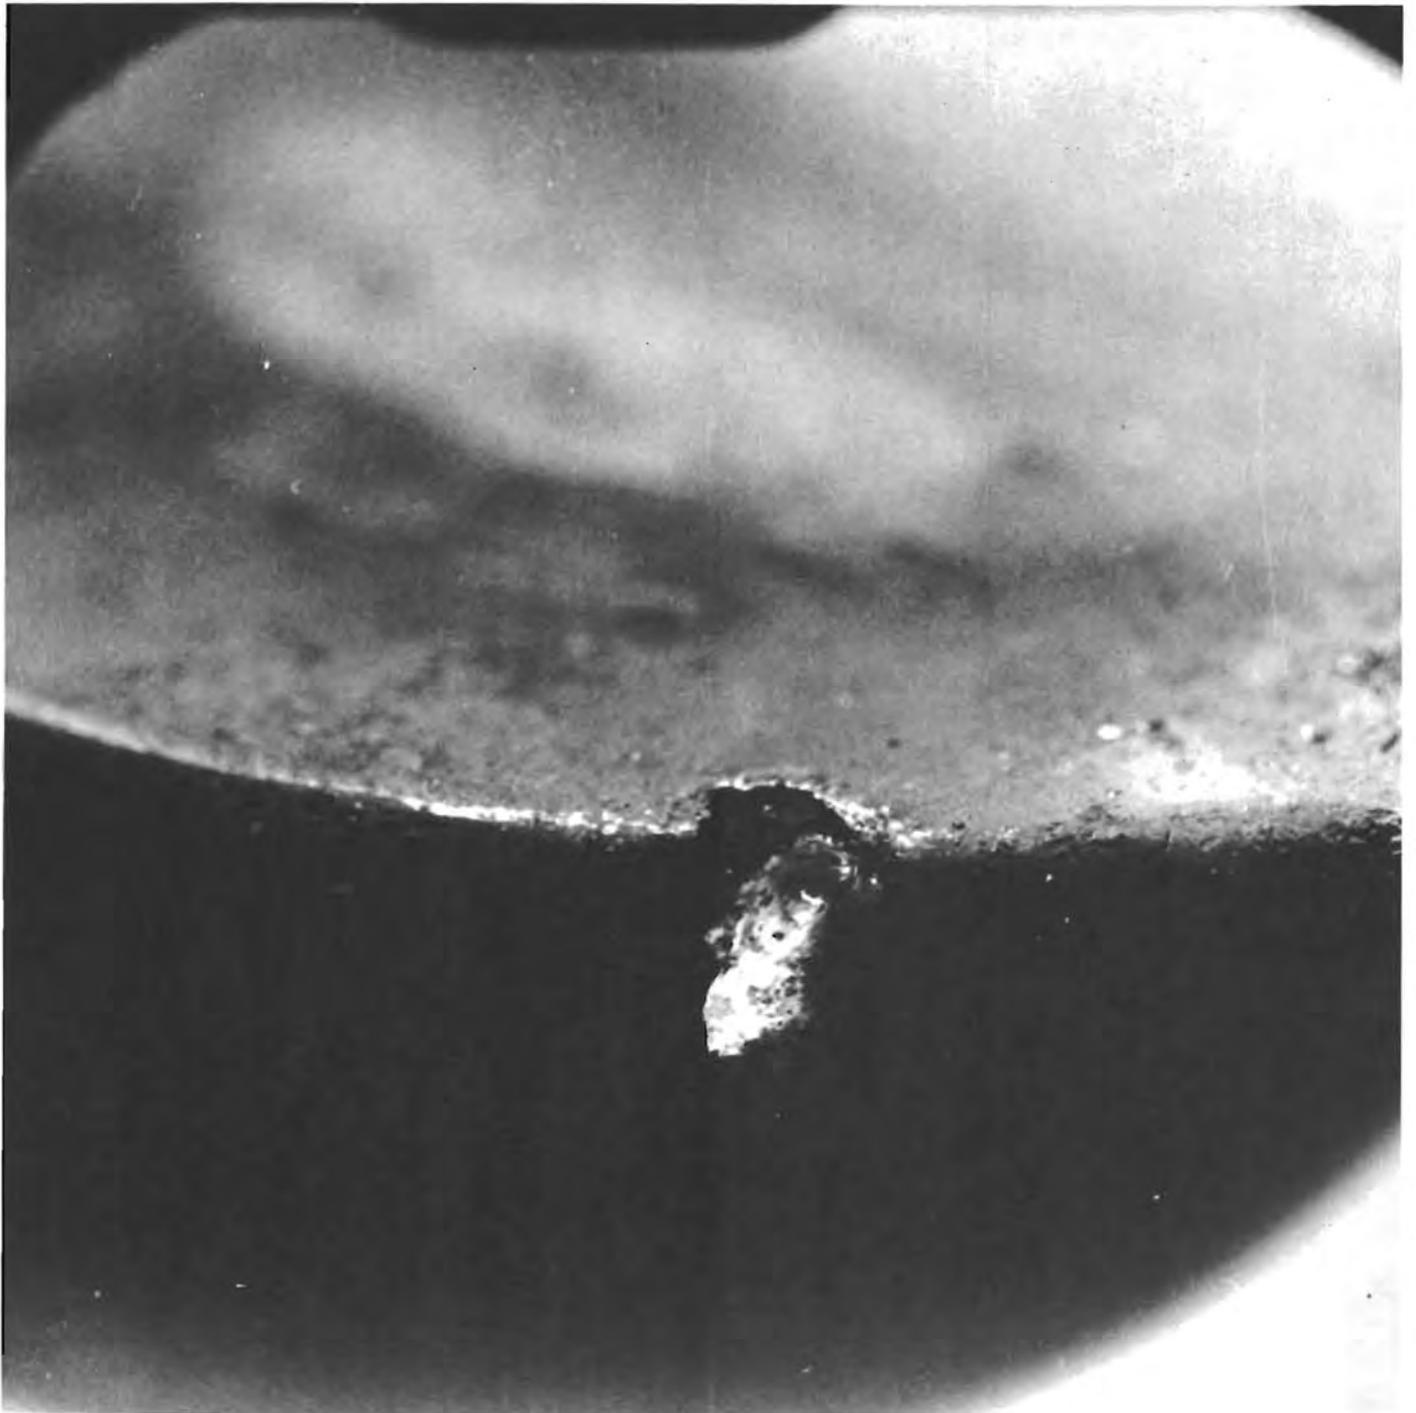
ENCLOSURE 5-31A

Evidence of electrical arcs from conductor to conductor and conductor to structure was found.

VIEW OF ARC ON PANEL 109

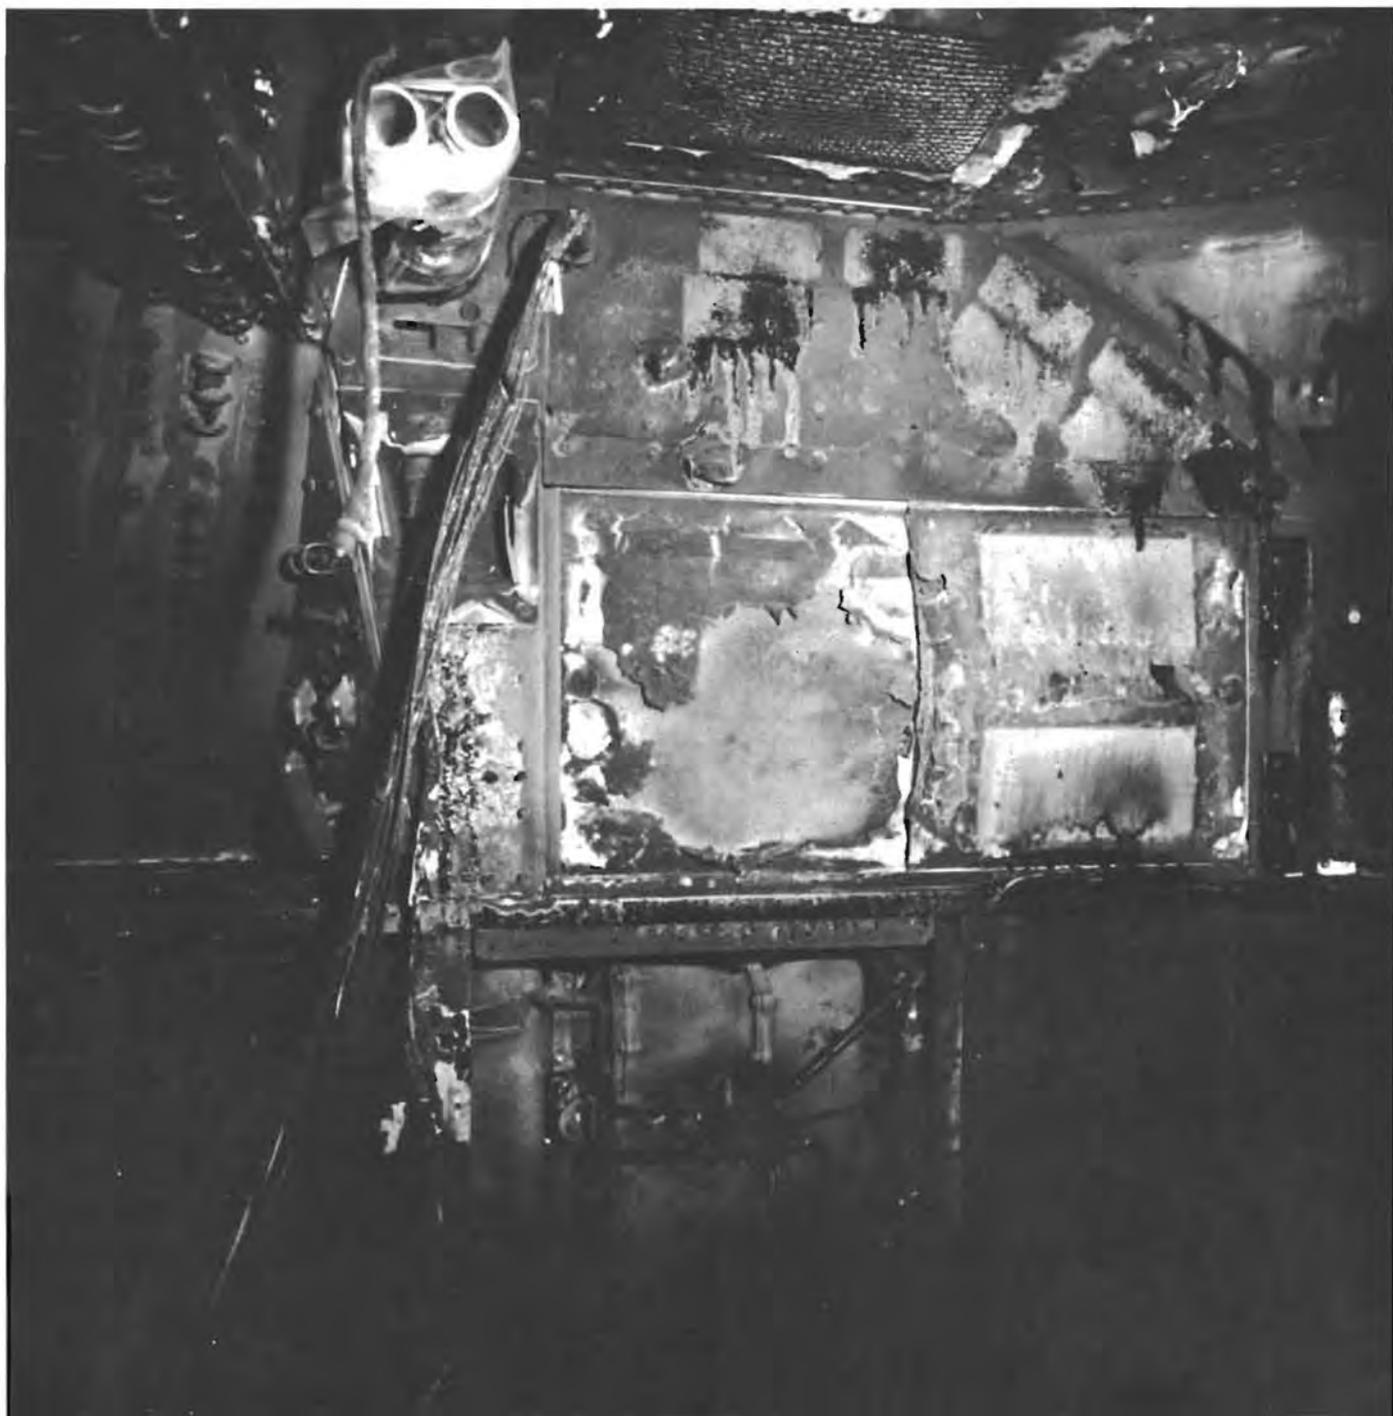
The conditions observed in the Right Hand Forward Equipment Bay showed only minimal fire damage (Enclosure 5-28 and 5-29). However, in the Left Hand Forward Equipment Bay (LHFEB) some of the bottom panels received very severe damage due to localized flame impingement originating from the Left Hand Equipment Bay. Heavy sooting in this area occurred during

LEFT HAND FORWARD EQUIPMENT BAY

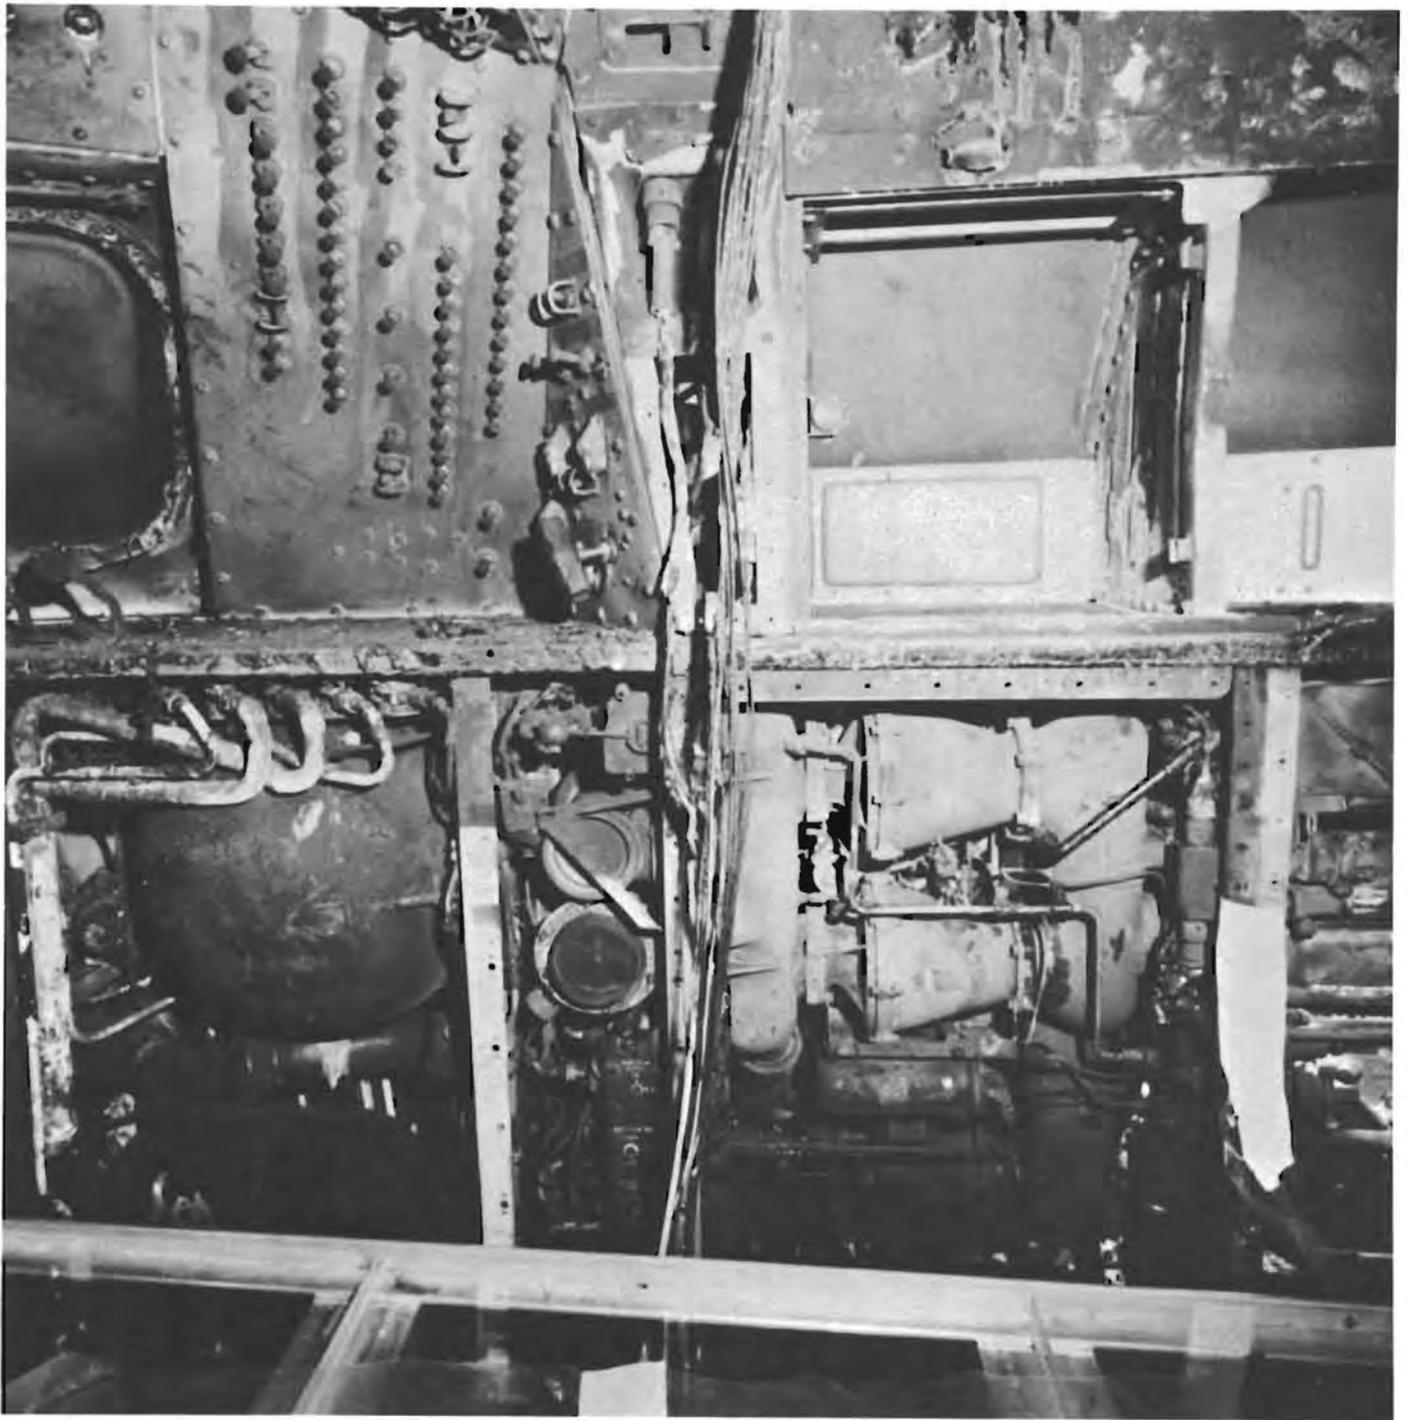
VIEW OF ENVIRONMENTAL CONTROL UNIT

Environmental Control Unit	Insulation completely burned on front of heat exchanger, decreasing fire damage toward rear and left. Tubing on floor separated and melted. Condensate streaks on back wall. Moderate fire damage to floor.
Surge Tanks and One-lb. Oxygen Bottle Area	Hot jet effect upper rear right-hand corner. Heavy soot. Moderate heat damage to insulation on front tubing. Melted plastic adhering to components in area.
Surge Tank, Cabin and Glycol Pressure Relief Valves	Slight to moderate heat damage from top to bottom. Heat damage to insulation on glycol lines. Debris in bottom of bay. Extensive melted plastic adhering to left-hand bulkhead and bottom.

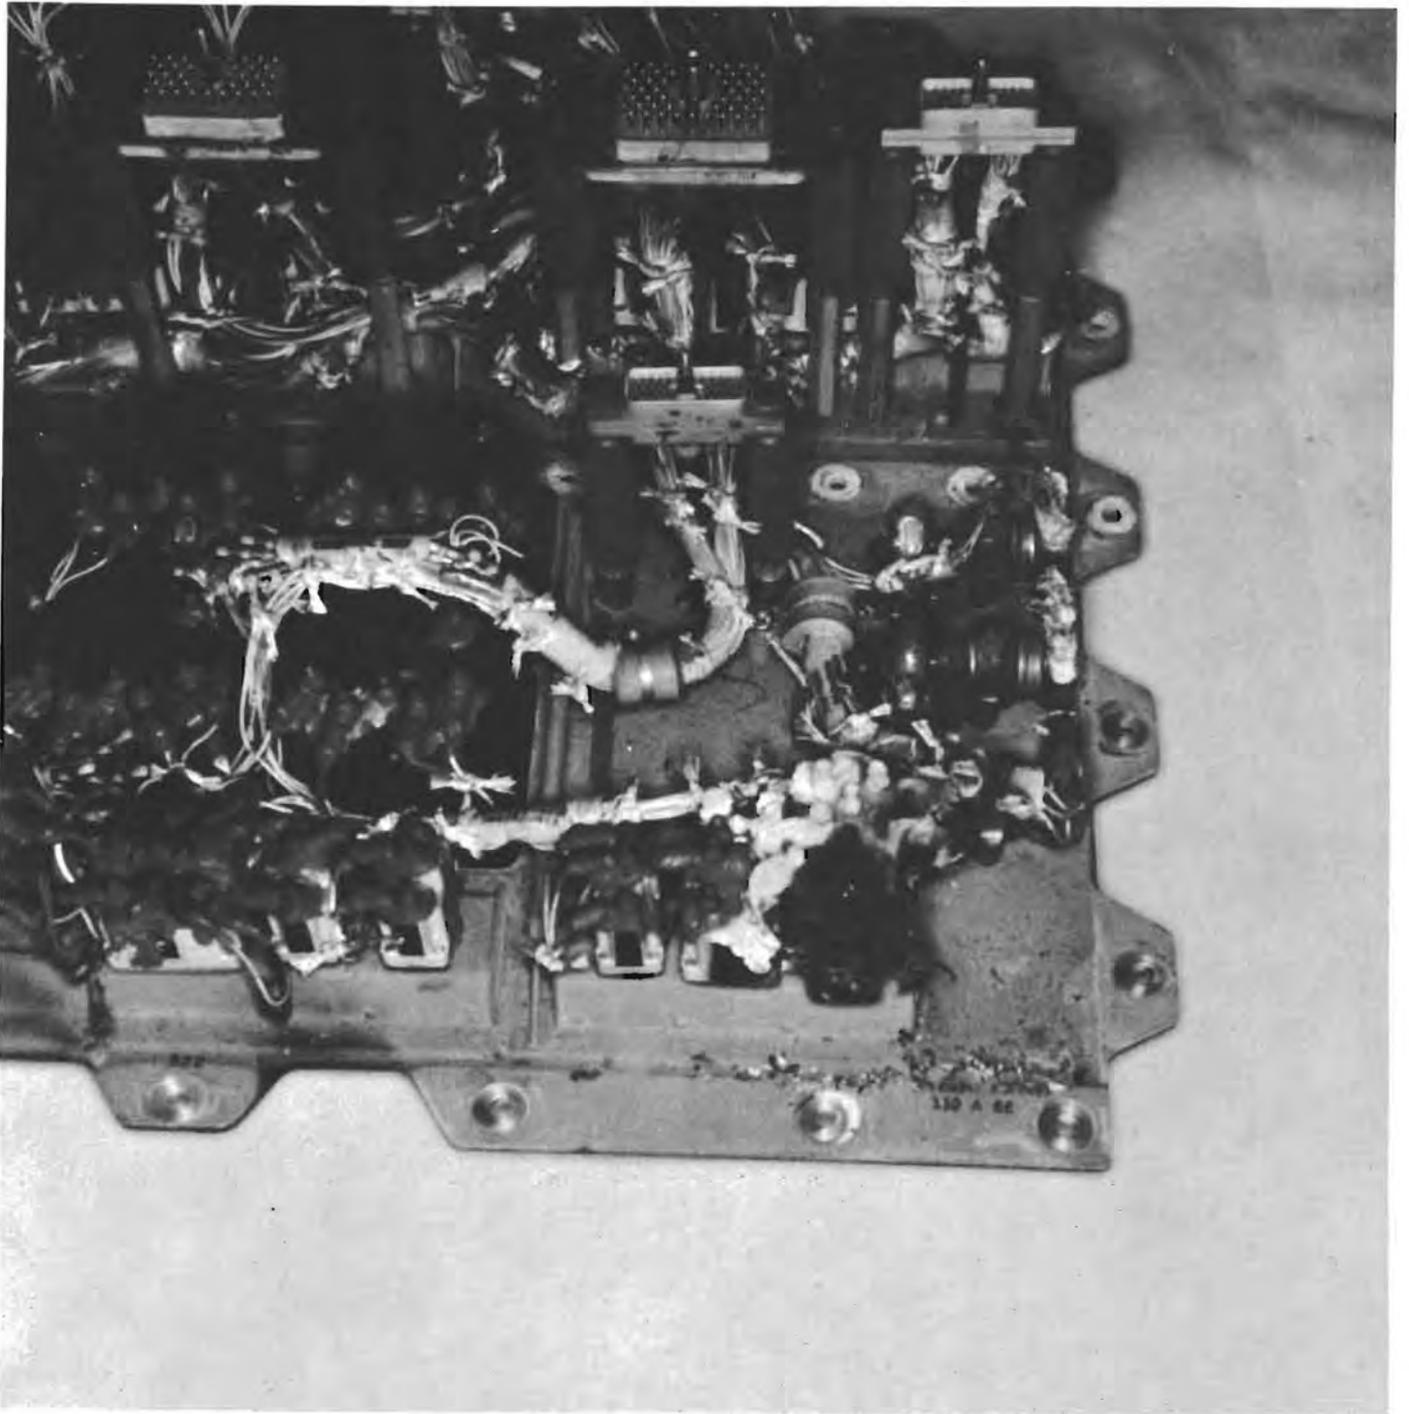
INTERIOR VIEW OF PANEL 13 SHOWING DAMAGE NEAR THUMB WHEELS
