# REPORT OF APOLLO 204 REVIEW BOARD

TO  
THE ADMINISTRATOR  
NATIONAL AERONAUTICS AND SPACE ADMINISTRATION

APPENDIX D  
PANEL 18

REPORT OF PANEL 18  
INTEGRATION ANALYSIS PANEL

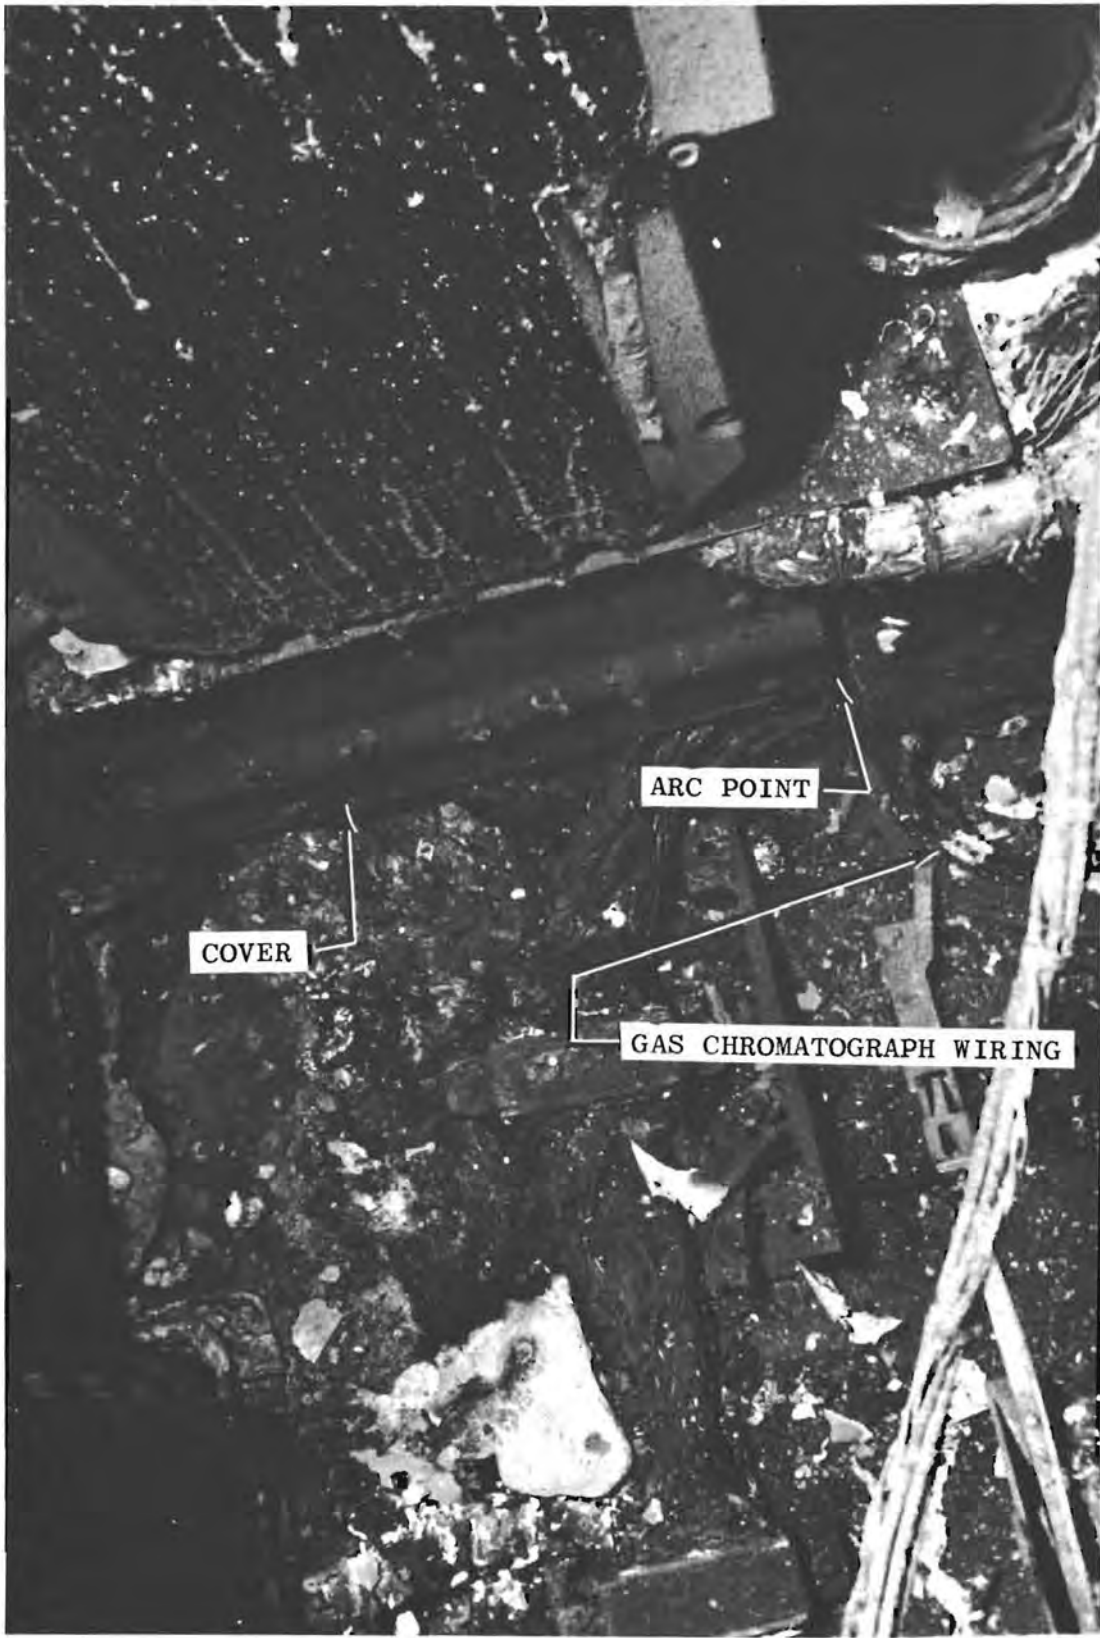
- (i) DC wiring completely burned through in harnesses providing power to Environmental Control System instrumentation.
- (ii) Arc between a DC wire and the cover of J-Box C15-1A52.
- (iii) Shorted AC wires providing power to the gas chromatograph connector.
- (iv) Shorted DC wires providing power to scientific equipment bay 2.
- (v) Two shorted AC phases in cabin air fan 1 wiring.
- (vi) Crushed DC harness in Environmental Control Unit providing power for instrumentation.
- (vii) Shorted DC wires providing power to the biomed recorder.
- (viii) Shorted AC wires in Environmental Control Unit providing power for suit compressor 2.
- (ix) Command Pilot suit wiring shorted.

The one probable ignition source is the DC wiring completely burned through in harnesses providing power to Environmental Control System instrumentation. Two potential initiation theories of a more general nature were also considered. These are described below.

ENVIRONMENTAL CONTROL SYSTEM INSTRUMENTATION HARNESSES  
AFTER ACCIDENT

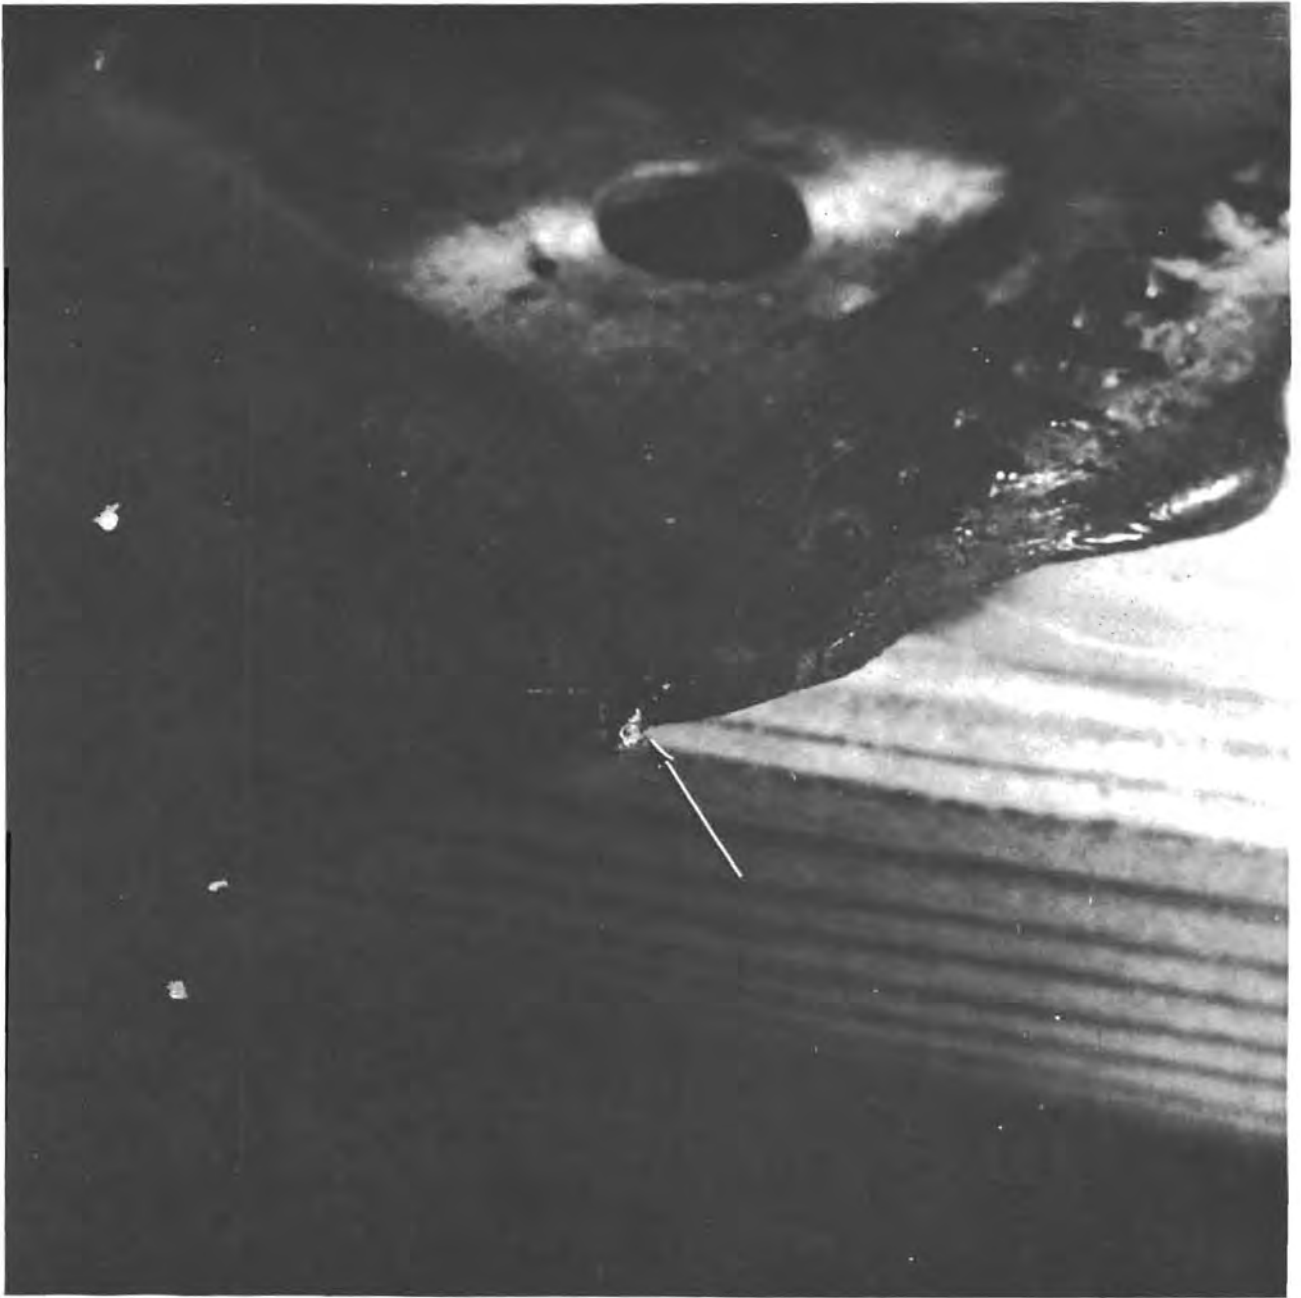
ARCED POINT ON WIRE AND COVER OF JUNCTION BOX C15-1A52

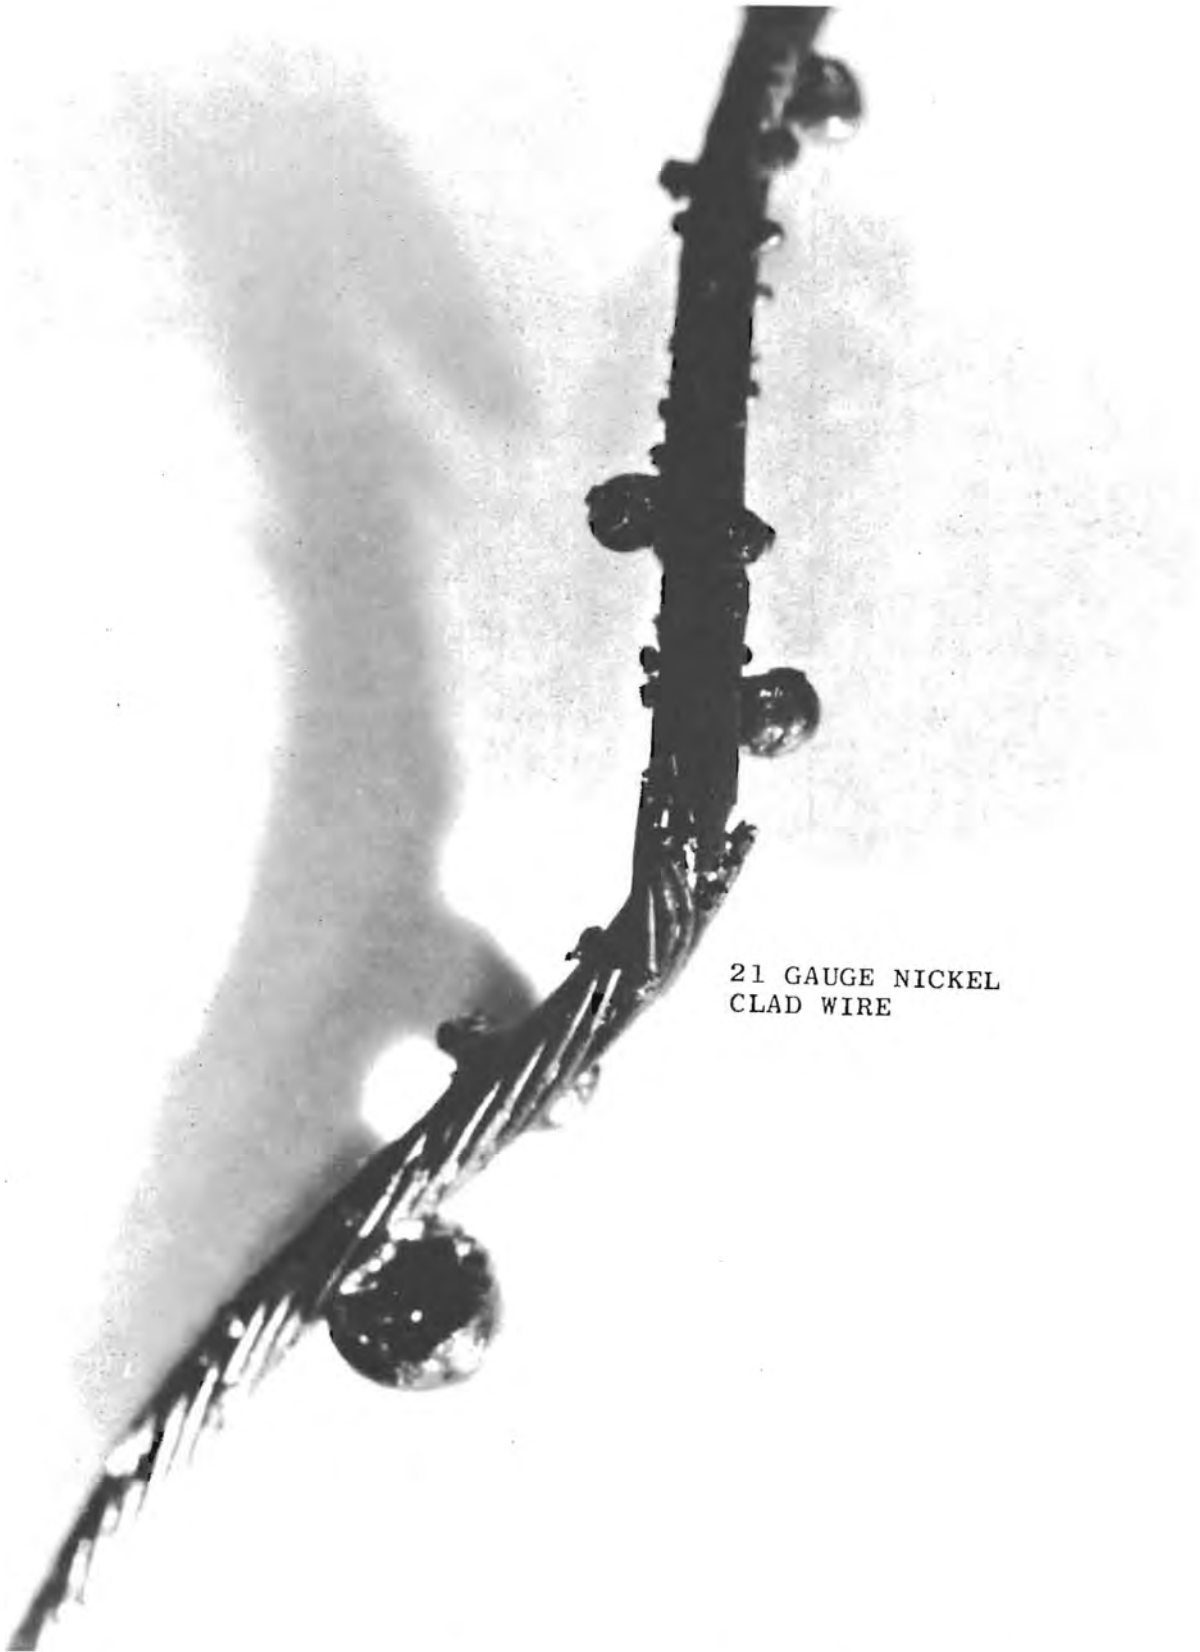
COPPER DROPLETS ON GAS CHROMATOGRAPH WIRES

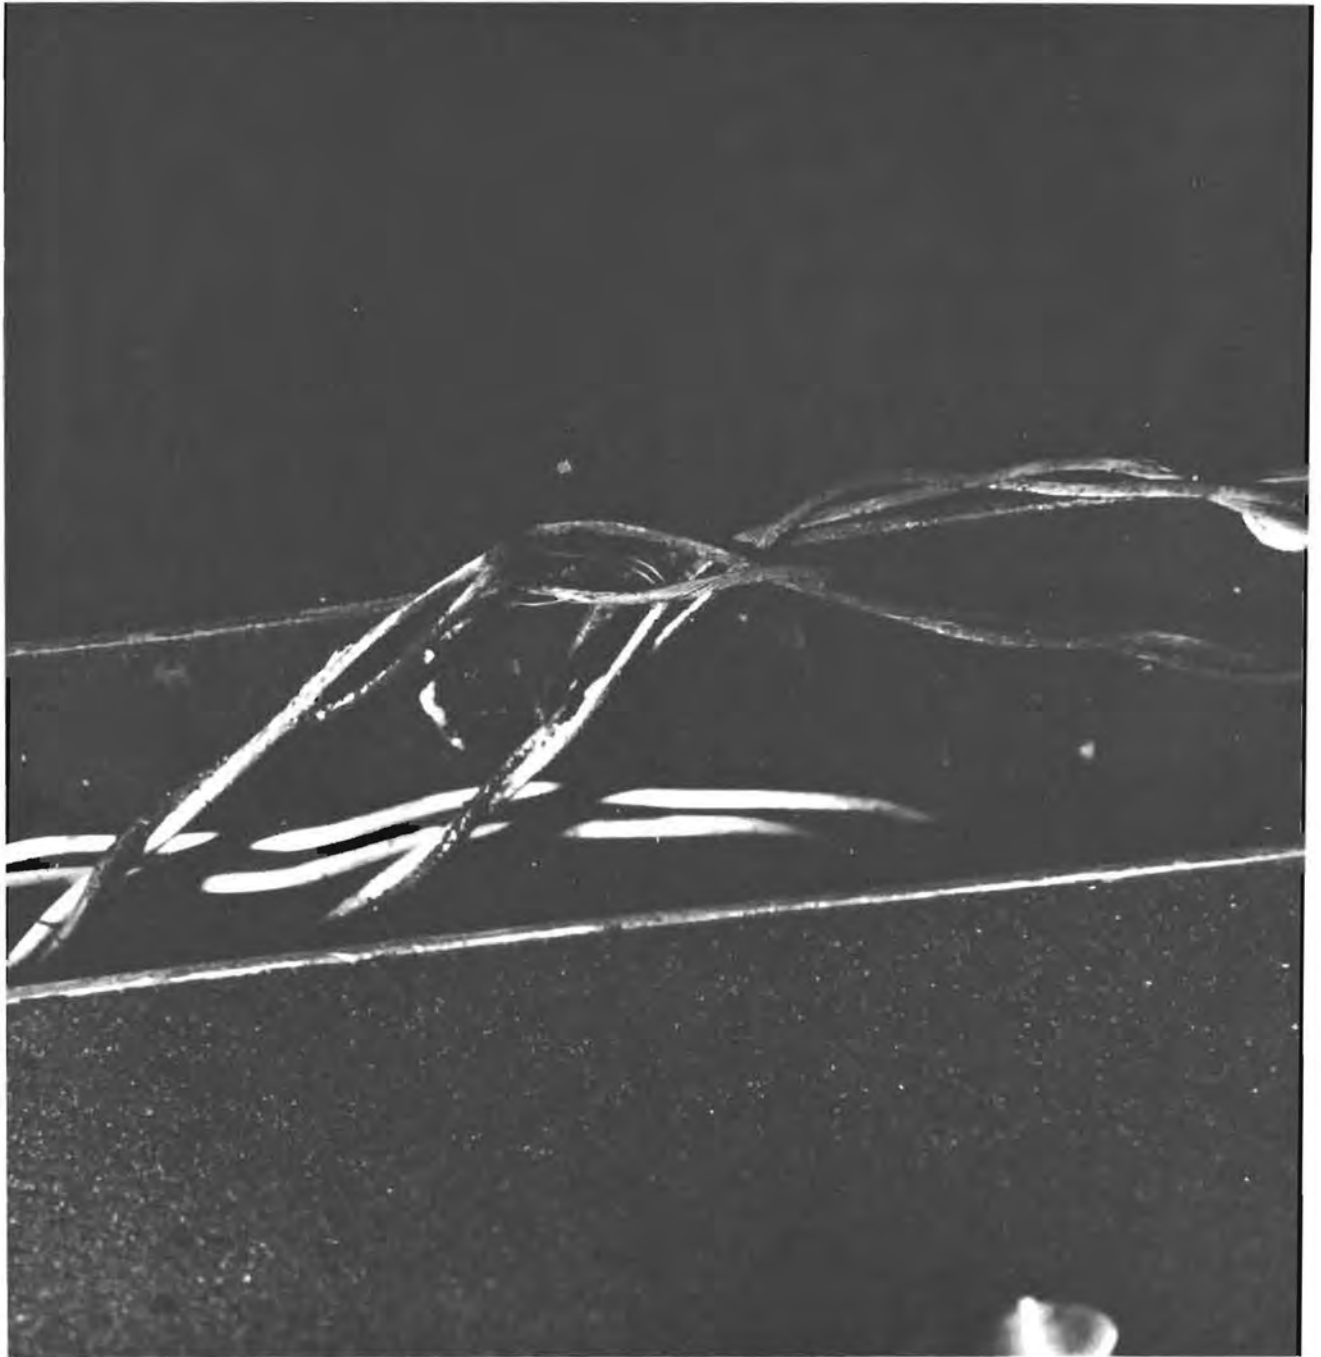
SHORTED DC WIRES ABOVE ENTRY BATTERIES

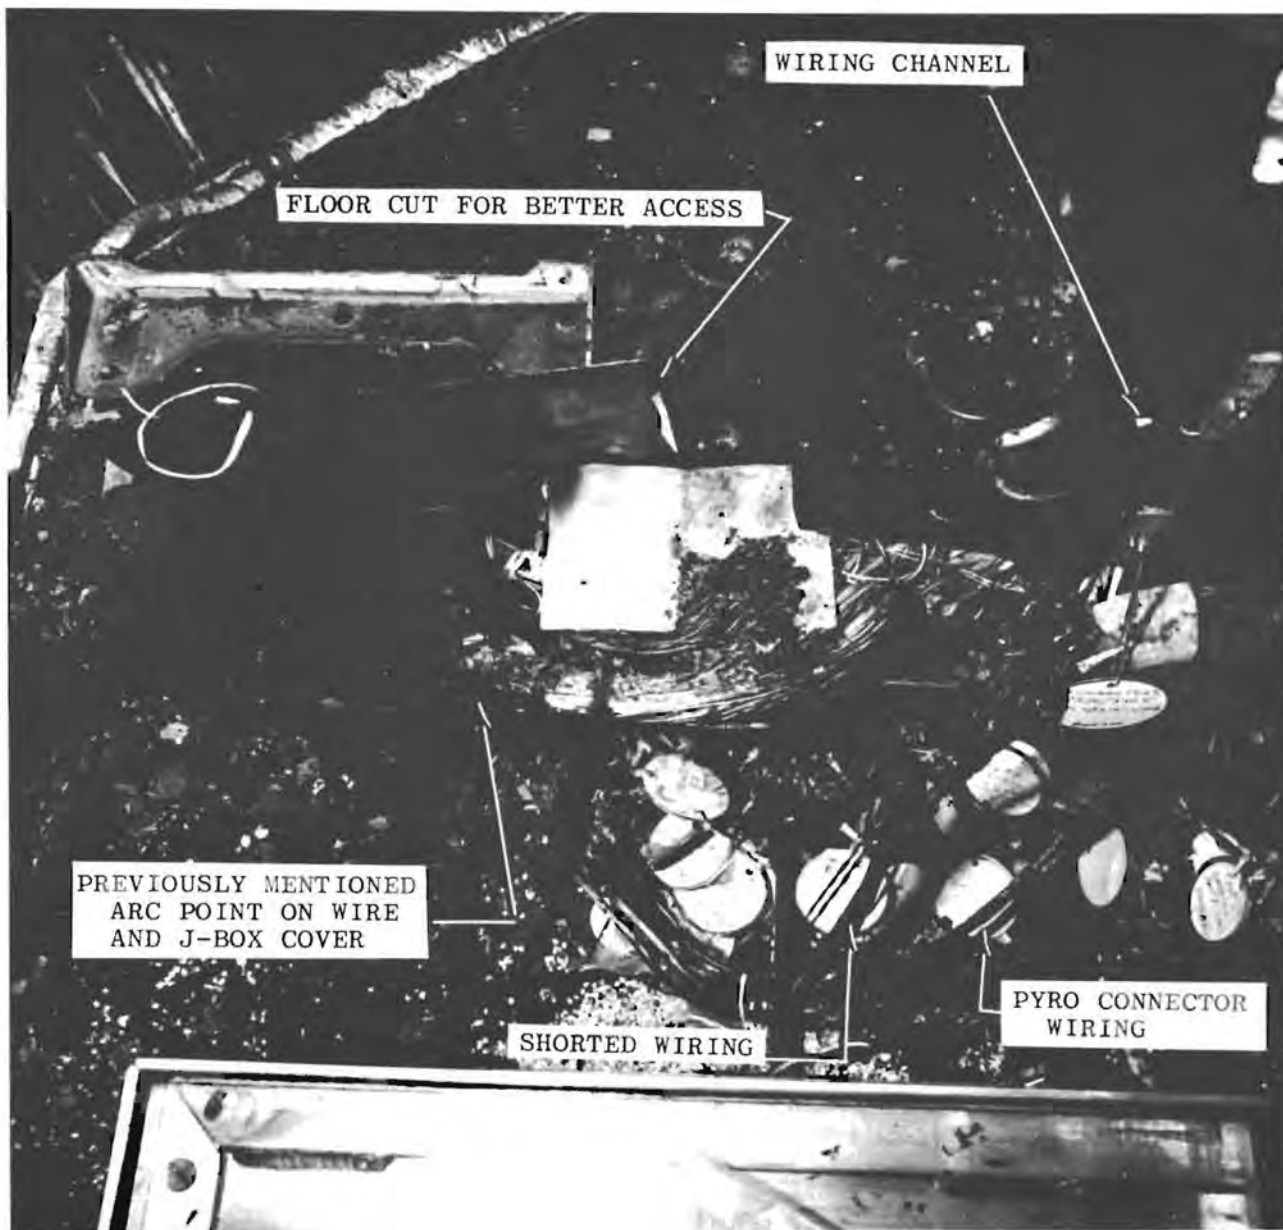
ENCLOSURE 18-44

SHORTING ON OCTAPUS CABLE

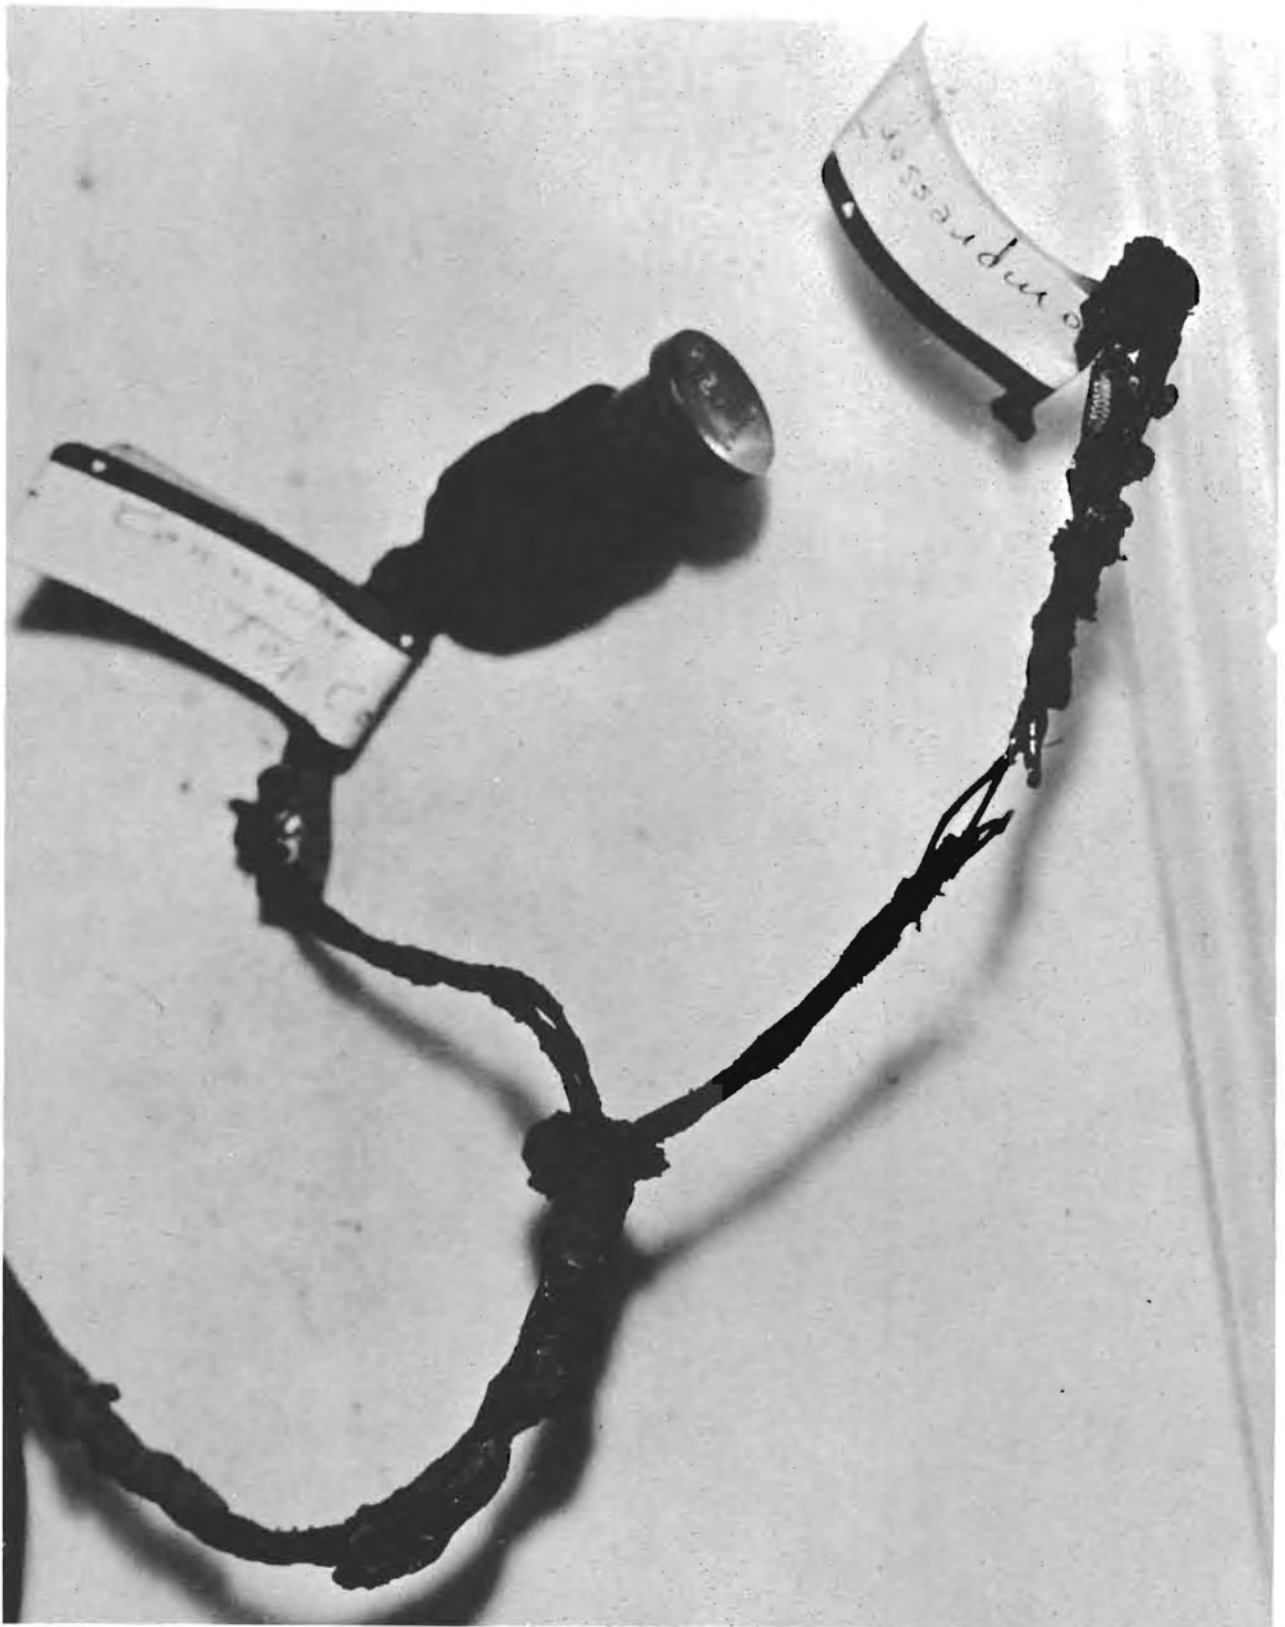
SUIT COMPRESSOR WIRING AFTER ACCIDENT

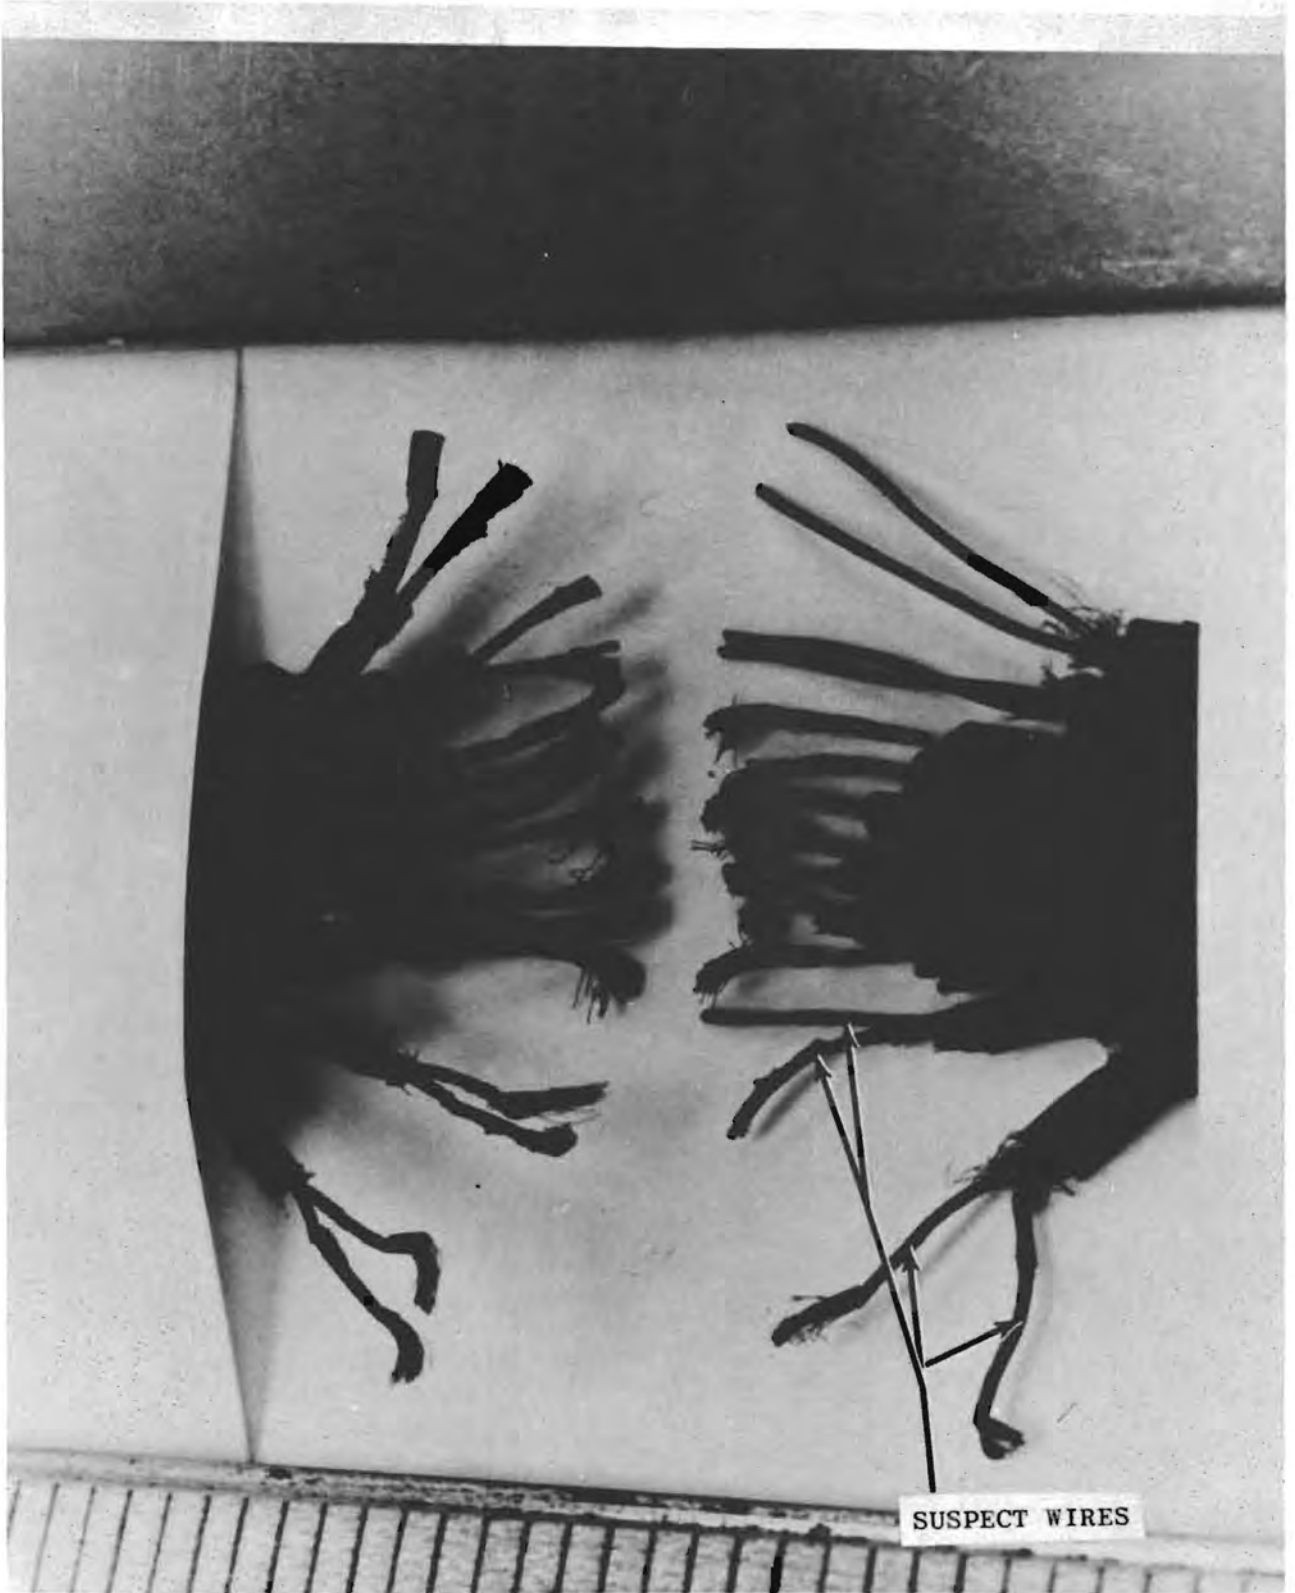
COMMAND PILOT'S SUIT WIRING

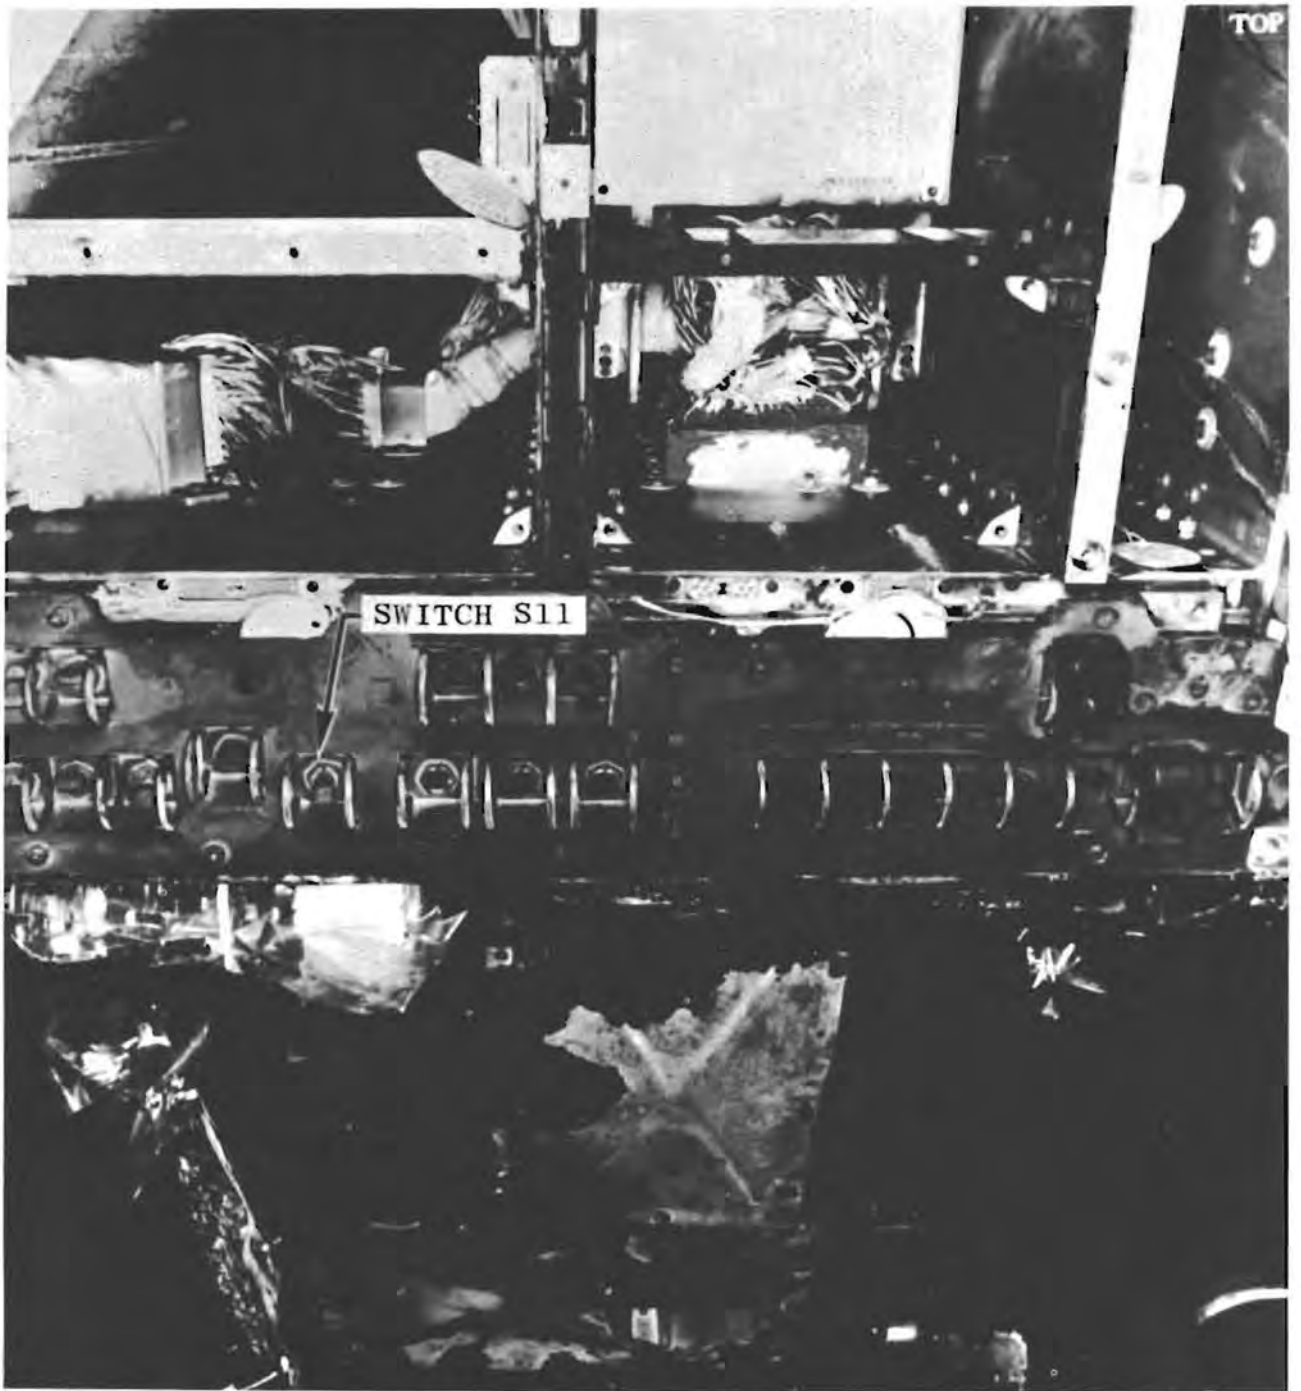
SHORT TO STRUCTURE BY TERMINAL OF SWITCH S11
