REPORT OF APOLLO 204 REVIEW BOARD

APPENDIX D
PANELS 6 thru 10

**REPORT OF PANEL 6
HISTORICAL DATA
APPENDIX D-6
TO
FINAL REPORT OF
APOLLO 204 REVIEW BOARD**

**REPORT OF PANEL 10
ANALYSIS OF FRACTURE AREAS
APPENDIX D-10
TO
FINAL REPORT TO
APOLLO 204 REVIEW BOARD**

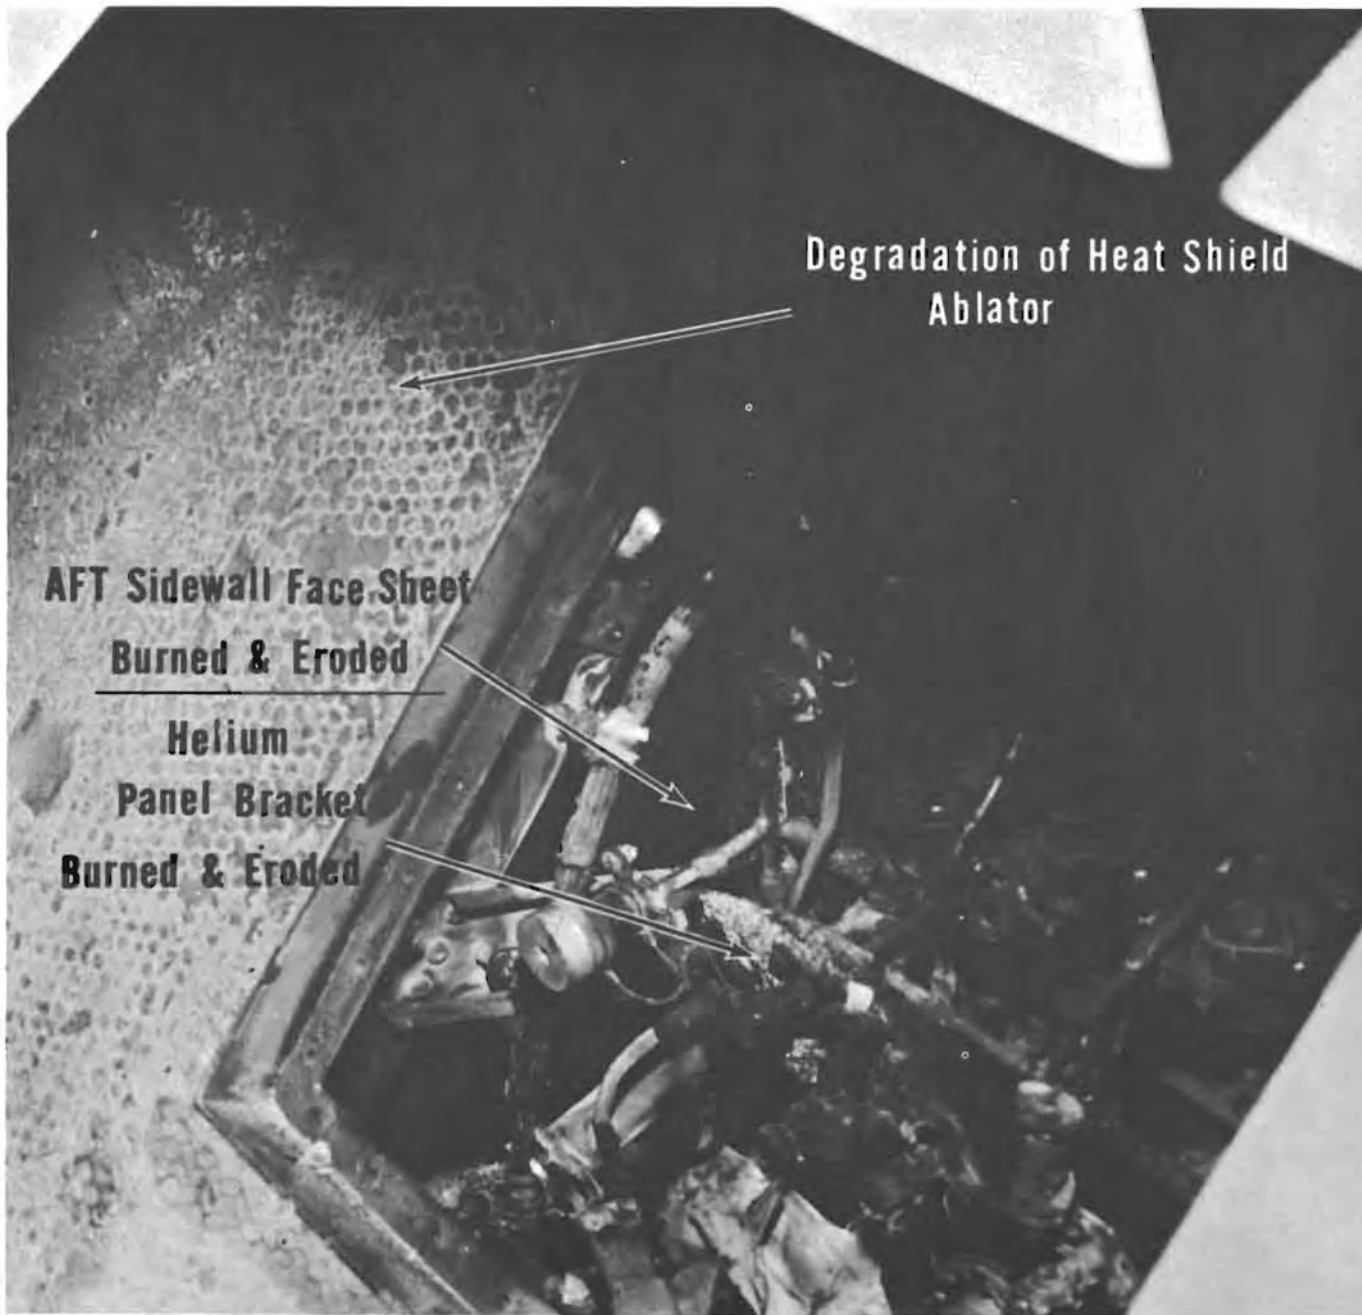
HELIUM ACCESS PANEL #15 +Y AXIS

Degradation of Heat Shield
Ablator

AFT Sidewall Face Sheet
Burned & Eroded

Helium
Panel Bracket
Burned & Eroded

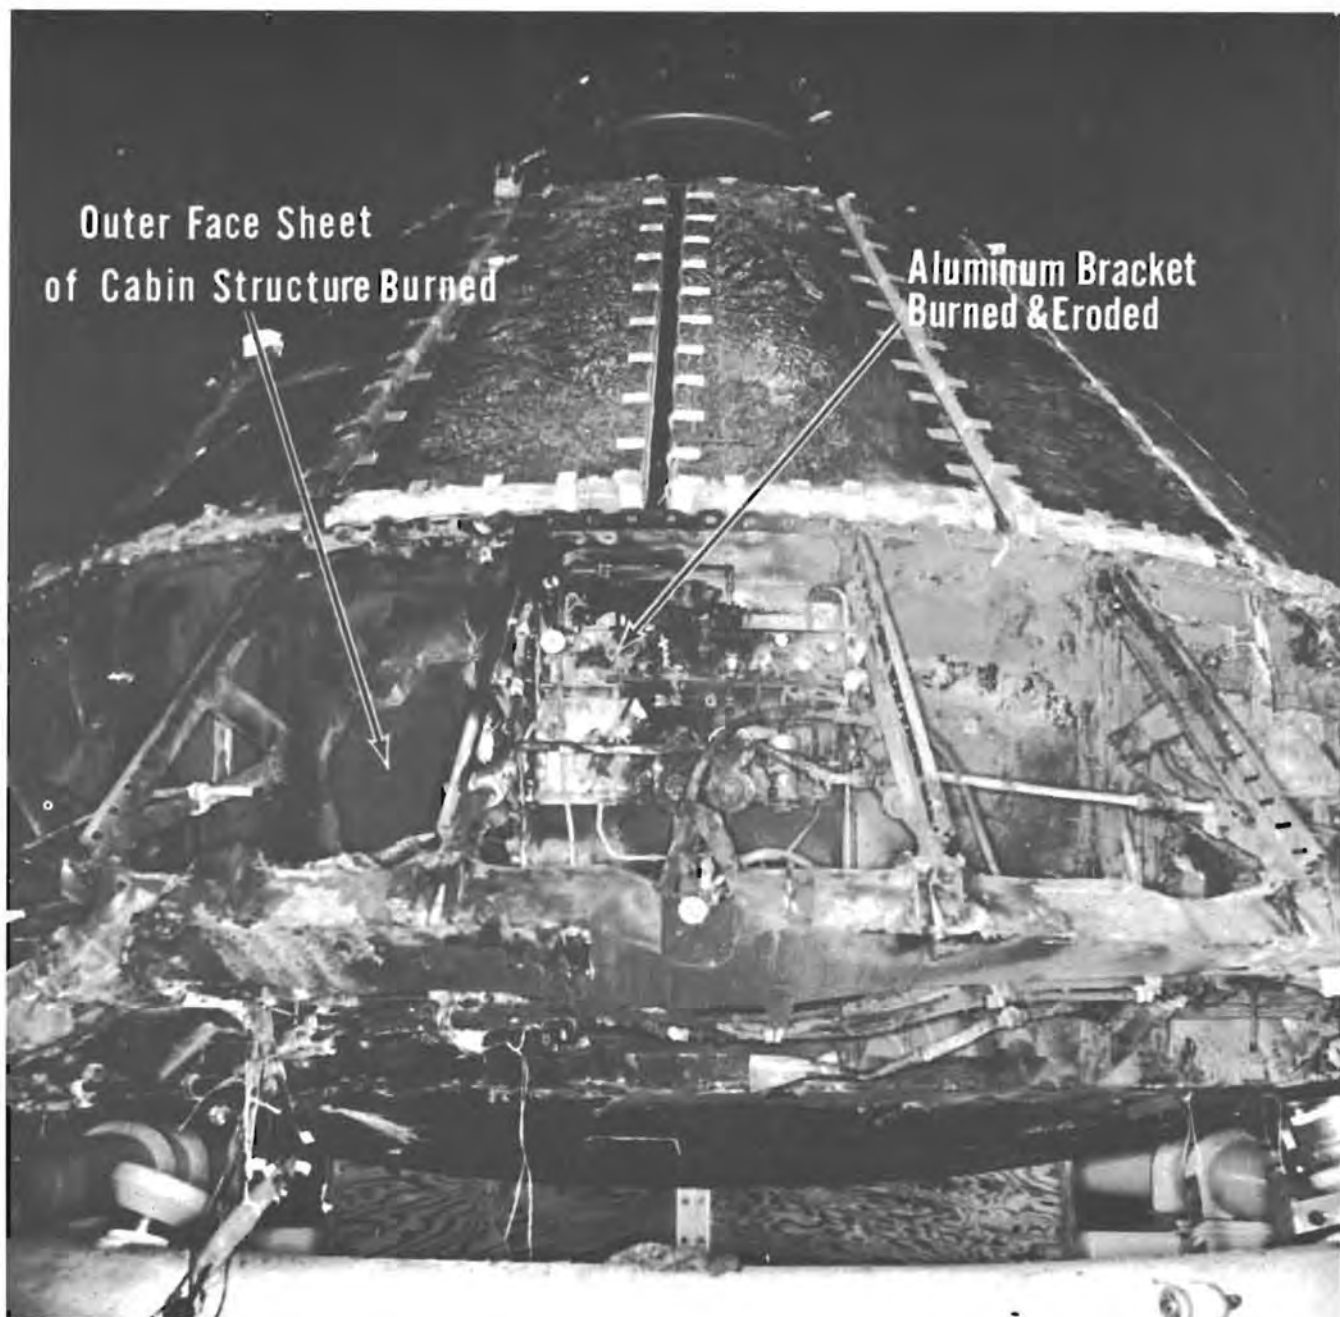
CREW COMPARTMENT STRUCTURE +Y AXIS

Outer Face Sheet
of Cabin Structure Burned

Aluminum Bracket
Burned & Eroded

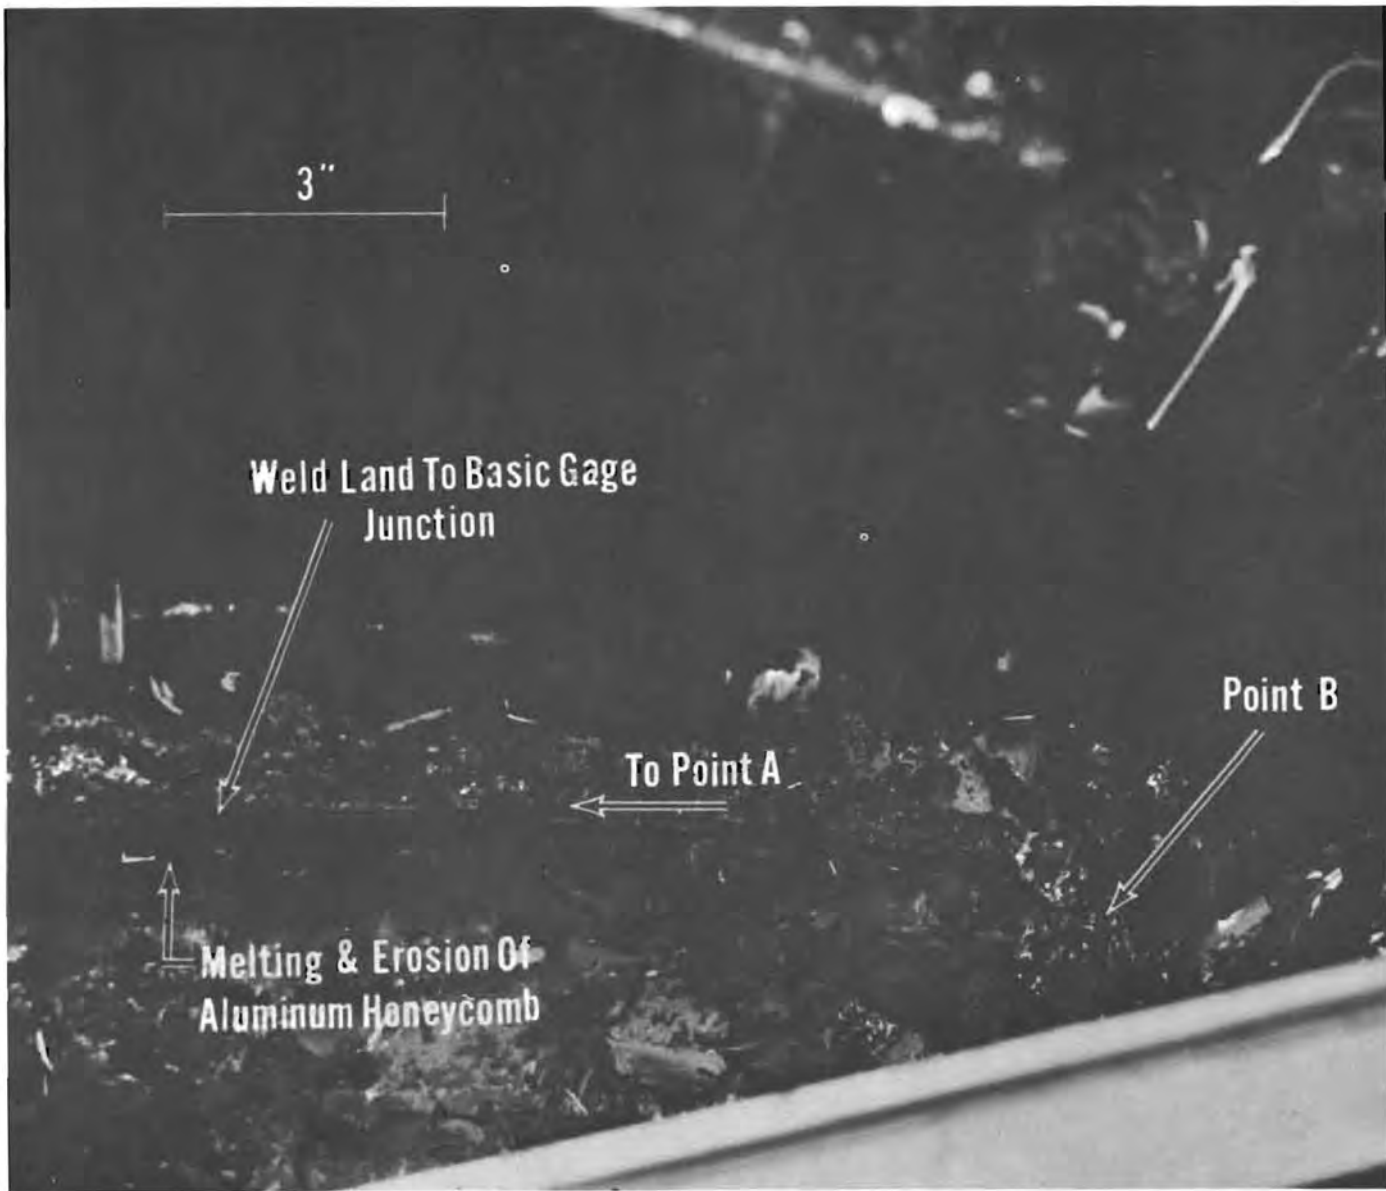
INNER FRACTURE OF CREW COMPARTMENT IN VICINITY OF POINT B

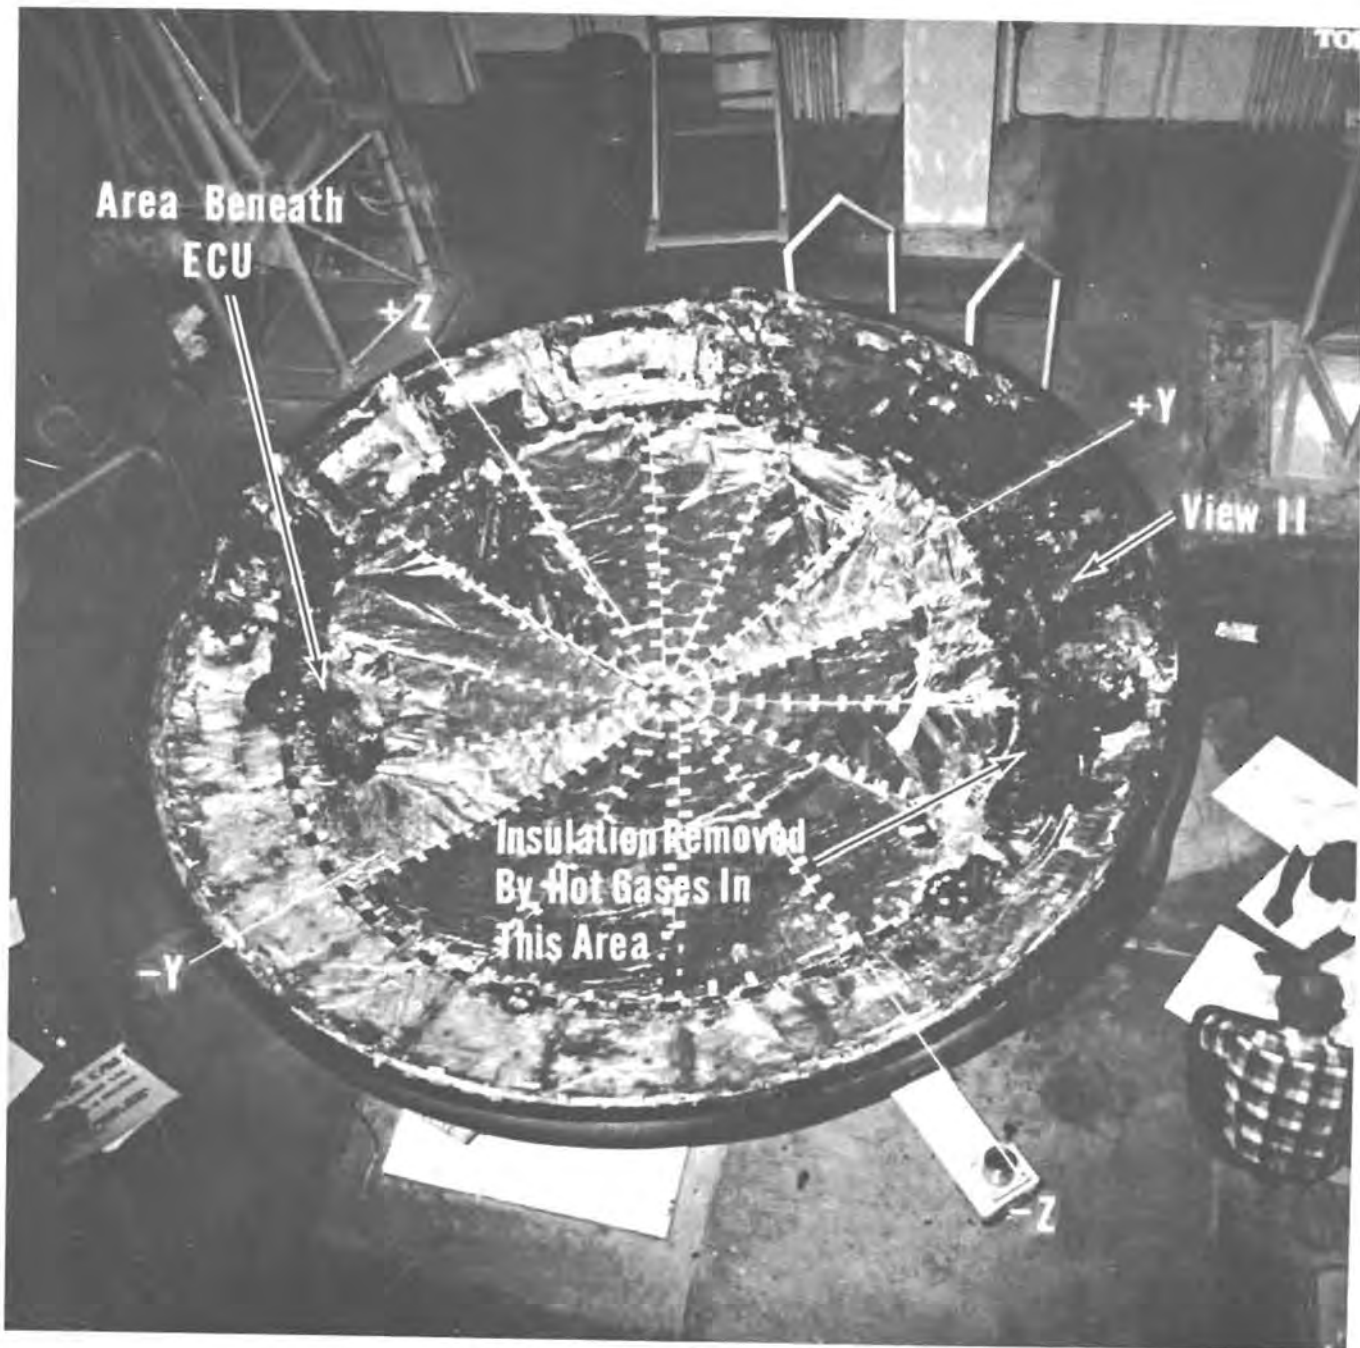
AFT HEATSHIELD DAMAGE VIEW 1

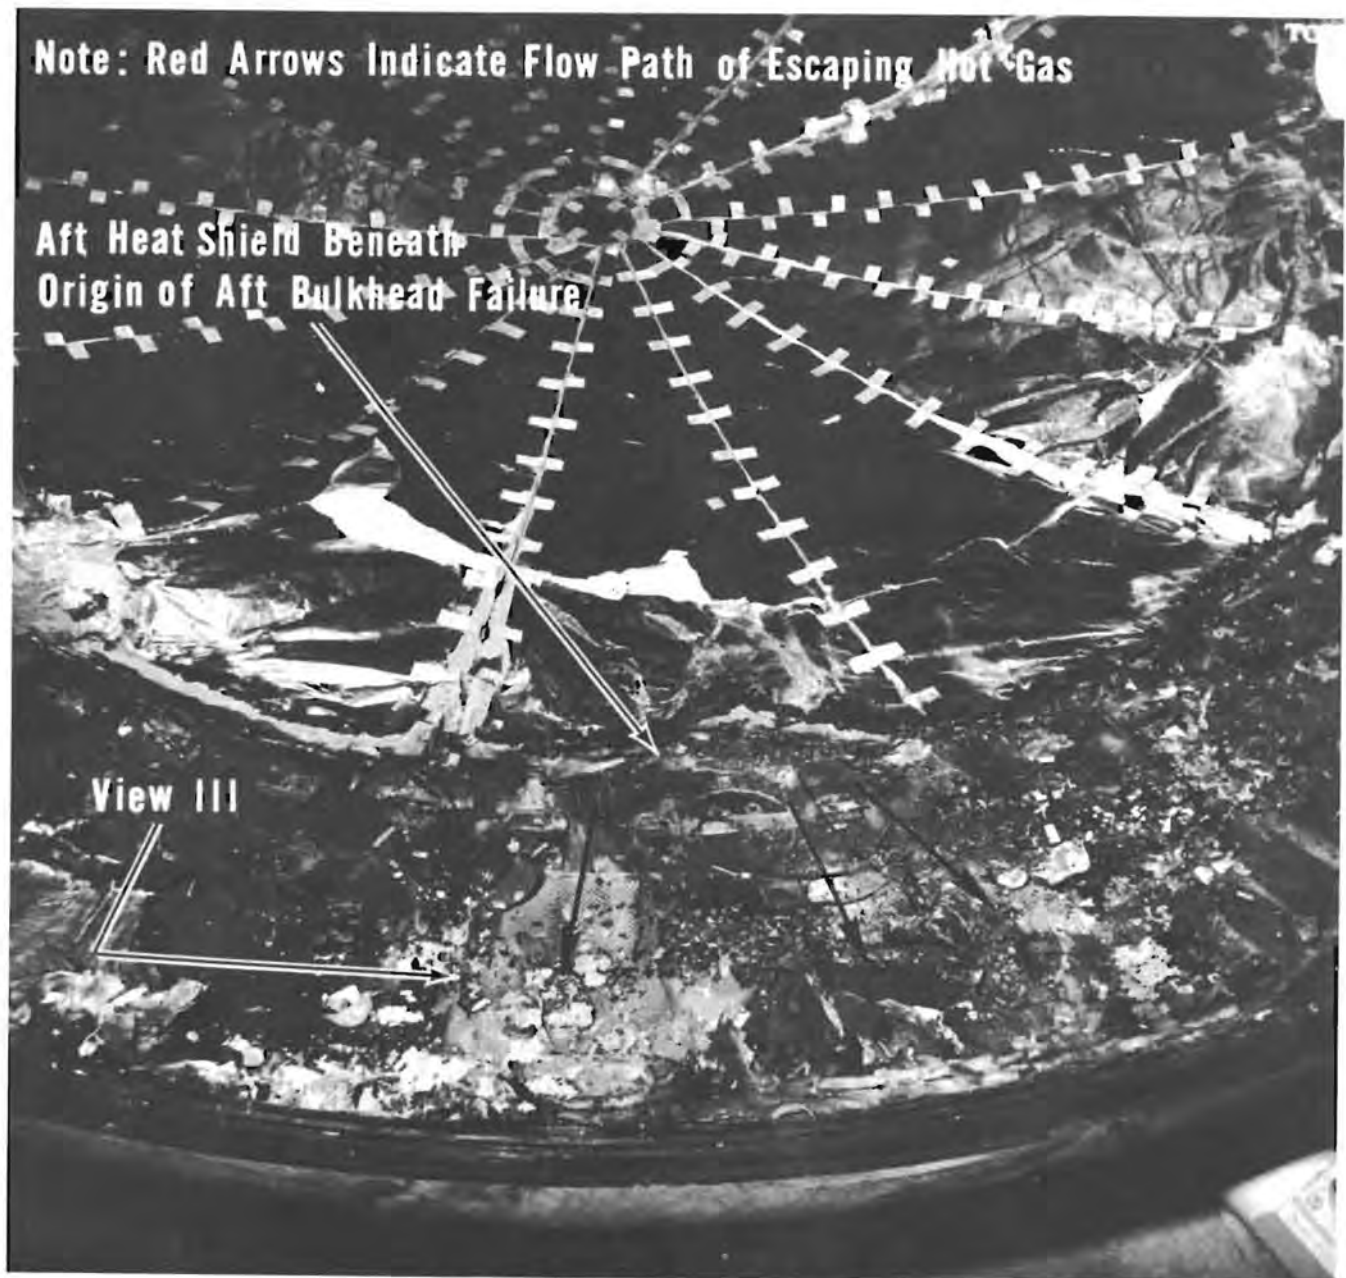
AFT HEATSHIELD DAMAGE VIEW II

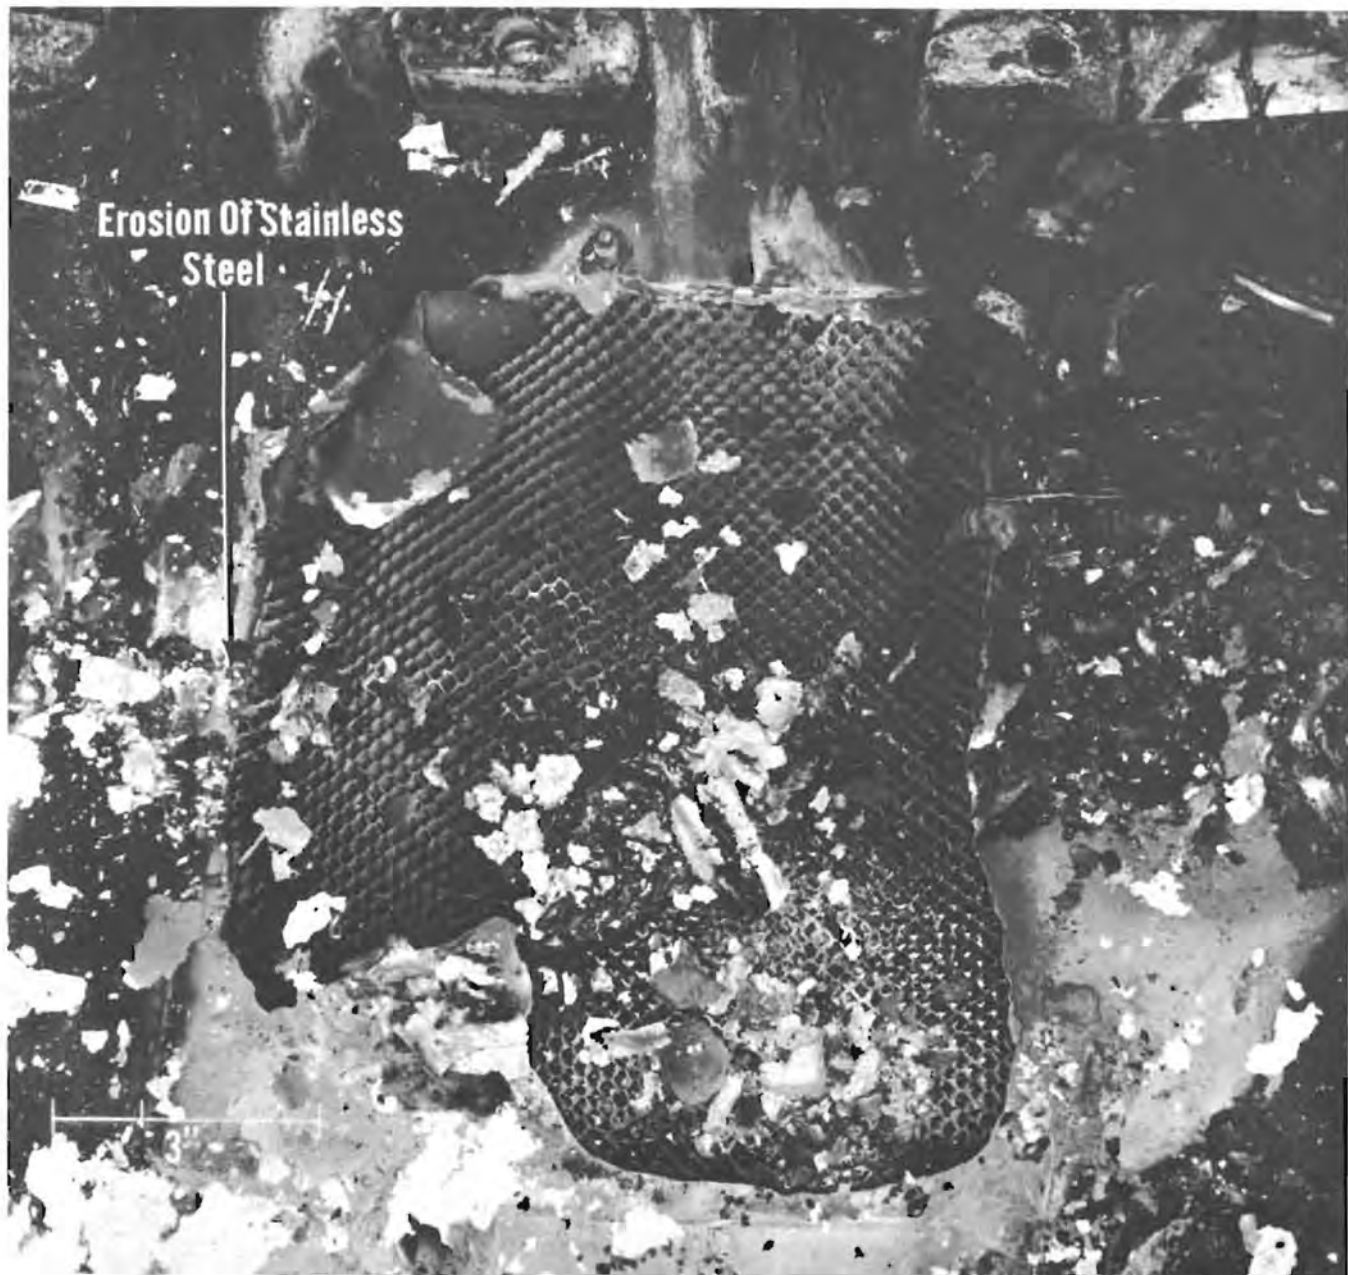
AFT HEATSHIELD DAMAGE VIEW III

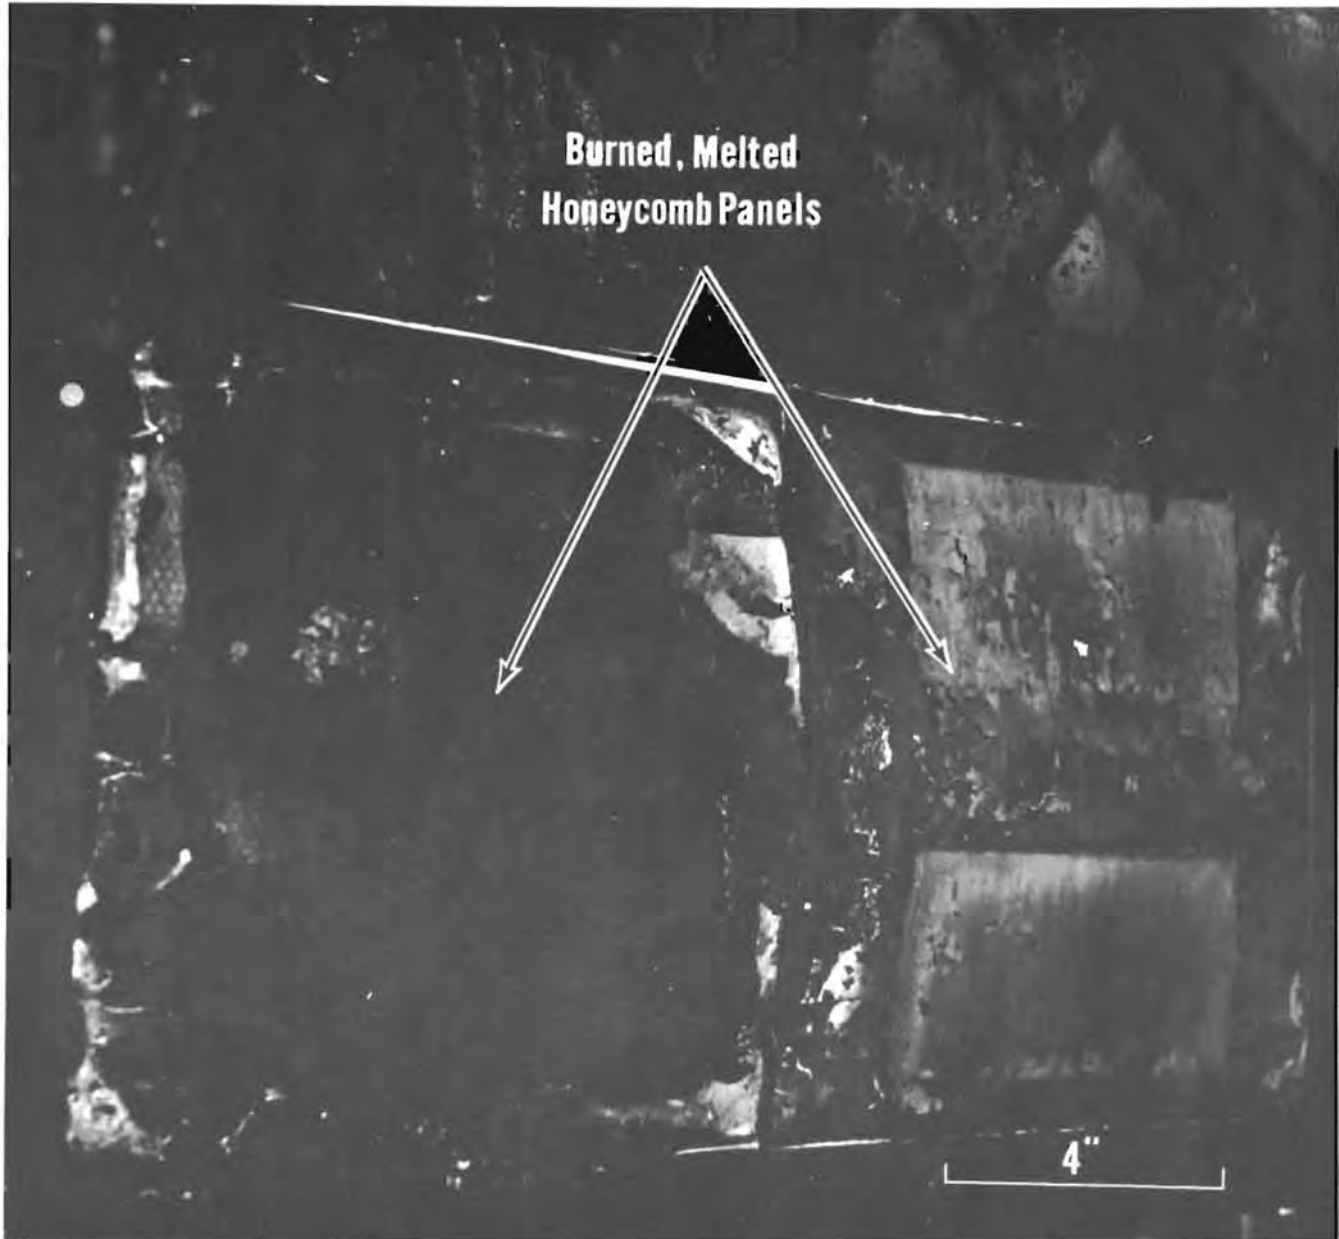
DAMAGED FOOD AND GARMENT STORAGE LOCKER DOORS

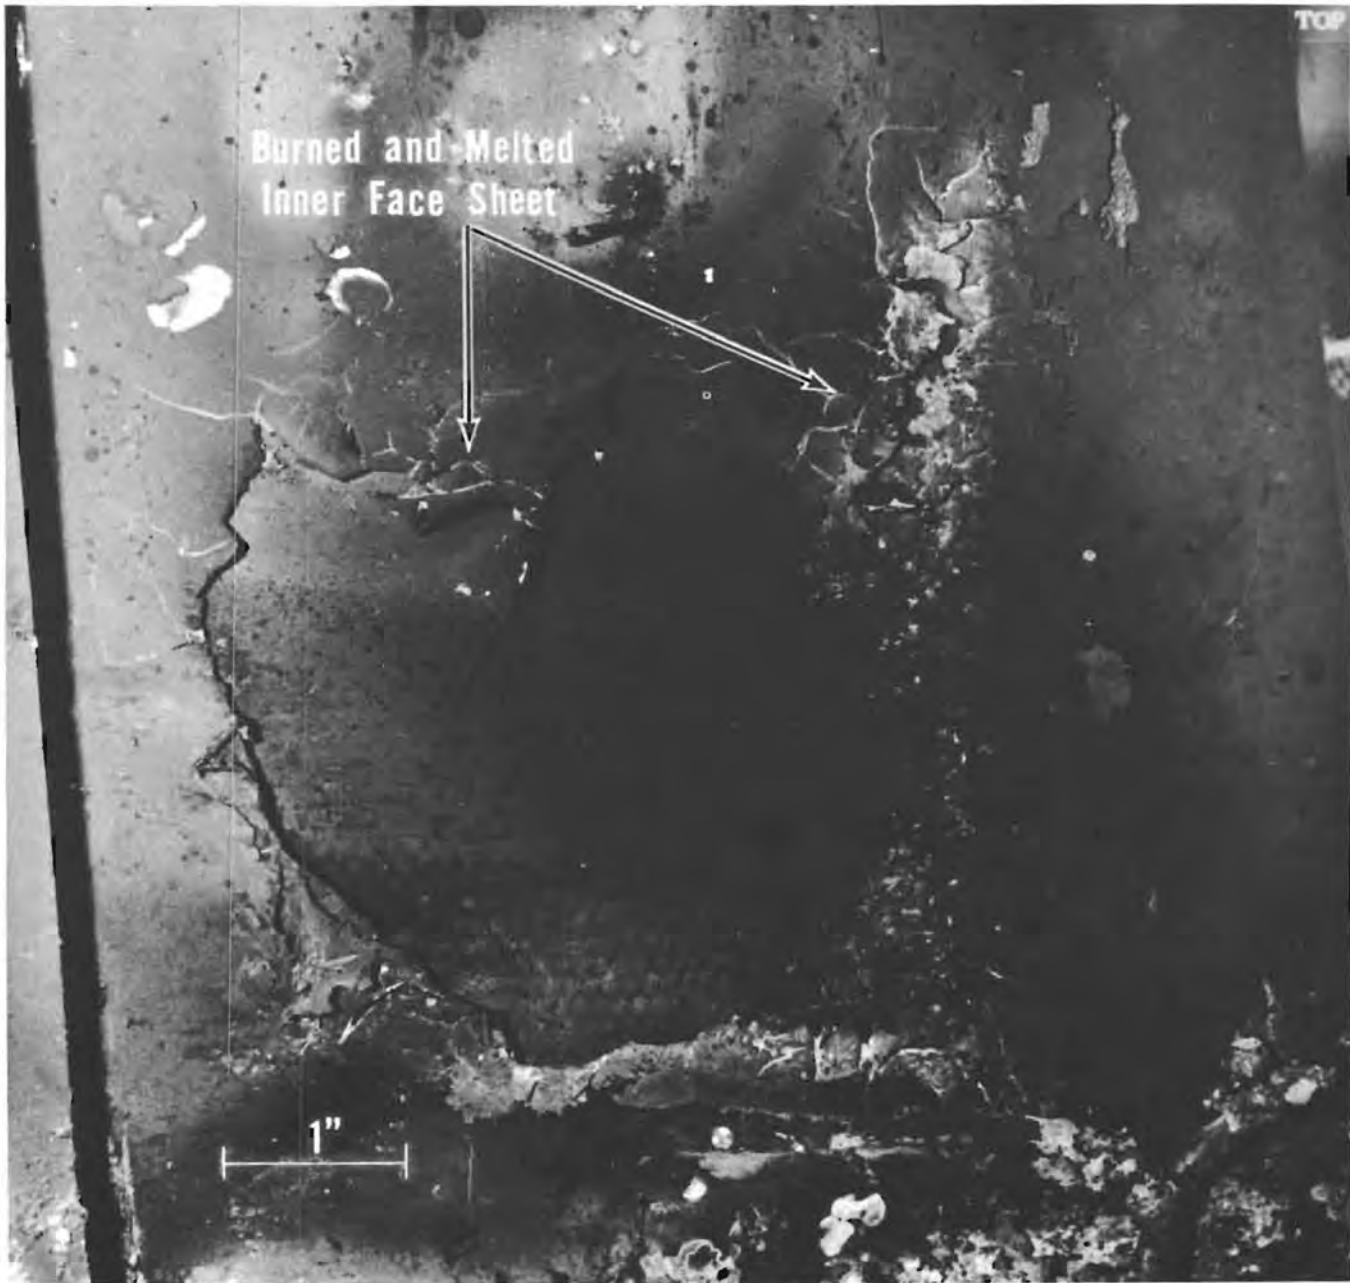
DAMAGED INNER SIDEWALL BELOW CO₂ ABSORBERS
