# **REPORT OF APOLLO 204 REVIEW BOARD**

## **APPENDIX G**

**PART 2**

**Addenda and Corrigenda**

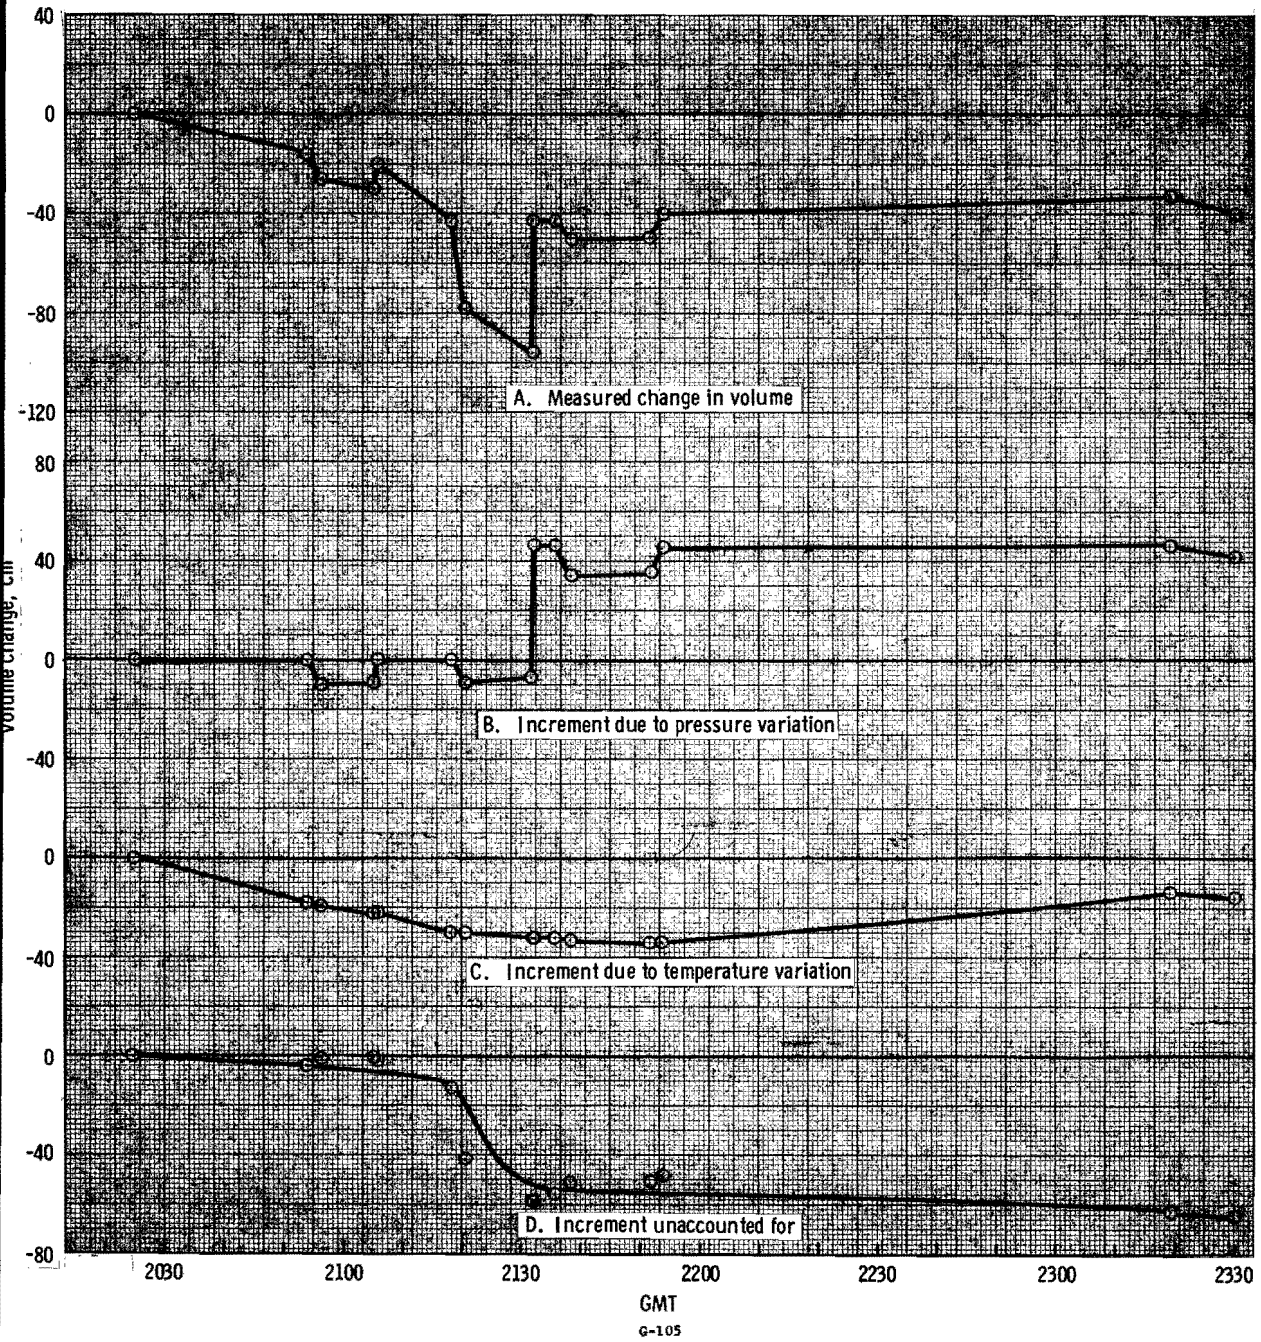
Enclosure G-4: Analysis of measured change of water/glycol volume

The data from the water/glycol cooling system has been analyzed for the time period from 20:30:00 to 23:30:00 GMT. This analysis disclosed the possibility of a small leak in the system (spacecraft and ground loop) in the order of 50cc during this time period.

The water/glycol loop includes the spacecraft and GSE as one closed loop system. From all of the data available it cannot be concluded whether the indicated leakage was internal or external to the spacecraft.

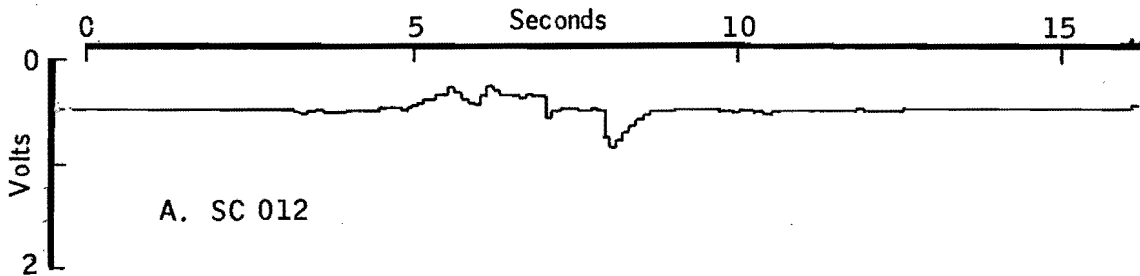
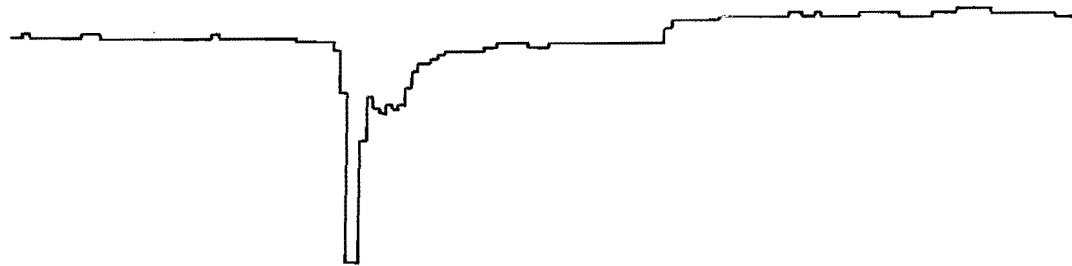
Enclosure G-6: Gas Chromatograph Trace Comparison

Laboratory tests were run on May 16 and 17 where water/glycol was dripped and sprayed on gas chromatograph wires. Both conditions produced outputs similar in magnitude and polarity to the output seen in S/C 012.

B. Test, result of handling the gas chromatograph cable.

C. Test, result of striking a dc arc near the gas chromatograph cable.  
(Short circuit current greater than 200 amperes)

D. Test, result of applying localized flame on gas chromatograph signal wire.

F. Test, result of moving a grounded aluminum plate between  
1 and 12 inches from the gas chromatograph signal wire.

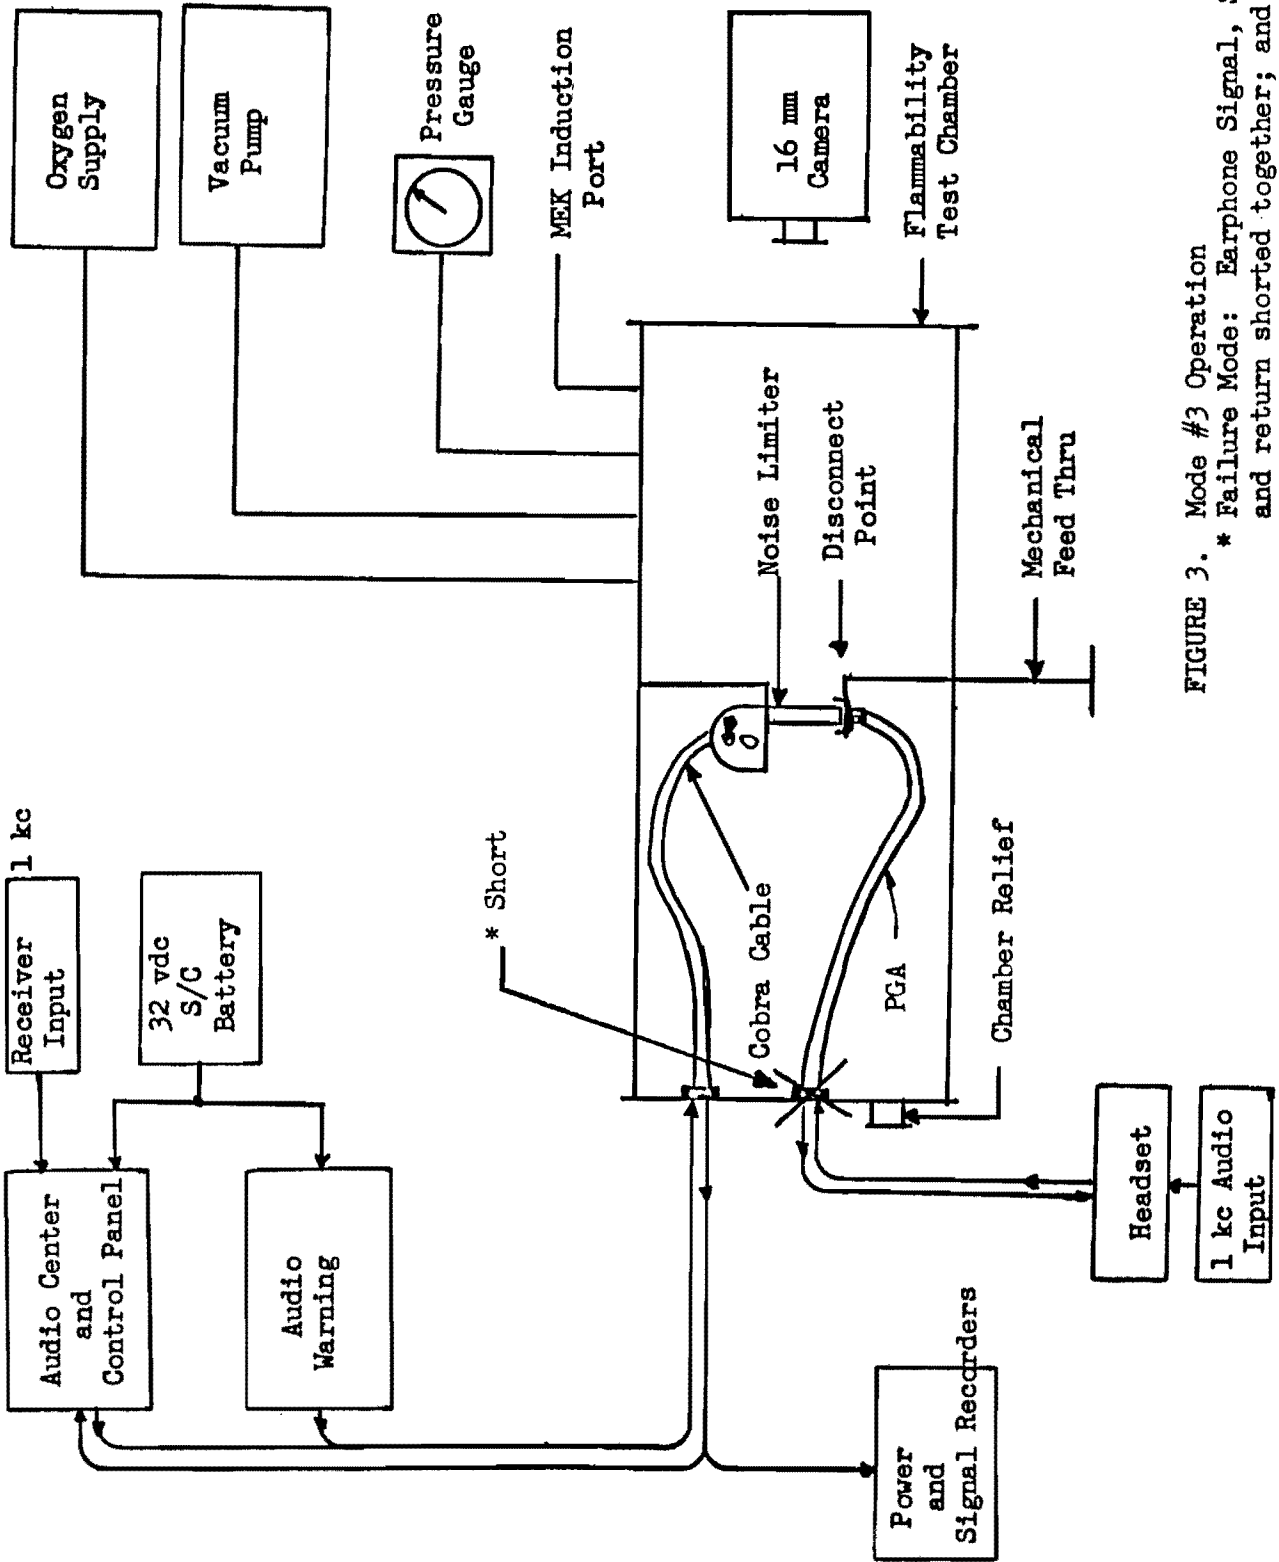
FIGURE 3. Mode #3 Operation  
 \* Failure Mode: Earphone Signal, Shield and return shorted together; and Mike Signal, Shield and return shorted together.
