APOLLO PROGRAM

FINAL FLIGHT EVALUATION REPORT APOLLO 10 MISSION

AUGUST 1969

FLIGHT EVALUATION REPORT - APOLLO 10 MISSION

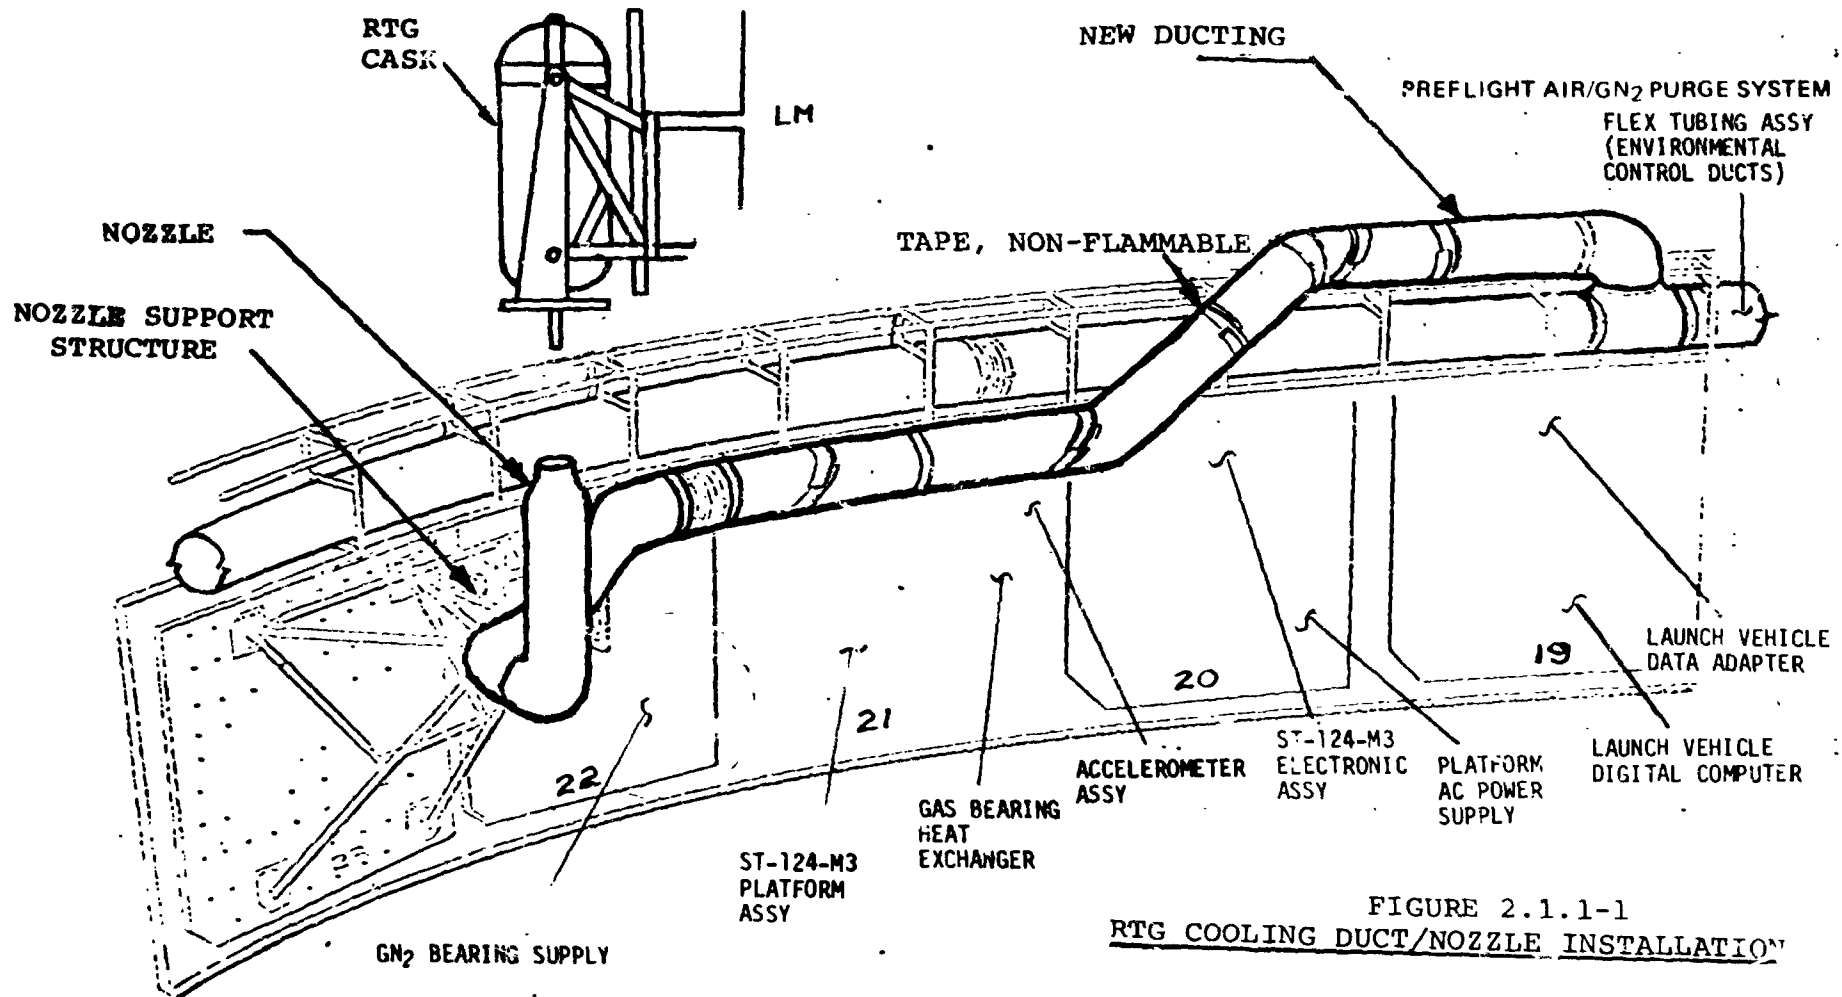
FIGURE 2.1.1-1
RTG COOLING DUCT/NOZZLE INSTALLATION

PROBLEM: AFTER SWITCHOVER FROM AIR TO GN₂, A REDUCTION WAS OBSERVED IN PRESSURE IN THE IU/S-IVB PURGE GASES. THE PRESSURE TRANSDUCER READING ON THE RTG COOLING NOZZLE DECREASED FROM 0.37 PSIG AT T-9:00 TO ALMOST ZERO GAGE PRESSURE AT T-8:30. THE CORRESPONDING GROUND SUPPORT EQUIPMENT (GSE) FLOWRATE INCREASED FROM AN INITIAL VALUE OF 200 LB/MIN TO AN OFF-SCALE VALUE OF MORE THAN 225 LB/MIN. THE UPSTREAM INLET PRESSURE DECREASED FROM 2.15 PSIG TO 1.66 PSIG. THE LOW PRESSURE AT THE INLET TO THE RTG NOZZLE INDICATED LOSS OF FLOW THROUGH THE NOZZLE. THE INCREASE IN FLOWRATE FROM THE GSE WITH A CORRESPONDING DECREASE IN INLET PRESSURE INDICATED THAT AN OPENING HAD OCCURRED SOMEWHERE IN THE PURGE DUCTING. THE ECS PURGE SYSTEM CONTINUED TO FUNCTION ADEQUATELY AS INDICATED BY A STABLE COMPARTMENT TEMPERATURE; THE DUCT FAILURE WAS ASSESSED AS NON-CRITICAL FOR THE APOLLO 10 LAUNCH, AND THE COUNTDOWN PROCEEDED.

MSFC TESTS INDICATE THE ECS AIR/GN₂ PURGE DUCT HAD A MASSIVE GAS LEAK AT THE DUCT JOINT APPROXIMATELY 4 INCHES INSIDE THE STAGE SKIN. THIS JOINT CONSISTED OF A FIBERGLASS DUCT WHICH FIT OVER A SHORT METAL DUCT STUB ATTACHED TO THE IU SKIN. THE FIBERGLASS DUCT WAS RETAINED BY A MARMAN CLAMP, WHICH WAS TORQUED TO 7+1 INCH-POUNDS.

ACTION: AS A RESULT OF THE MSFC TESTS, A SECOND MARMAN CLAMP WILL BE ADDED, AND BOTH CLAMPS WILL BE TORQUED TO 20+2 INCH-POUNDS. THIS CONFIGURATION HAS BEEN TESTED TO 9 TIMES THE NORMAL OPERATING PRESSURE WITH NO FAILURES. THIS CHANGE (IBM ECP 1905) HAS BEEN COMPLETED ON APOLLO 11, AND IT WILL BE ACCOMPLISHED ON ALL SUBSEQUENT LAUNCH VEHICLES.

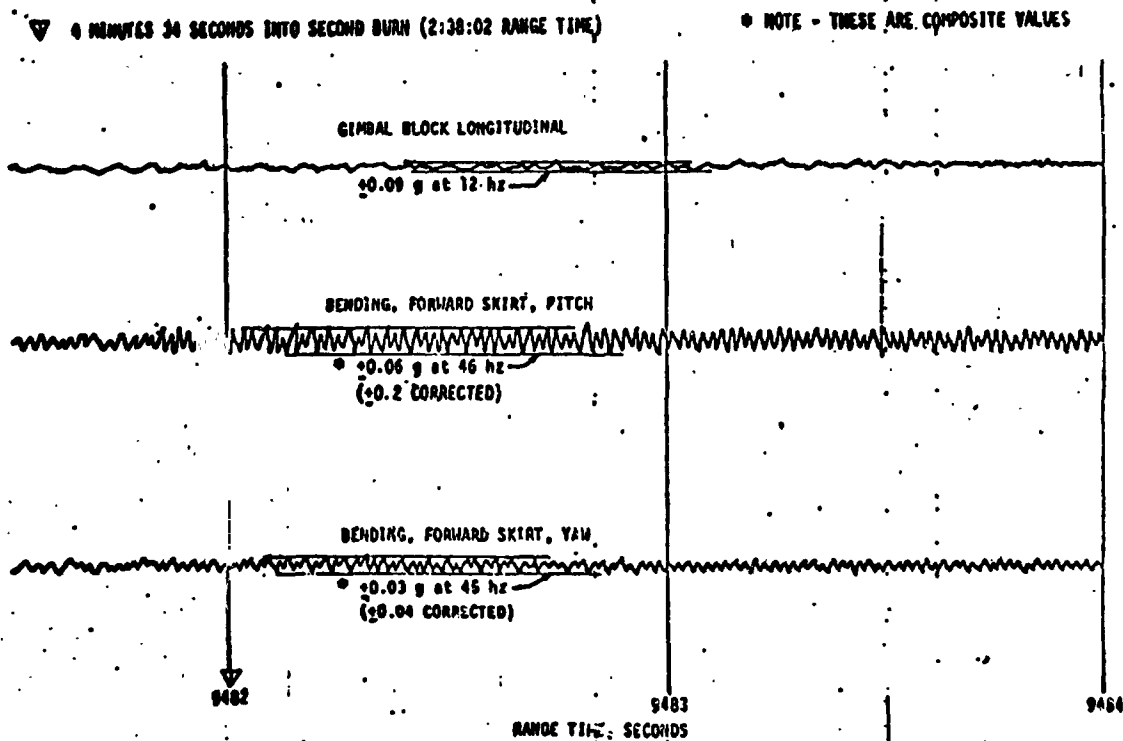
FIGURE 2.1.2-1 S-IVB SECOND BURN LONGITUDINAL AND LATERAL OSCILLATIONS

PROBLEM: DURING THE FIRST S-IVB BURN, 19 HERTZ LONGITUDINAL OSCILLATIONS OF APPROXIMATELY +0.25 G WERE OBSERVED AT THE ENGINE GIMBAL BLOCK. A SLIGHT CHANGE IN OSCILLATORY THRUST, DERIVED FROM CHAMBER PRESSURE, WAS ALSO EVIDENT DURING THIS TIME PERIOD. A REVIEW OF THE APOLLO 8 FLIGHT DATA SHOWED SIMILAR THRUST OSCILLATIONS AS ON APOLLO 10, BUT AT APPROXIMATELY 1/2 THE G LEVEL. THIS ACTIVITY IS WITHIN THE NORMAL J-2 ENGINE UNCOUPLED THRUST LEVEL, AND IT DOES NOT REPRESENT CONCERN FOR FUTURE APOLLO MISSIONS.

LOW FREQUENCY, LOW AMPLITUDE VIBRATION WAS ALSO PRESENT THROUGHOUT THE SECOND BURN. SHORTLY AFTER STEP PRESSURIZATION, A PREDOMINANT HIGH FREQUENCY OSCILLATION OF 46 HERTZ OCCURRED AND REMAINED UNTIL CUTOFF. THE MOST PROBABLE CAUSE WAS SEQUENTIAL VENTING OF THE DUAL VENT VALVES IN THE FORWARD SKIRT AREA, WHICH TENDS TO EXCITE THE FORWARD SKIRT RING MODE. TESTS WERE RUN AT AEDC TO ATTEMPT TO DUPLICATE THE FLIGHT DATA. APOLLO 11 WAS NOT CONSTRAINED BECAUSE THERE WAS NO ADVERSE EFFECT ON EITHER THE STRUCTURE OR THE VENTING SYSTEM DURING THE APOLLO 10 MISSION.

THE CREW REPORTED A LOW FREQUENCY LATERAL AND LONGITUDINAL OSCILLATION DURING BOTH S-IVB BURNS, WITH A HIGHER FREQUENCY VIBRATION SUPERIMPOSED ON IT BEGINNING 4 MINUTES AND 40 SECONDS INTO THE SECOND BURN. LONGITUDINAL 19 HZ OSCILLATIONS WERE EXPERIENCED DURING THE FIRST BURN AT A MAXIMUM AMPLITUDE OF +0.25 G ON THE LONGITUDINAL GIMBAL BLOCK ACCELEROMETER. A FREQUENCY ANALYSIS OF THE CHAMBER PRESSURE (Pc) SHOWS A CHANGE IN THE THRUST OSCILLATIONS DURING THE SAME TIME OF FLIGHT. THE AS-503 S-IVB DATA SHOWED 19 HZ LONGITUDINAL OSCILLATIONS SIMILAR TO AS-505 AT ABOUT ONE-HALF THE AMPLITUDE. S-IVB-201 AND S-IVB-204 THRUST DATA SHOWED 18-19 HZ OSCILLATIONS EQUAL IN AMPLITUDE TO AS-505. LONGITUDINAL VIBRATIONS WHICH ARE RESPONSES TO UNCOUPLED THRUST OSCILLATIONS ALSO OCCURRED DURING S-IC AND S-II MAINSTAGE BURNS. THE AMPLITUDE OF THE 19 HZ THRUST OSCILLATIONS CALCULATED FROM Pc IS WITHIN THE NORMAL J-2 UNCOUPLED THRUST LEVELS (NOISE LEVEL THRUST OSCILLATIONS). THE OSCILLATIONS ARE CONSISTENT WITH THE ENGINE NOISE LEVEL THRUST OSCILLATIONS AND THEY ARE OF NO CONCERN FROM STABILITY CONSIDERATIONS. SIMILAR VIBRATION LEVELS WERE ALSO PRESENT THROUGHOUT THE SECOND BURN. AN INCREASE IN THE PITCH & YAW VIBRATION LEVEL OCCURRED DURING THE SECOND BURN 4 SECONDS BEFORE THE ASTRONAUT COMMENT. THE PREDOMINANT FREQUENCY WAS 46 HZ WHICH REMAINED UNTIL ENGINE CUTOFF. THE FUEL STEP PRESSURIZATION AND VENT SEQUENCE OCCURRED 3 SECONDS BEFORE THIS VIBRATION LEVEL INCREASE. THE PROBABLE CAUSE IS THE PROXIMITY (0.1 PSI) OF THE DUAL VENT VALVE SETTINGS.

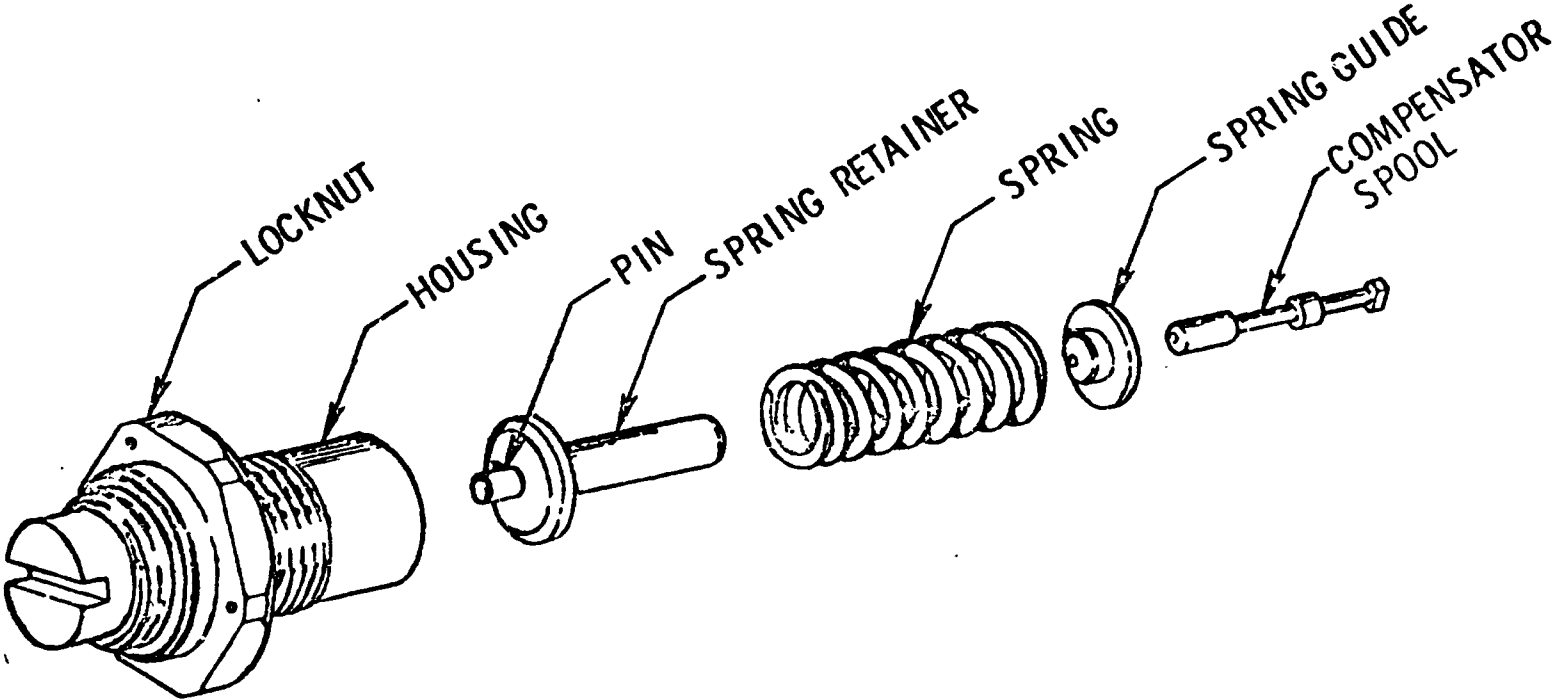
FIGURE 2.1.3-2 PRESSURE COMPENSATOR ASSEMBLY

PROBLEM: DURING THE TLI BURN AND THE PROPELLANT DUMP, THE AUXILIARY HYDRAULIC PUMP OPERATED ABNORMALLY. THE PUMP WAS CAVITATING, HEATING UP, PRESSURIZING THE SYSTEM TOO SLOWLY, AND DRAWING 19 AMPS INSTEAD OF THE EXPECTED 40 AMPS. DURING THE PRESSURIZATION CYCLE AFTER SECOND BURN AND DURING THE PROPELLANT DUMP, THE PUMP CURRENT WAS 15 TO 16 AMPERES AND THE SYSTEM PRESSURE WAS LESS THAN THE 1500 PSI LOWER LIMIT OF THE MEASURING SYSTEM. THERE WAS ENOUGH PRESSURE AVAILABLE, HOWEVER, TO CENTER THE J-2 ENGINE DURING THESE PERIODS.

AN AUXILIARY PUMP GROUND TEST WAS RUN IN AN ATTEMPT TO DUPLICATE THE FLIGHT DATA BY INTRODUCING KNOWN FAILURES. THE PRIME SUSPECT, STRUCTURAL FAILURE OF THE COMPENSATOR SPRING GUIDE, DID PRODUCE SIMILAR DATA. ADDITIONAL FAILURE TESTS (COMPENSATOR SPRING BREAKAGE, VALVE PLATE TORSION SPRING FRACTURE, AND STOP PIN FAILURE) DID NOT DUPLICATE FLIGHT DATA.

ACTION: TESTS WITH A FAILED COMPENSATOR SPRING GUIDE REPRODUCED THE FLIGHT DATA. THE SPRING GUIDES WERE REDESIGNED SOME TIME AGO, BUT IT IS SUSPECTED THE OLD DESIGN FLEW ON AS-505 THE COMPENSATOR SPRING GUIDE ON S-IVB-506 WAS REPLACED BEFORE CDDT TO INSURE ADEQUATE PERFORMANCE DURING THE APOLLO 11 MISSION.

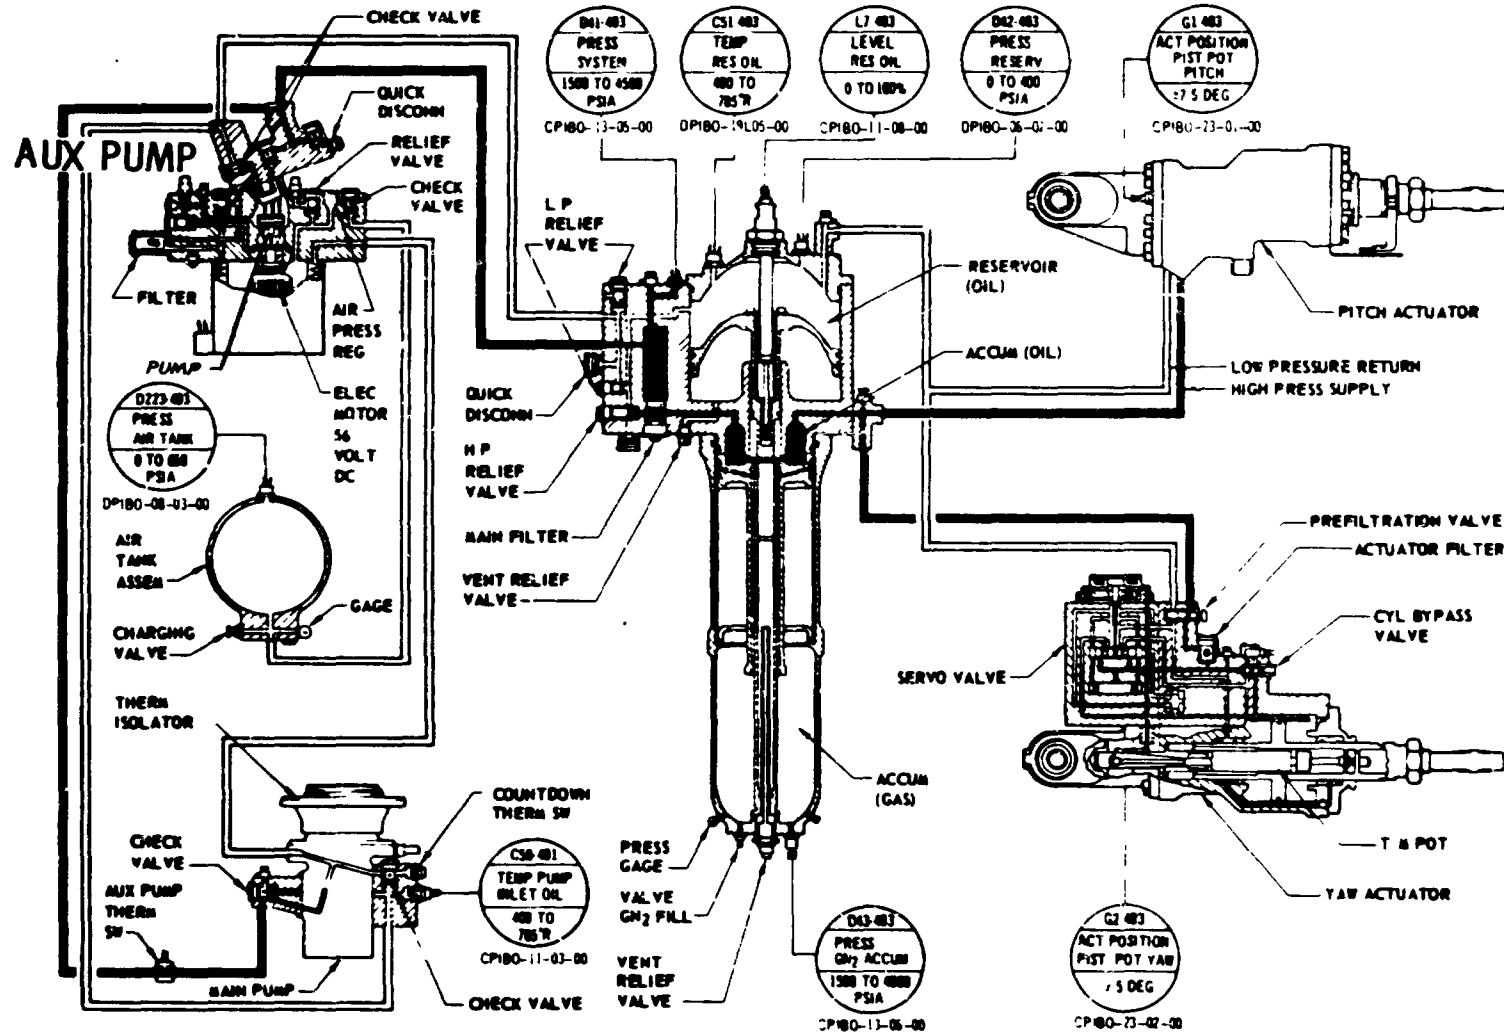
FIGURE 2.1.3-1. S-IVB HYDRAULIC SYSTEM

BACKGROUND: THE AUXILIARY HYDRAULIC PUMP IS A FIXED ANGLE, VARIABLE DELIVERY PUMP WITH A RATED FLOW OF 1.5 GPM AT A MINIMUM OF 3,500 PSIA. THE PUMP IS DRIVEN BY A 56 VDC MOTOR REQUIRING EITHER A GROUND SERVICE POWER OR STAGE POWER. THE MOTOR CAVITY IS FILLED WITH DRY AIR. THIS AIR MAINTAINS A POSITIVE PRESSURE WITHIN THE MOTOR TO PREVENT EXCESSIVE BRUSH WEAR; IT ALSO TRANSFERS MOTOR-GENERATED HEAT TO THE HYDRAULIC FLUID. THE HEAT THERMALLY CONDITIONS THE FLUID DURING PRELAUNCH PROPELLANT LOADING OPERATIONS AND DURING THE ORBITAL COAST PHASE. FOR THE COAST PHASE, THE PUMP TURNS ON AT PRE-PROGRAMMED INTERVALS FOR HEATING AND CIRCULATING THE FLUID.

THE AUXILIARY HYDRAULIC PUMP WAS TURNED ON 6 MINUTES PRIOR TO SECOND BURN. THE ACTUATORS CENTERED THE J-2 ENGINE IN RESPONSE TO THE 3635 PSIA SYSTEM PRESSURE. AT ENGINE IGNITION, THE ACTUATORS RESPONDED NORMALLY TO THE APPLIED GUIDANCE SIGNALS. THE AUXILIARY PUMP RESPONDED BRIEFLY WITH HIGH FLOW TO MEET THIS DEMAND WHILE THE ENGINE DRIVEN PUMP WAS BROUGHT UP TO SPEED. SHORTLY AFTER ENGINE IGNITION, THE ENGINE DRIVEN PUMP OUTPUT PRESSURE EXCEEDED THE NORMAL 3635 PSIA BY 3 PERCENT. THE AUXILIARY PUMP RESPONDED TO THIS EXCESS PRESSURE BY FEATHERING TO THE NO-FLOW CONDITION WITH A CORRESPONDING DROP TO A CONTINUOUS 21 AMPERE DEMAND. AT ABOUT 2:37 GET, THE AUXILIARY PUMP CURRENT DECREASED UNEXPECTEDLY TO 19 AMPERES. THE CURRENT REMAINED AT THIS LEVEL DURING THE 4.1 SECOND INTERVAL FOLLOWING ENGINE CUTOFF INSTEAD OF RISING TO THE NORMAL 40 TO 70 AMPERES.

ONE PRESSURIZATION WAS PROGRAMMED BETWEEN SECOND BURN AND THE CHILL DOWN EXPERIMENT/PASSIVATION EVENT. NO MEASURABLE SYSTEM PRESSURE WAS OBSERVED (TRANSDUCER RANGE AND SYSTEM CHARACTERISTICS DO NOT ALLOW DETECTION BELOW 1500 PSI). HOWEVER, THE ACTUATORS CENTERED THE ENGINE WHICH INDICATES THAT THE AUXILIARY PUMP PRODUCED SOME PRESSURE AND FLOW.

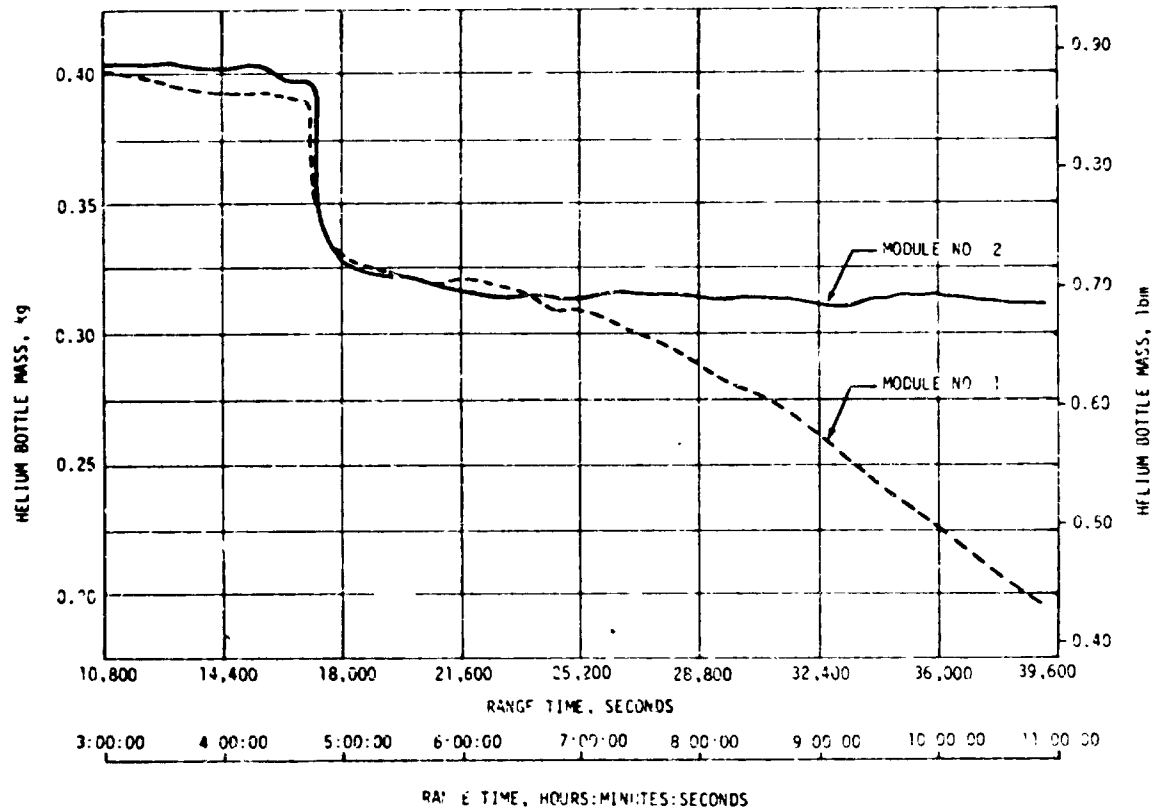
FIG. 2.1.4 S-IVB APS HELIUM BOTTLE MASS

PROBLEM: THE OPERATIONS OF THE APS PRESSURIZATION SYSTEM WAS SATISFACTORY WITH THE EXCEPTION OF A HELIUM LEAK IN MODULE NO. 1. THE LEAK STARTED APPROXIMATELY 6.5 HOURS AFTER LIFTOFF AND EXTENDED THROUGH LOSS OF DATA (10:54:00). THE LEAK RATE AT LOSS OF DATA WAS APPROXIMATELY 3278 SCCM (200 SCIM).

ACTION: AS A RESULT OF A SIMILAR LEAK WHICH OCCURRED ON AS-504 (APOLLO 9), FIVE "O" RINGS IN THE HIGH-PRESSURE HELIUM PLUMBING WERE CHANGED ON APOLLO 10 AND SUBSEQUENT. THE LEAKAGE RATES EXPERIENCED ON APOLLO 9 AND APOLLO 10 WOULD NOT IMPAIR THE ACCOMPLISHMENT OF THE S-IVB PORTION OF THE APOLLO 11 MISSION.

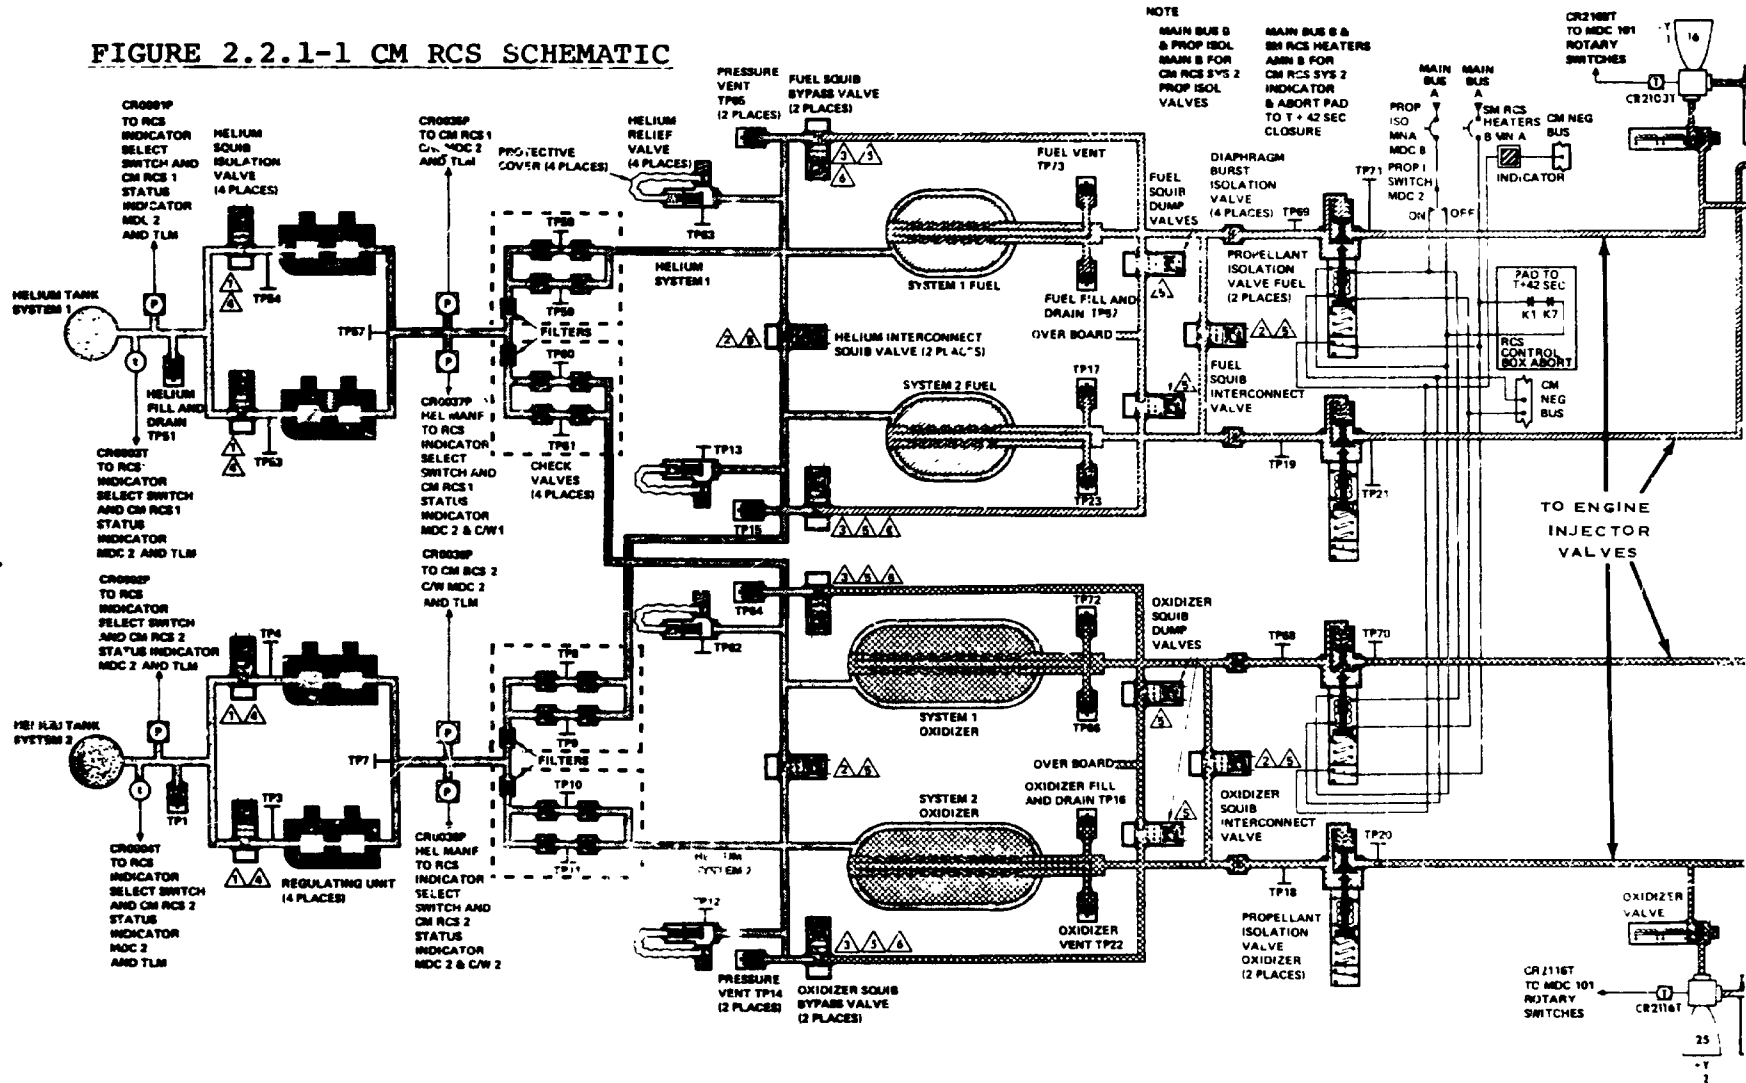
FIGURE 2.2.1-1 CM RCS SCHEMATIC

PROBLEM 1: THE HELIUM MANIFOLD PRESSURE IN CM RCS SYSTEM 1 BEGAN TO DECAY AT A RATE OF 0.13 PSIA/HR FOLLOWING HELIUM SERVICING 3.5 DAYS PRIOR TO LAUNCH. AFTER 2.5 DAYS, THE PRESSURE HAD DROPPED FROM 45 TO 37 PSIA. THE PRESSURE IN THE HELIUM MANIFOLDS BETWEEN THE PROPELLANT TANKS AND THE CHECK VALVES WAS CHECKED; THE OXIDIZER SIDE WAS AT THE INITIAL PRESSURE, BUT THE FUEL SIDE WAS LOW. NEITHER A HELIUM LEAK NOR A FUEL LEAK COULD BE DETECTED; HOWEVER, A FUEL LEAK OF SUFFICIENT MAGNITUDE TO CAUSE THE PRESSURE DROP DEFINITELY WOULD HAVE BEEN DISCOVERED. THE CONCLUSION WAS THAT THE LOW PRESSURE HELIUM MANIFOLD IN THE FUEL LEG WAS LEAKING SLIGHTLY BUT AT A RATE ACCEPTABLE FOR THE MISSION. THE SYSTEM WAS THEN REPRESSURIZED TO 49 PSIA. THE LEAK RATE DECREASED AS THE MISSION PROGRESSED, REACHING 0.04 PSIA/HR BY THE END OF THE MISSION. ONLY PART OF THIS DECREASE RESULTED FROM THE REDUCED SYSTEM PRESSURE; THUS, THE LEAK CORRECTED ITSELF TO SOME EXTENT AND/OR THE CHARACTERISTICS OF THE HELIUM CHANGED AS IT BECAME DILUTED BY PROPELLANT PERMEATING THE BLADDER.

ACTION: POSTFLIGHT TESTING OF THE COMMAND MODULE INCLUDED A VERY THOROUGH MASS SPECTROMETER LEAK CHECK ON SYSTEM 1, AT BOTH 50 AND 285 PSIG. NO LEAKS WERE DETECTED; HOWEVER, DURING THE POSTFLIGHT DECONTAMINATION PROCEDURES, CERTAIN TYPES OF LEAKS COULD BE ELIMINATED.

FOR FUTURE MISSIONS, THE SYSTEM WILL BE PRESSURIZED TO 100 PSIA ABOUT 30 DAYS PRIOR TO FLIGHT TO INSURE THAT ANY LEAKS CAN BE DETECTED AND APPROPRIATE CORRECTIVE ACTION TAKEN PRIOR TO START OF THE LAUNCH COUNTDOWN.

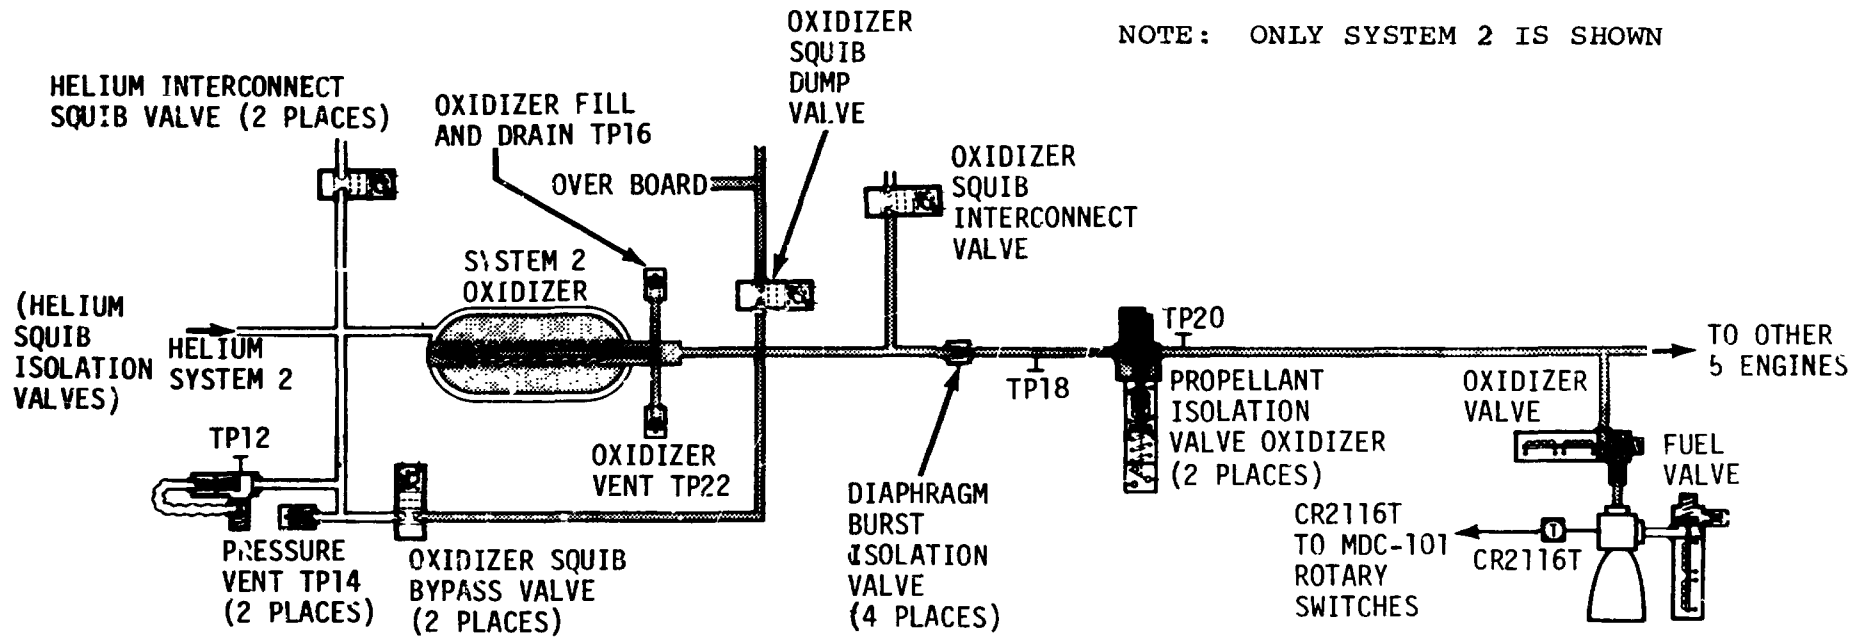
Figure 2.2.2-1. CM RCS OXIDIZER SUPPLY

PROBLEM: DURING THE FINAL SWITCH LIST VERIFICATION, WHEN THE PROPELLANT ISOLATION VALVES OF THE COMMAND MODULE RCS SYSTEM WERE OPENED, THE PRESSURE IN THE CM RCS HELIUM SYSTEM 2 DROPPED FROM 44 PSIA TO 37 PSIA. THIS INDICATED THAT THE OXIDIZER PROPELLANT BURST DIAPHRAGM WAS RUPTURED, ALLOWING OXIDIZER TO FLOW FROM THE TANK INTO THE MANIFOLD WHEN THE ISOLATION VALVE WAS OPENED. THE OXIDIZER ISOLATION VALVE BACKED UP BY THE ENGINE VALVES PREVENTED LOSS OF OXIDIZER, AND THE SYSTEM WAS VISUALLY VERIFIED TO BE LEAK-TIGHT; THEREFORE, IT WAS DECIDED THAT THE SYSTEM WAS ACCEPTABLE FOR FLIGHT. THE ISOLATION VALVES WERE CLOSED AFTER ORBITAL INSERTION. THE ENGINE VALVES WERE THEN OPENED BY MEANS OF THE REACTION CONTROL HEATER CIRCUITS, AND THE OXIDIZER WAS VENTED FROM THE MANIFOLD FOR 25 MINUTES. FOUR PERCENT OF THE OXIDIZER IN SYSTEM 2 WAS LOST, HOWEVER, THE MAXIMUM PREVIOUS PROPELLANT USAGE DURING A MISSION WAS 35% OF ONE SYSTEM. AFTER THE MISSION, THE OXIDIZER AND FUEL BURST DISCS WERE SIMILAR IN PHYSICAL APPEARANCE, INDICATING THAT THE OXIDIZER BURST DISC HAD FAILED BECAUSE OF PRESSURE.

THE BURST DIAPHRAGMS CONFINE THE PROPELLANTS TO AS SMALL AN AREA AS POSSIBLE. THEY ASSURE AGAINST DOWNSTREAM LEAKAGE OF PROPELLANT ISOLATION VALVES, ENGINE INJECTION VALVES OR PLUMBING.

ACTION: CAUTION NOTES HAVE BEEN ADDED TO THE PRELAUNCH CHECKOUT PROCEDURES IN THE PLACES WHERE THE ALLOWABLE LIMITS ON THE BURST DISC (241 +16 PSID IN THE FLOW DIRECTION AND 10 PSID IN THE REVERSE DIRECTION) COULD BE EXCEEDED. TO ALLOW EARLY DETECTION OF ANY SIMILAR PROBLEM IN THE FUTURE, A LEAK CHECK OF THE BURST DISC HAS BEEN ADDED AFTER REACTION CONTROL SYSTEM PROPELLANT SERVICING.

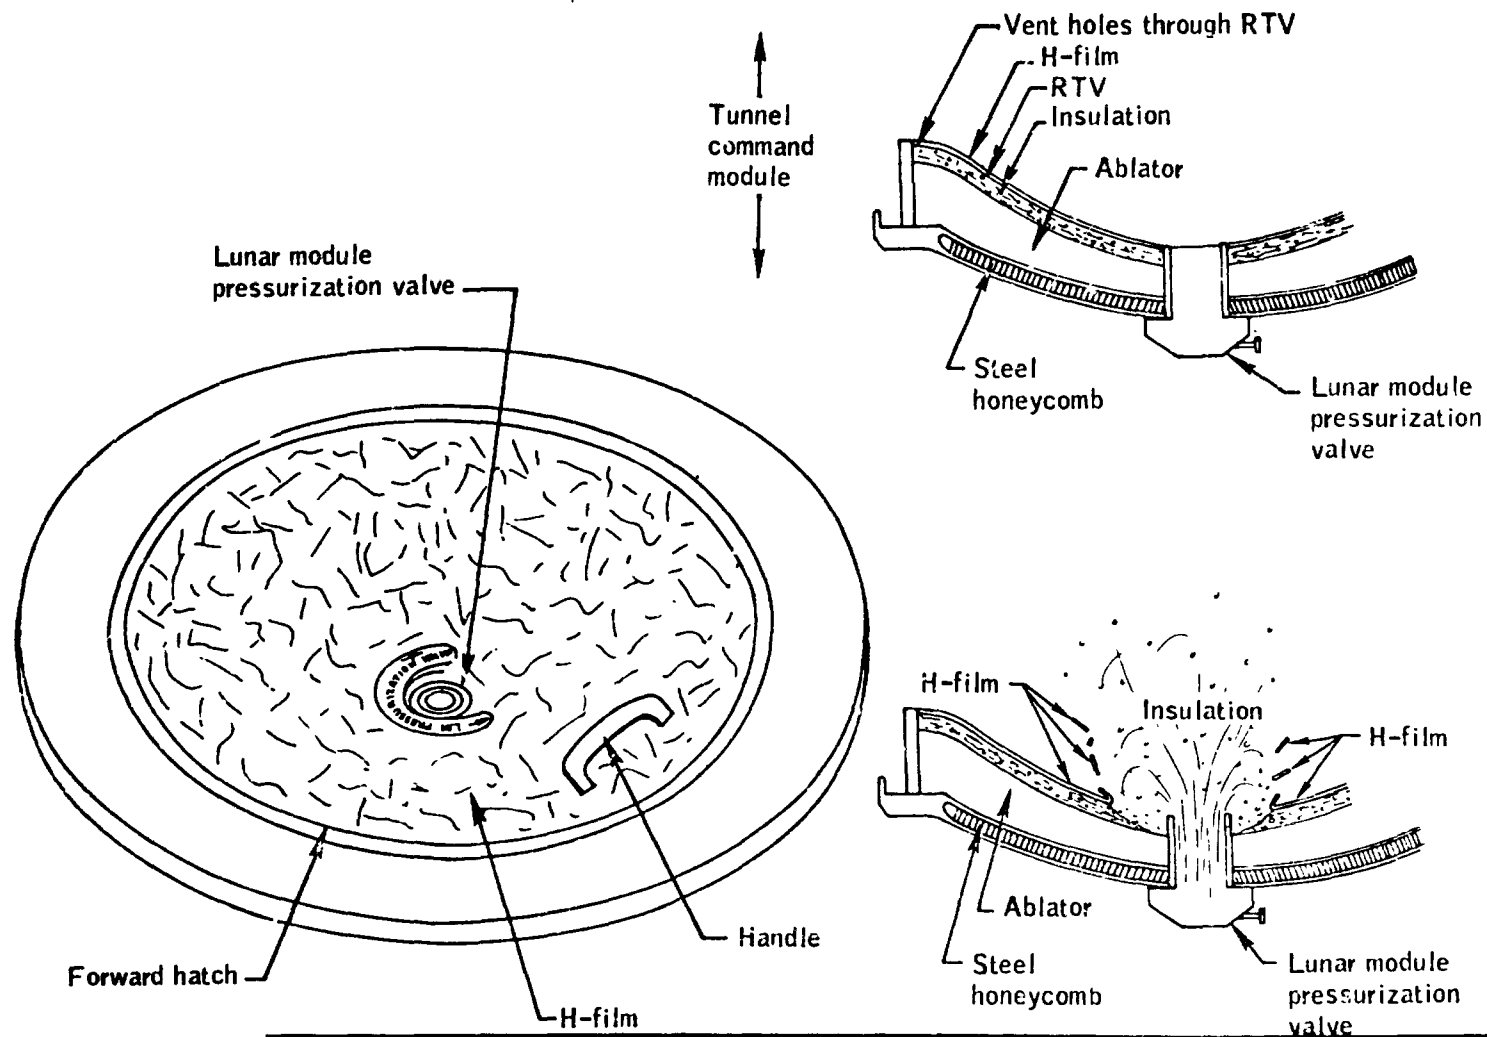
FIG. 2.2.6-1 FORWARD HATCH THERMAL COATING.

PROBLEM: WHEN THE LUNAR MODULE CABIN WAS FIRST PRESSURIZED THE THERMAL COATING ON THE COMMAND MODULE HATCH CAME OFF IN PIECES. THE INSULATION BLANKET VENT HOLES WERE PLUGGED, PRODUCING THE DAMAGE. ONE POSSIBILITY IS THAT THE PREFLIGHT BAKING OF THE HATCH AT 900°F FOR 15 HOURS WEAKENED THE INSULATION TO THE EXTENT THAT INTERNAL PIECES OF INSULATION BROKE LOOSE AND PLUGGED THE HOLES DURING TUNNEL DEPRESSURIZATION. ANOTHER POSSIBILITY IS THAT THE VENT HOLES WERE INADVERTENTLY SEALED WHEN THE INSULATION BLANKET WAS POTTED WITH RTV OR WHEN THE H-FILM TAPE WAS INSTALLED ON THE HATCH SURFACE.

ACTION: ON THE APOLLO 11 COMMAND MODULE, THE INSULATION HAS BEEN DELETED BECAUSE OF THE EFFECTS NOTED AND BECAUSE A REEVALUATION OF THERMAL CONDITIONS HAS SHOWN THAT THE INSULATION IS NOT NECESSARY. HOWEVER, TO MINIMIZE CONDENSATION, A SINGLE LAYER OF H-FILM TAPE HAS BEEN APPLIED OVER THE EXTERIOR SURFACE OF THE HATCH ABLATOR. SOME WATER AND ICE CAN BE EXPECTED ON APOLLO 11 BUT TO A LESSER DEGREE THAN OBSERVED ON APOLLO 10.

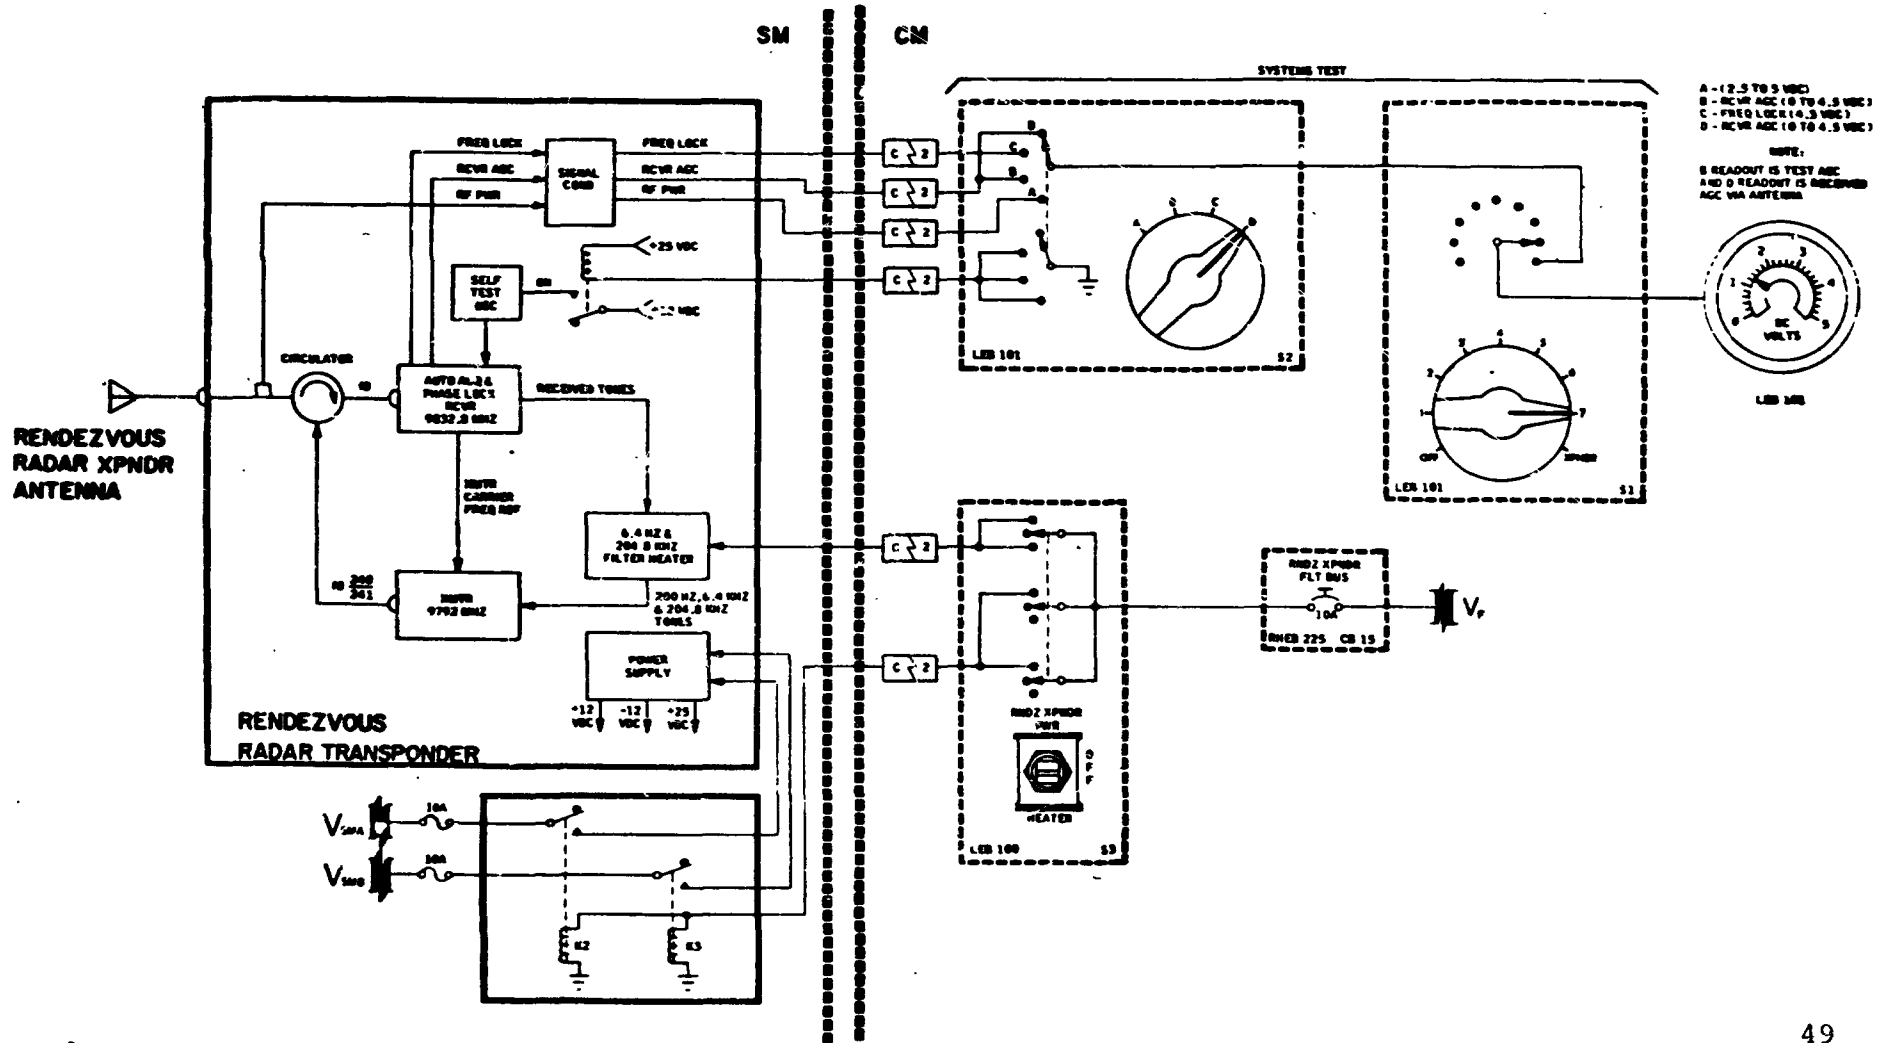
FIGURE 2.2.9-1 RENDEZVOUS RADAR TRANSPONDER CONTROL CIRCUITRY

DURING POSTFLIGHT TESTS OF THE SWITCH AND WIRING, NO DEFECTS WERE FOUND, AND THE ANOMALY CANNOT BE ATTRIBUTED TO ANY CM HARDWARE.
