APOLLO 10

RECOVERY FLASHING BEACON FAILURE

ANOMALY REPORT NO. 2

APOLLO 10 MISSION
RECOVERY FLASHING BEACON FAILURE

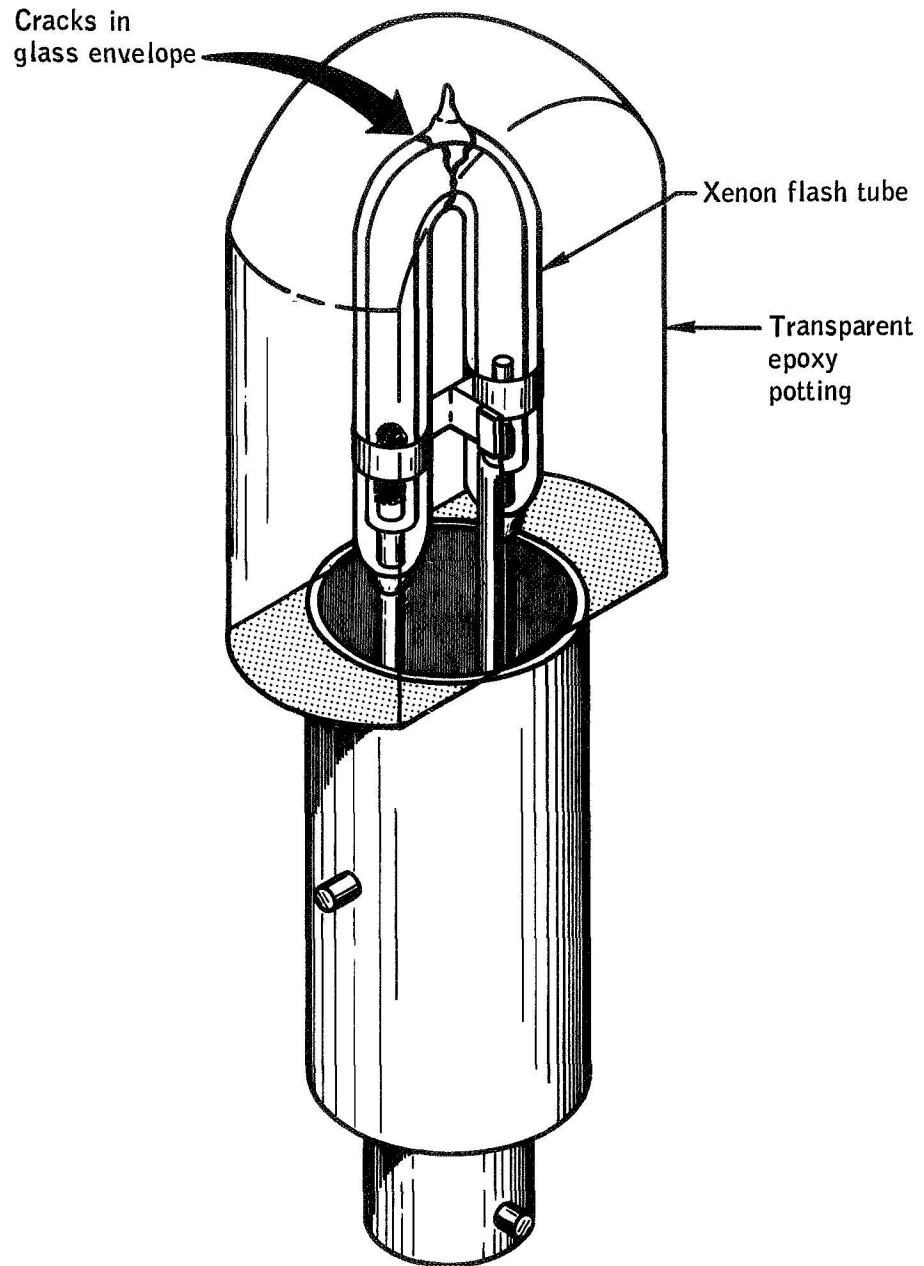
The glass flash tube was found cracked (fig. 1) during the postflight inspection of the flashing light, although there was no evidence of any impact to the lamp or deployment mechanism. Lamp tests indicated that the trigger coil and connector functioned properly, but the xenon flash tube was not operating. Broken xenon flash tubes were also found on the Apollo 11 spacecraft during the postflight inspection and on command and service modules 111 during preflight testing.

The flash tube consists of a xenon filled "U" shaped Vycor glass tube encapsulated in transparent epoxy for protection. The temperature coefficients of expansion for the glass and epoxy are 8×10^{-7} and 3.8×10^{-5} per degree centigrade. Tests have shown that the differential thermal expansion between the lamp glass and epoxy potting causes the glass flash tube to crack when the lamp is operated for extended periods of time at the higher flash rate. The cracked glass allows the xenon gas to escape and the lamp thus becomes inoperative.

Extended periods of lamp operation in the high flash-rate mode increase the temperature of the lamp such that thermally induced stresses due to differential expansion between the flash tube and its epoxy encapsulant crack the flash tube.

Figure 1.- Lamp assembly showing area of failure.

Volume II of the Apollo Operations Handbook specifies using the high flash-rate mode during descent on the main parachutes. For Apollo 12 and subsequent, the Apollo Operations Handbook was changed to specify use of the low flash-rate mode only.
