MSC-00126

APOLLO 10 MISSION REPORT

AUGUST 1969

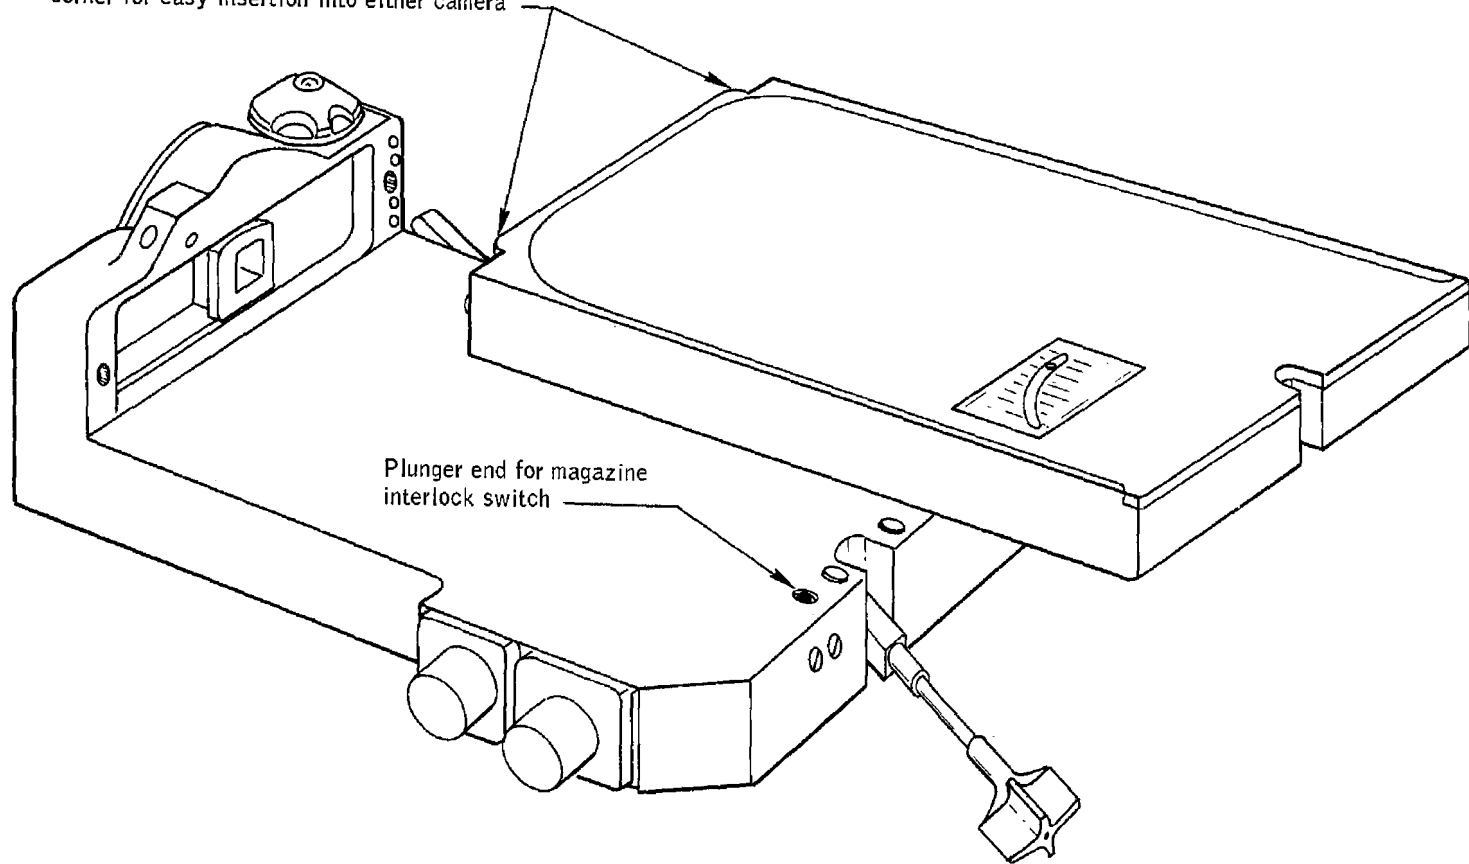
Figure 15-46.- Magazine installation in 16-mm cameras.

Radii on edges to be large enough to relieve corner for easy insertion into either camera
