REPORT OF APOLLO 13 REVIEW BOARD

NATIONAL AERONAUTICS AND SPACE ADMINISTRATION

June 15, 1970

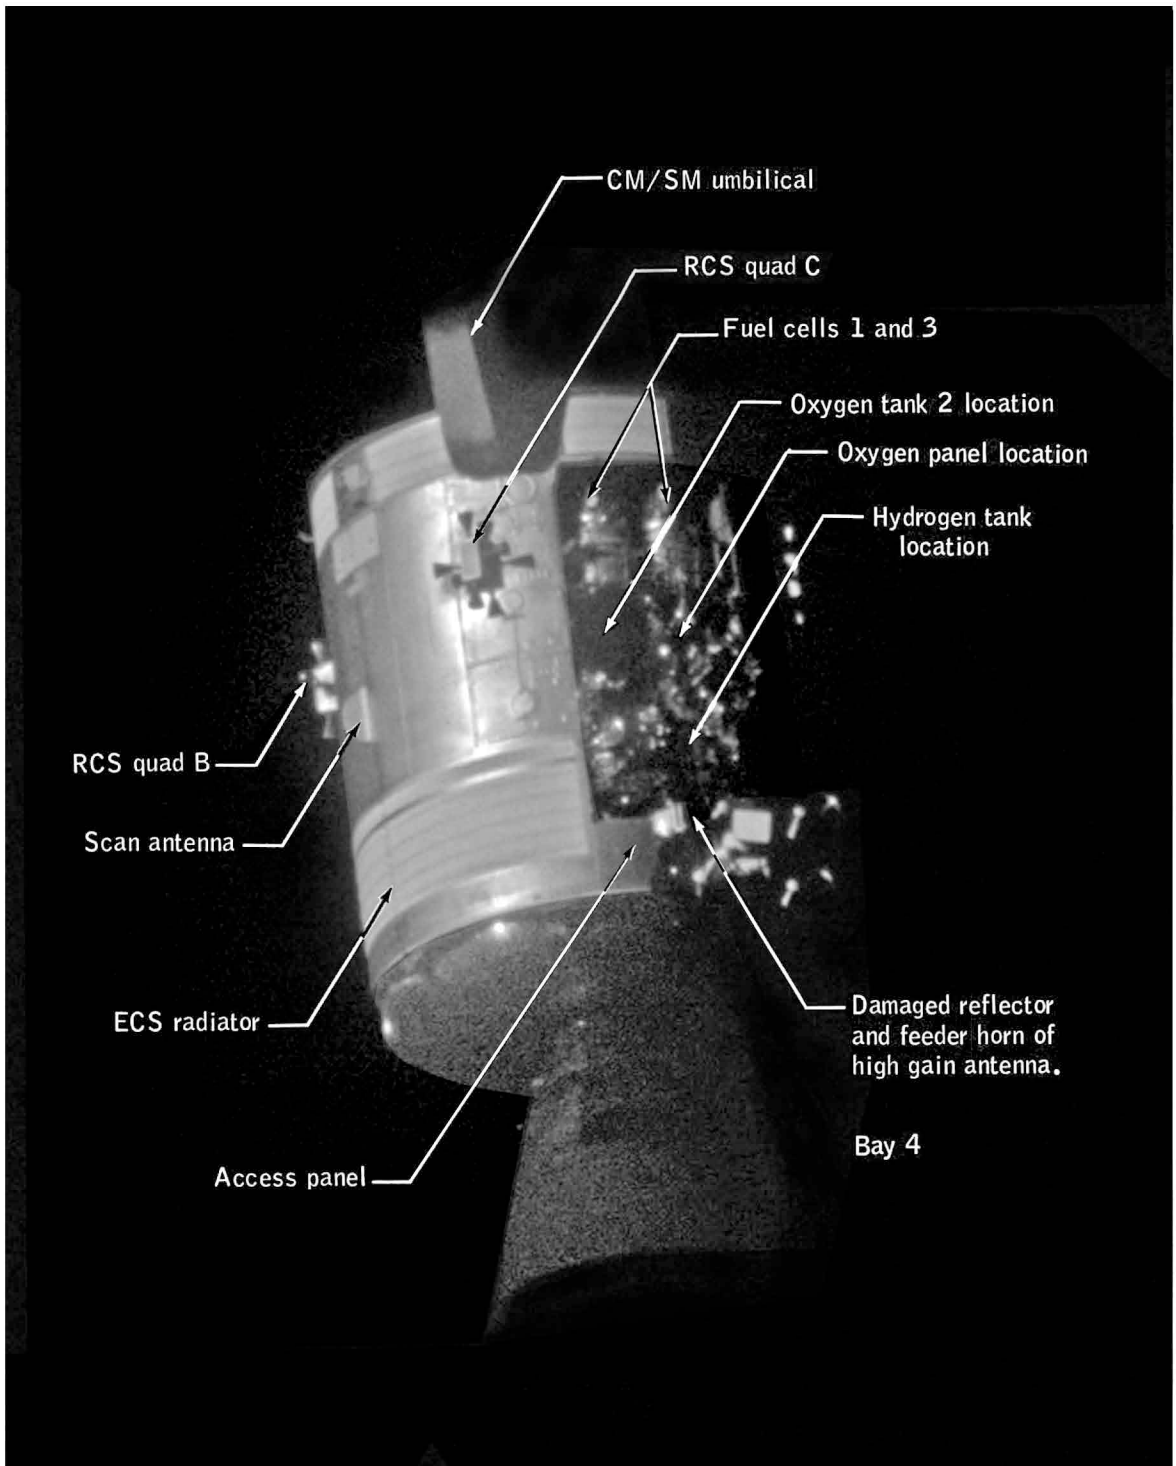
Inflight photograph of service module showing damage to bay 4.

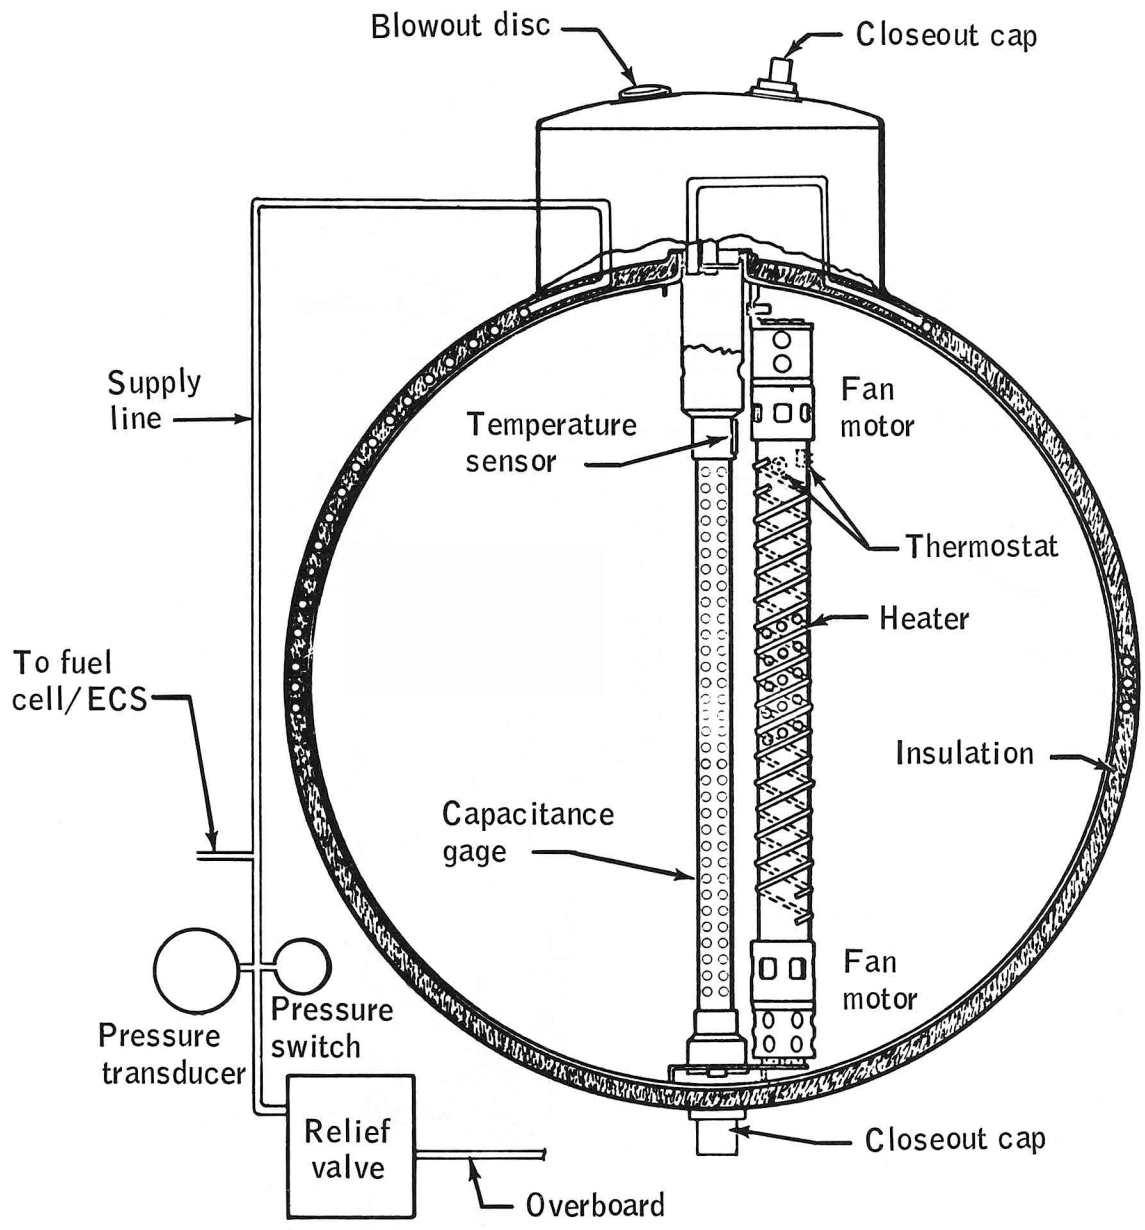
Figure 4-1.- Oxygen tank no. 2 internal components.

As shown in figure 4-2, the fill line from the exterior of the SM enters the oxygen tank and connects to the inner cylinder of the capacitance gage through a coupling of two Teflon adapters or sleeves and a short length of Inconel tubing. The dimensions and tolerances selected are such that if "worst case" variations in an actual system were to occur, the coupling might not reach from the fill line to the gage cylinder (fig. 4-3). Thus, the variations might be such that a very loose fit would result.

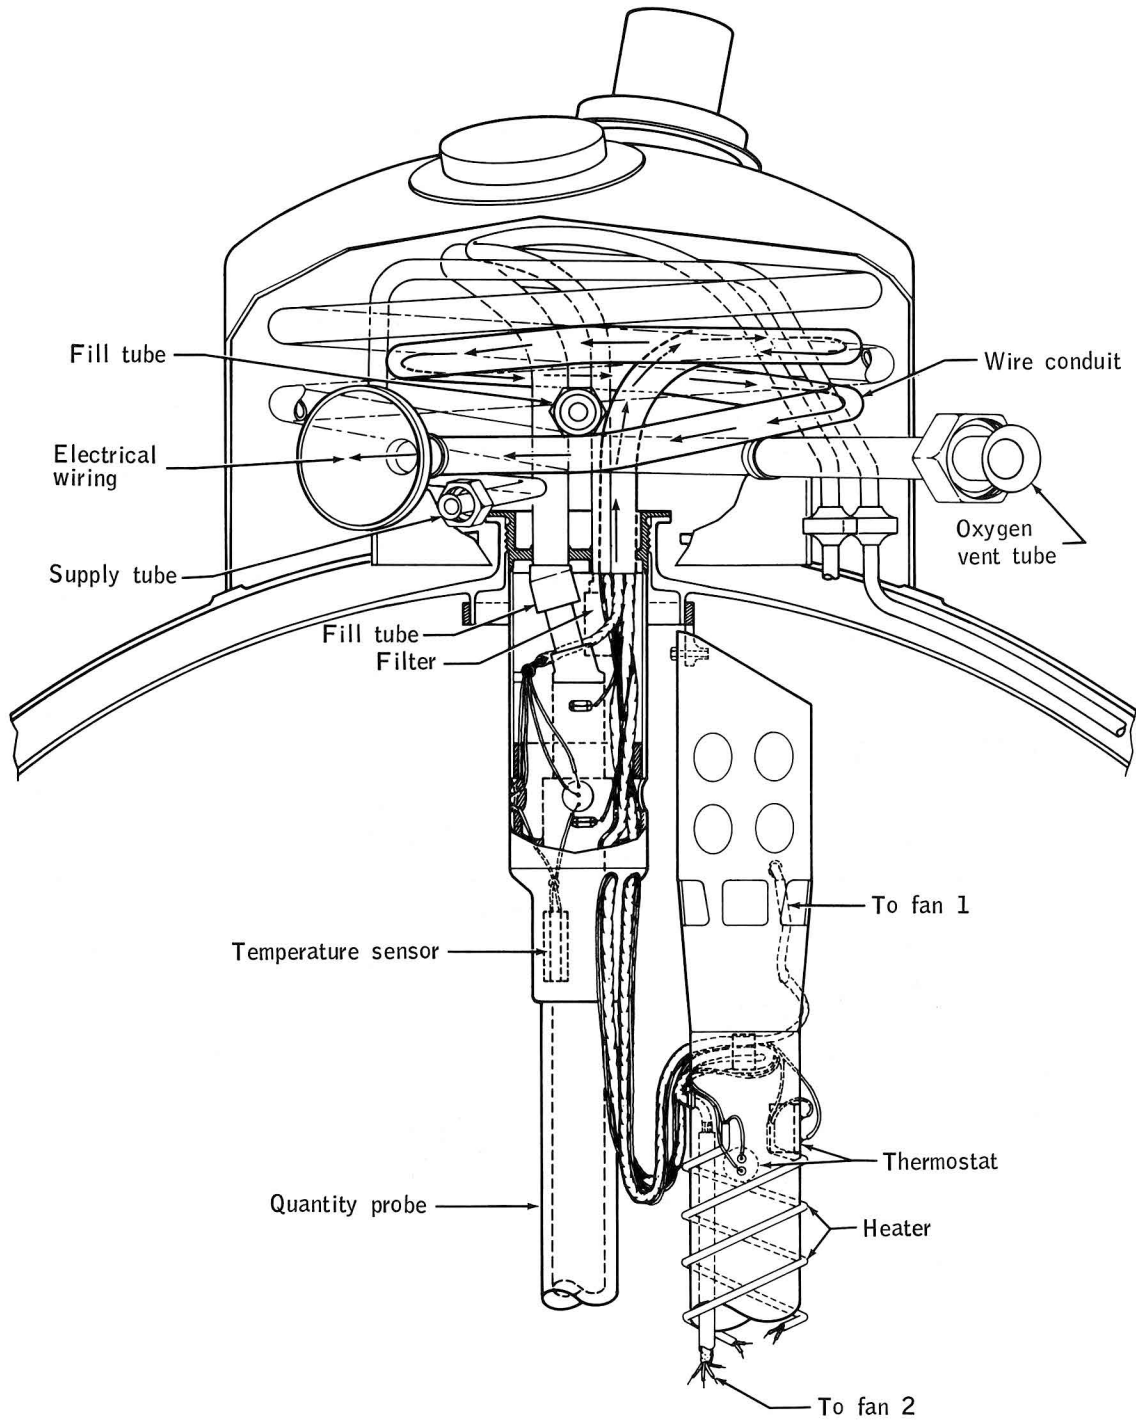
Figure 4-2.- Oxygen tank wiring and lines.

The supply line from the tank leads from the head of the quantity probe to the dome and thence, after passing around the tank between the inner and outer shells, exits through the dome to supply oxygen to the fuel cells in the service module (SM) and the environmental control system (ECS) in the command module (CM). The supply line also connects

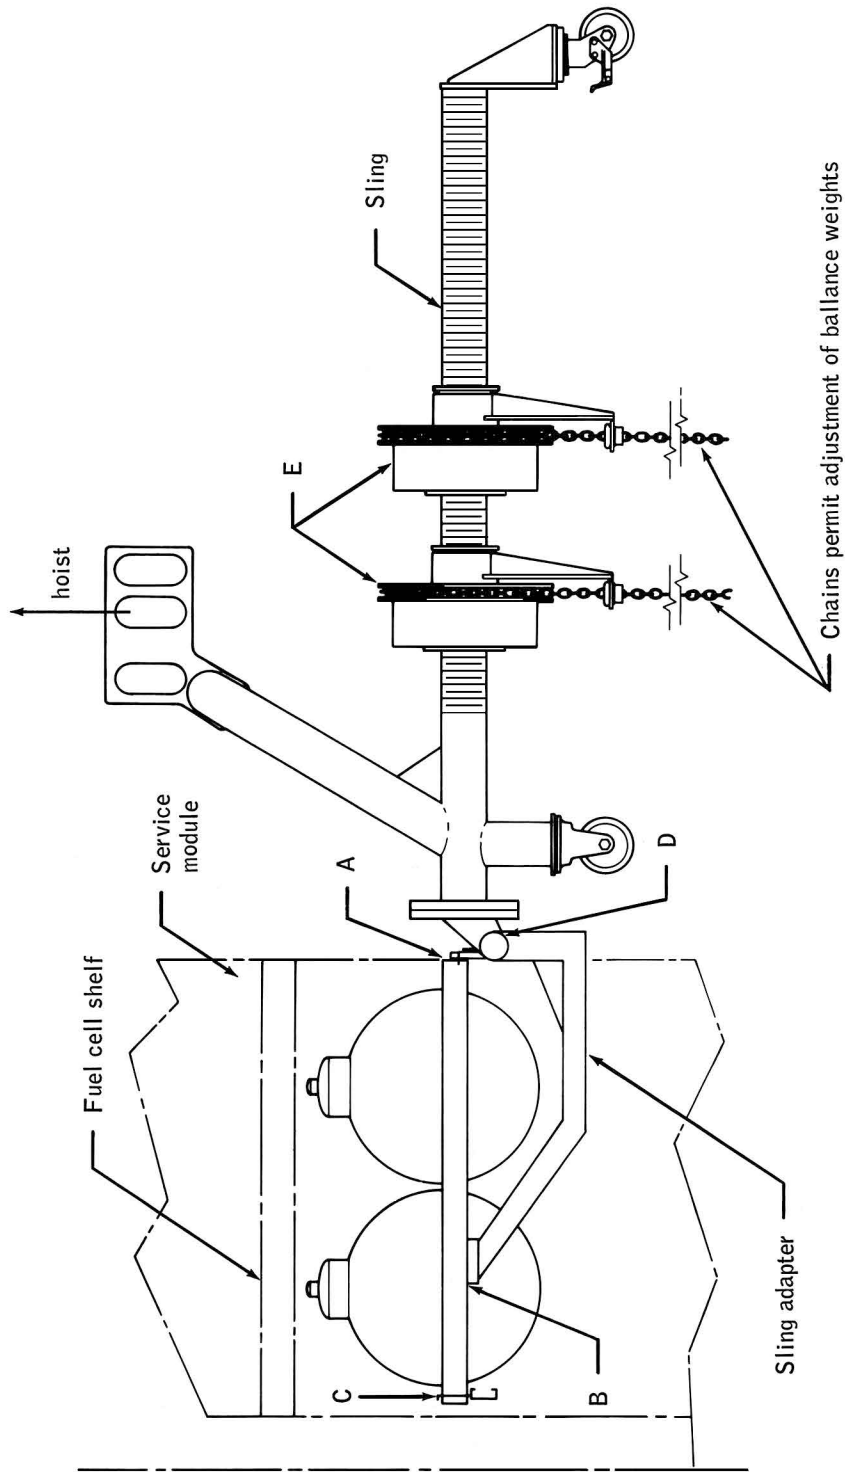
Figure 4-9.- Hoist and sling arrangement - oxygen shelf.

The oxygen shelf was removed in the manner shown in figure 4-9. After various lines and wires were disconnected and bolts which hold the shelf in the SM were removed, a fixture suspended from a crane was placed under the shelf and used to lift the shelf and extract it from bay 4. One shelf bolt was mistakenly left in place during the initial attempt to remove the shelf; and as a consequence, after the front of the shelf was raised about 2 inches, the fixture broke, allowing the shelf to drop back into place. Photographs of the underside of the fuel cell shelf in SM 106 indicate that the closeout cap on the dome of oxygen tank no. 2 may have struck the underside of that shelf during this incident. At the time, however, it was believed that the oxygen shelf had simply dropped back into place and an analysis was performed to calculate the forces resulting from a drop of 2 inches. It now seems likely that the shelf was first accelerated upward and then dropped.

The remaining bolt was then removed, the incident recorded, and the oxygen shelf was removed without further difficulty. Following removal, the oxygen shelf was retested to check shelf integrity, including proof-pressure tests, leak tests, and functional tests of pressure transducers and switches, thermal switches, and vacuum pumps. No cryogenic testing was conducted. Visual inspection revealed no problem. These tests would have disclosed external leakage or serious internal malfunctions of most types, but would not disclose fill line leakage within oxygen tank no. 2. Further calculations and tests conducted during this investigation, however, have indicated that the forces experienced by the shelf were probably close to those originally

calculated assuming a 2-inch drop only. The probability of tank damage from this incident, therefore, is now considered to be rather low, although it is possible that a loosely fitting fill tube could have been displaced by the event.

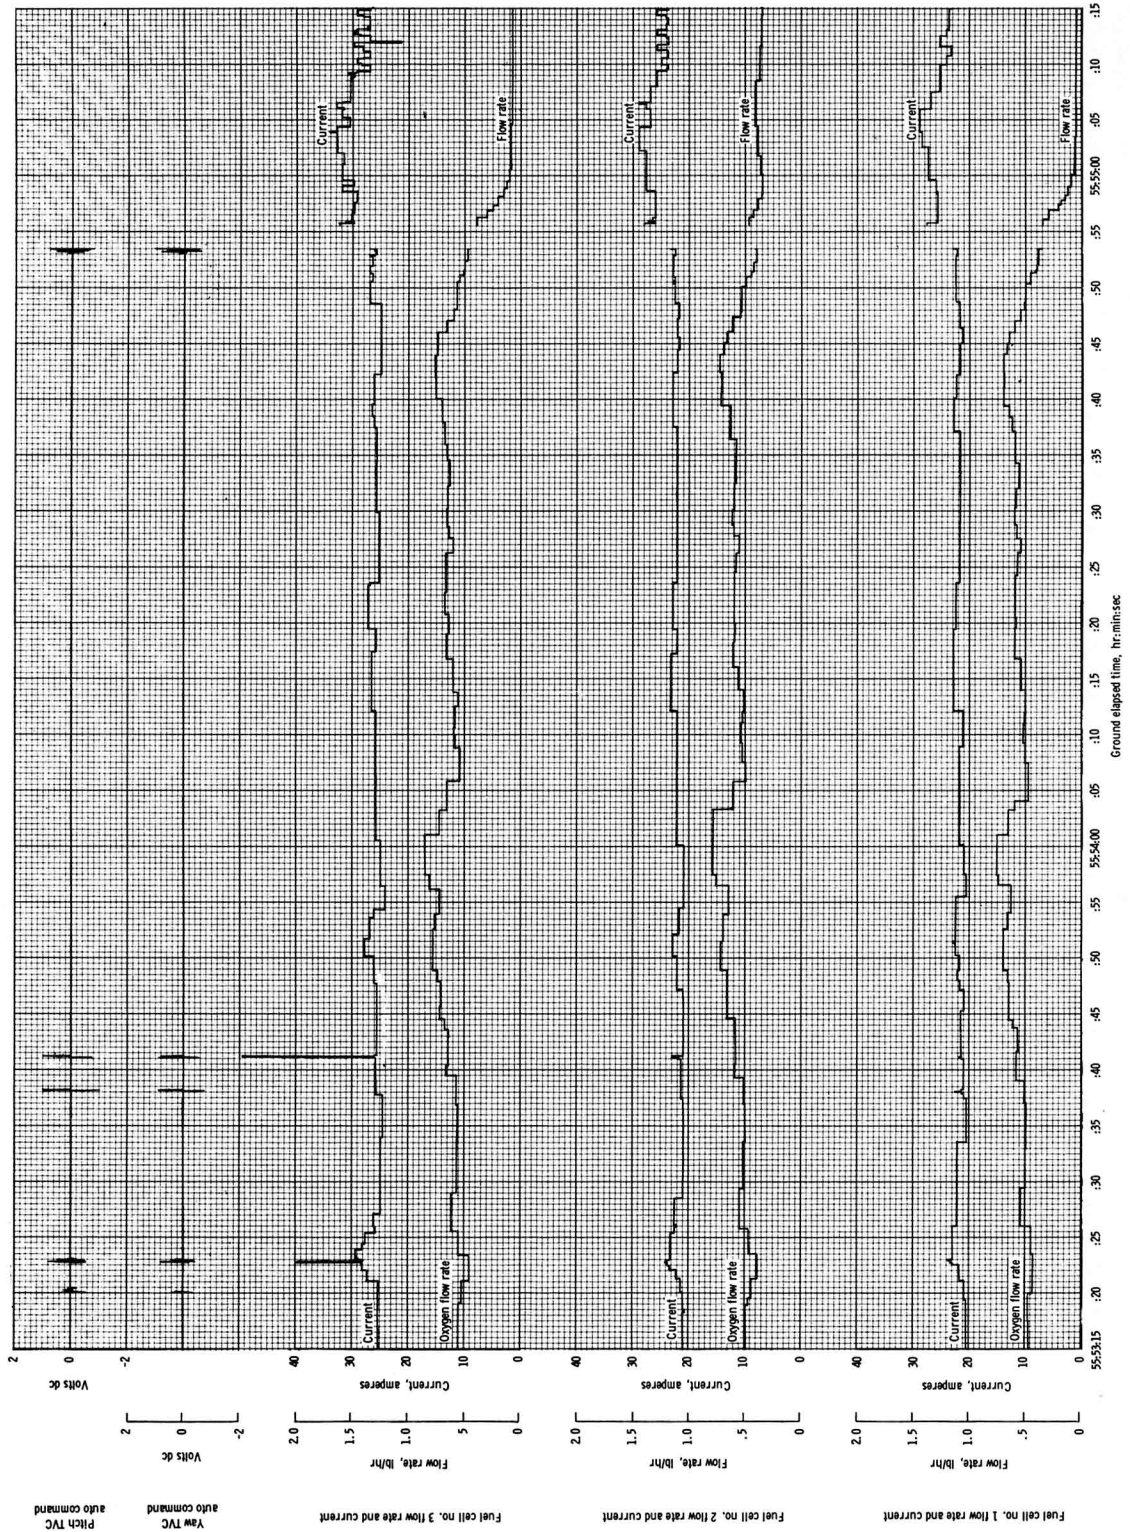
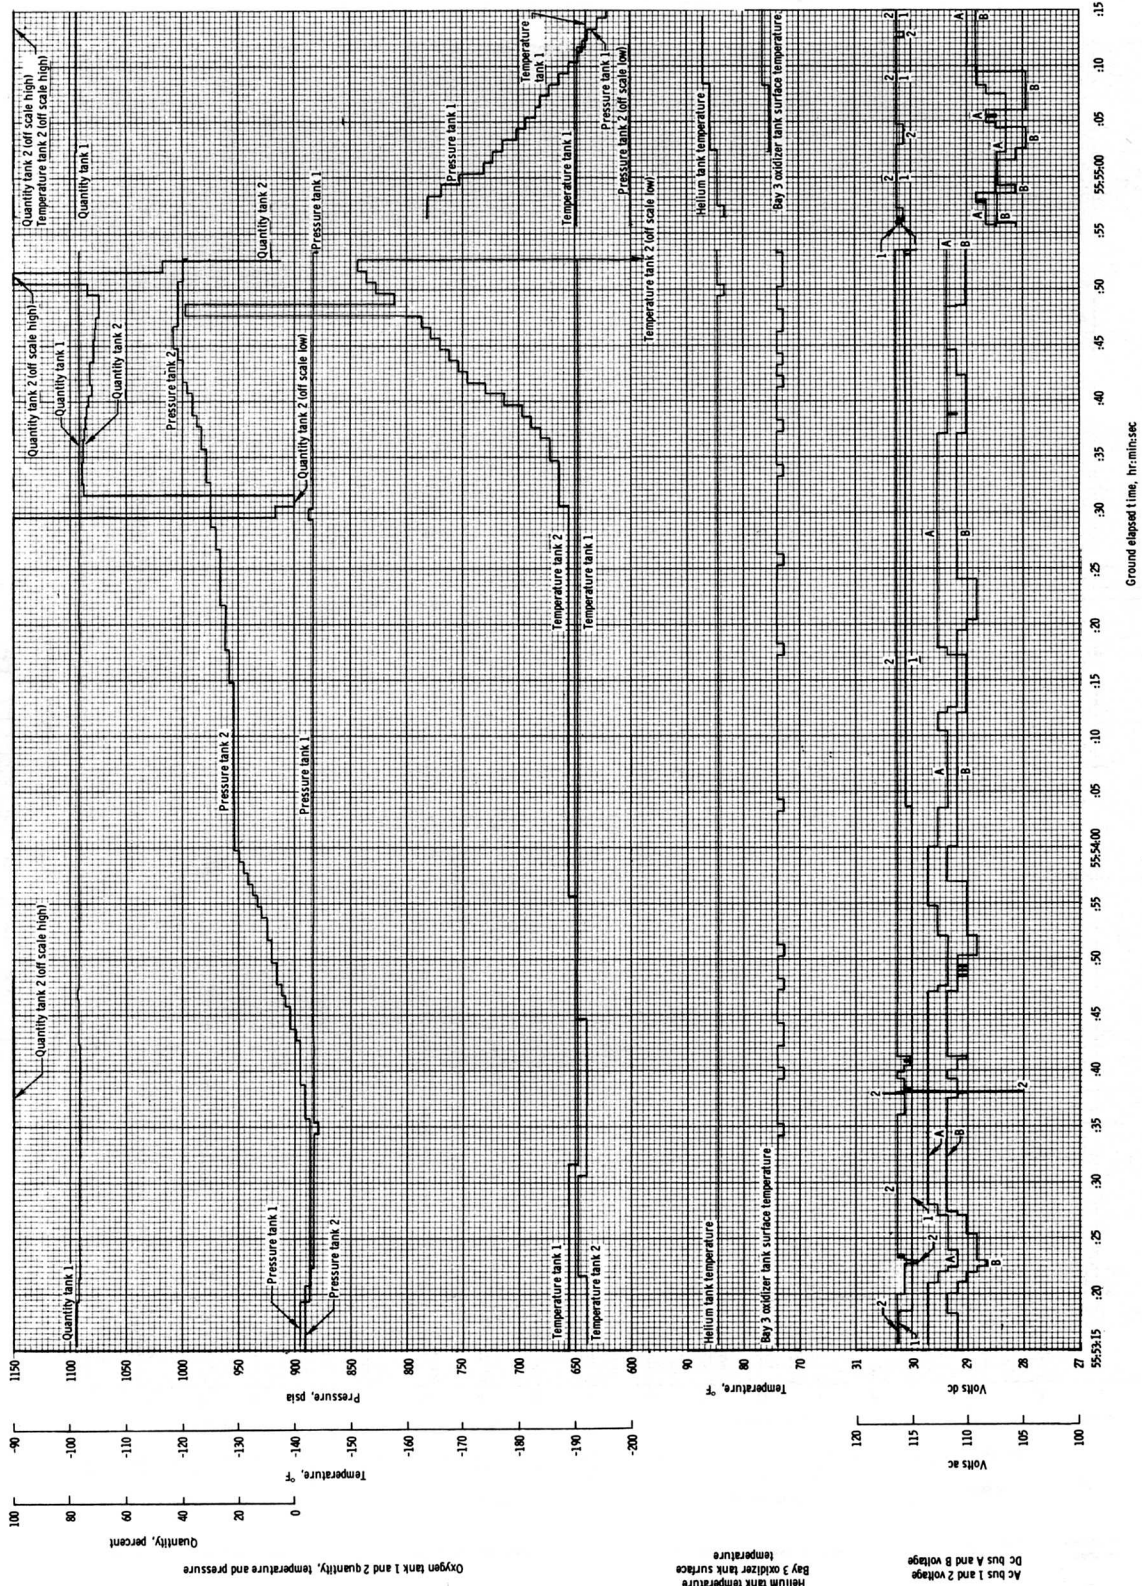
Figure 4-10.- Telemetry record.

The various telemetered parameters of primary interest are shown in figure 4-10 and listed in table 4-11.

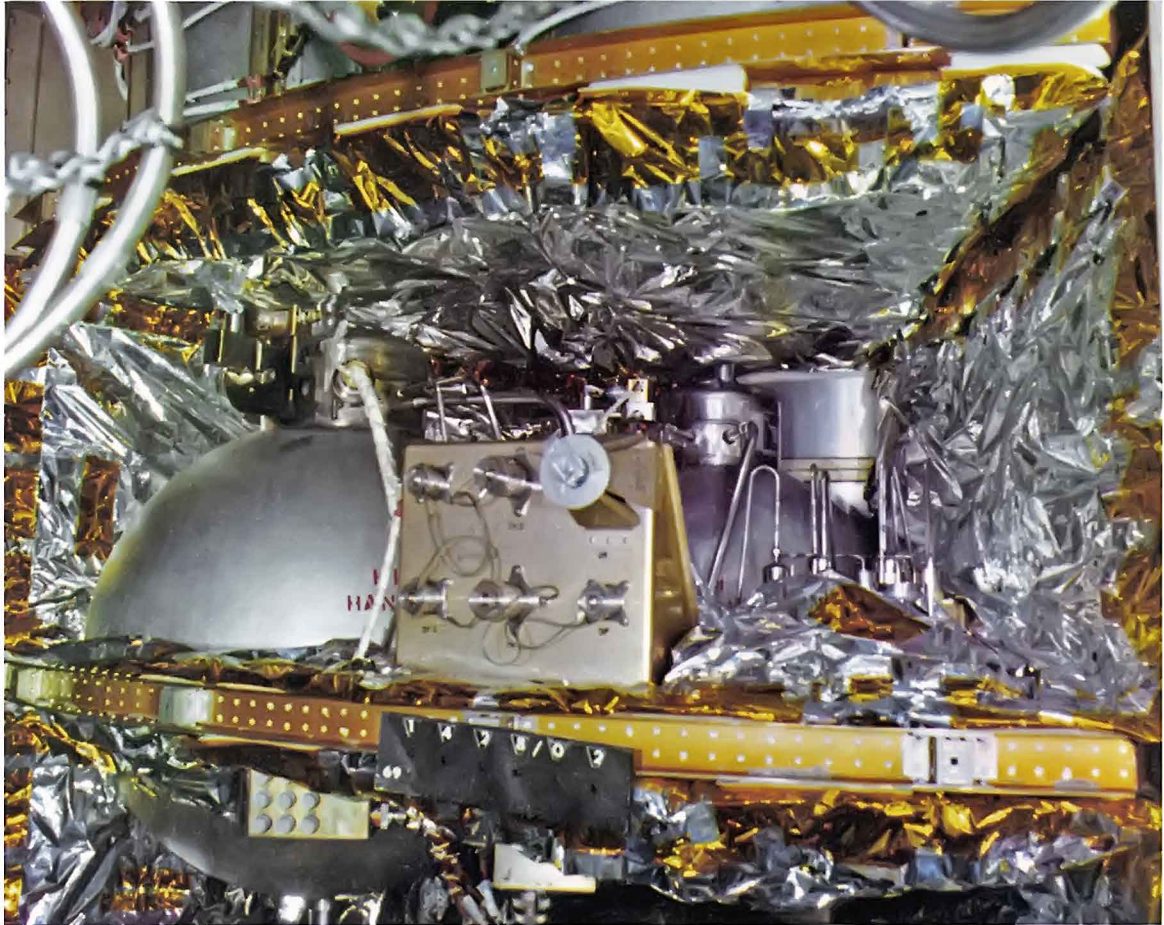
4-11.-
Figure ~~XX-XX~~ Closeup view of oxygen tank shelf.

Release of the oxygen then began to pressurize the oxygen shelf space of bay 4. If the hole formed in the pressure vessel were large enough and formed rapidly enough, the escaping oxygen alone would be adequate to blow off the bay 4 panel. However, it is also quite possible that the escape of oxygen was accompanied by combustion of Mylar and Kapton (used extensively as thermal insulation in the oxygen shelf compartment, figure 4-11, and in the tank dome) which would augment the

pressure caused by the oxygen itself. The slight temperature increases recorded at various SM locations indicate that combustion external to the tank probably took place. Further testing may shed additional light on the exact mechanism of panel ejection. The ejected panel then struck the high-gain antenna, disrupting communications from the spacecraft for the 1.8 seconds.
