# **REPORT OF APOLLO 13 REVIEW BOARD**

**APPENDIX F - SPECIAL TESTS AND ANALYSES**

**APPENDIX F**  
**SPECIAL TESTS AND ANALYSES**

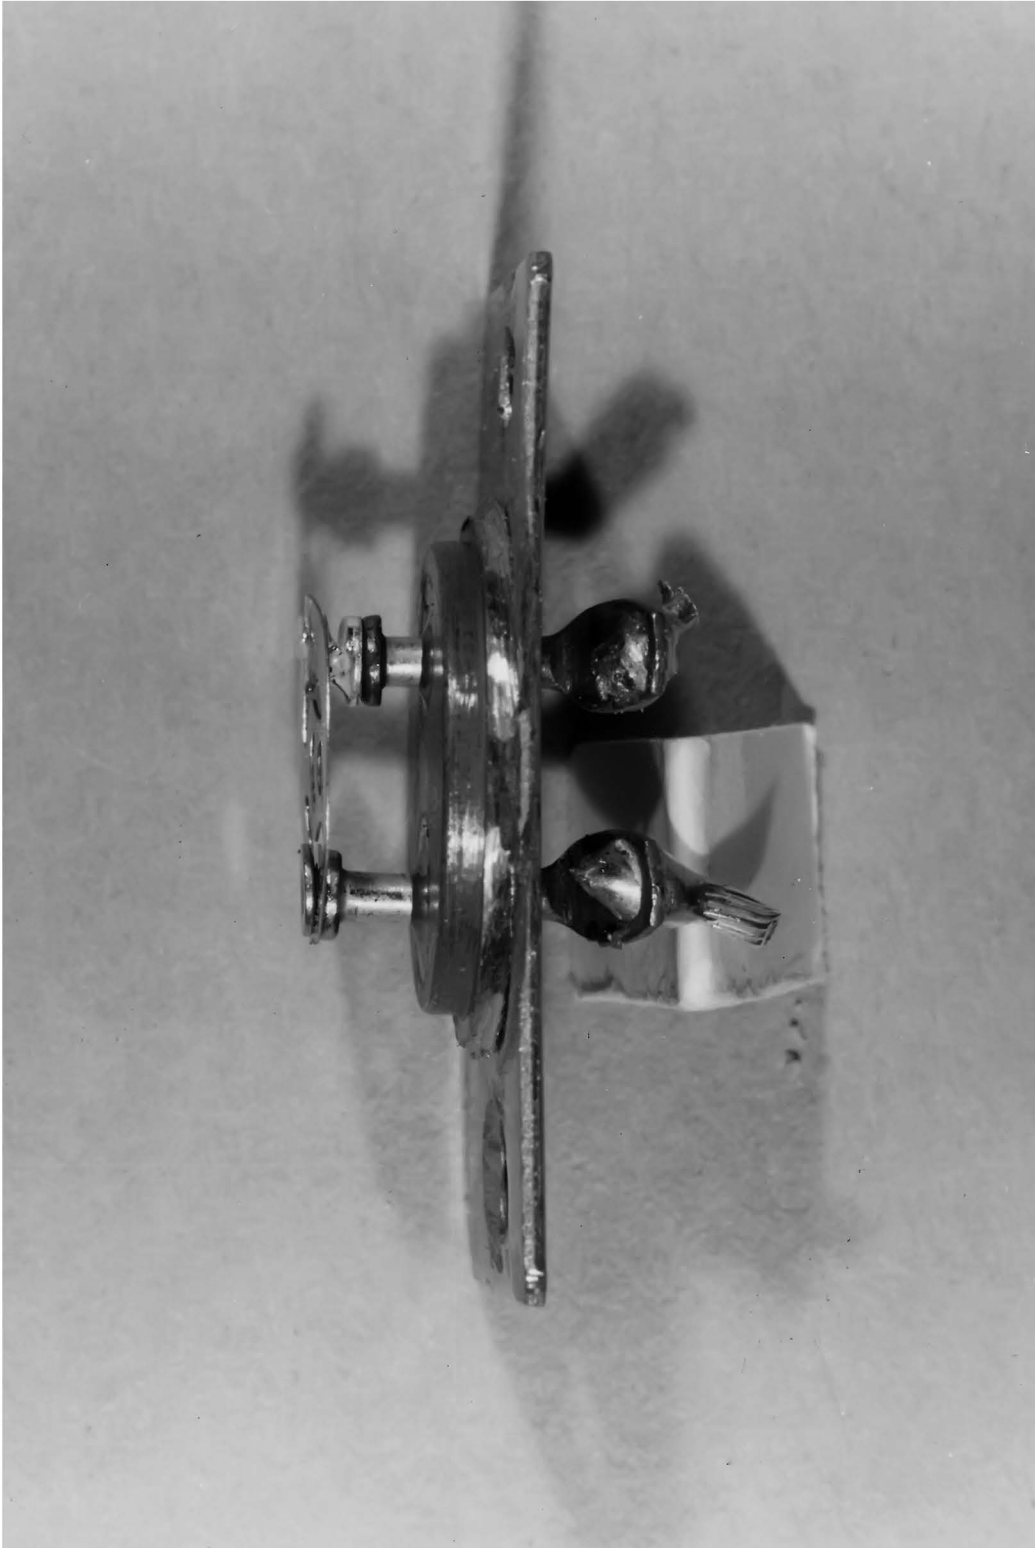
Batteries were used as a power source to test the switches. They were initially supplied with 31 V dc at currents up to 3.5 amperes. No contact degradation was observed under these conditions. When the voltage was raised to 65 V dc, some increase in contact resistance (up to about 3 ohms from a few milliohms) was noted at 1.25 amperes, although the switch continued to operate. The current was then increased to 1.5 amperes at 65 V dc; and when the switch attempted to open, it fused closed. The body of the switch was removed and the condition of the contact can be seen in figure F3.1-1.

Thermostatic switches similar to those in oxygen tank no. 2 will fuse closed when they attempt to open with a 65 V dc potential and currents in excess of 1.5 ampere.

Figure F3.1-1.- Fused thermal switch control.

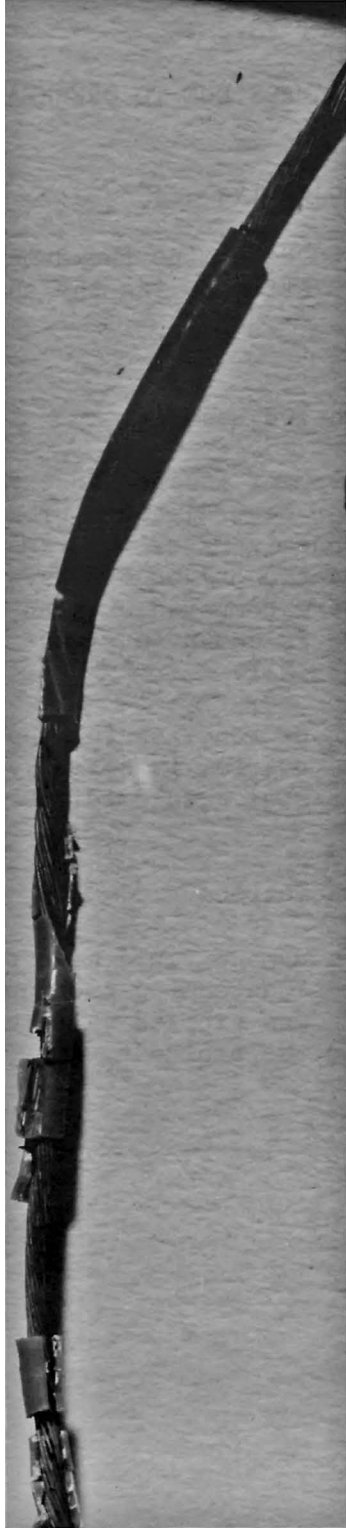
The tests reveal that severe damage could have resulted to the wire insulation during the abnormal detanking procedure. In several places along the leads, bare wire was exposed which could have led to the short circuits that initiated the accident.

Figure F3.2-1.- Damaged Teflon insulation.

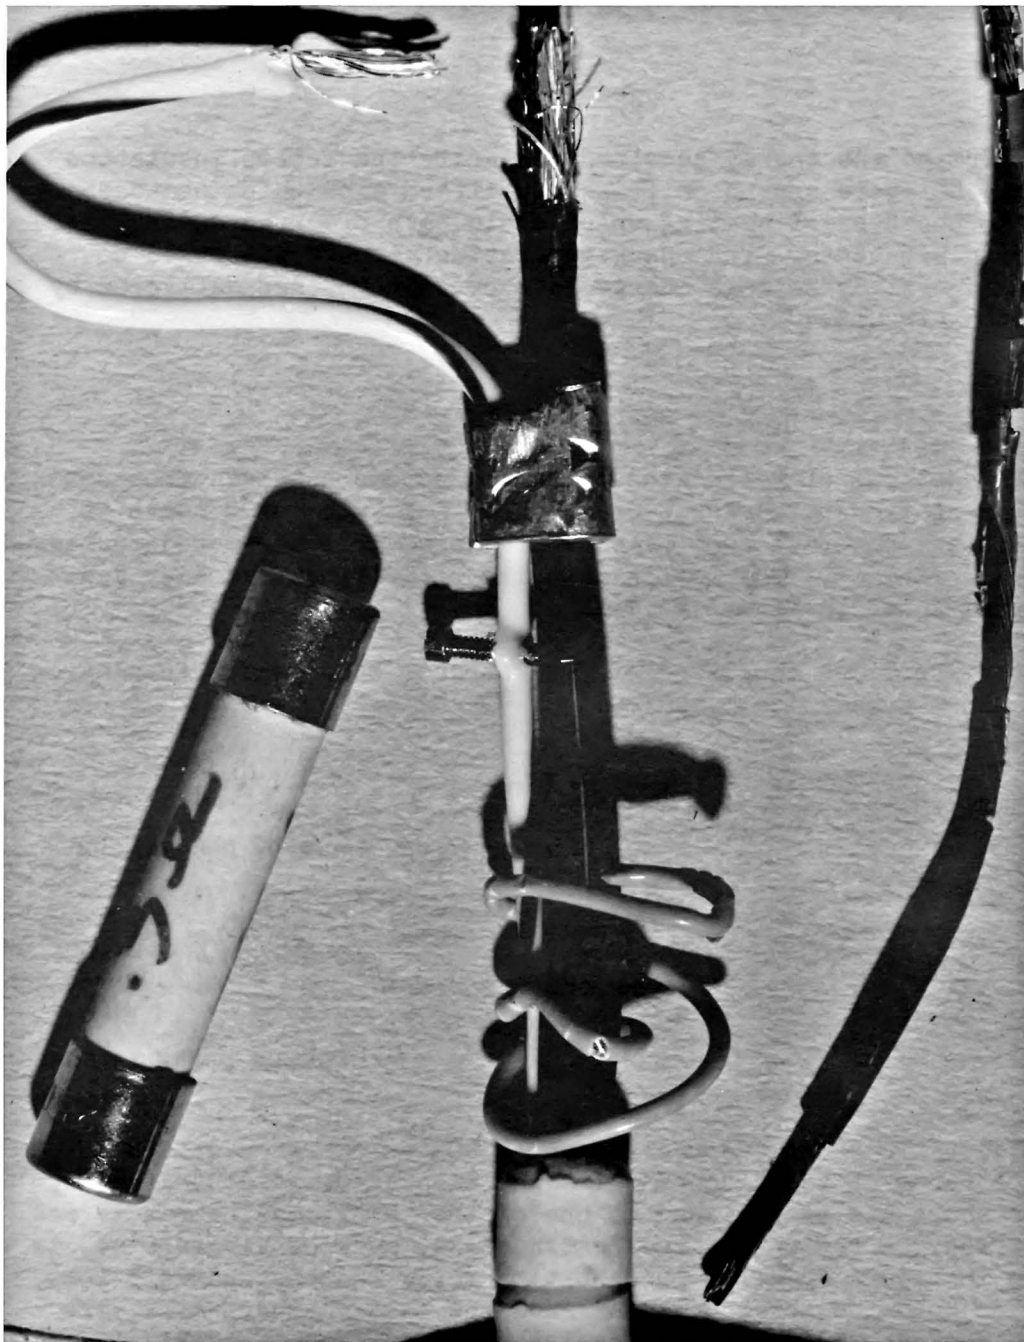
Sample sections of Teflon-insulated conductors obtained from Beech Aircraft Corporation through MSC were baked in oxygen for 5 hours at 572° F, held overnight at room temperature in oxygen, and baked further for 2 hours at 842° F. The Teflon lost its pliability, cracked, and flaked off as shown in figure F3.4-1.

Figure F3.4-1.- Heat degraded wire and test harness replica.

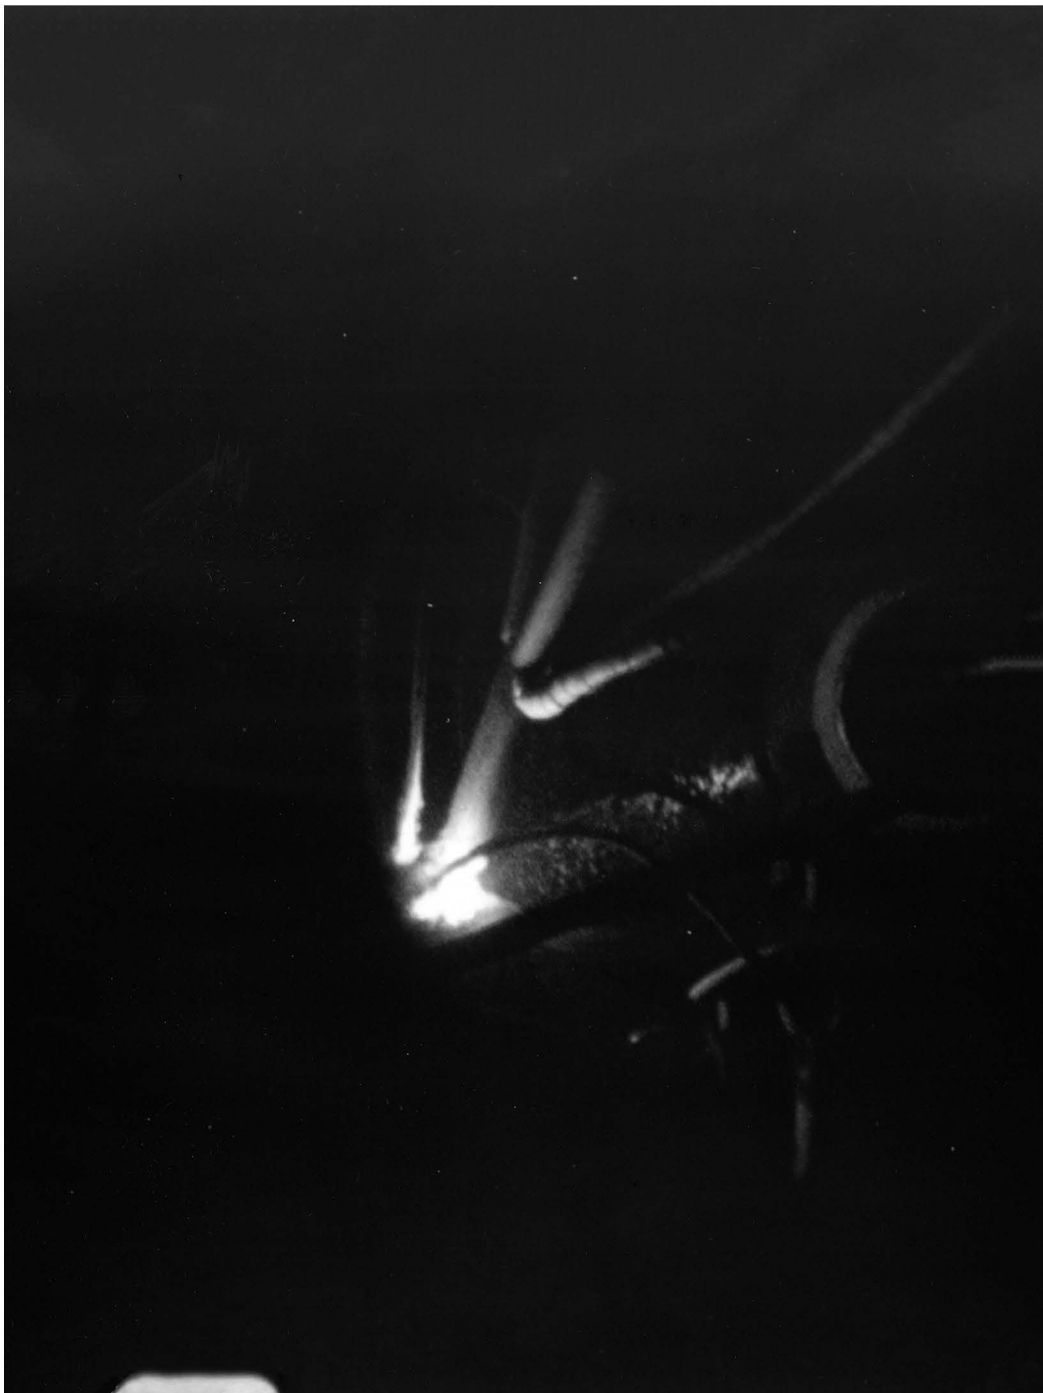
The propagation observed in the color motion picture coverage internally proceeded from the ignition site (fig. F3.5-6) vertically downward. Figure F3.5-7 shows burning of the insulation on the fan motor wire bundle just before reaching the other wire bundles. Figure F3.5-8 shows the burning of several of the wire bundles. Figure F3.5-9 shows the burning of the wire bundles just prior to reaching the Teflon insulator, and figure F3.5-10 shows the more subdued fire after the propagation had progressed further into the upper probe region. Figure F3.5-11 shows the dense smoke after propagation of the burning into the insulator.

Figure F3.5-6.- Internal chamber view shortly after ignition.

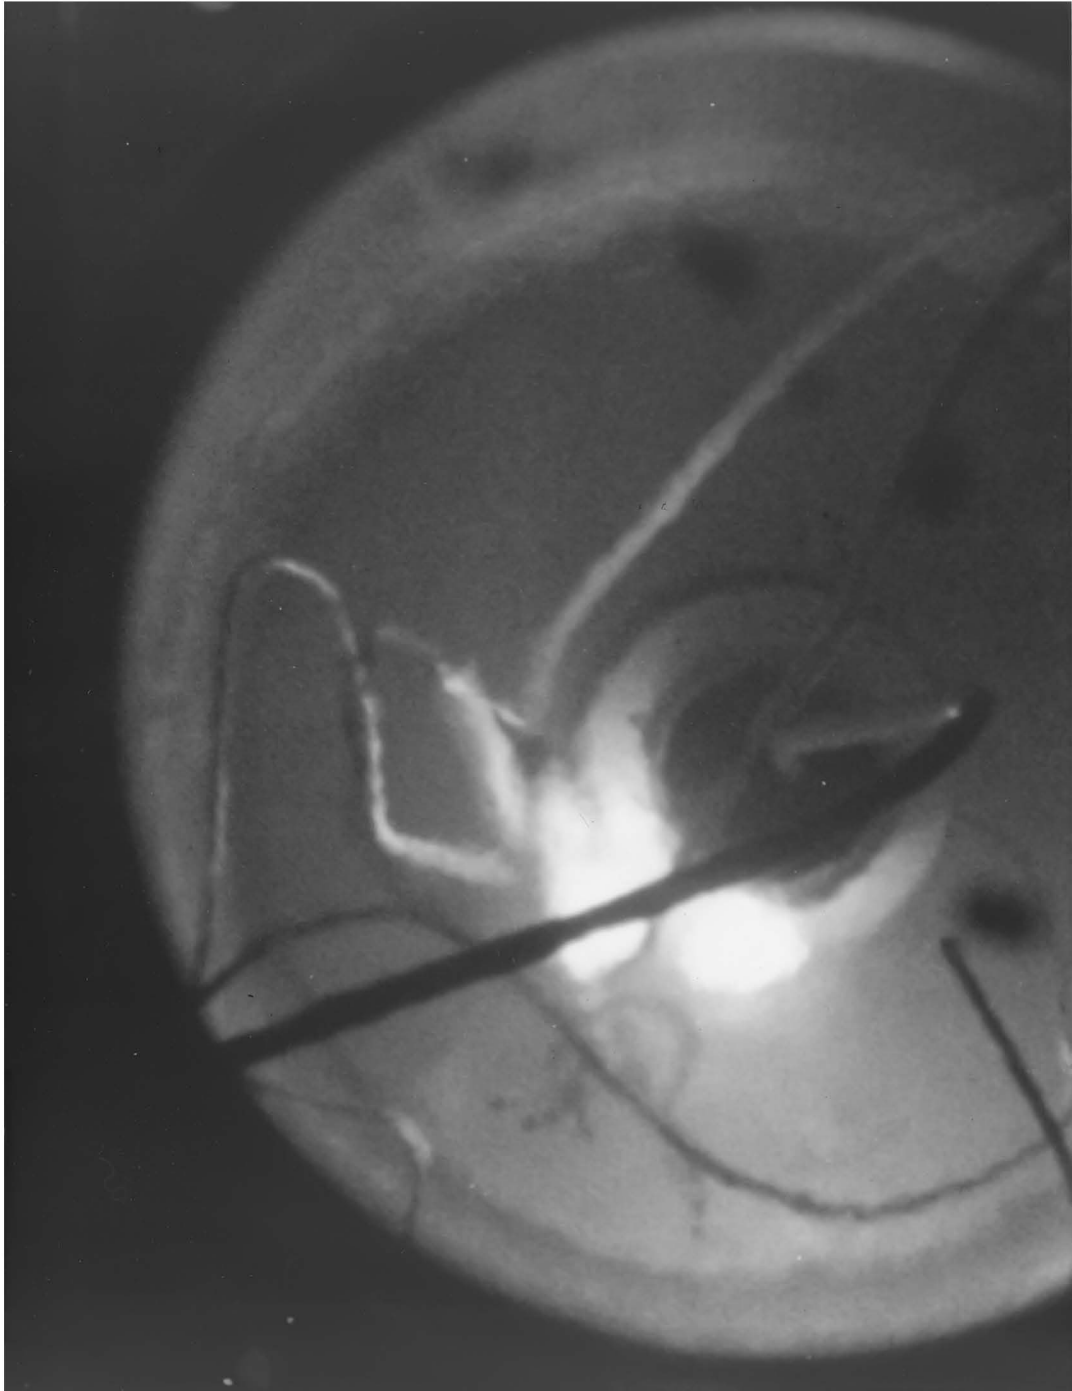
Figure F3.5-8.- Burning of adjacent wire bundles.

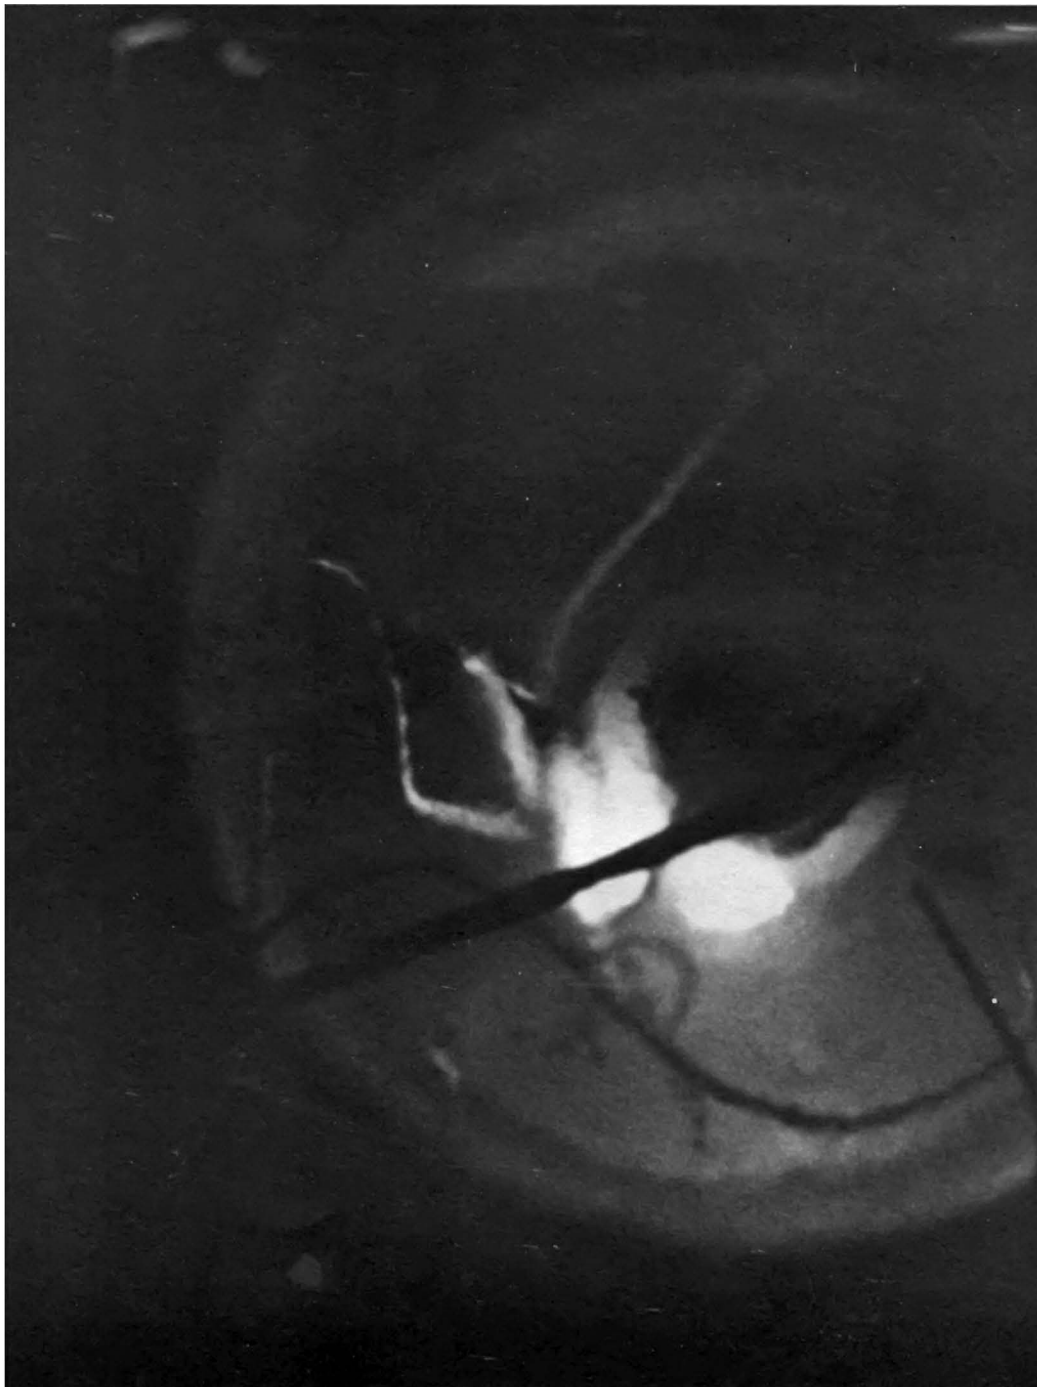
Figure F3.5-9.- Burning bundles prior to reaching probe insulator.

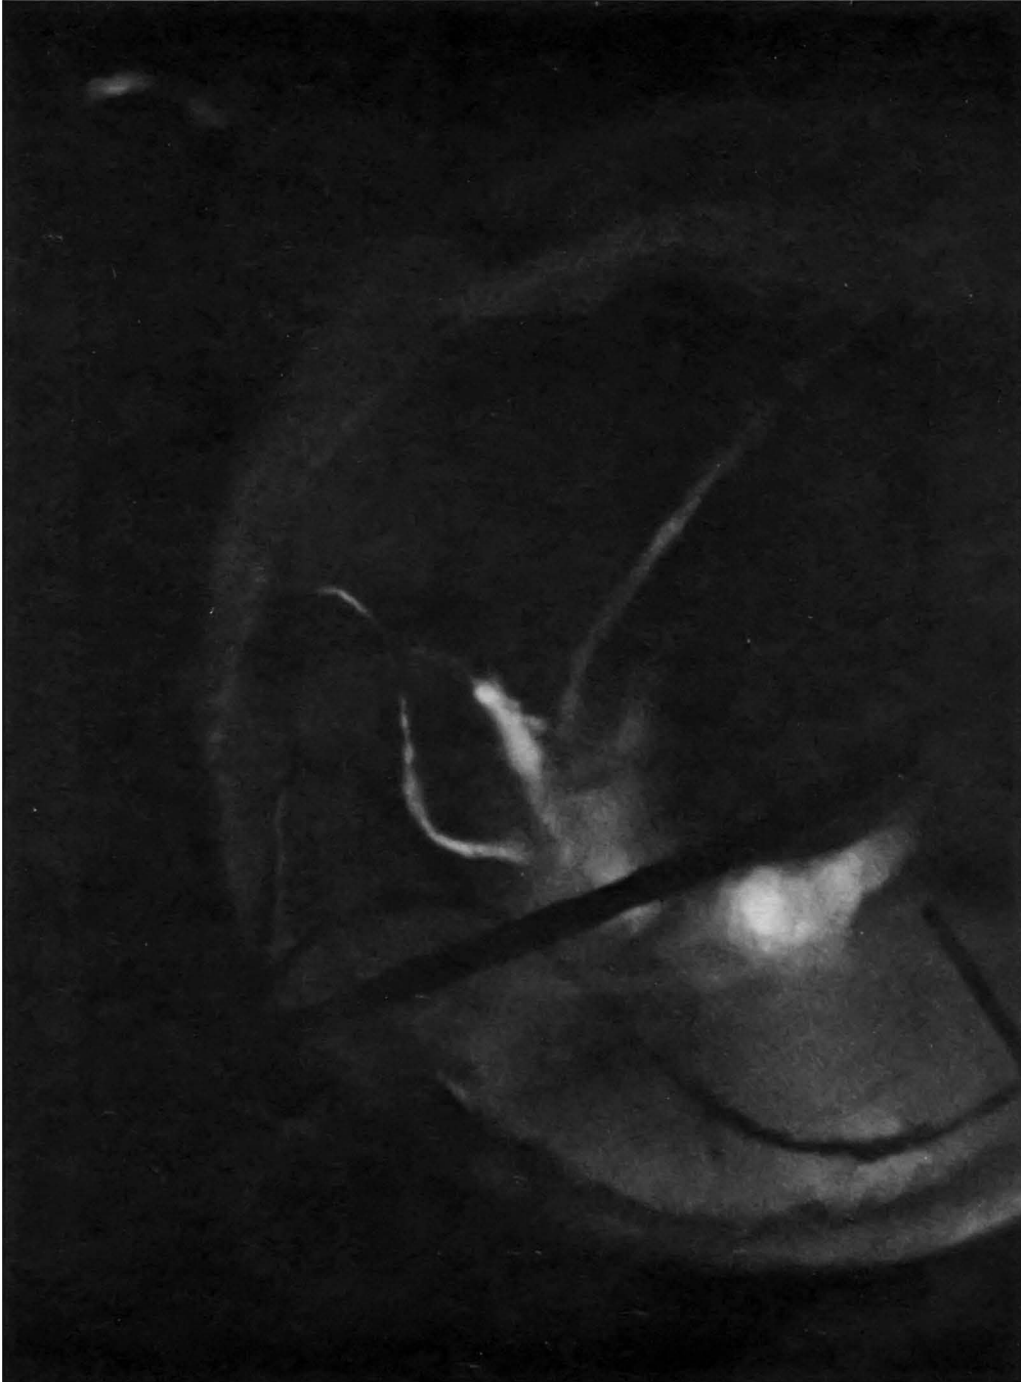
Figure F3.5-10.- Burning progressed into insulator.

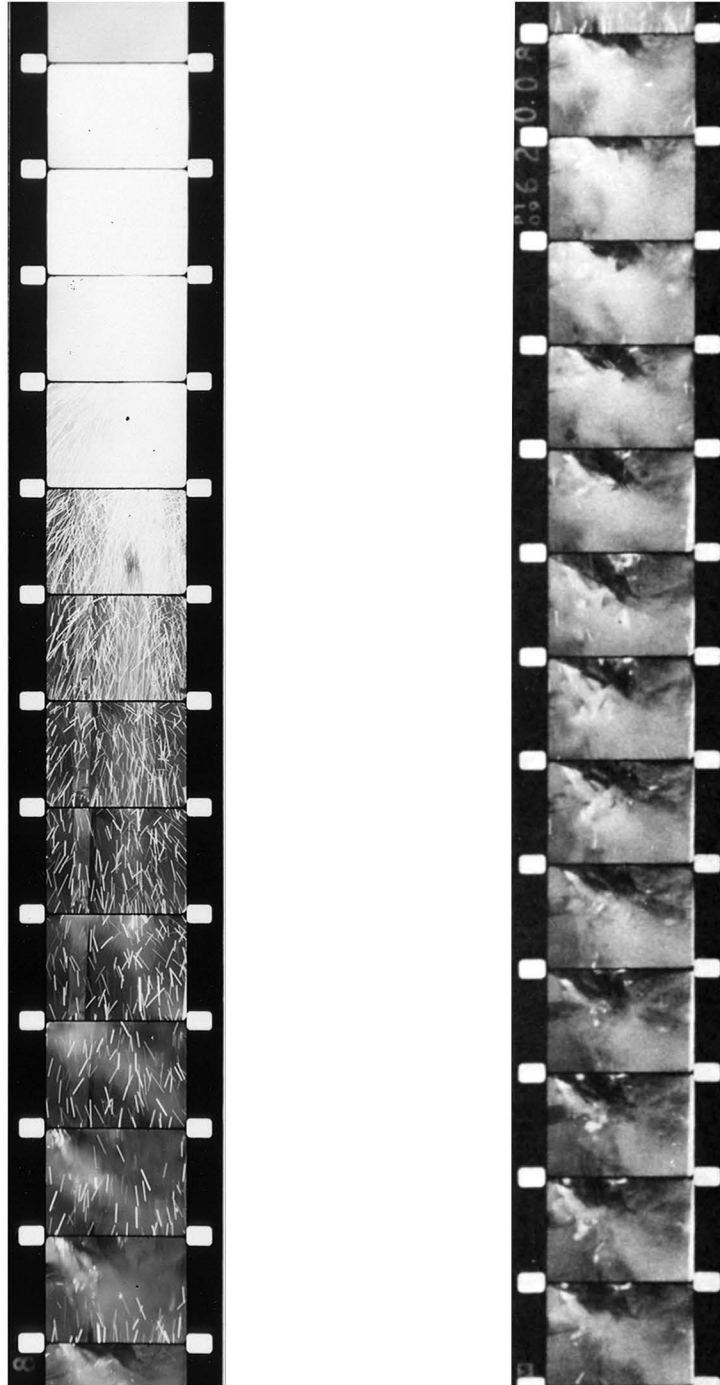
Figure F3.5-12 shows the conduit and chamber interface burnthrough scenes taken from the external movie coverage. The time for this sequence (24 frames) is 1 second. The small amount of external burning resulted

Figure F3.5-12.- External views of chamber-conduit interface at time of failure.

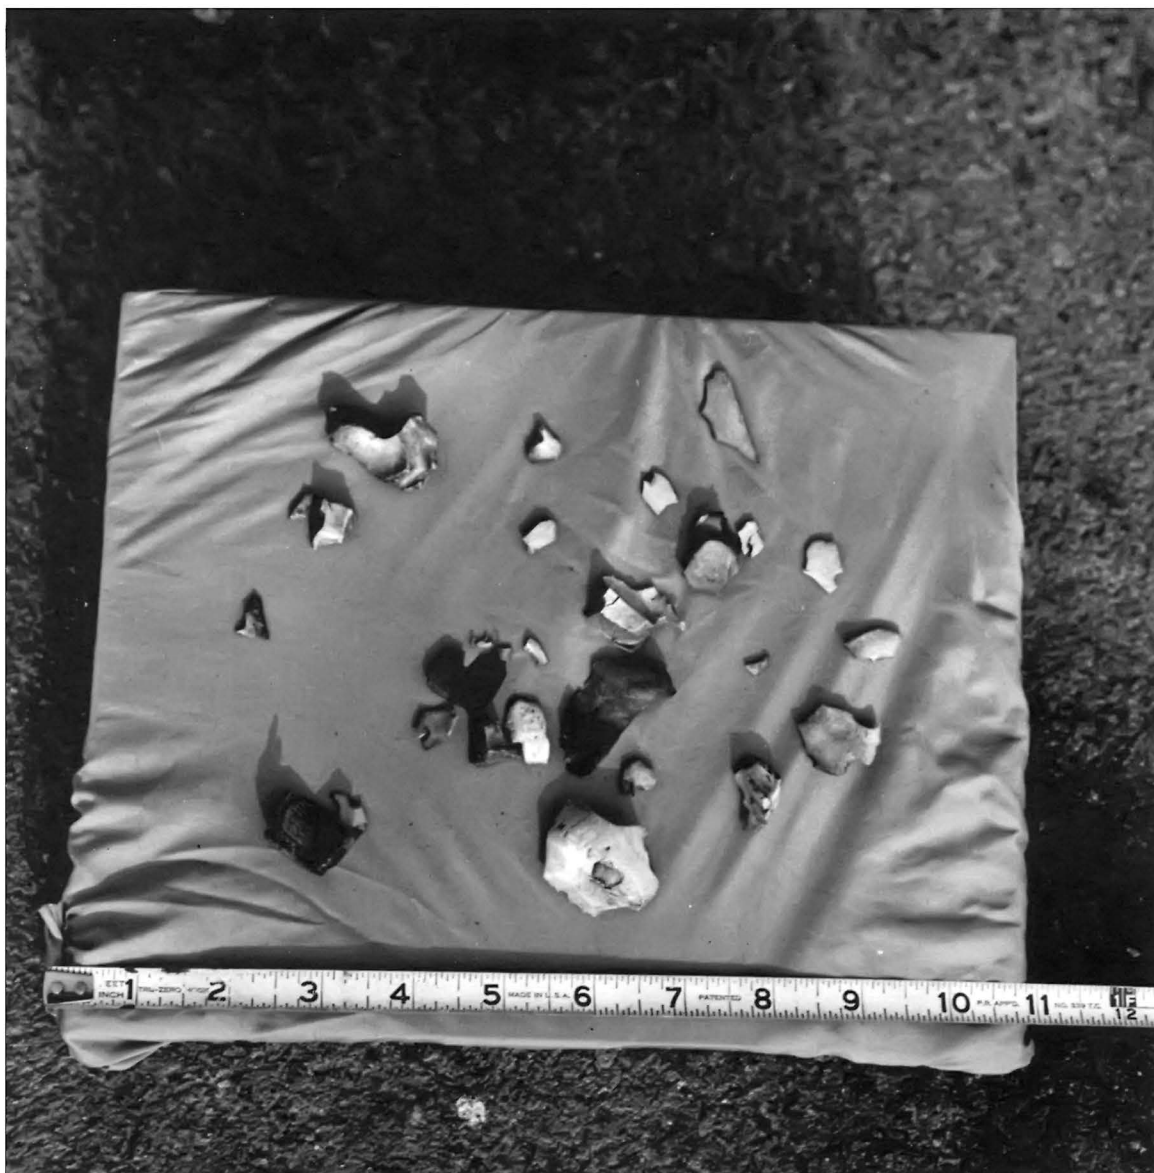
After the test, the section of conduit was found approximately 8 feet from the chamber. Several pieces of the Teflon insulator, two pieces of the conduit swedgelock nut, and one piece of conduit tubing were gathered from a 20-foot radius around the test area (fig. F3.5-13). The only item remaining in the test chamber was a portion of the Inconel section of the capacitance probe (fig. F3.5-14). The stainless steel portion was completely gone and a portion of the Inconel was burned. No remains of the aluminum portion of the probe could be found. The conduit-chamber interface was torched out to a maximum diameter of 1-7/8 inches (see figs. F3.5-15 and F3.5-16).

Figure F3.5-13.- Parts of probe insulator and tubing collected from area around test chamber.

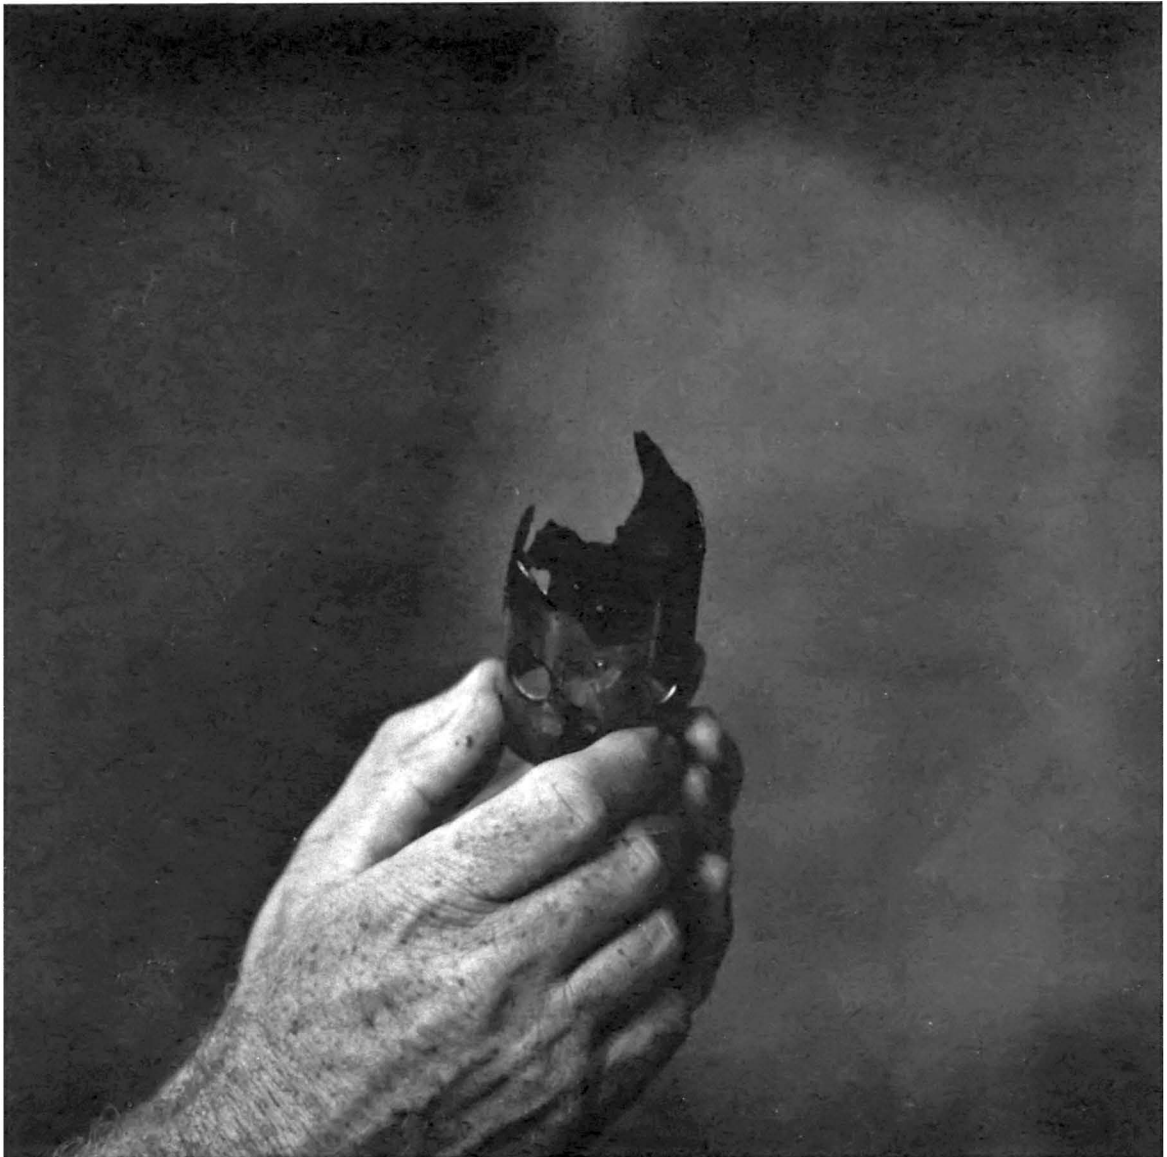
Figure F3.5-14.- Portion of probe which remained in the test chamber.

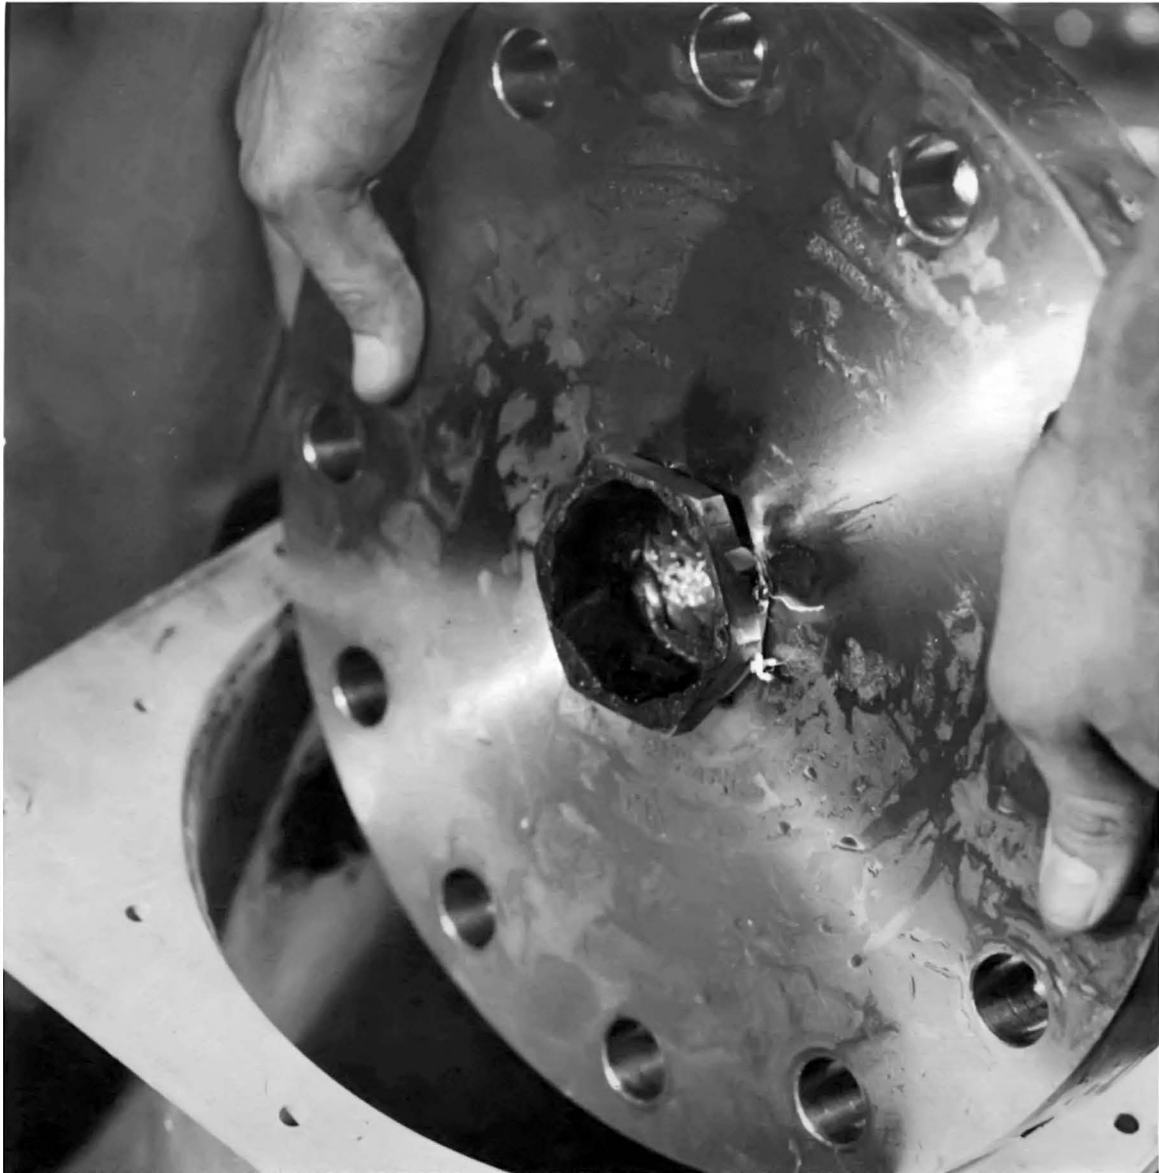
Figure F3.5-15.- External view of chamber flange on which conduit-quantity probe interface was mounted (after test).

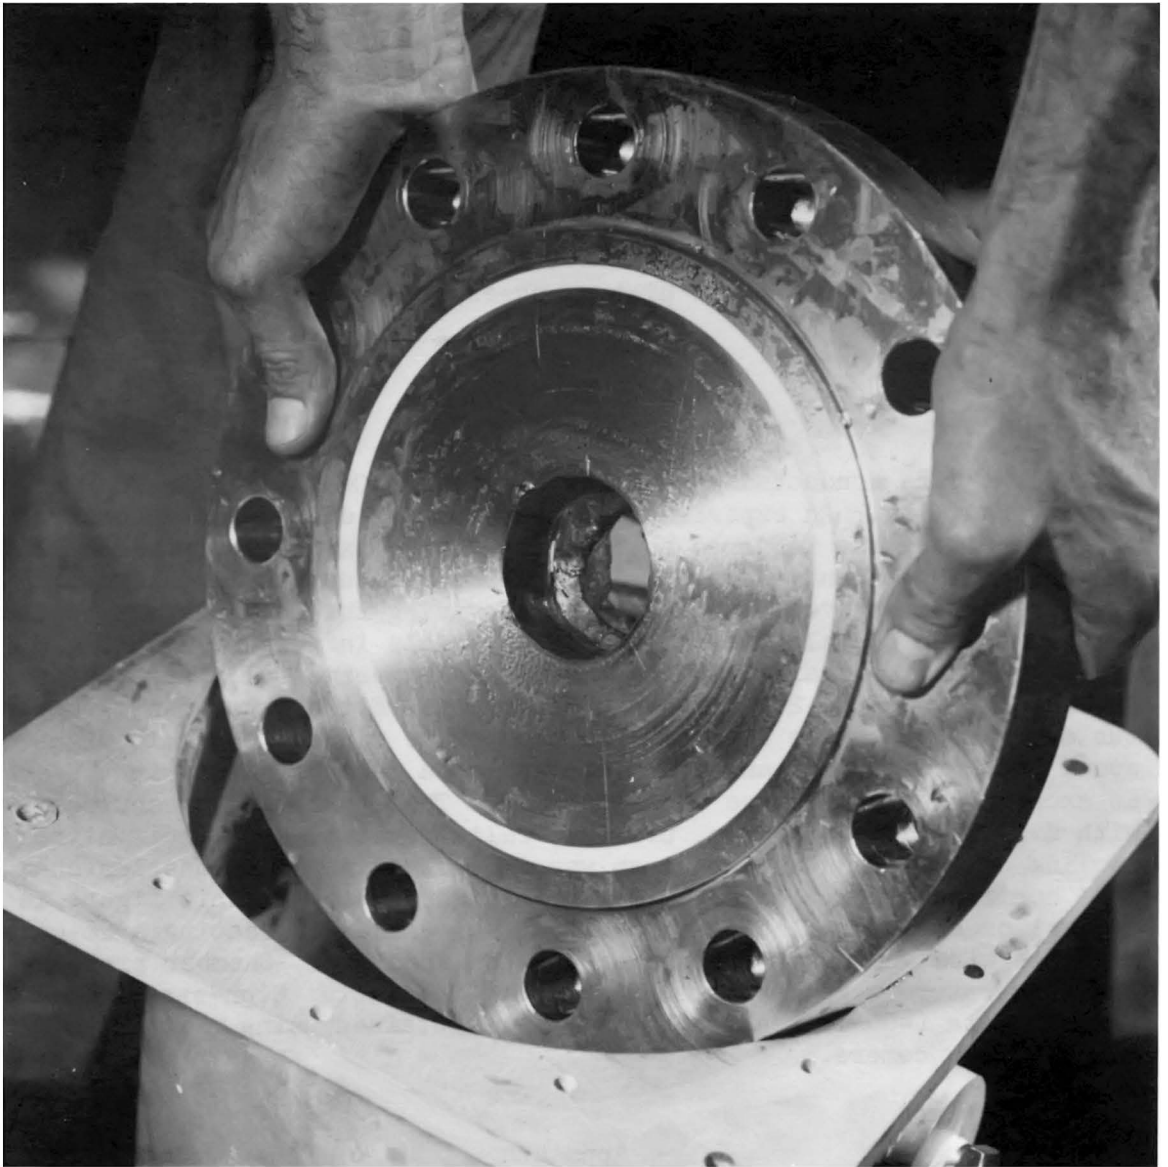
Figure F3.5-16.- View of chamber flange internal surface after test.

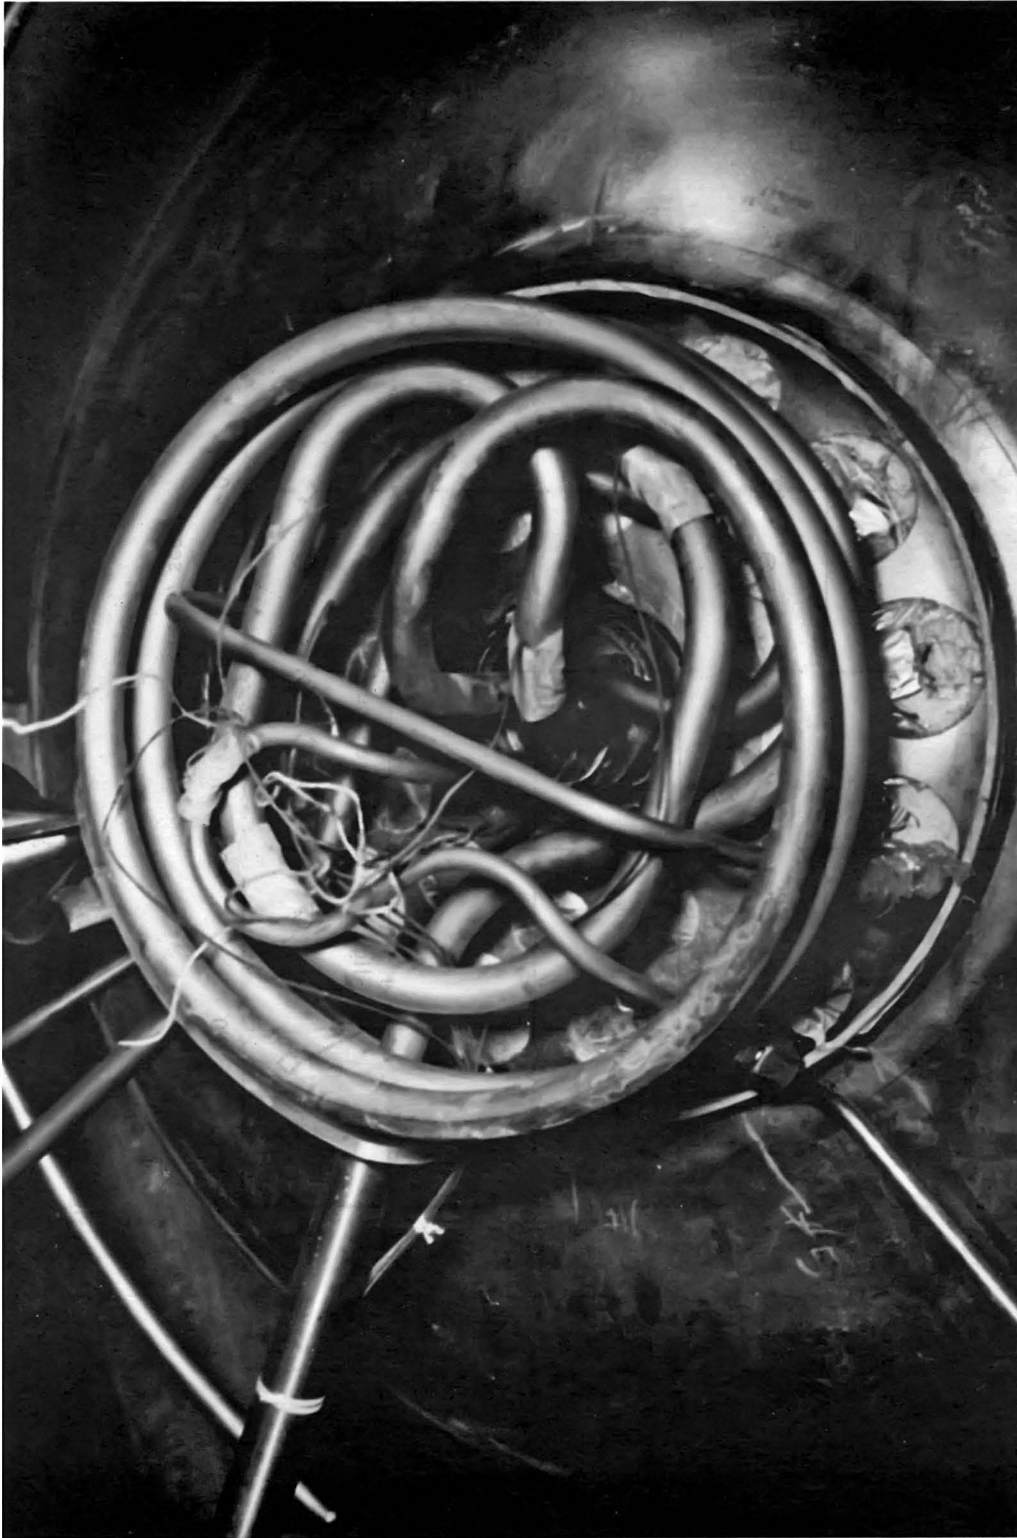
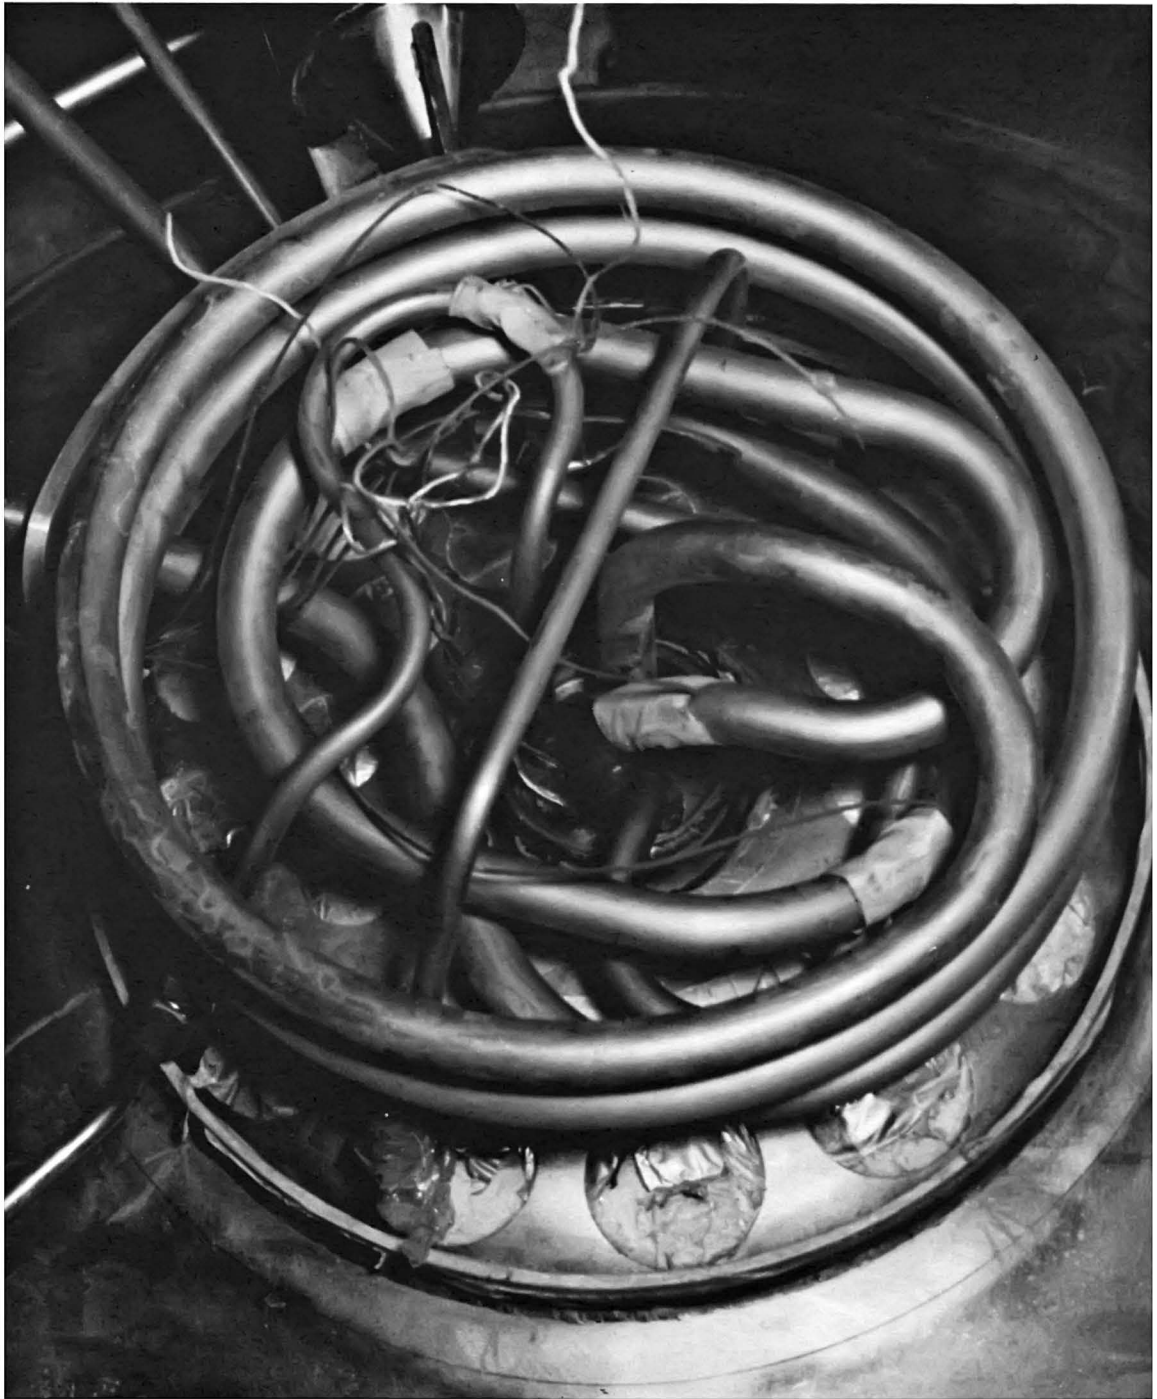
(a) Wide-angle view.  
Figure F3.7-3.- View of failed conduit.

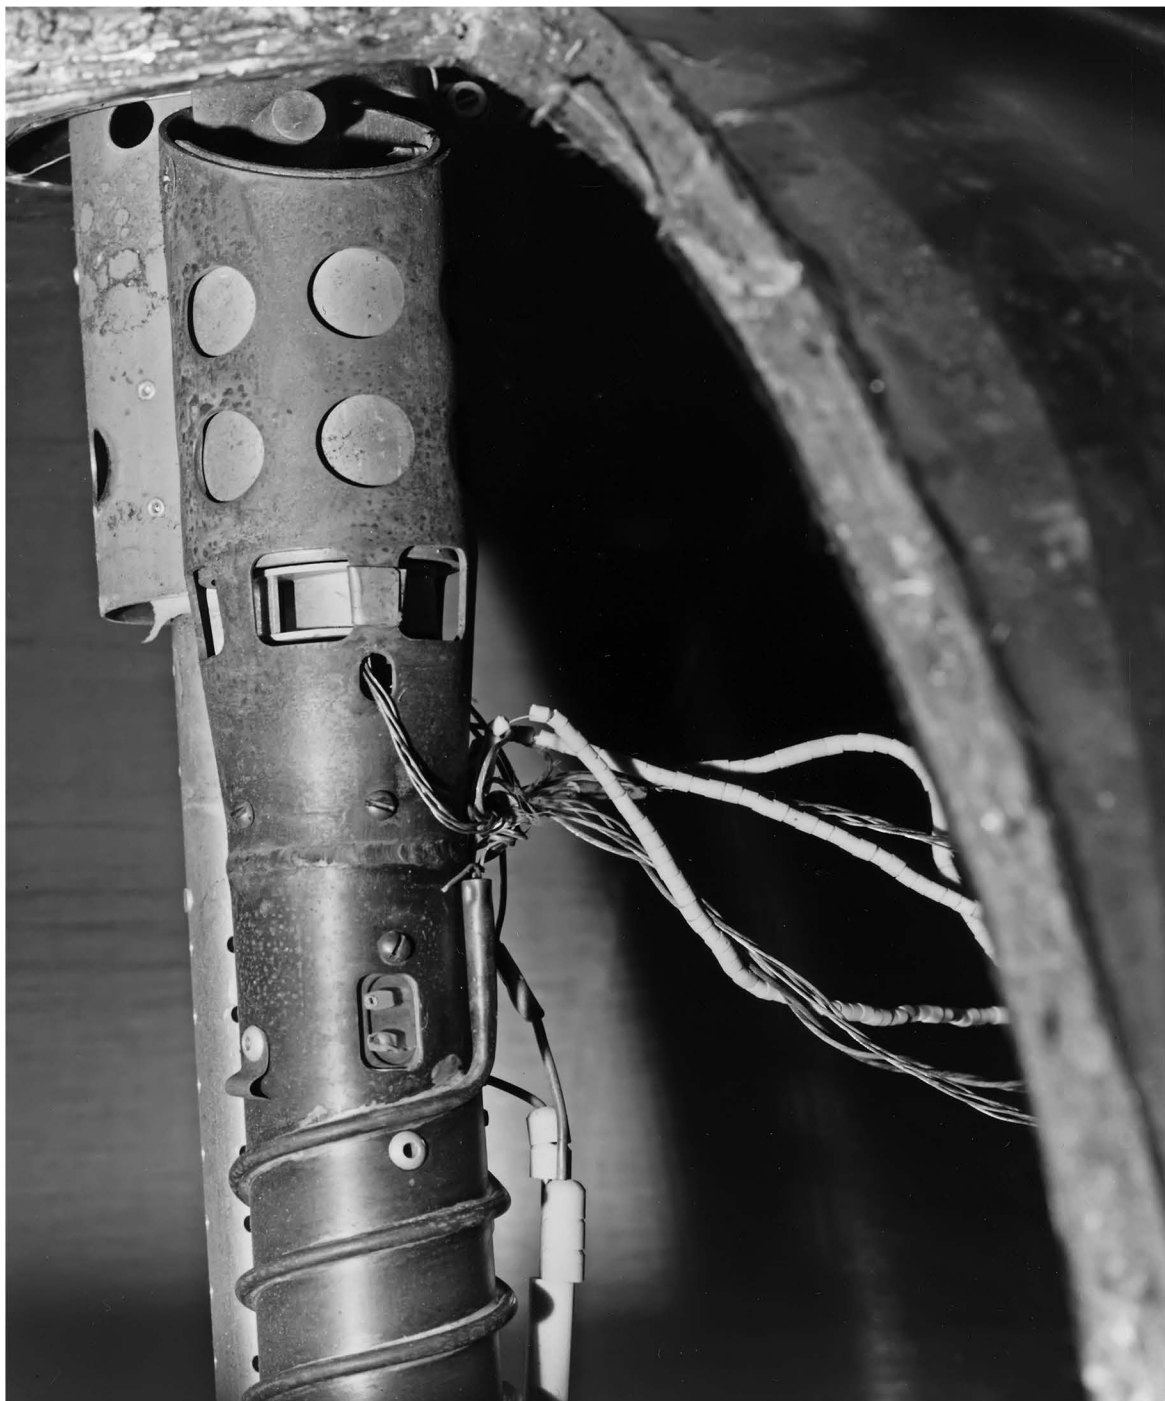
Figure F3.7-4.- Posttest internal view of tank components.

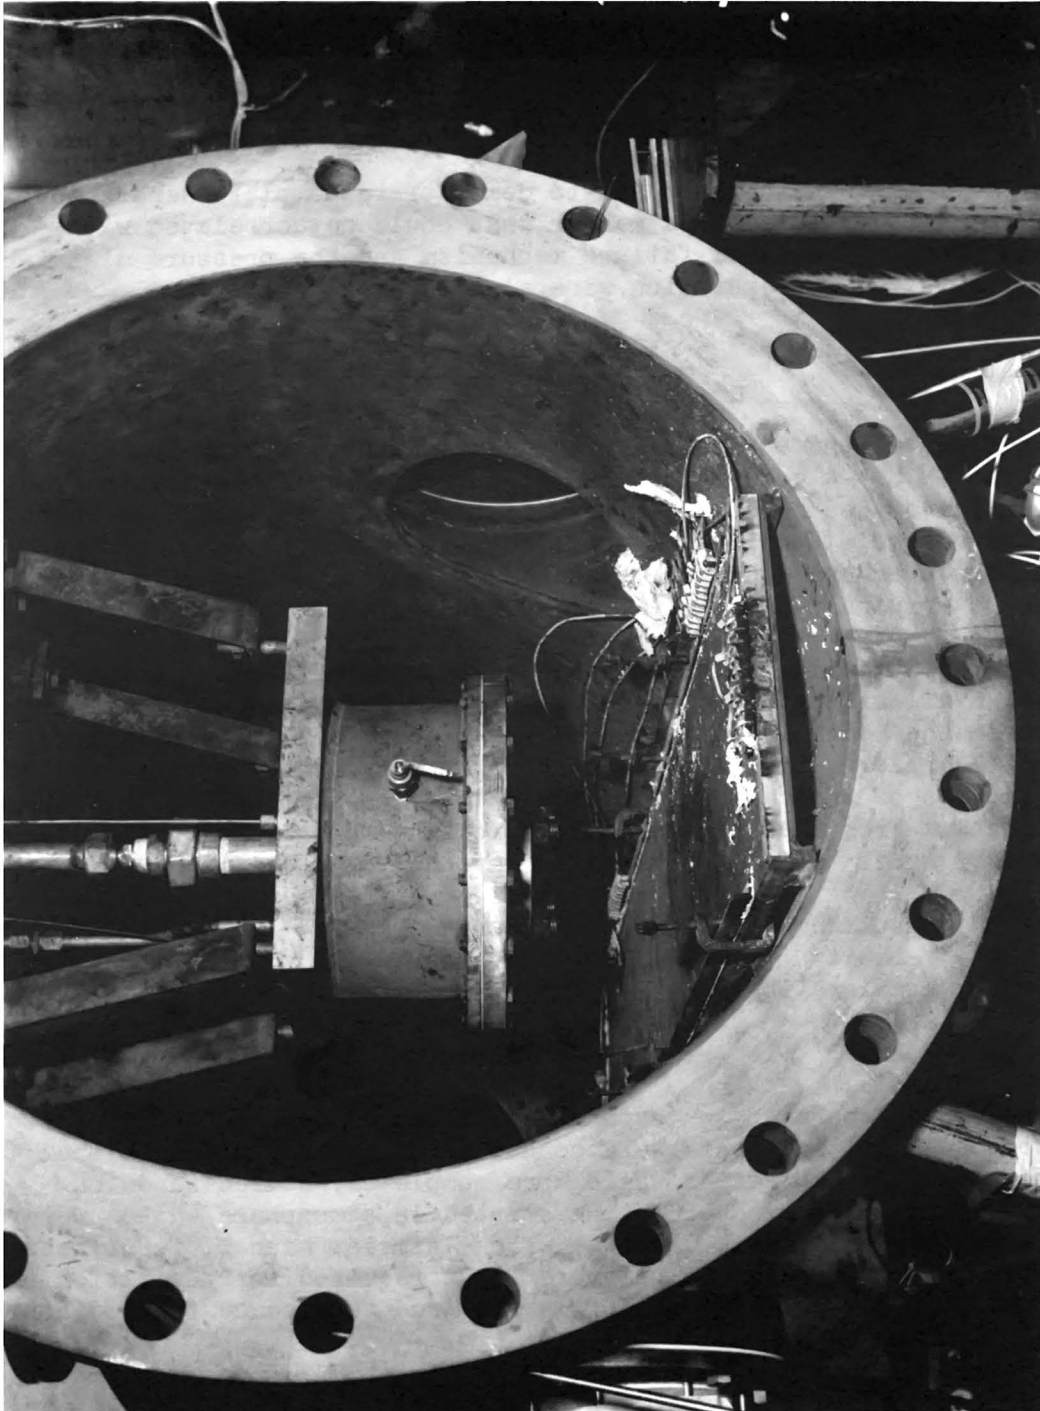
The Mylar insulation blanket burns completely when ignited locally and exposed simultaneously to oxygen from a 1000 psi/-190° F source. The pressure rise rate increases from 6 psi/sec without combustion to about 42 psi/sec with the combustion of Mylar. A substantial increase in the pressure rise rate in the oxygen tank shelf space due to Mylar combustion might therefore be expected. From tests conducted elsewhere, it is further concluded that an ignition source is required to achieve Mylar/oxygen combustion.

Figure F3.9-5.- View of chamber conditions after test.
