# **REPORT OF APOLLO 13 REVIEW BOARD**

**APPENDIX F - SPECIAL TESTS AND ANALYSES**

**APPENDIX F**  
**SPECIAL TESTS AND ANALYSES**

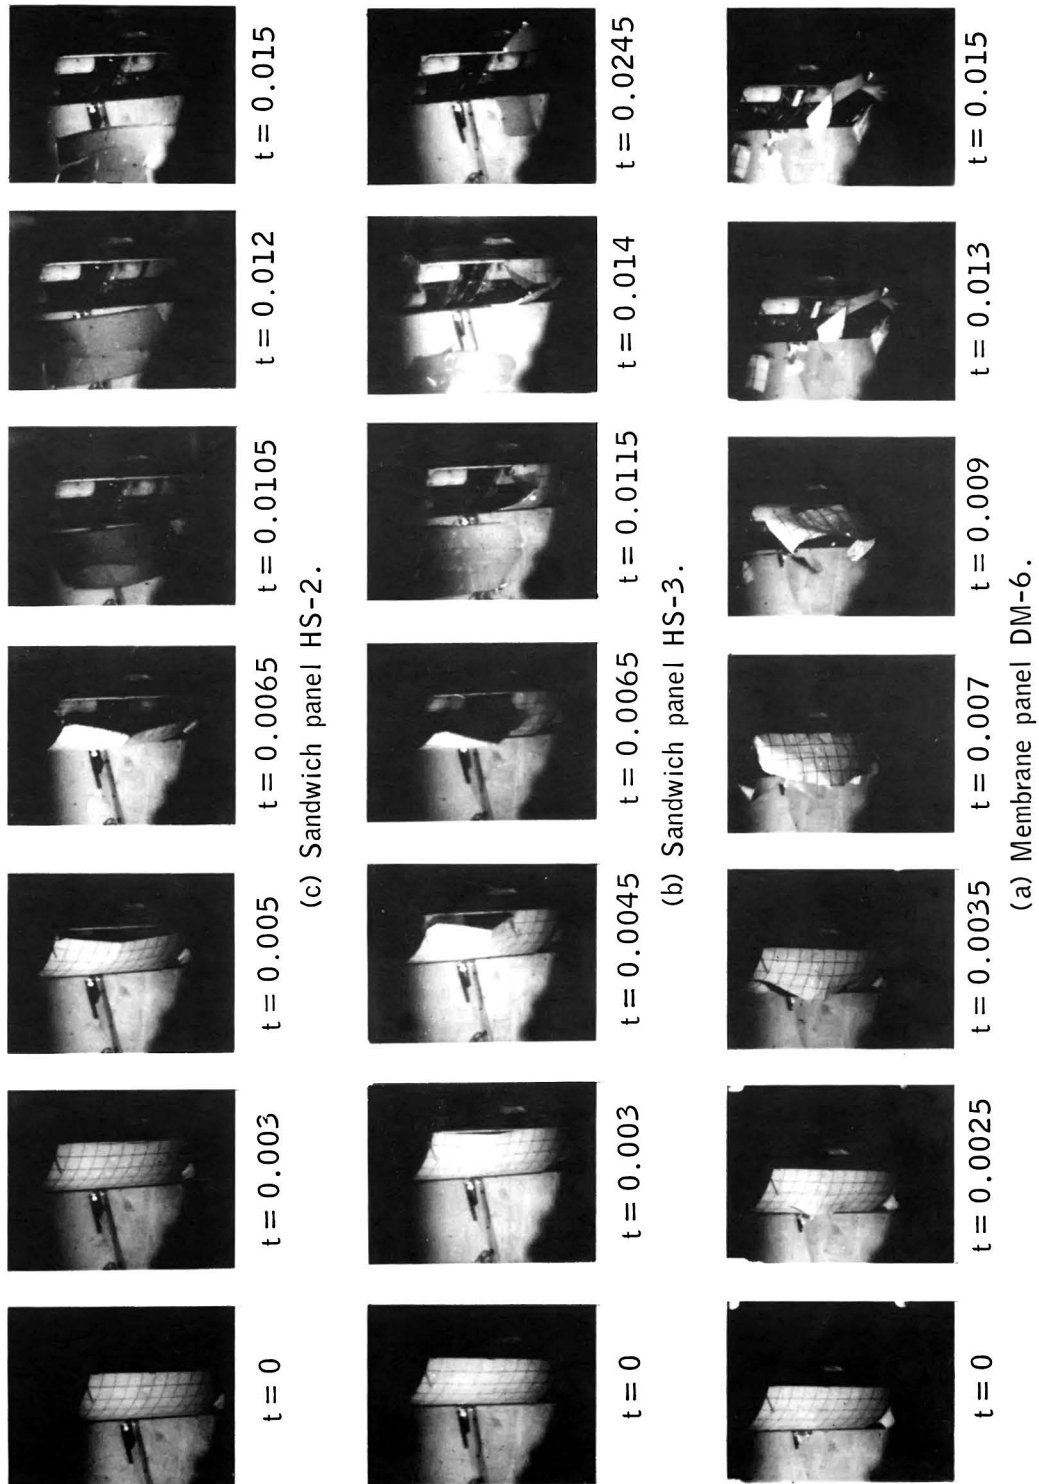
Demonstration of panel separation.- Panel separation has been demonstrated with both membrane and sandwich panels. Two sandwich panels separated completely from the test fixture during vacuum tests. Two membrane panels, although less representative of flight conditions, also separated completely in vacuum tests. However, similar tests with membrane panels in atmosphere left portions of panels attached to the test fixture as illustrated in figures F3.10-4(b) and (c). Complete separation in atmosphere could not be achieved due to mass and drag of the air.

Figure F3.10-5.- Sequential failure of two sandwich and one membrane panel ( $t$  = time from first observed failure).
