MSC APOLLO 13 INVESTIGATION TEAM

REPORT SUMMARIES

MAY 1970

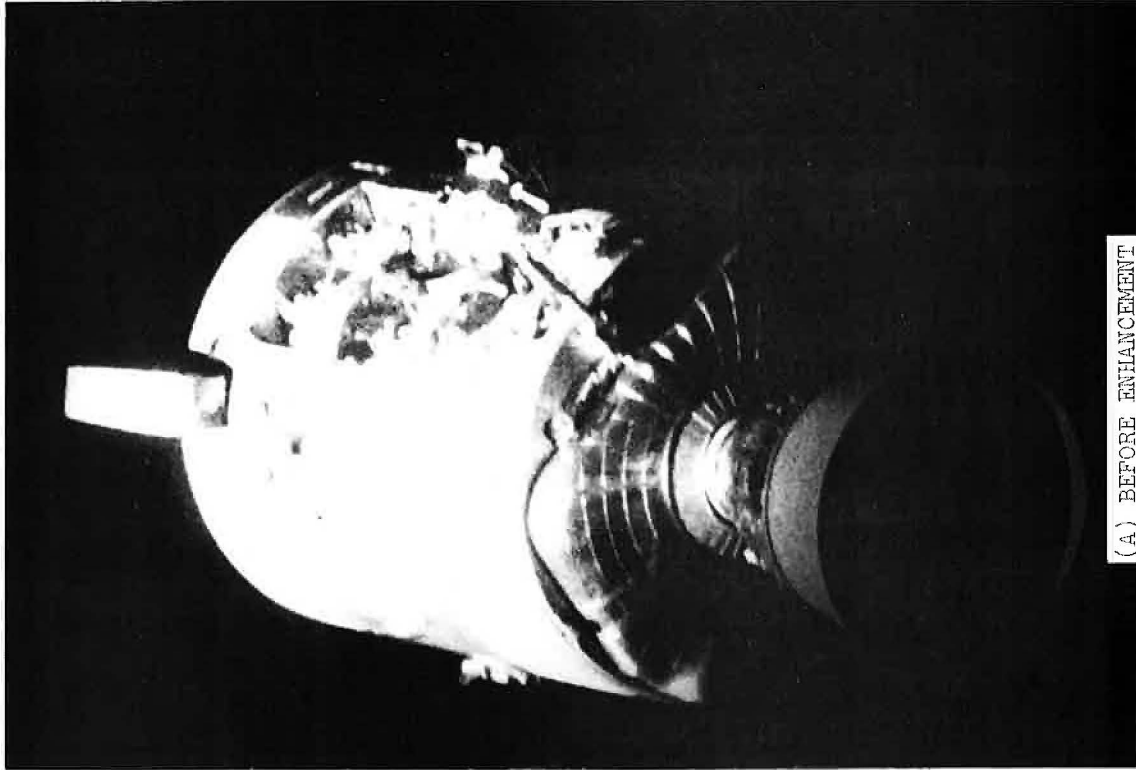
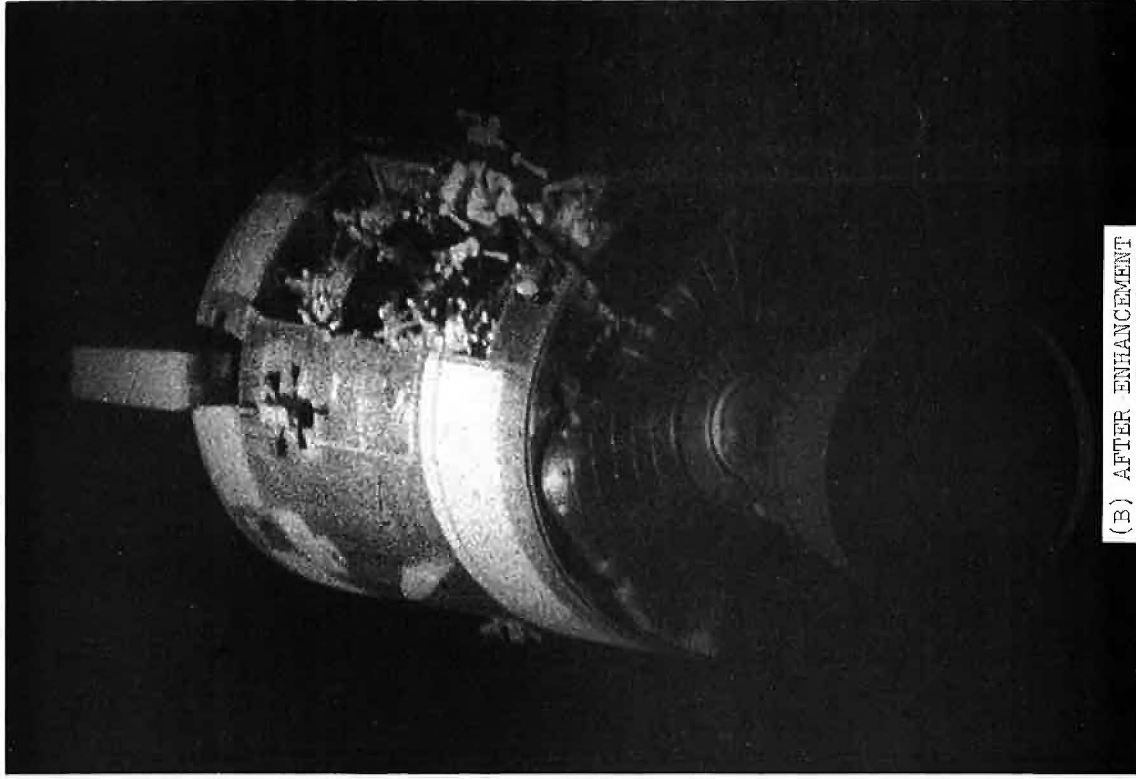
APOLLO 13 SERVICE MODULE PHOTOGRAPH
(MAGAZINE R, FRAME 8500)

Additional information on exterior placement of the loosened Mylar was more evident in the blue-layer prints, more contrast in the red layer, and more interior definition with the green layer when compared with the blue and red. The processing did not provide a clear image of the no. 2 oxygen tank.

(A) BEFORE ENHANCEMENT

(B) AFTER ENHANCEMENT

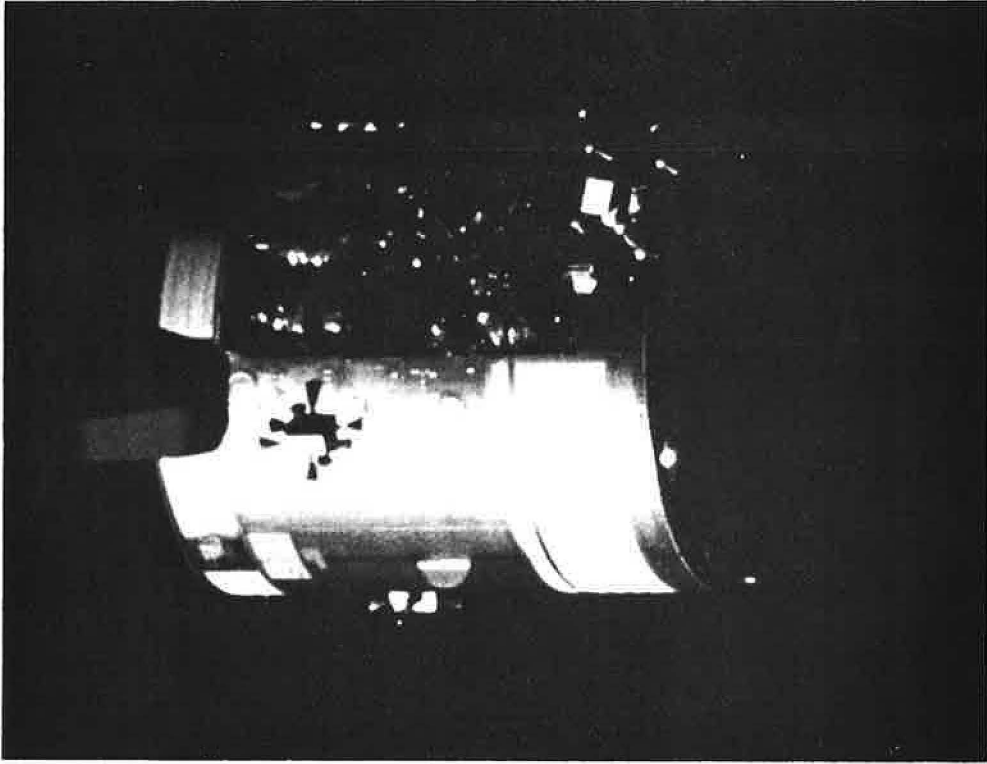
APOLLO 13 SERVICE MODULE INFIGHT, MAGAZINE N, FRAME 8464

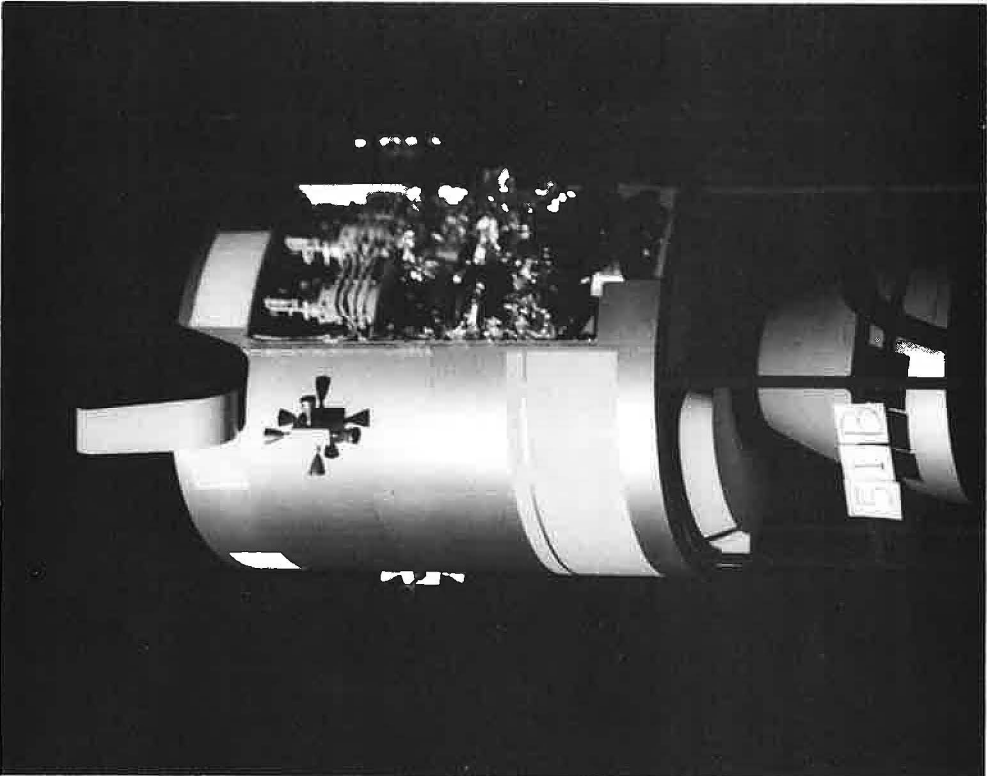
APOLLO 13 SERVICE MODULE MOCKUP AT MSC WITH LIGHTING DUPLICATING THE IN-FLIGHT CONDITIONS OF MAGAZINE N, FRAME 8464

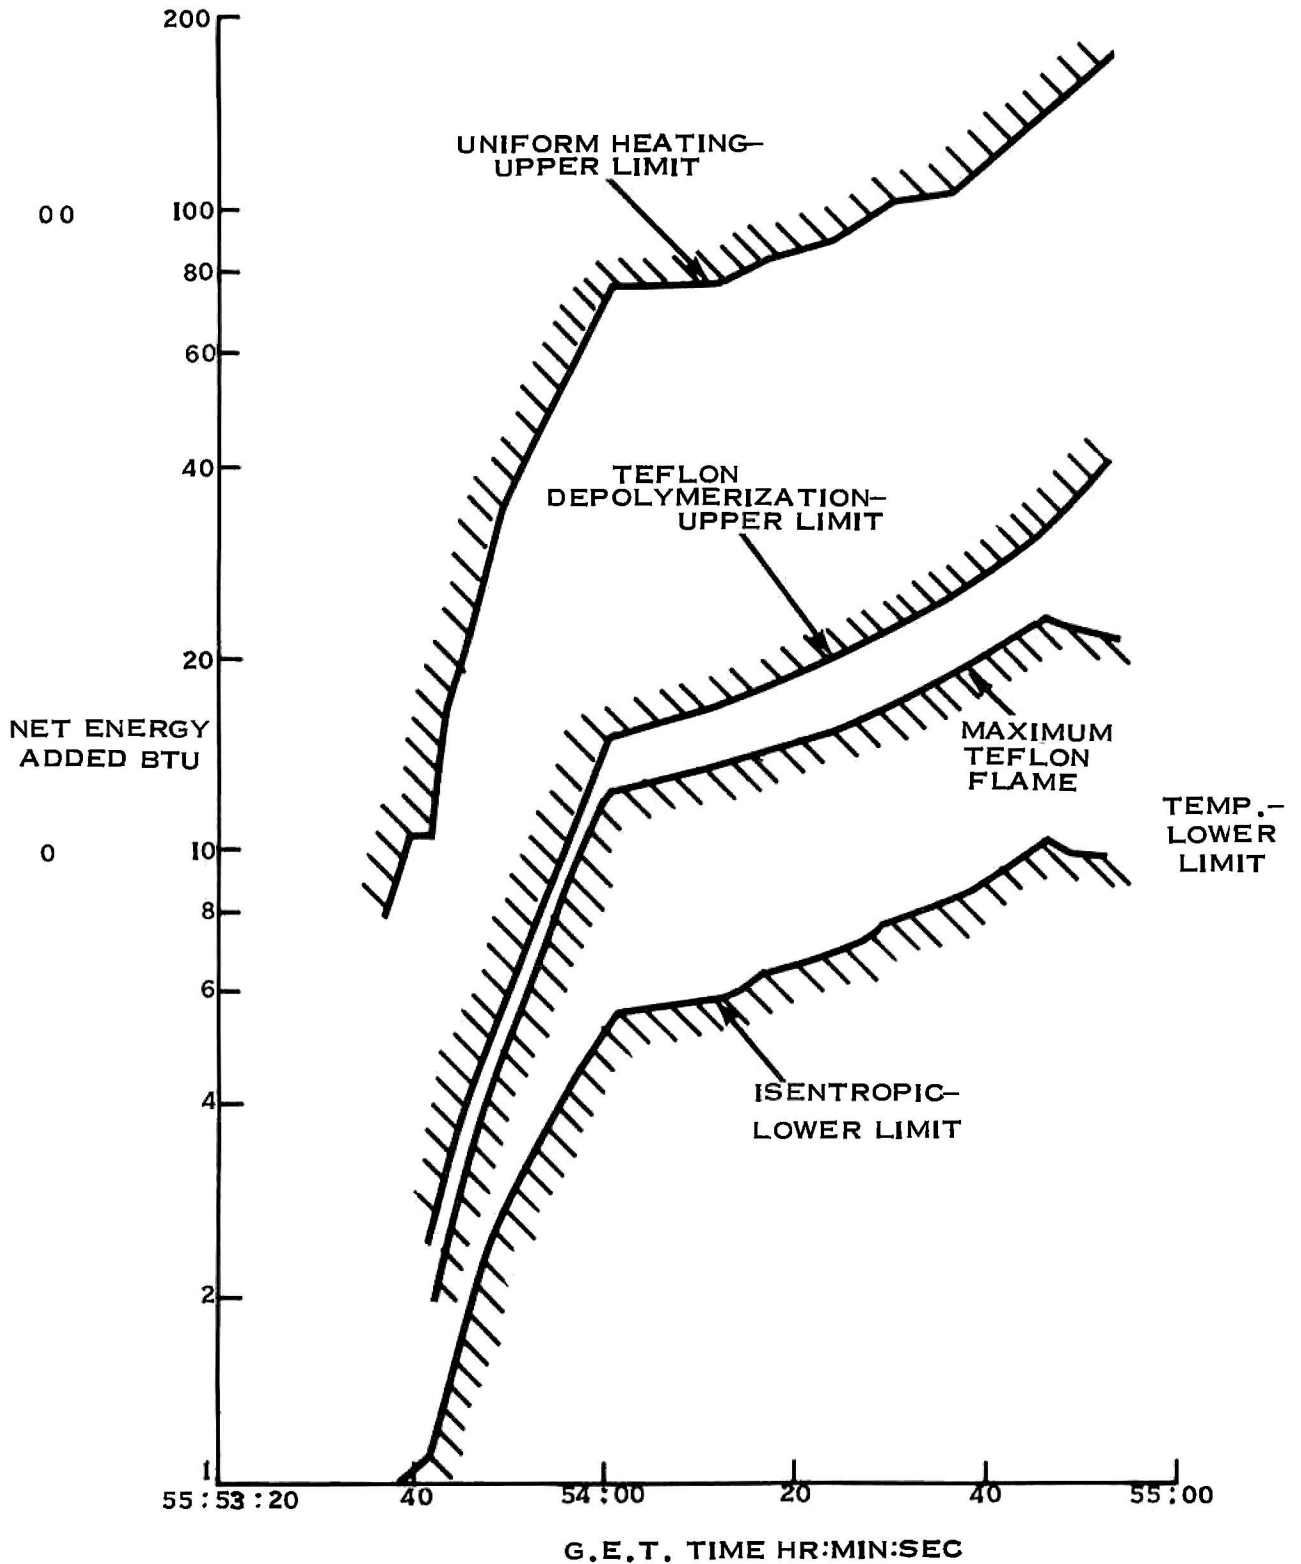
THERMODYNAMIC LIMITATIONS
TO THE NET ENERGY ADDITION TO
THE 2 OXYGEN TANK

The thermodynamic limitations on the net energy added to the oxygen in the Apollo 13 No. 2 tank are shown on the attached figure. The limits have been established under the constraints of the measured pressures and temperatures, the tank volume, and the oxygen mass. The calculations include nominal mass usage, nominal heat leak, and the work which the fluid performs on the tank. The ultimate limits of uniform heating and an isentropic process have previously been reported. The isentropic limit has been lowered due to increased accuracy obtained in the calculation procedures. This lower limit is, however, within the accuracy of knowledge of the thermodynamic properties of supercritical oxygen.
