MSC APOLLO 13 INVESTIGATION TEAM

SPACECRAFT INCIDENT INVESTIGATION

VOLUME I ANOMALY INVESTIGATION

FINAL REPORT

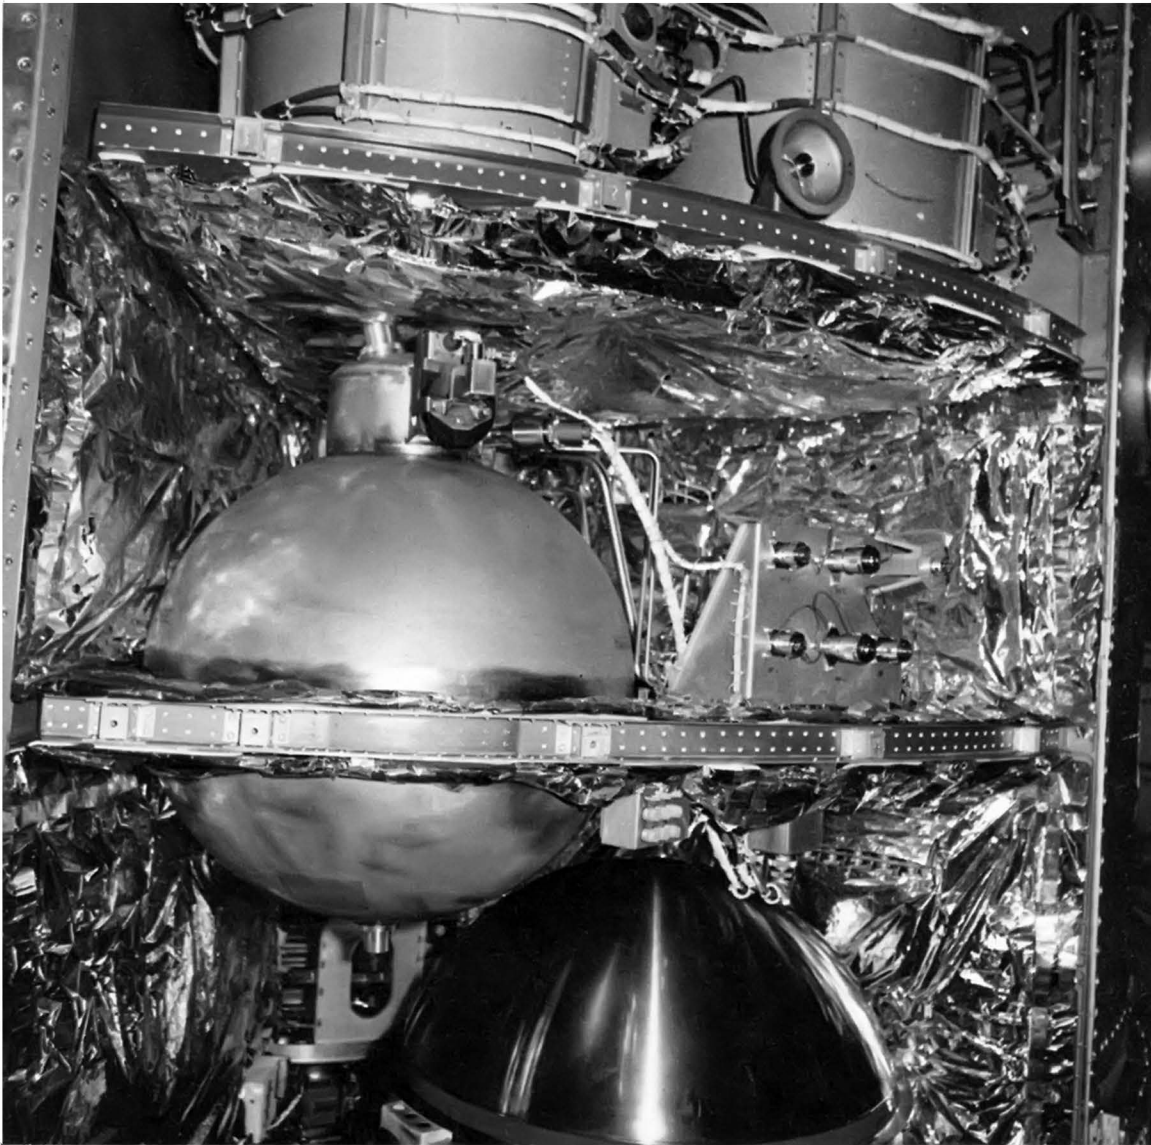
(a) Cryogenic oxygen tank 2.
Figure 4-17.- Bay 4 closeout photography.

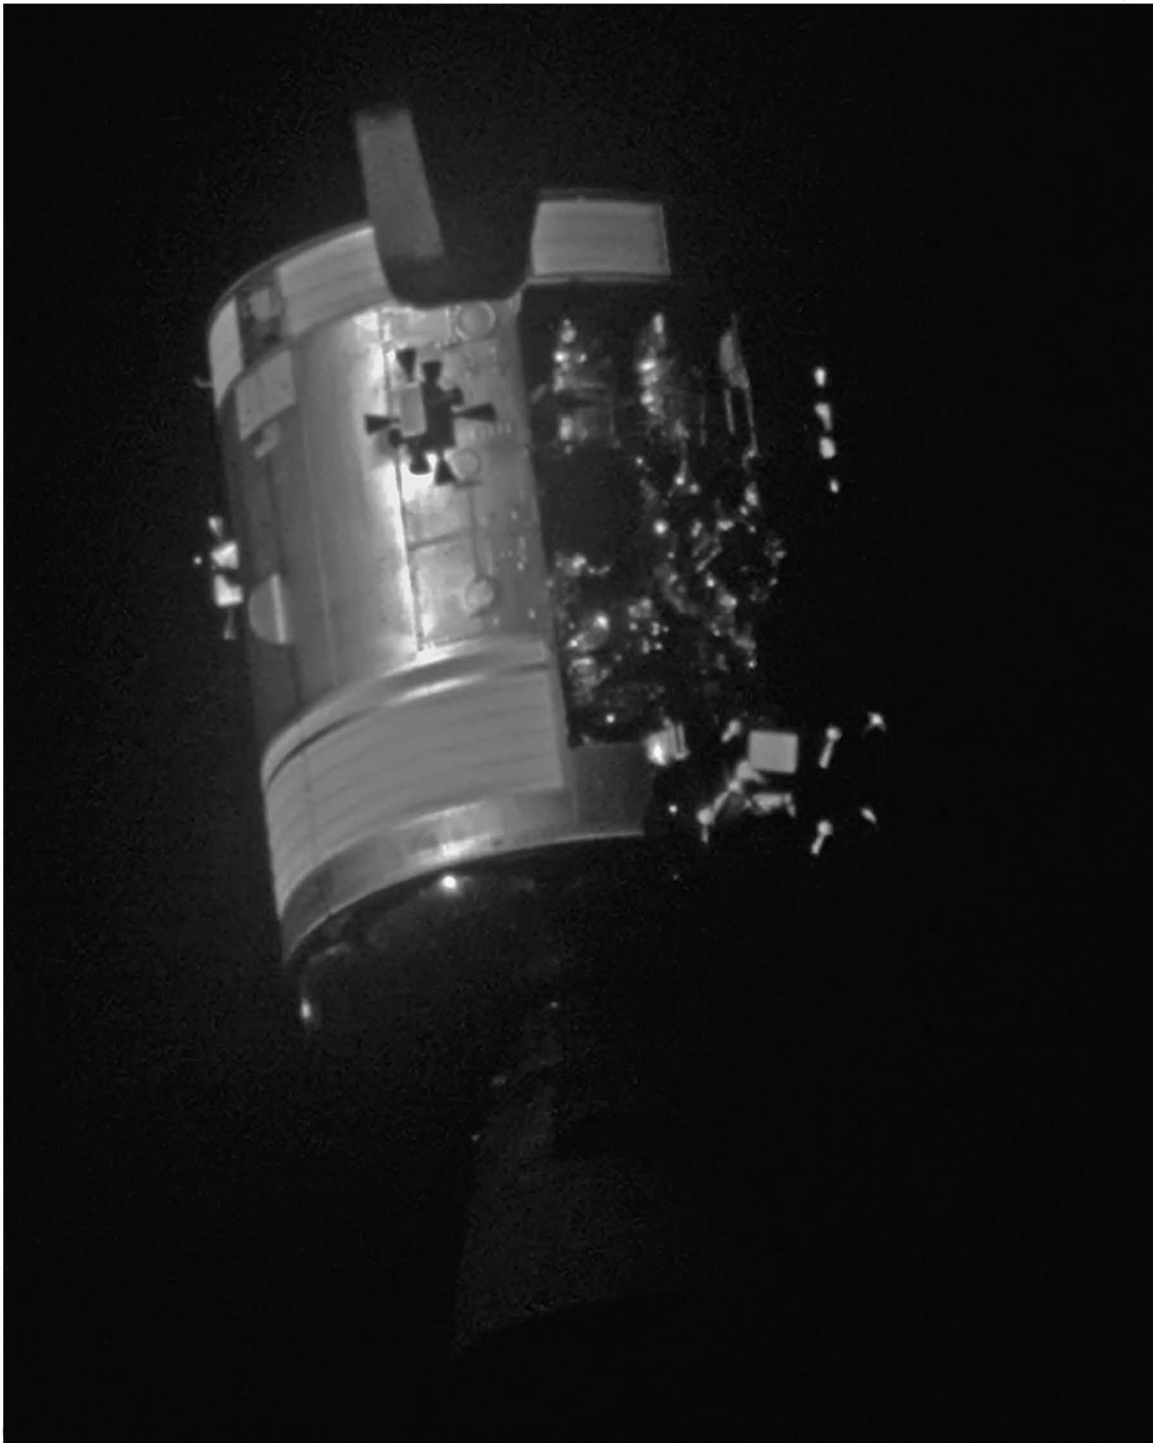
Figure 4-18.- 70-mm color film frame 8464.

h. One of the four reflectors and feeder horns for the high-gain antenna was damaged. The attitude of the antenna, with the damaged reflector nearest the service module, had changed since the incident because the gimbals are free to rotate whenever the power is turned off.

(a) Onboard camera view.

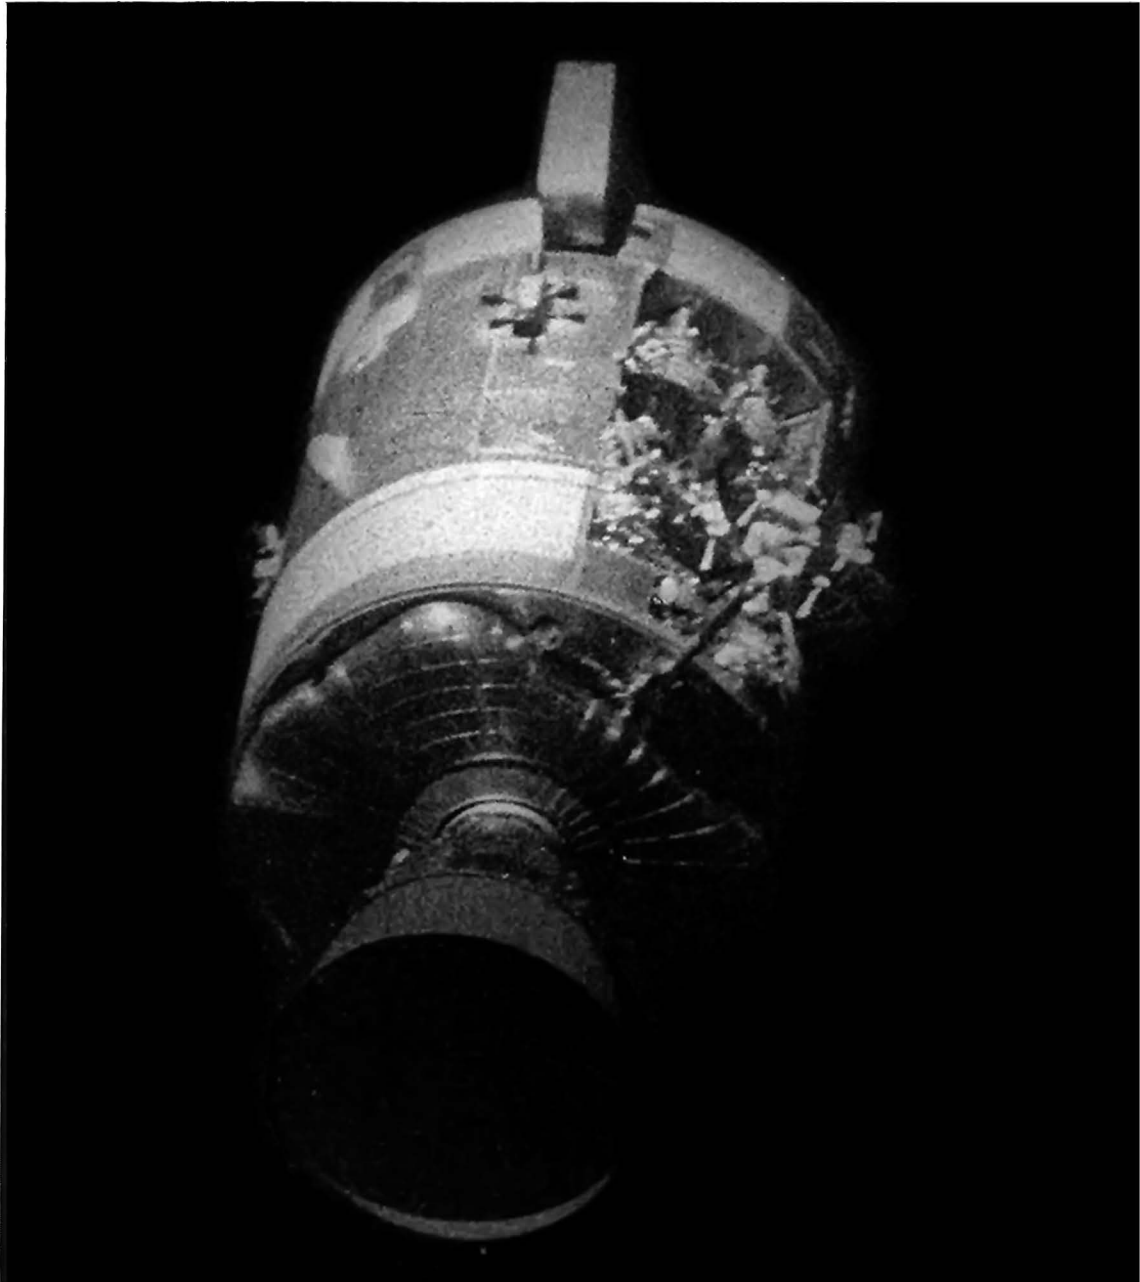
Figure 4-19.- 70-mm black and white film frame 8501.

(a) Onboard camera view.

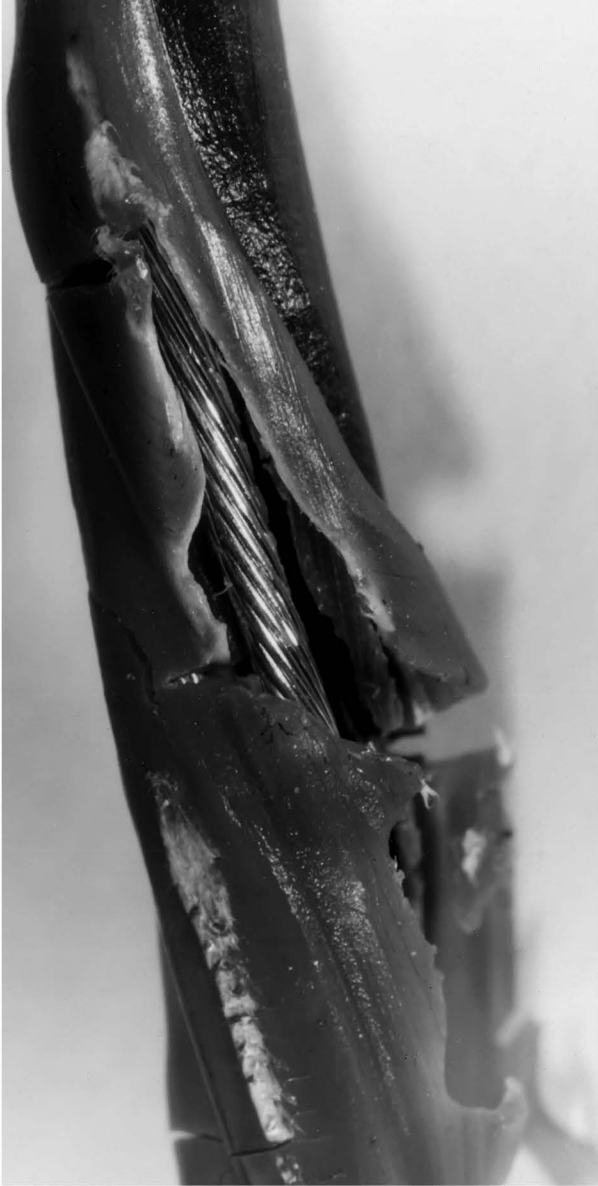
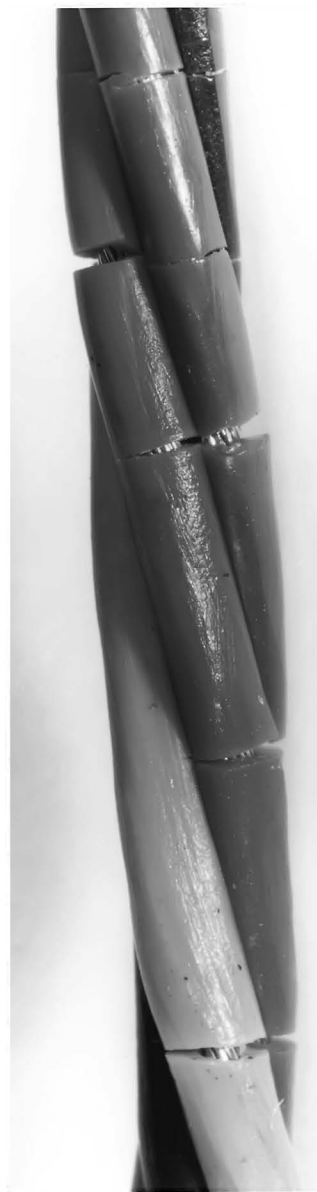
Figure 4-43. - Fan motor wire damage from heater tests.

This test showed that insulation will be severely damaged by the abnormal heater operation so that numerous locations for electrical shorts or arcs are available when the fan circuits are powered.

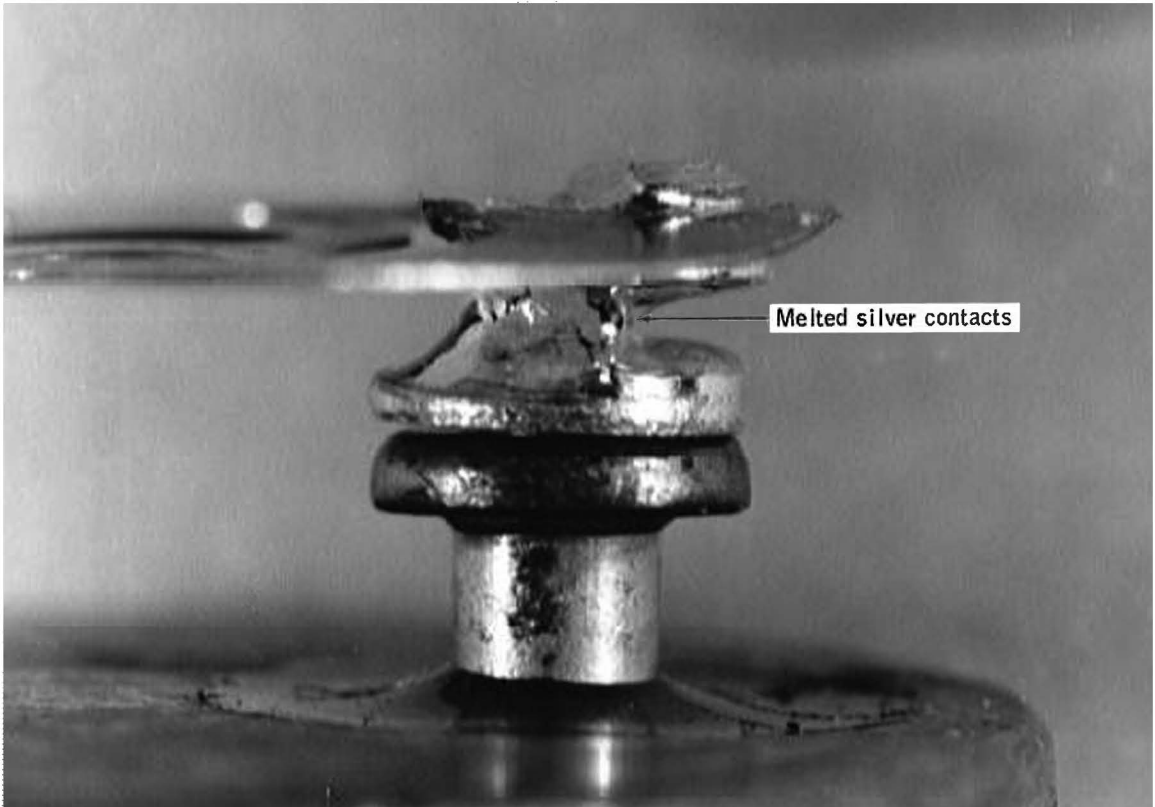
(b) Welded contacts after test.

Figure 5-5.- Heater thermal switch.
