MSC APOLLO 13 INVESTIGATION TEAM

SPACECRAFT INCIDENT INVESTIGATION

VOLUME II MANUFACTURING AND TEST HISTORY OF OXYGEN TANK

FINAL REPORT

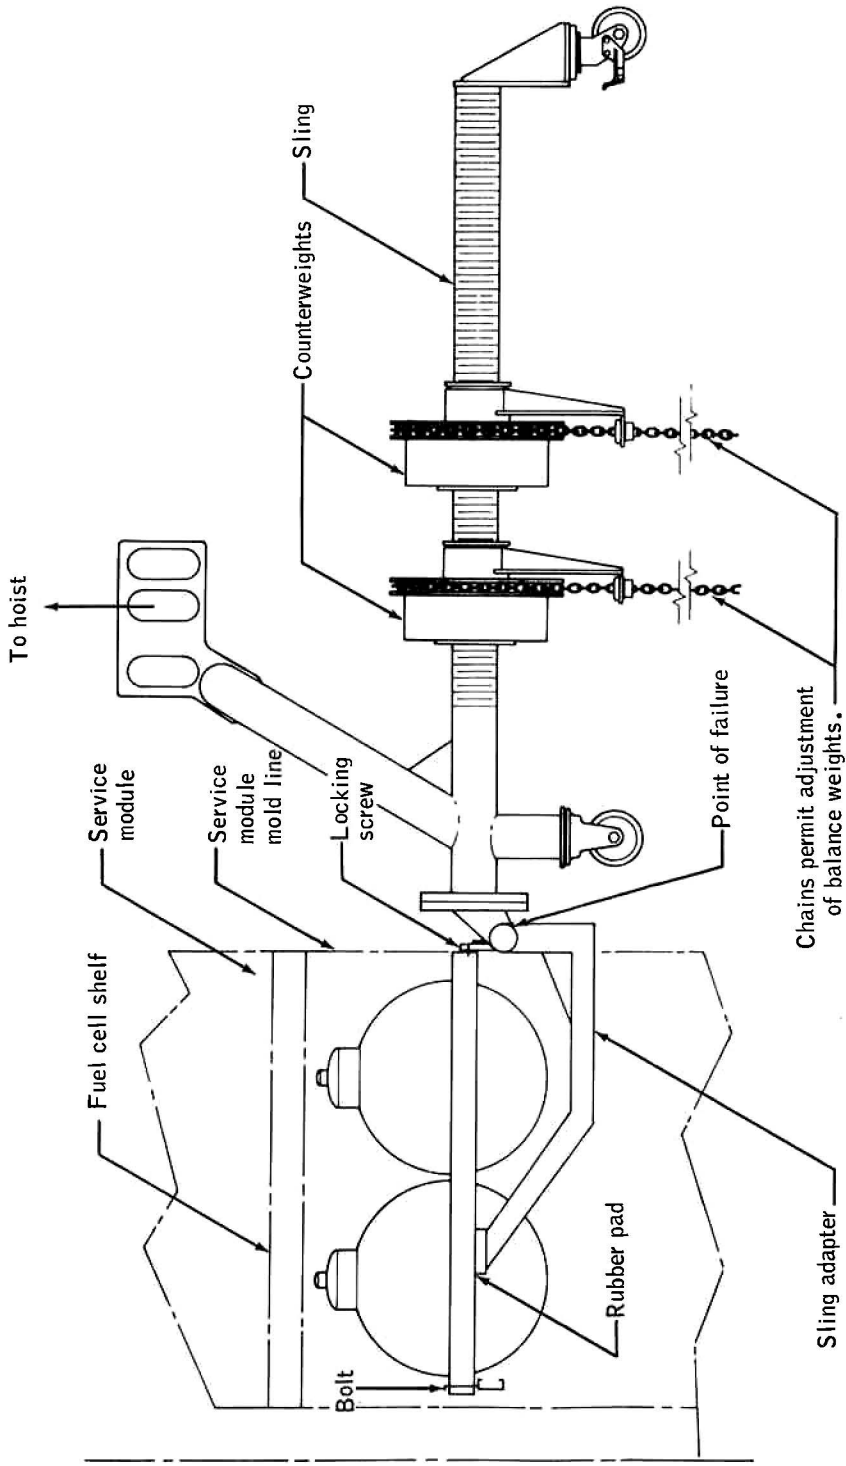
Figure 2-2.- Oxygen shelf and hoist assembly.

According to the technicians and inspectors, all steps had proceeded normally until step 9, when adapter 9EHL009 failed at a weld joint between two 3 inch 1/8 inch wall aluminum tubes (fig. 2-2 point D), allowing the shelf with a portion of the adapter attached, to drop back down onto the service module support angles. The distance of the drop was estimated at the time to be approximately 2 inches.

1. A 10-32 screw attaching tank no. 1 and the shelf assembly to a bracket between radial beams 3 and 4 had not been removed, leading to high moments on the 9EHL009 adapter.
2. The normal periodic proof load was 2 days overdue. This period was extended by NR and NASA QC for the emergency usage on this removal.
3. The normal load and proof load, 200 lb and 300 lb respectively, were low for the actual estimated shelf weight of 247 lbs.
4. The weld joint which failed had poor penetration and a lack of wetting with the cross section less than parent metal thickness in the tension area of the weld.

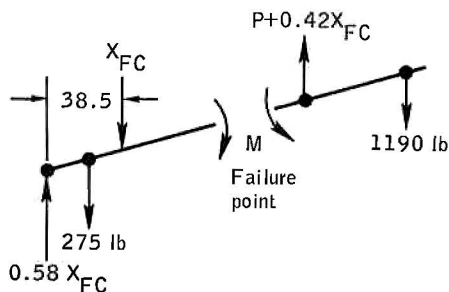
Case 1 - Fuel cell shelf contact

Assume a force, X_{FC} , exerted by fuel cell shelf.
 For an $X_{FC} > 406$ lb, the ground support equipment bearing pads swing free: This loading condition reduces the moment at the failure point to 15 percent of its balanced one g value. i.e., $M = 1110$ in-lb.

Conclusion: Sequence excluded

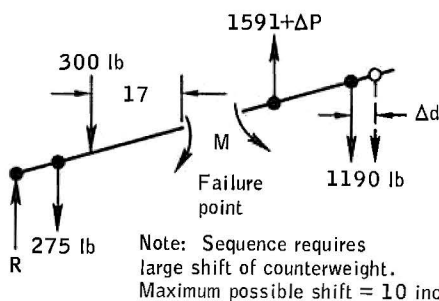
Case 2 - Counter weight shift and shelf contact

Assume shelf contact force to be constant 300 lb and counter weight C.G. adjusted Δd to balance loads
 Moment, M , at failure point: $8500 < M < 16,000$ in-lb

Conclusion: Sequence unlikely

very large movement of the counterweight center of gravity to produce moments consistent with the failure. For example, a shift of 10 inches in center of gravity requires that the counter weights be moved to the out-board stops; moving one counterweight only to achieve this configuration requires a shift of 29 inches. This sequence is considered unlikely.

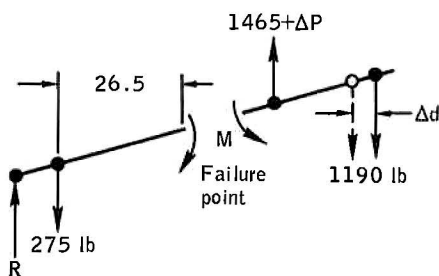
Case 3 - Counter weight shift

Moment, M , at failure point: $8500 < M < 16,000$ in-lb
 Counter weight C.G. adjusted to balance loads:
 Maximum possible shift = 10 inches.

Case 3 postulates adjustment of the counterweight center of gravity to attempt to level the assembly. As noted, this procedure requires less than a 2 inch shift of the counterweight center of gravity to achieve failure of the fixture. This sequence agrees with most of the witness statements and is considered the most probable.

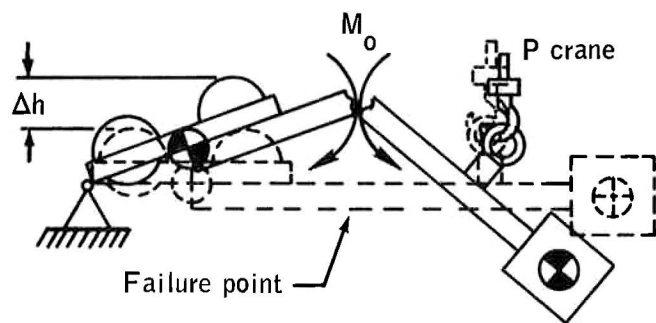
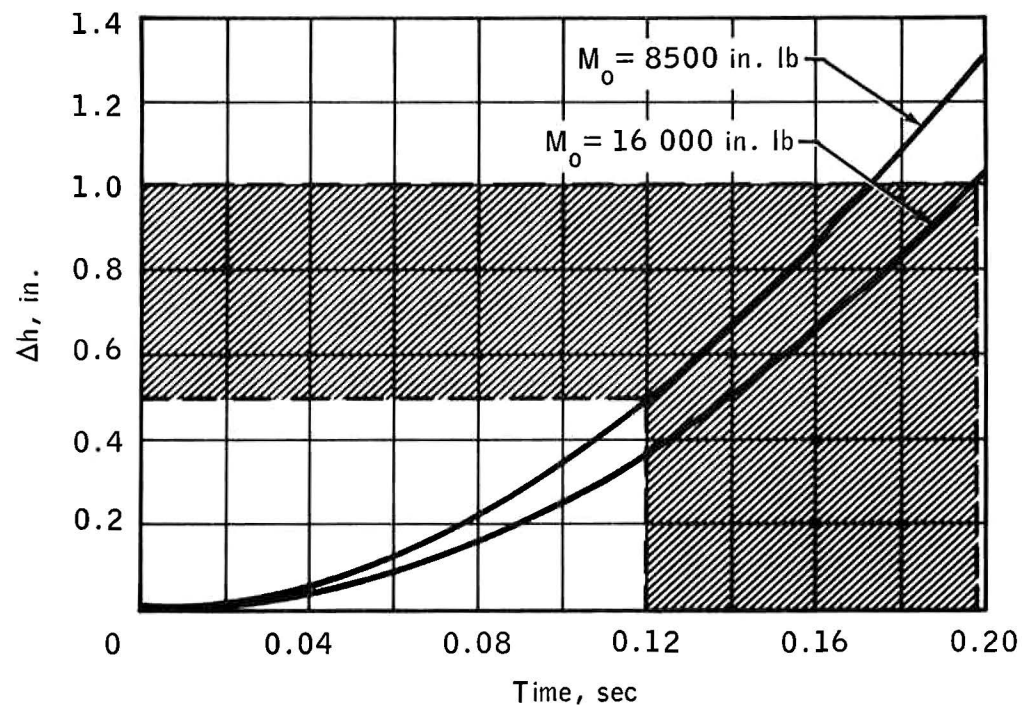
Figure 2-4.- Postfailure dynamics .

Case I.- The rate at which the weld fails, as shown in figure 2-4, determines the displacement and velocity of the top of the tank. Calculated times greater than 0.1 second were required to produce an impact of the tank and the fuel cell shelf. This slow failure of the weld was considered improbable.

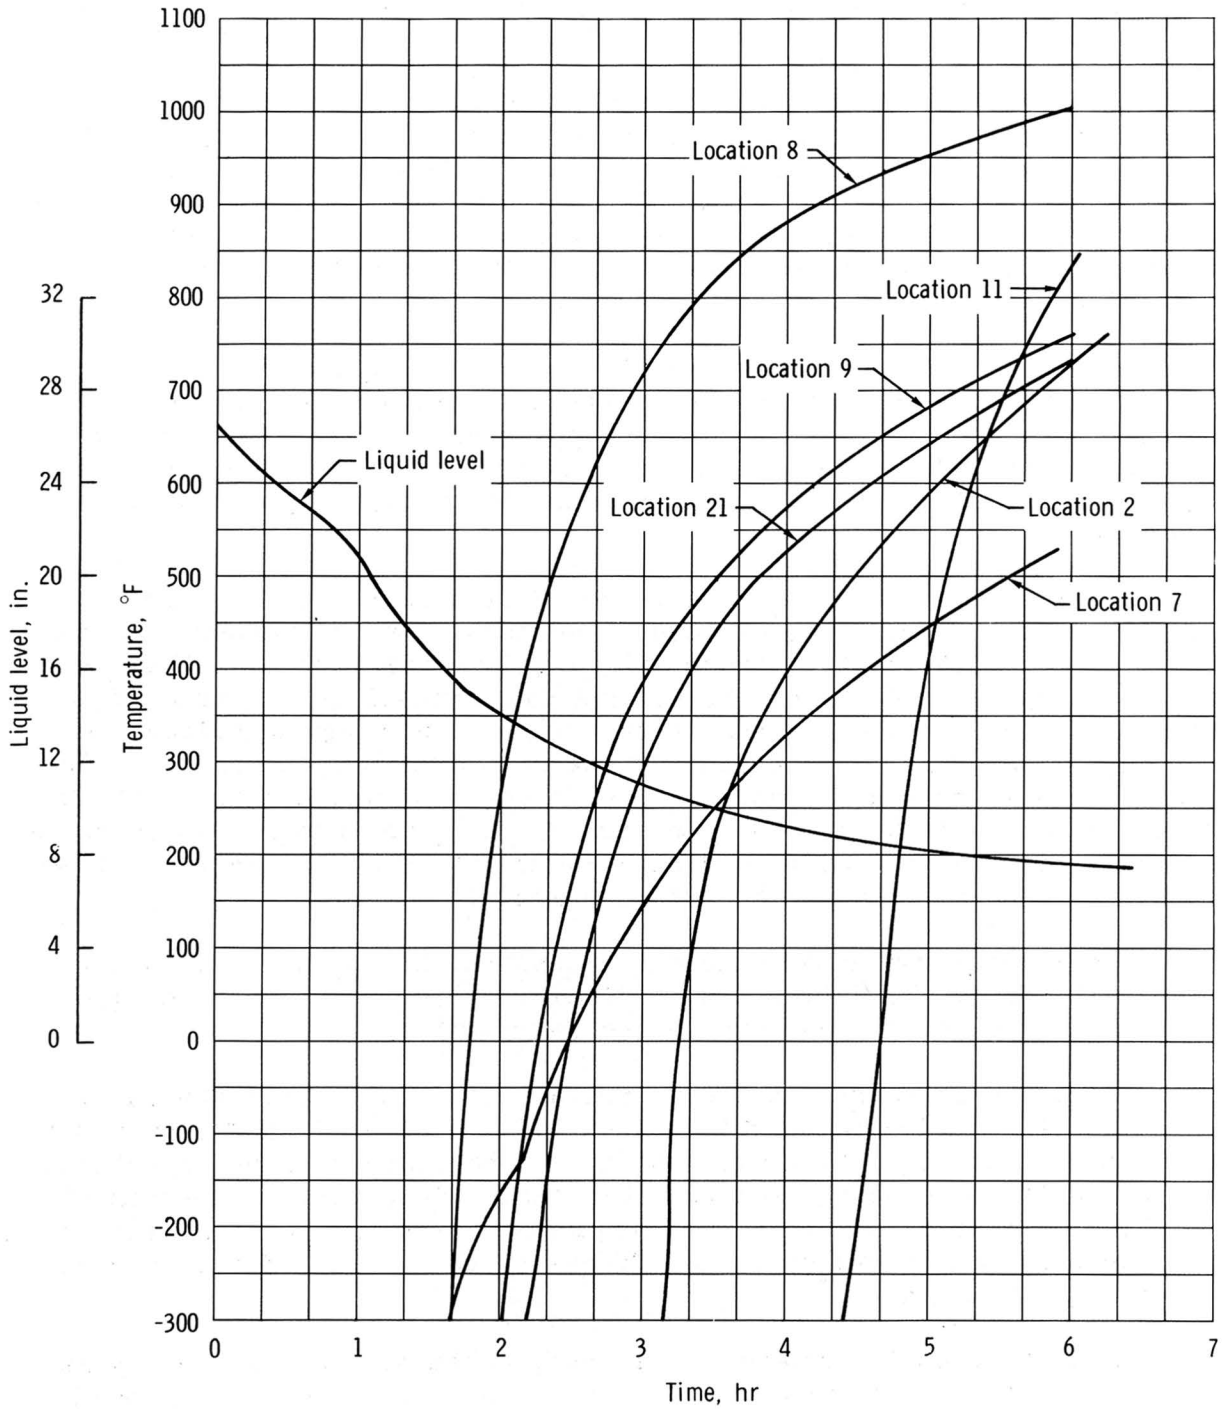
Figure 3-14. - Heater/fan typical test results.

MSC Heater Boil-off Testing.- A spacecraft fan/heater probe (no thermal switches) instrumented with 13 thermocouples, was placed in a full tank of liquid nitrogen (same approximate size as a flight tank). Liquid was then boiled off at ambient pressure by running the fans and heaters continuously. After six hours (fig. 3-14) with the fluid level still two inches above the lower fan, the surface temperature of the uppermost heater coil had stabilized at 1000° F. Directly behind this element, in the inside of the probe, the lower fan wiring is routed through a thin stainless steel conduit touching the .020 inch heater probe wall. All fans and heaters continued to operate for the remaining four hours of the test, with the fan motor case temperature reaching some 350° F.

Post-test disassembly showed that the fan wiring had adhered to the conduit wall (some insulation was torn in its removal); that the insulation had changed composition and was very hard; and that complete circumferential cracking had occurred producing segments of insulation not over 3/4-inch long for a six inch length extending downward from the hottest portion.

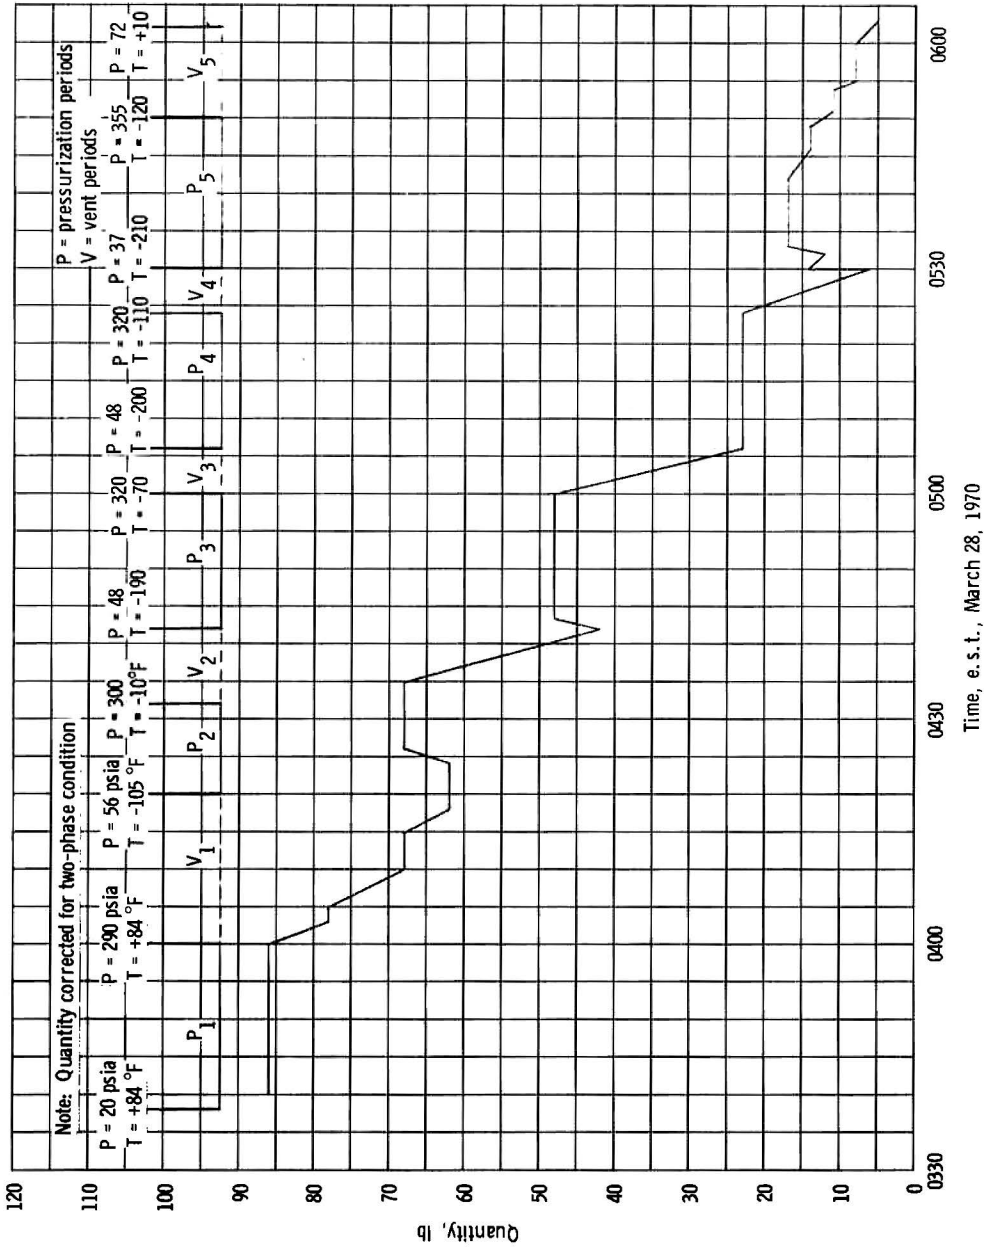
Figure 3-15. - Oxygen quantity during detanking.

From figure 3-15 the maximum detanking rate occurred during the third venting. From the quantity gage readout over the six minute period, the flow rate was 0.07 lb/sec. Since the fluid quantity flowing
