MANNED SPACECRAFT CENTER INTERNAL NOTE

APOLLO 13 CRYOGENIC OXYGEN TANK 2 ANOMALY

ANOMALY REPORT NO. 1

July 1970

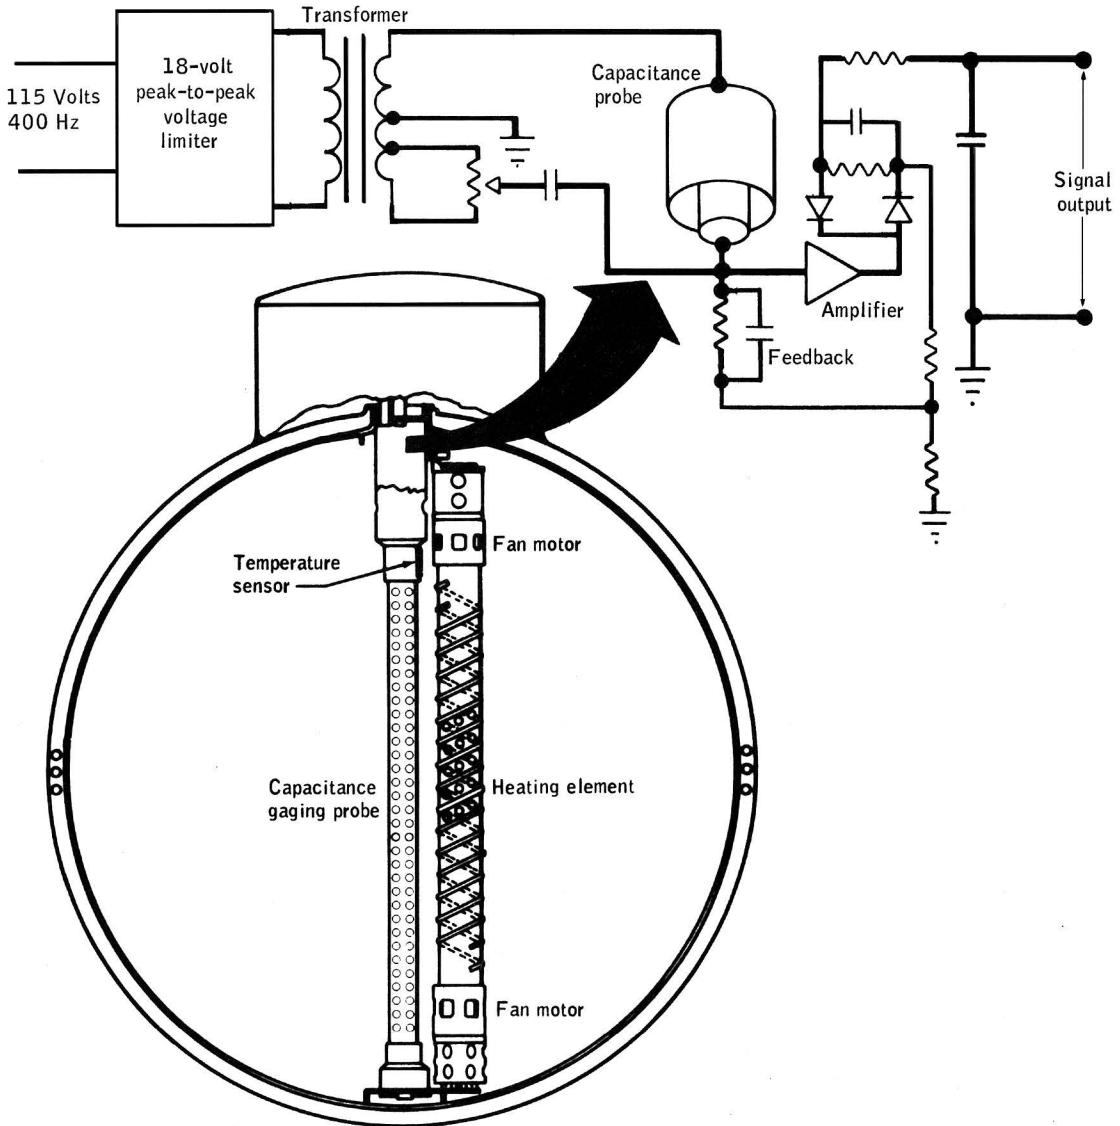
Figure 4-1.- Quantity gage.

The first anomalous inflight condition associated with the cryogenic oxygen tank 2 occurred at 46:40:06 when the ac-powered destratification fans in both cryogenic oxygen tanks were turned on. Within about 3 seconds after fan activation, the quantity measurement for cryogenic oxygen tank 2 abruptly indicated full-scale high. This system indicates density of the cryogenic oxygen by measuring its dielectric constant, which is a function of density. This instrument is a capacitor which consists of two concentric aluminum tubes inside the tank (fig. 4-1).

Tests have shown that an open-circuit in the leads to the capacitor assembly or a short across the capacitor or its leads will drive the output to full scale. If this short-circuit is removed, the output signal drops abruptly from full scale to zero, and then in about a second, it settles out to the proper reading, as noted in the data of figure 4-2. This agrees with the flight data from the quantity probe. Tests also show that if the inner tube is shorted to ground, the output may oscillate in a random manner. Such an oscillation was noted several minutes after data recovery following the incident. It should be noted that with a short-circuit in the quantity gaging system inside the tank, the maximum current that could be drawn is 15 milliamperes.

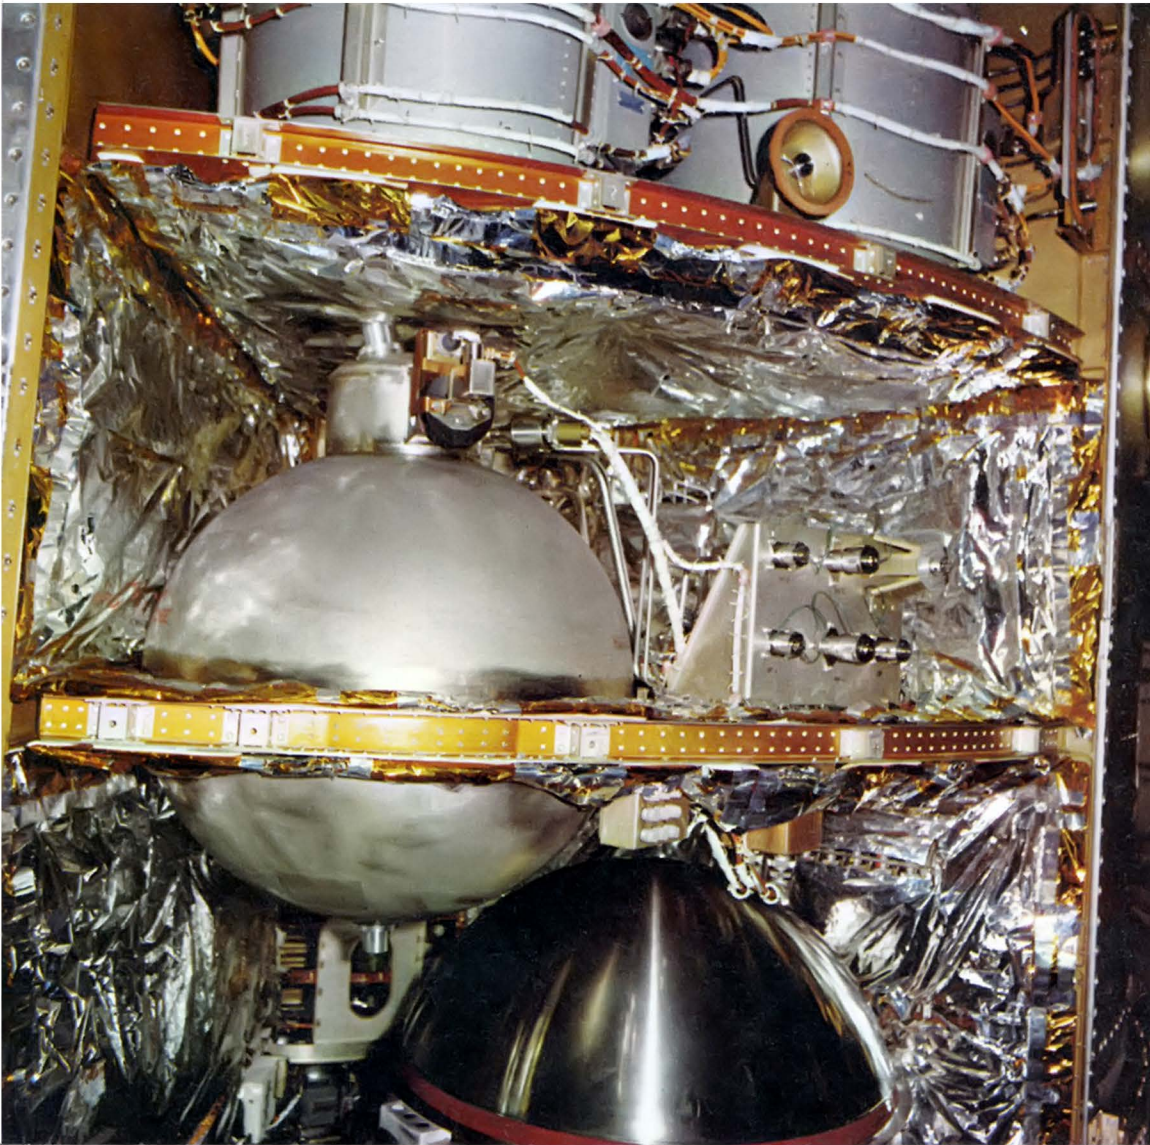
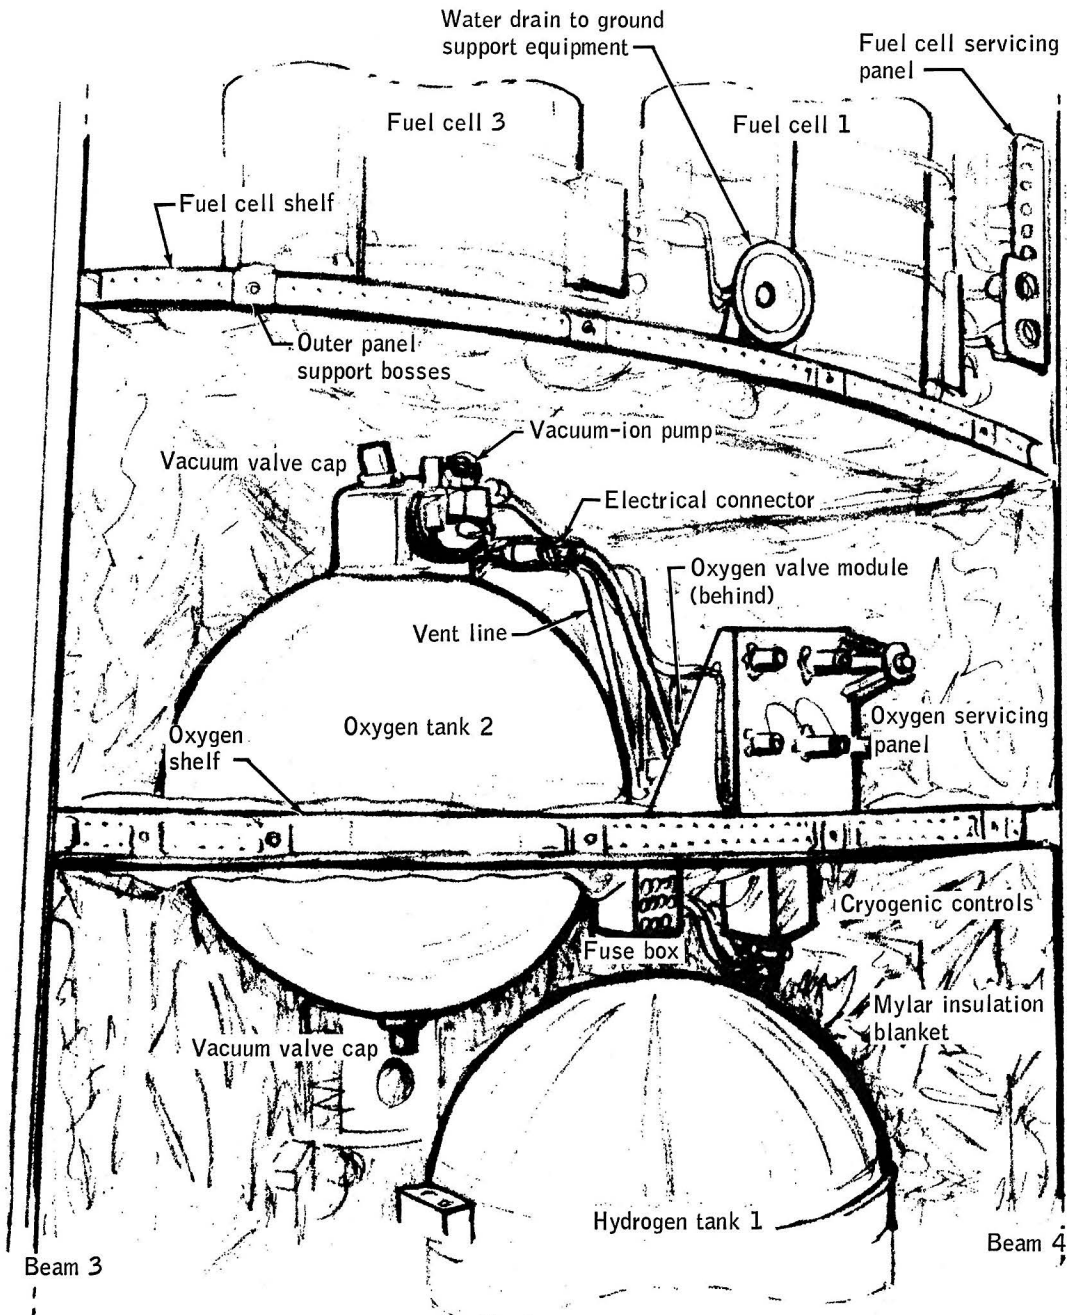
Figure 4-17.- Bay 4 closeout photography.

(a) Cryogenic oxygen tank 2.

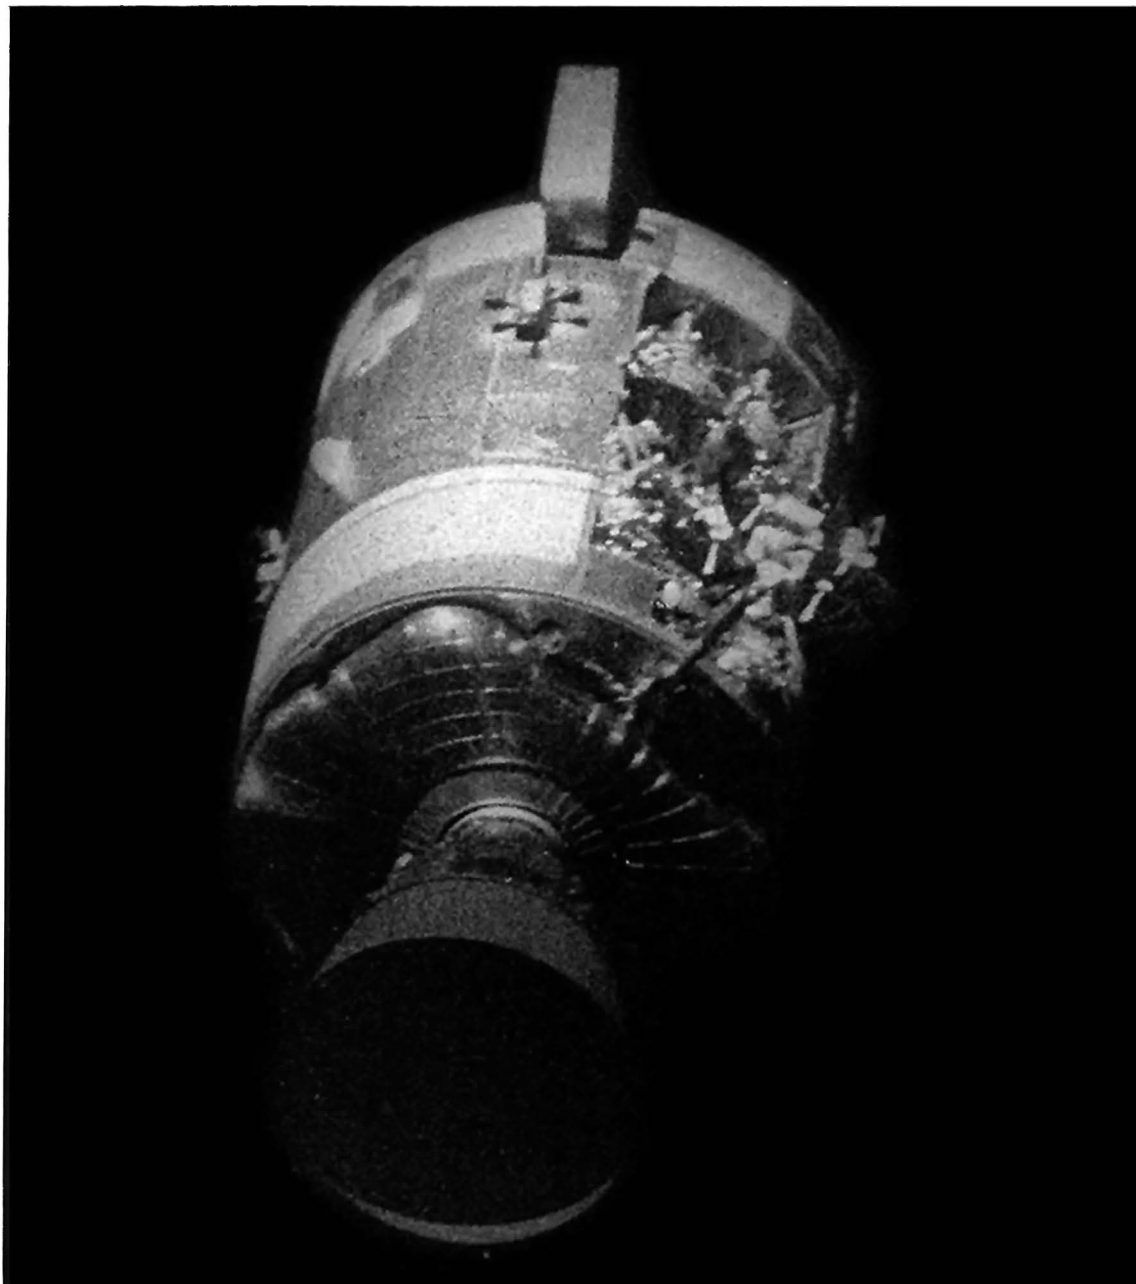
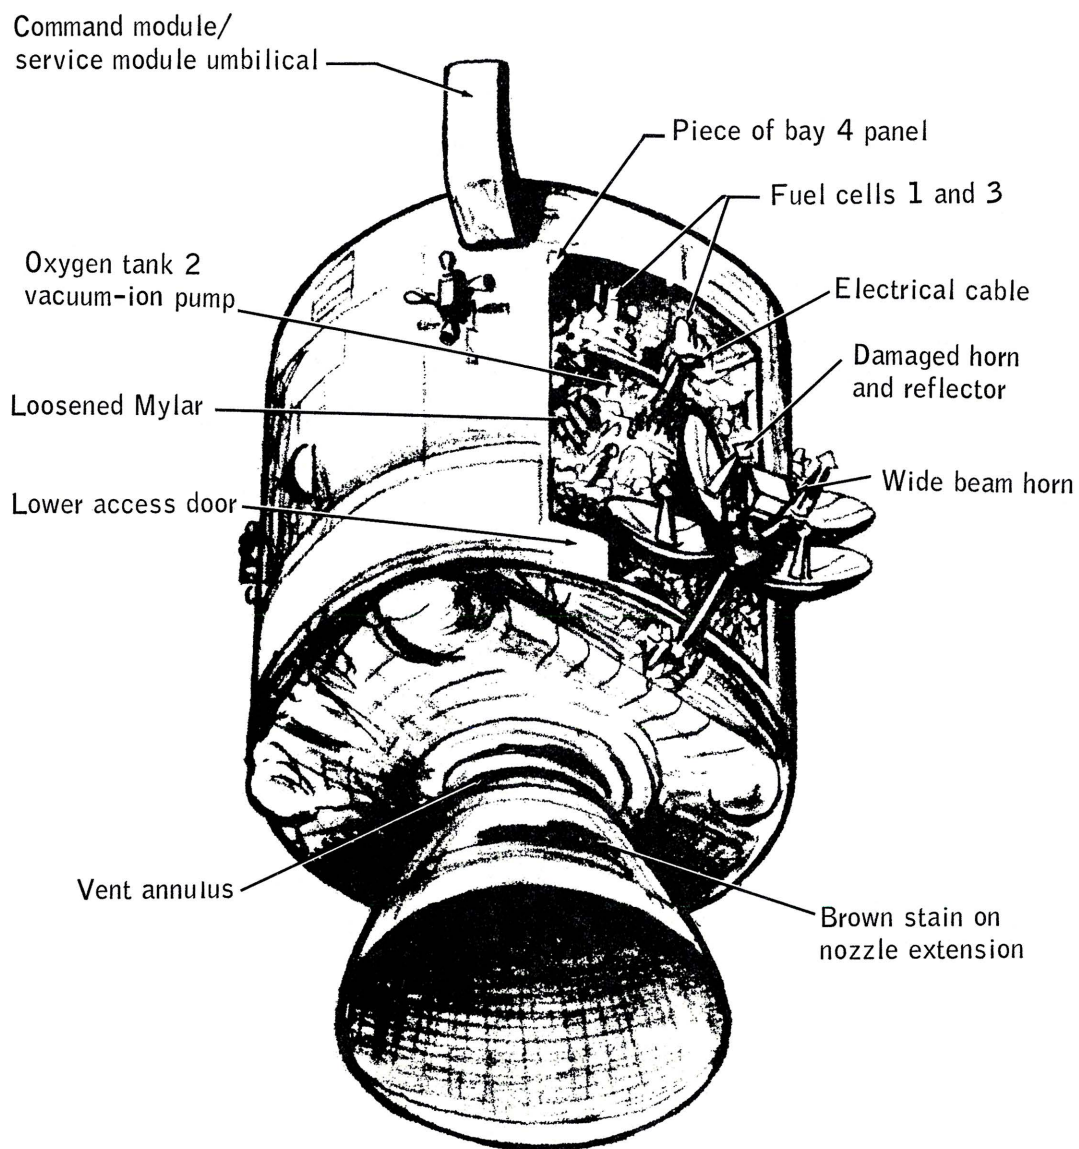
Figure 4-19.- 70-mm black and white film frame 8501.

h. One of the four reflectors and feeder horns for the high-gain antenna was damaged. The attitude of the antenna, with the damaged reflector nearest the service module, had changed since the incident because the gimbals are free to rotate whenever the power is turned off.

i. The oxygen service panel appeared in its normal position, but with considerable loosened Mylar and Kapton in the area.

j. A brown stain was observed on the outside surface of the service propulsion system engine nozzle extension, near the plus Z axis, and in line with the vent path from the vent annulus around the nozzle.

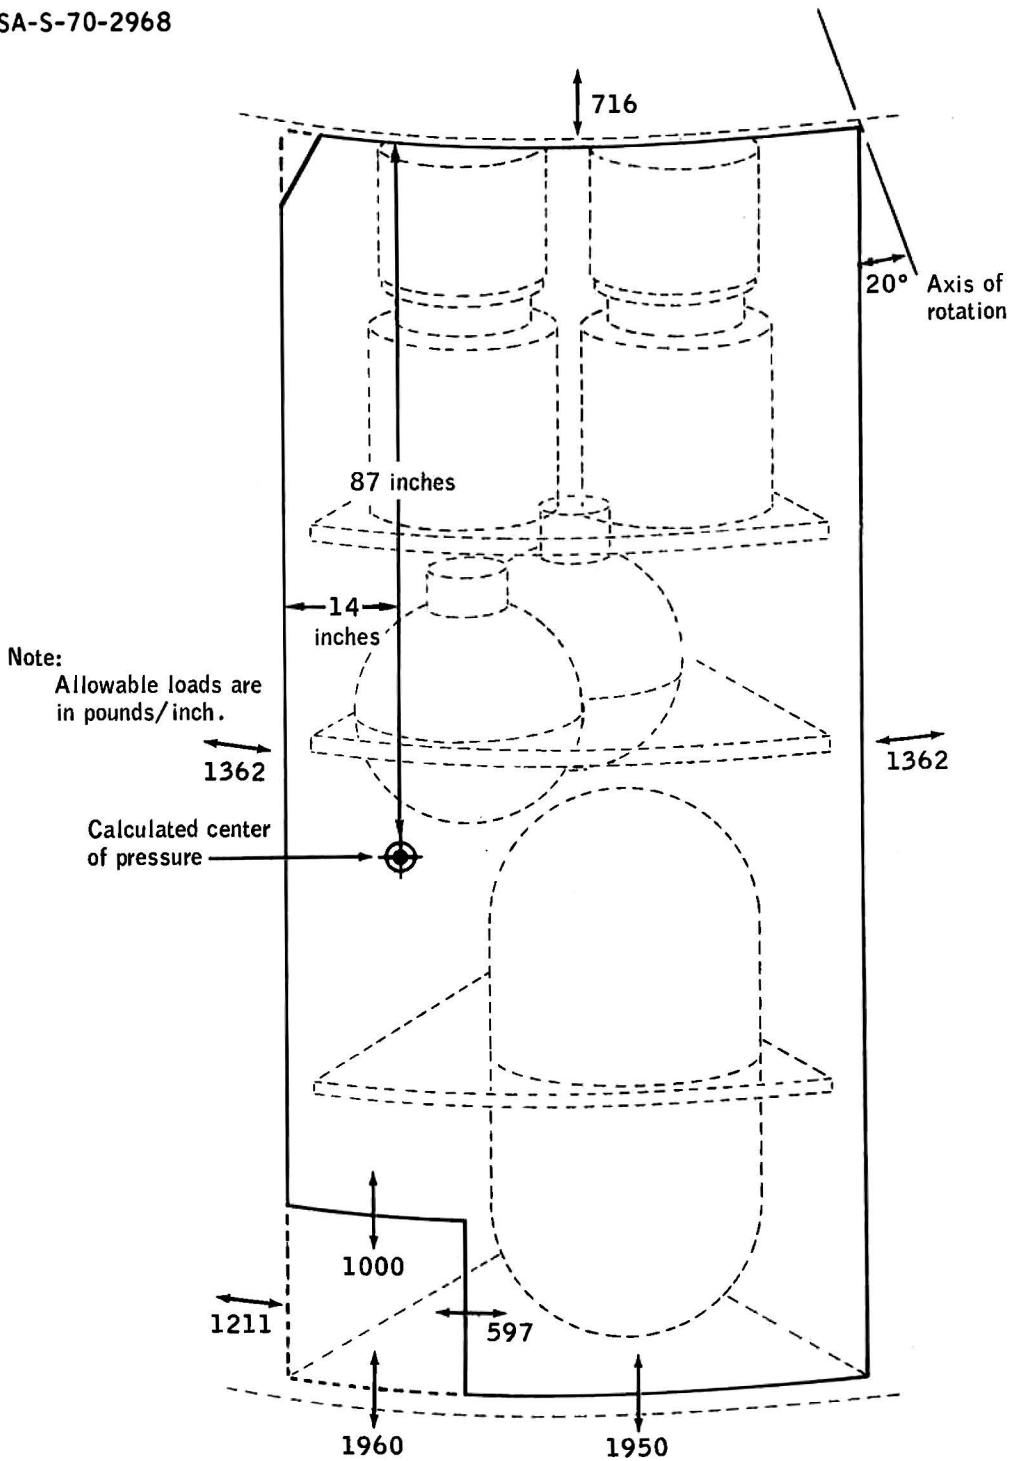
Figure 4-23.- Joint design allowables and axis of rotation.

Two simplified limiting cases may be used to describe the basic structural behavior of the panel. The first considers the panel as a flat plate supported on all edges. In this case the panel transfers loads to the boundary by bending. The second case considers the panel as a pure membrane which transfers loads into attachments by in-plane extension. The photographs of the service module show failure at the attachments along all the boundaries except for a small piece of structure (approximately 6 by 4 inches) in the upper left-hand corner (viewed from the exterior). If the panel behaved as a flat plate and failed cleanly at the attachments, the bolts would fail in tension at approximately 5100 pounds per bolt. This load on the bolt would require a shear load in the adjacent core of 785 pounds/inch which is greater than 3 times the core-failure load. Since no facesheet nor core is evident along the edge, the structure did not behave as the simplified model of a flat plate.

Because of the evidence which suggested primarily membrane behavior, simplified representations of the structure were used to investigate its behavior. Structural analyses were performed for numerous pressure distributions as well as for temperature gradients for both hot and cold inner facesheets. The results show that the peak pressure must exceed 20 psi and that temperature gradients of interest result in small edge loads. The static allowables for failure with a failure mode of shear tearout are shown in figure 4-23.

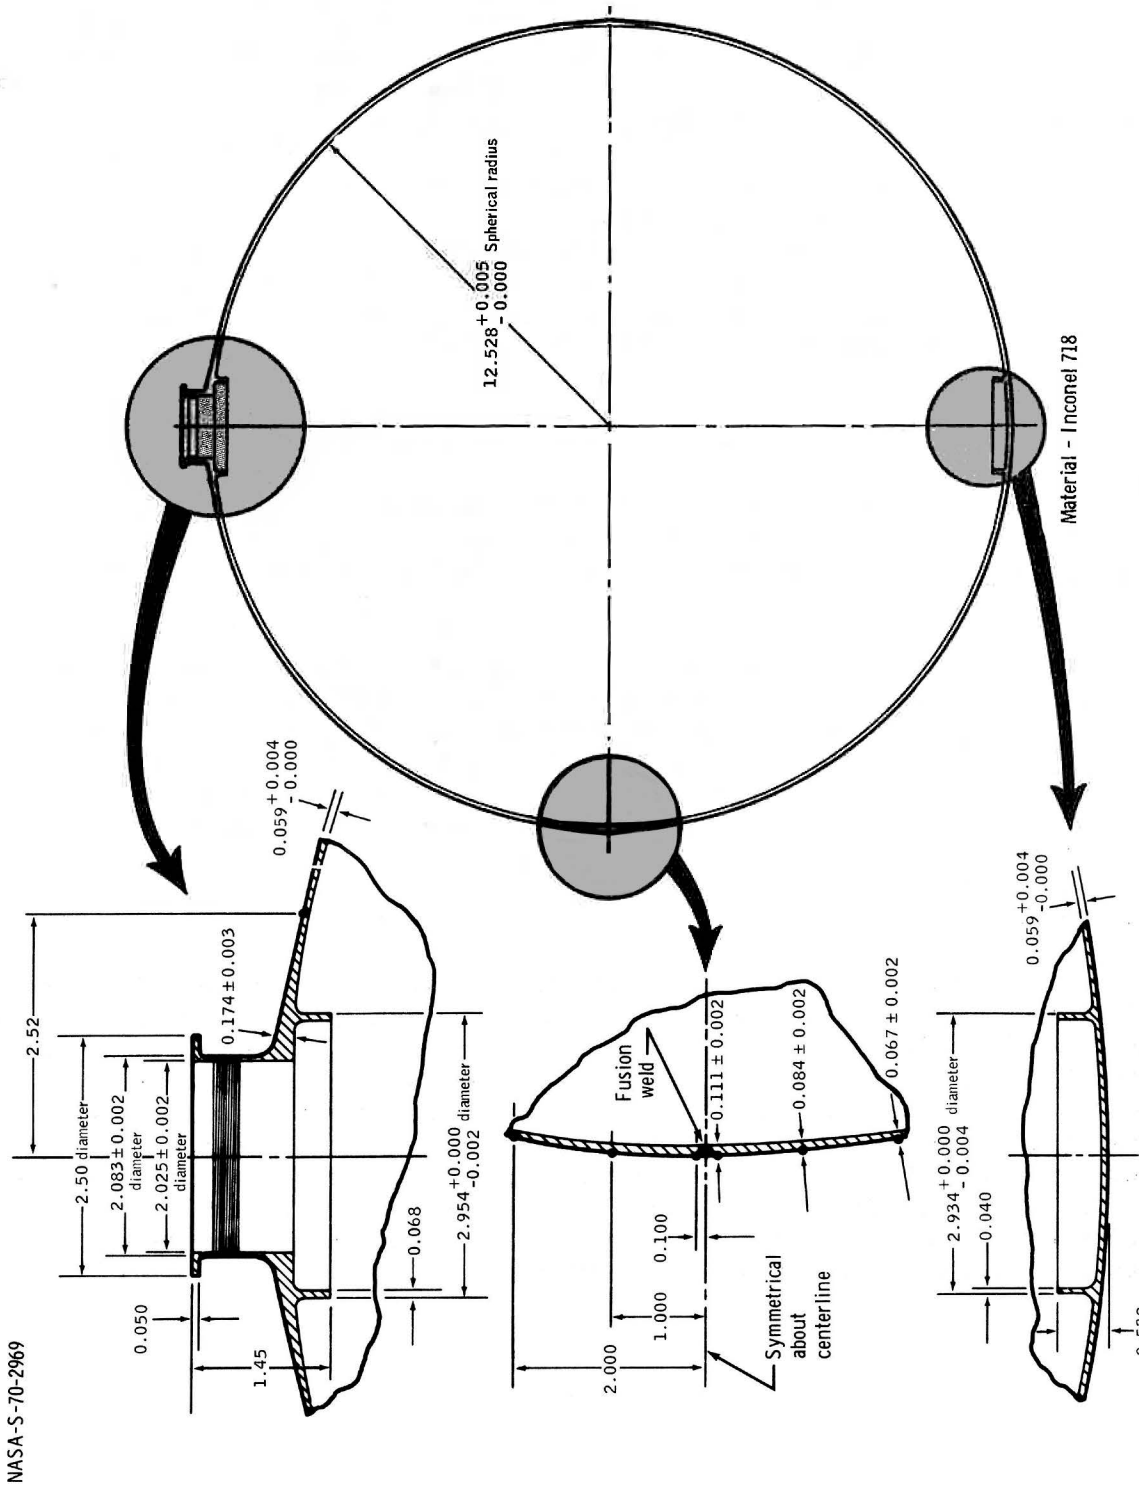
Figure 4-24.- Cryogenic oxygen tank, pressure vessel.

The cryogenic oxygen tank is fabricated from Inconel 718 and is composed of two hemispheres assembled by fusion welding. A sketch of the tank is shown in figure 4-24. The basic wall thickness of 0.059 inch with increasing thickness at the welds and boss areas. The inside radius is 12.528 inches. The limit design pressure (maximum operating pressure) is 1025 psi, proof pressure is 1367 psi, and design burst pressure at ambient temperature is 1538 psi. Structural analyses have predicted a positive margin at design conditions; burst tests using liquid nitrogen demonstrated burst strengths in excess of 2200 psi. Preflight fracture mechanics analysis of cryogenic oxygen tank 2 predicted that no flaw propagation would occur until a pressure of 1050 psi was reached and that the failure mode at pressures less than 1240 would be leakage.

Localized heating of the tank material is the probable mode of the loss of tank pressure integrity and is supported by all known test analyses and by telemetry data. Considering that only polytetrafluoroethylene was burning in the tank, then the only place where the polytetrafluoroethylene comes close to, or touches, the pressure vessel wall is in the electrical conduit. Tests of burning insulation in the electrical conduit shows that in a few seconds the generated heat fails the tube. Following the tube failure, the pressure in the annulus region would rapidly rise until the exterior shell burst disk (approximately 3 square inches) would rupture at approximately 80 psia.

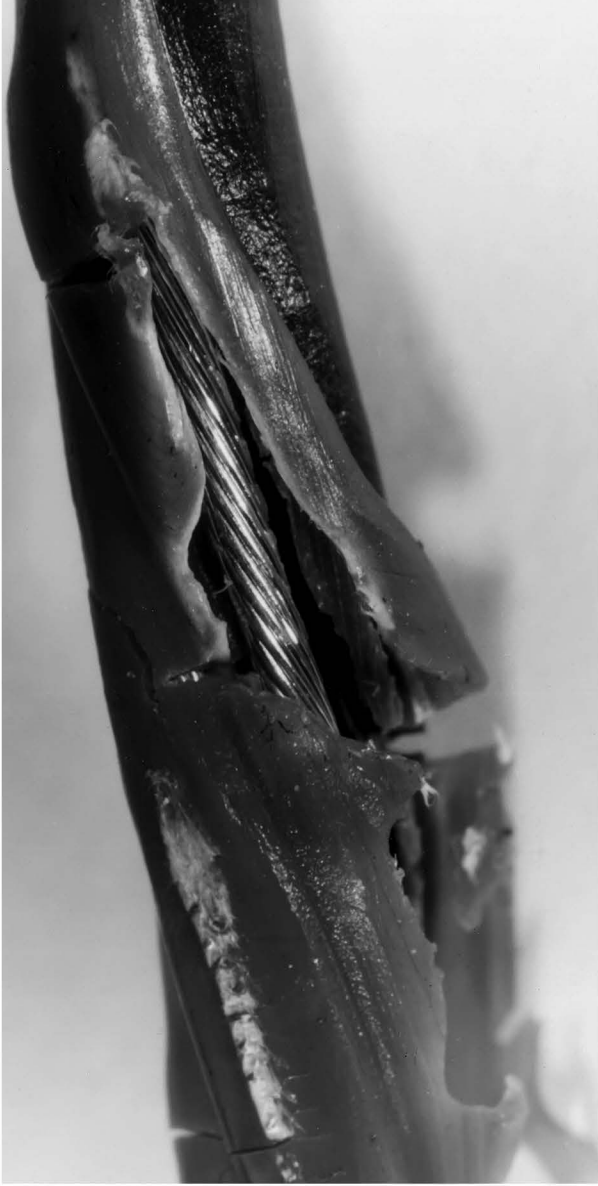
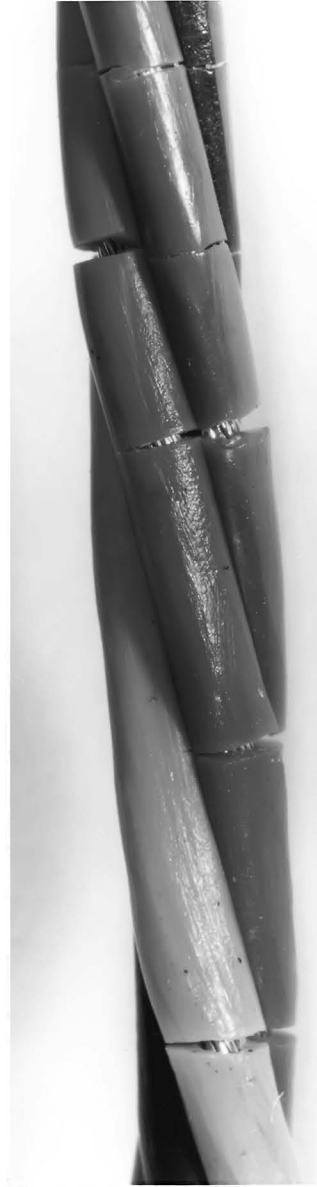
Figure 4-43. - Fan motor wire damage from heater tests.

This test showed that insulation will be severely damaged by the abnormal heater operation so that numerous locations for electrical shorts or arcs are available when the fan circuits are powered.

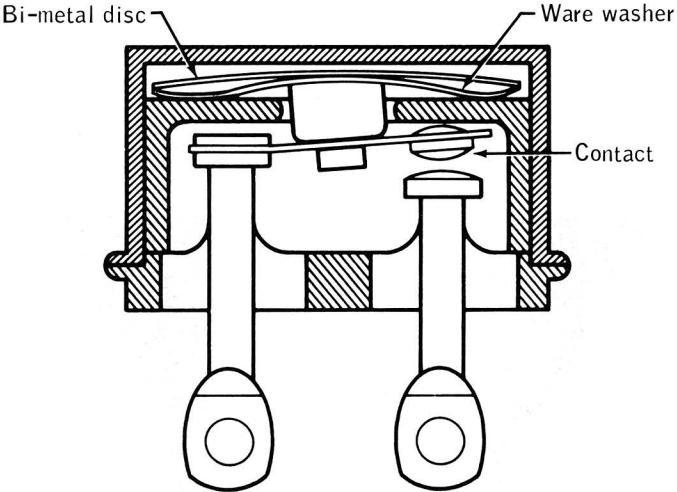
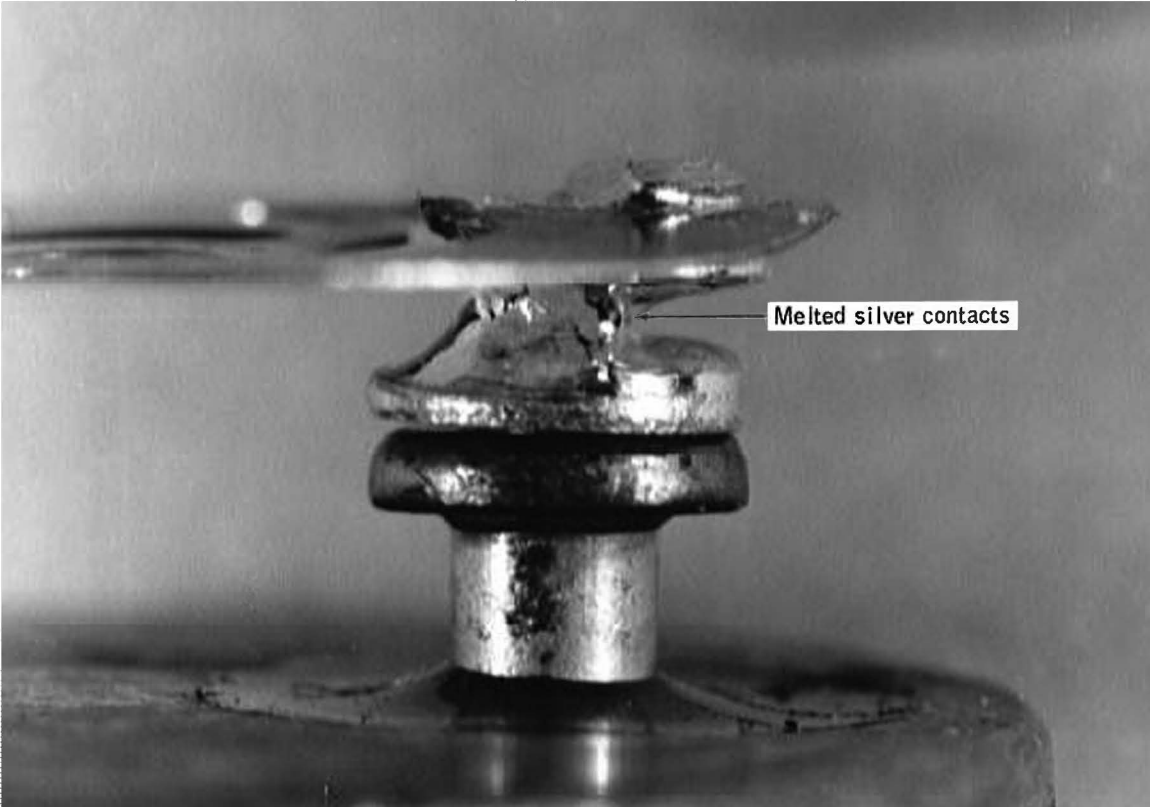
Figure 5-5.- Heater thermal switch.

The thermal switches, which normally open at about 80° F, show no sign of operation from the heater voltage data. Inflight, these switches have not operated due to the temperatures in the tank. Further, the switches in the past have not operated under a load on the ground, and they were not designed or tested for this condition.

(b) Welded contacts after test.
