APOLLO 13 MISSION
HIGH-GAIN ANTENNA ACQUISITION PROBLEM

ANOMALY REPORT 2

MANNED SPACECRAFT CENTER
HOUSTON, TEXAS
December 1970

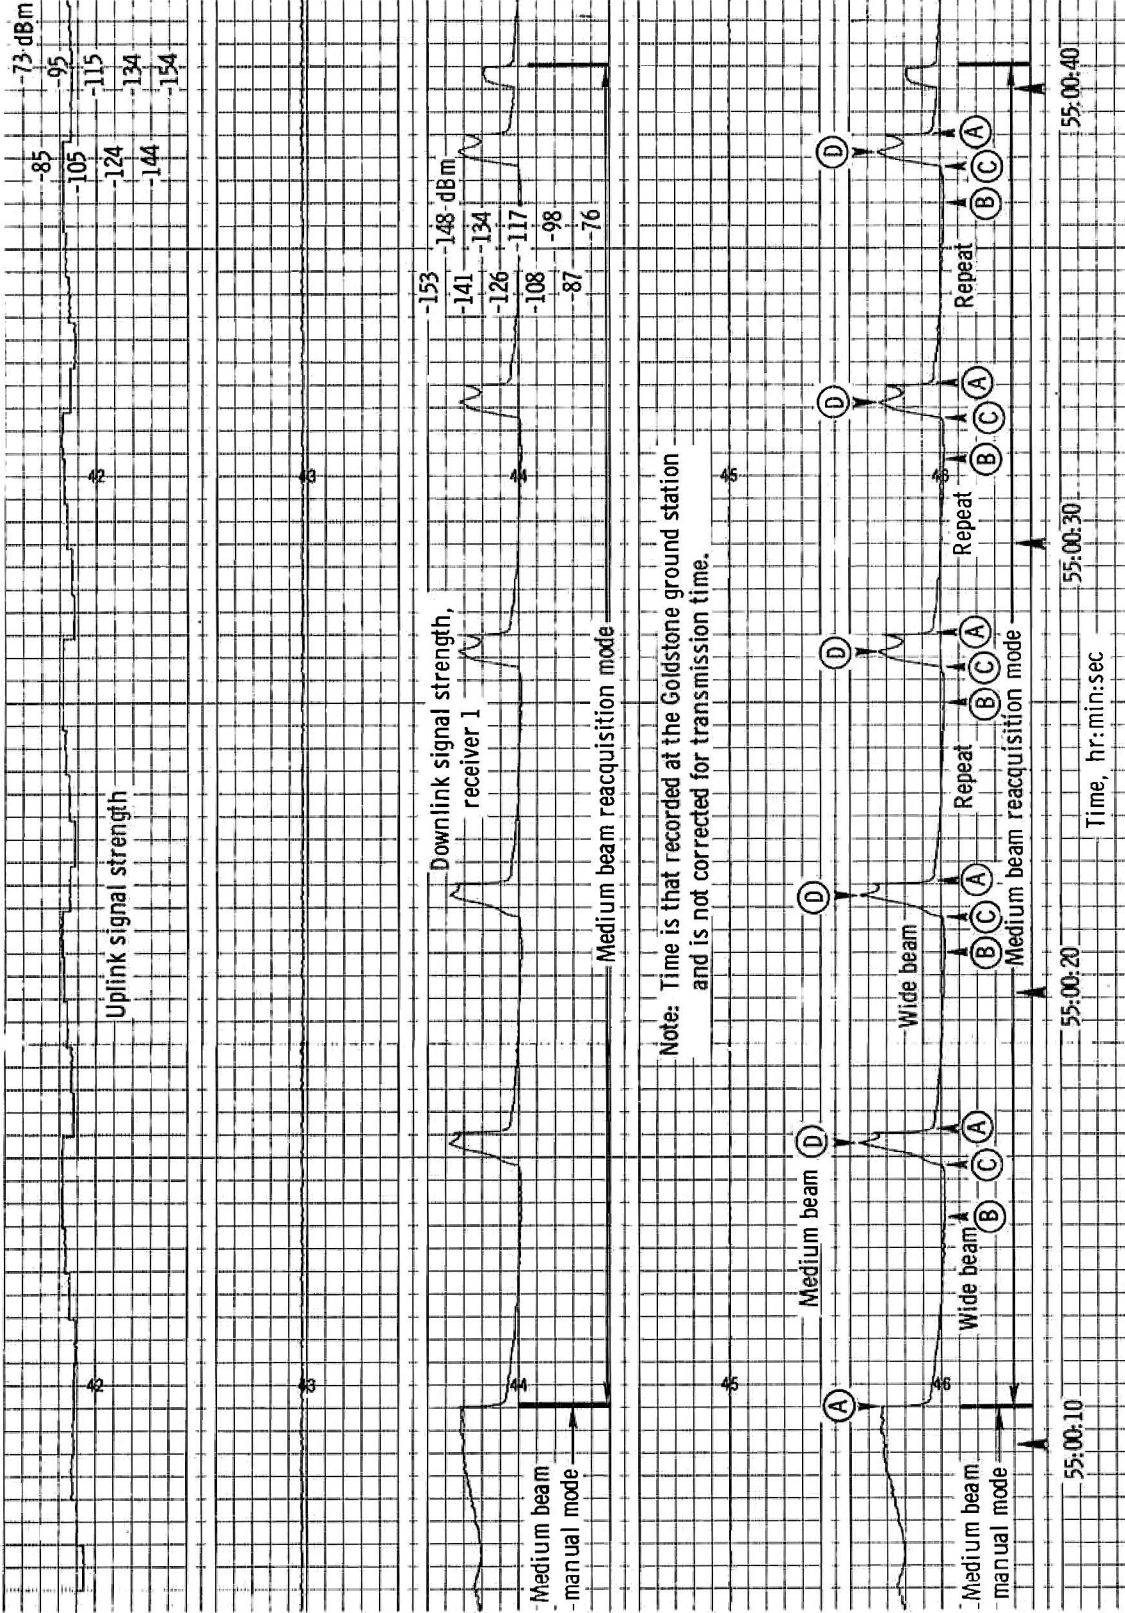
Figure 1. - Recorded signal strengths during high gain antenna operation.

At 55:00:10, the reacquisition mode was selected. Starting at 55:00:10 and continuing to 55:00:40, deep repetitive transients were noted approximately every 5 seconds on the phase-modulated downlink carrier and the antenna would not lock up and track.

At the time of the anomaly, the antenna boresight axis was approximately 35° away from the line-of-sight to the ground station because, 7 hours earlier, the Command Module Pilot had manually adjusted the antenna to the ground-requested settings of plus 23° in pitch and 267° in yaw. The most favorable settings for 55 hours were actually plus 5° in pitch and 237° in yaw. When the transmission was switched from the omnidirectional antenna to the manual mode of the high-gain antenna, there was a 6-dB decrease in uplink signal strength and a 17-dB decrease in downlink signal strength. With the high-gain antenna in the wide-beam mode and nearly boresighted, the uplink and downlink signal strengths should have been at least equal to the signal strength obtained with the omnidirectional antenna. A comparison of the wide-, medium-, and narrow-beam transmit and receive patterns indicates that the high-gain antenna was in the medium-beam, manual mode at the time of acquisition and remained in this configuration until the reacquisition mode was selected at 55:00:10. Starting at 55:00:10 and continuing to 55:00:40, deep repetitive transients occurring approximately every 5 seconds were noted on the phase-modulated downlink carrier (fig. 1).

The antenna functions which caused the cyclic inflight RF signatures resulting from a shift in the function lines can be explained with the aid of figures 1 and 2, with the letters A, B, C, and D corresponding to events during the cycle. Starting at approximately 55:00:10, the antenna was switched from manual to auto reacquisition with the beam select switch in the medium-beam position. From point A to the scan-limit function line just prior to point B, the antenna acquired the earth in wide beam. When the antenna reached the scan-limit function line, the antenna control logic switched the system to the manual mode and drove back toward the manual settings until the scan-limit-warning function line at point C was reached, thereby maintaining wide-beam operation. When the antenna reached the scan-limit-warning function line, the system automatically switched to the medium-beam mode and continued to drive in the manual mode until the manual setting error was nulled out at point A. The antenna control logic then switched to the auto-track mode and repeated the cycle. The most important feature of this cycle is that the antenna moved at the manual scan rate between points B and D, which is confirmed by the rapid changes in the downlink signal strength.

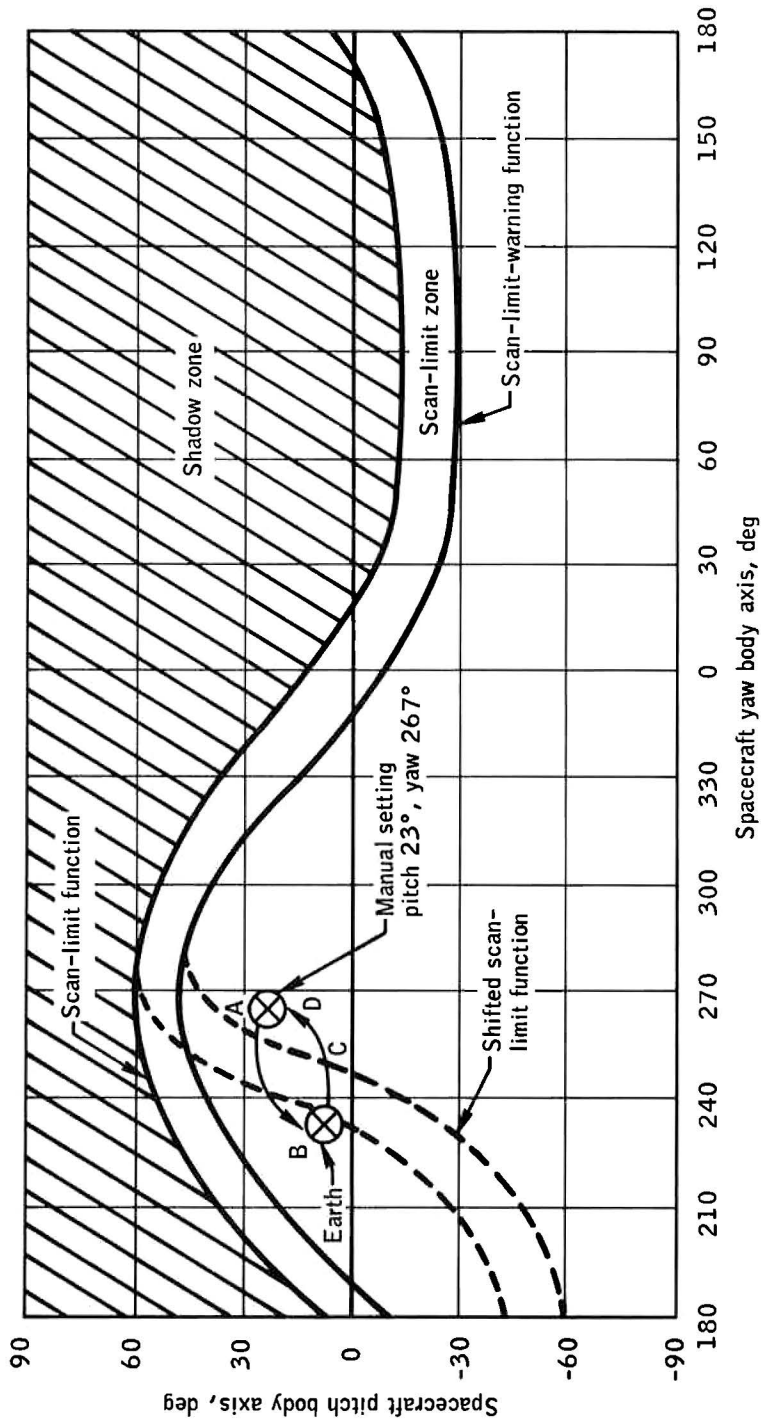
Figure 2.- Shift in scan-limit and scan-limit-warning function lines.

Most probably, a short occurred in the primary winding of the C-axis induction potentiometer which resulted in an effective shift in the scan-limit and scan-limit-warning functions.

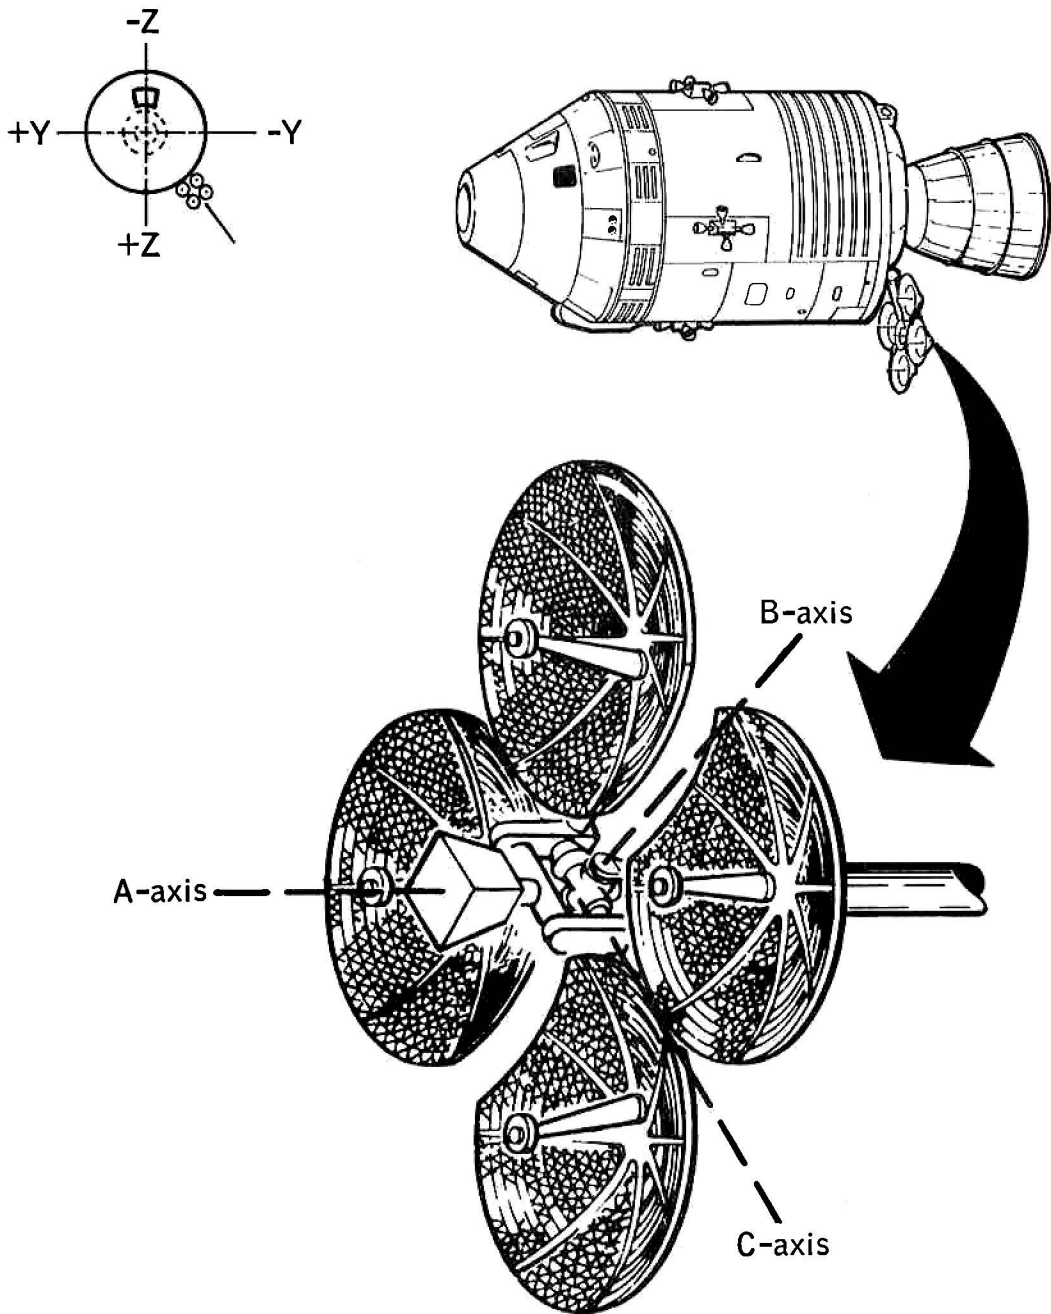
Figure 3.- Antenna gimbal axes.

The scan-limit and scan-limit-warning functions are generated by the C- and A-axis angles. The C- and A-axes are shown in figure 3. Figure 4 shows the scan-limit and scan-limit-warning function lines in the antenna coordinate (C- and A-axes) system. The C-axis and A-axis angle signals are generated in the high-gain antenna gimbals by two separate induction transducers. The C-axis signal comes from a linear induction potentiometer. The A-axis signal comes from a device similar to a synchro resolver. The A-axis signal is then half-wave, phase-sensitive demodulated, and the C-axis signal is half-wave rectified. The two signals and a dc bias are then summed by a differential amplifier shown on figure 5. The output of this summing amplifier is then compared to another dc bias voltage in a second differential amplifier. When the output of the first amplifier exceeds the dc bias supplied to the second amplifier, the second amplifier switches, indicating to the antenna logic that the scan-limit line has been reached. A similar circuit implements the scan-limit-warning line.

a. The high-gain antenna is pointed using 3 gimbals (fig. 3). The B-axis is nulled out for A-axis and C-axis tracking and is used only for tracking where the boresight to the target passes close to the end of the antenna boom. The B-axis drive is then used to eliminate the requirement for high A-axis slewing rates. B-axis offset could not have caused the problem because if a maximum possible offset of about 20° existed, the A-axis and C-axis track loops would have detected and nulled out the offset without driving into the scan limit.

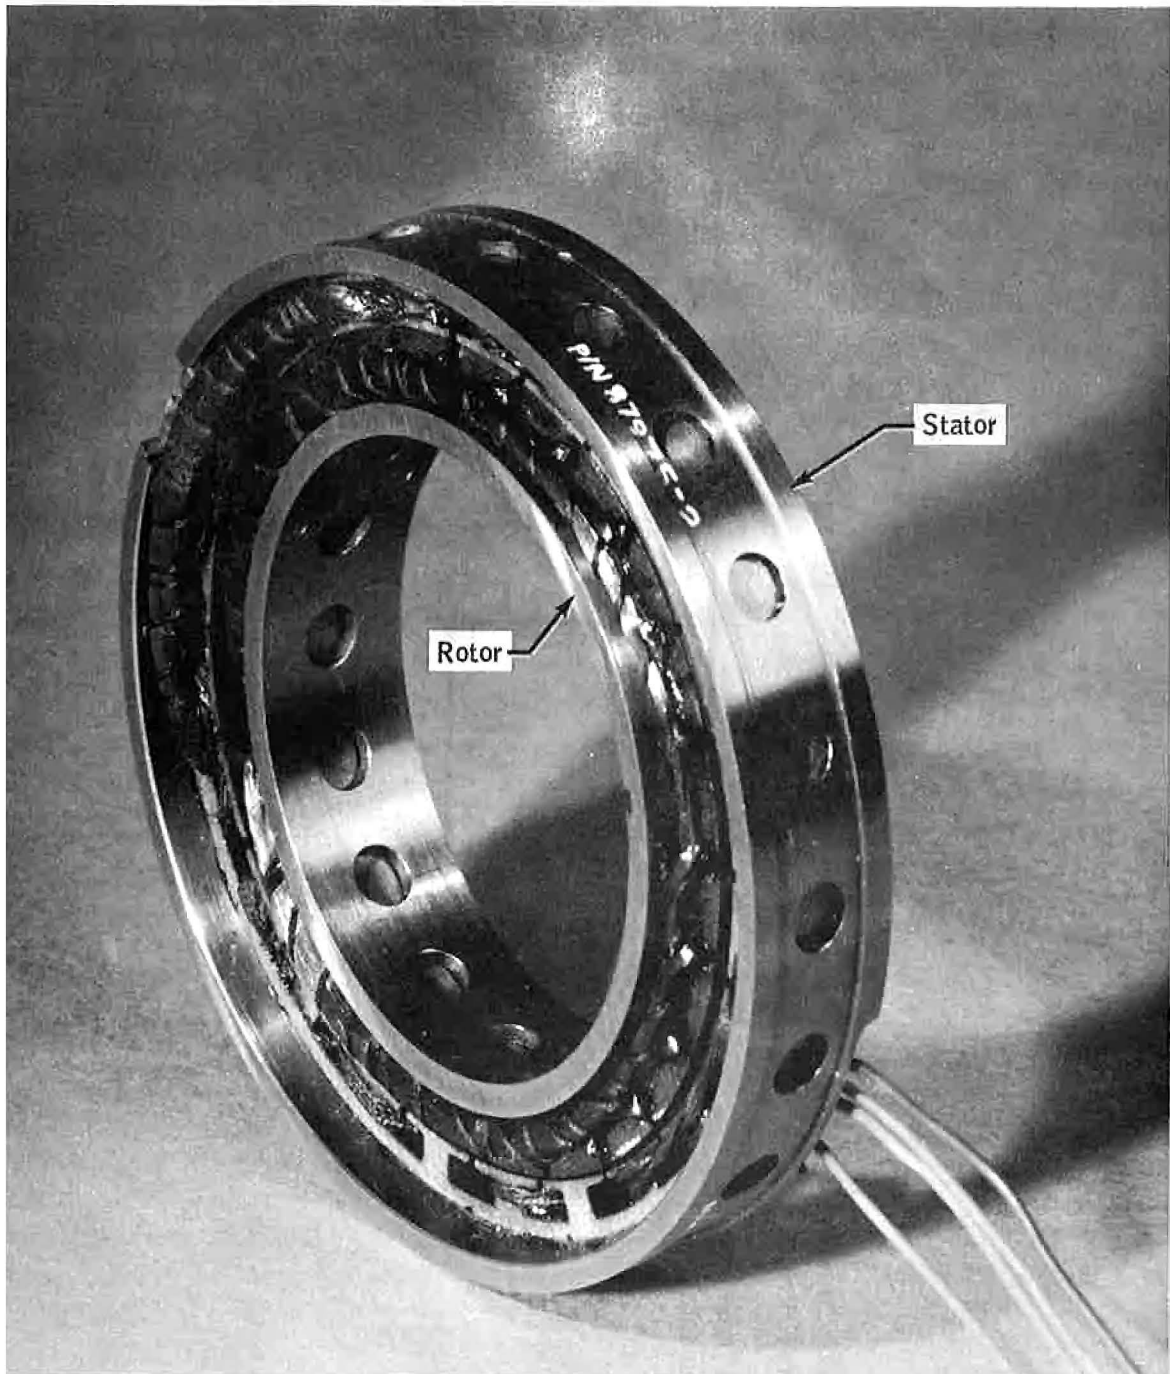
Figure 6.- C-axis induction potentiometer.

The only component identified with a failure mode that would produce a shift in the scan-limit functions and a slope change is the C-axis induction potentiometer located in the antenna. This potentiometer (fig. 6) is used to provide a voltage proportional to the C-axis angular orientation. It consists of three separate coils, each with a symmetrical winding on opposite sides of the rotor or stator. These coils include the primary winding on the stator: the compensation, or bias, winding on the stator; and the linear output winding located on the rotor. The bias winding is used to shift the normal $\pm 70^\circ$ linear output to a new linear output over the range of from minus 10° to plus 130° .

Tests have been added at the launch site to ensure proper scan-limit and scan-limit-warning functions prior to flight. In addition, a procedure has been developed to determine acceptable spacecraft attitudes for high-gain antenna operation in the event another scan-limit shift occurs on a future flight.

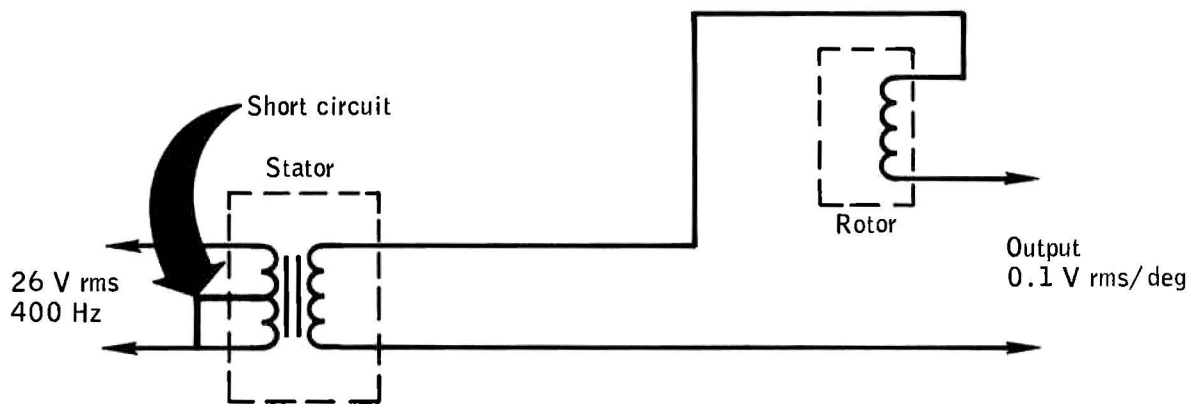
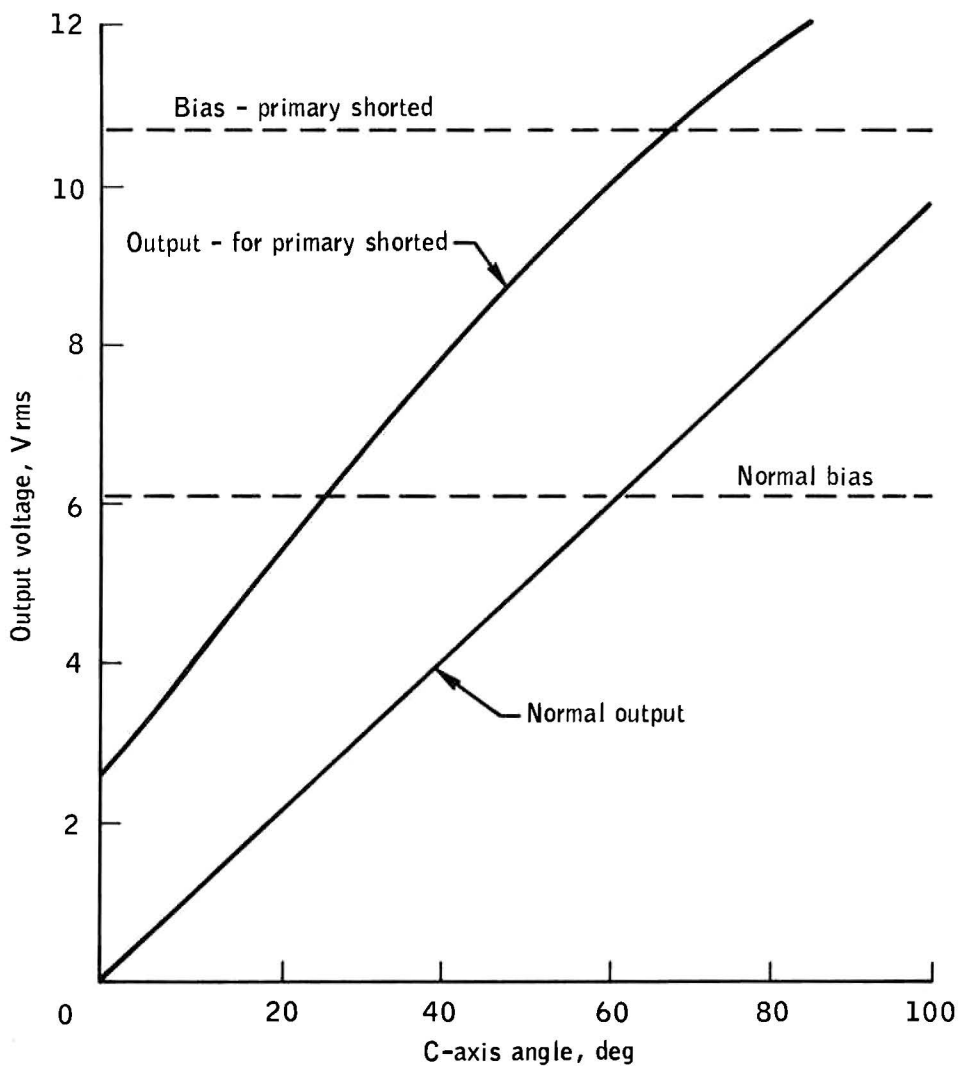
Figure 7.- C-axis induction potentiometer schematic and operational characteristics.

Shorting one-half of the primary winding of the stator to ground would produce a greater slope in the curve of the induction potentiometer output voltage compared with angular travel. This short would also produce nonlinear effects because the magnetic flux would be concentrated in one-half of the primary winding. The normal transfer function of the potentiometer and the transfer function required to produce the flight anomaly are shown in figure 7.
