NATIONAL AERONAUTICS AND SPACE ADMINISTRATION

APOLLO 13 MISSION
5-DAY REPORT

MANNED SPACECRAFT CENTER
HOUSTON, TEXAS
APRIL 1970

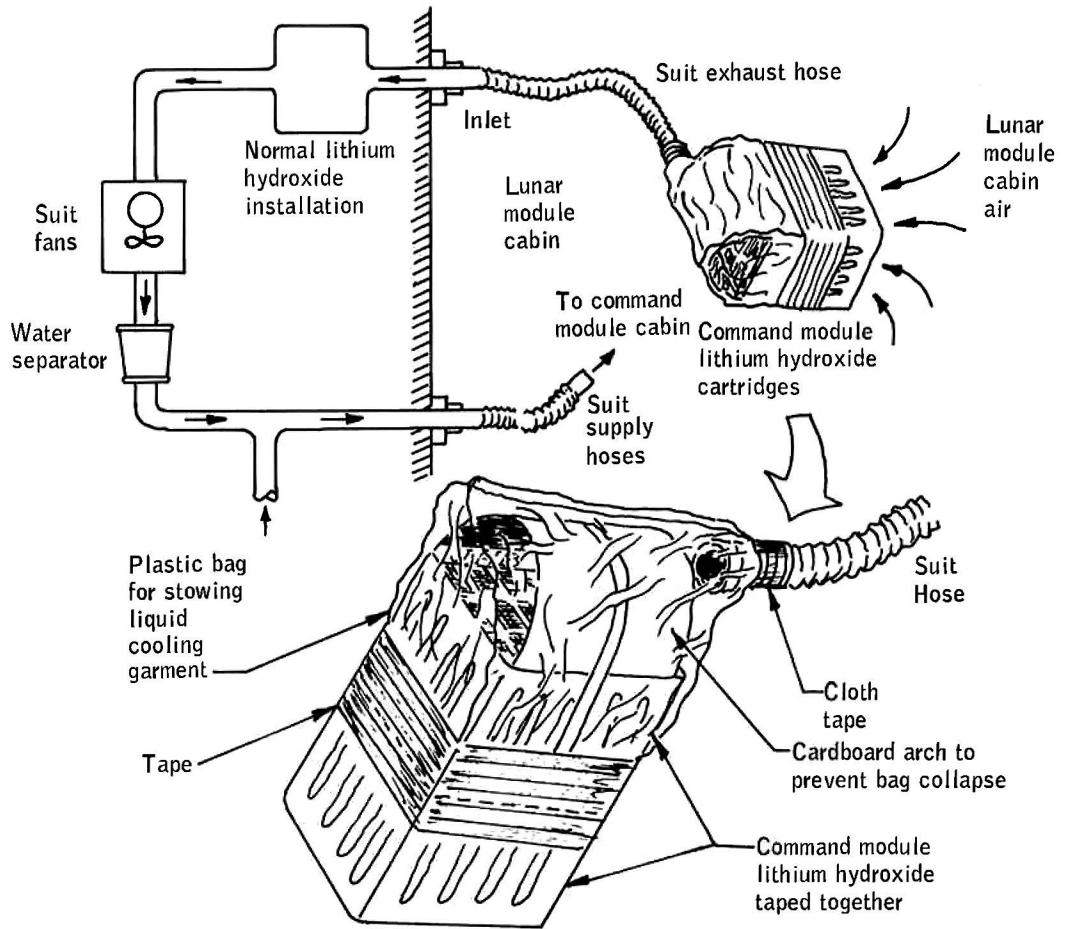
Figure 1.- Supplemental carbon dioxide removal system.

To provide supplemental carbon-dioxide removal capability to the lunar module, four command module lithium hydroxide cartridges were improvised into the oxygen supply loop using command module hoses, liquid-cooled-garment bags, and tape (fig. 1). This arrangement proved extremely successful since the partial pressure of carbon dioxide never exceeded 7.6 mm Hg while using command module cartridges.
