NATIONAL AERONAUTICS AND SPACE ADMINISTRATION

APOLLO 13
30-DAY FAILURE AND ANOMALY LISTING REPORT

MANNED SPACECRAFT CENTER
HOUSTON, TEXAS
MAY 1970

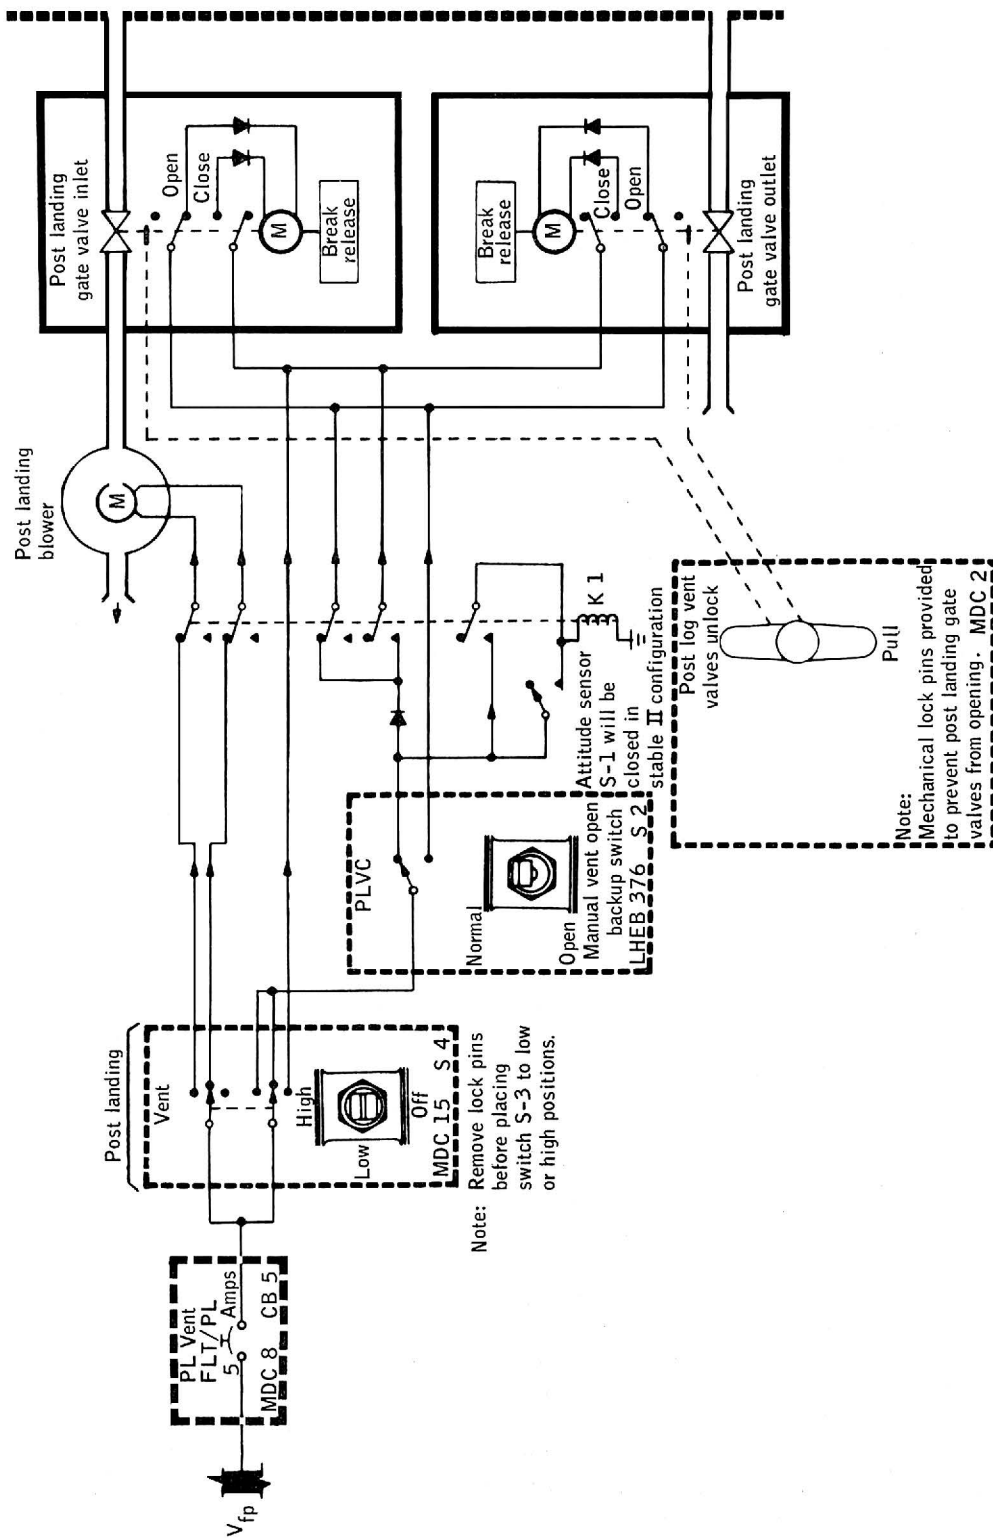
Figure 1.- Post landing vent valve control circuit.

During postlanding activities, the recovery forces discovered that the postlanding ventilation valve inlet was closed and the exhaust was open.

The ventilation valve is opened by first pulling the postlanding vent valve unlock handle on panel 2 (fig. 1). The handle is attached by a cable to two pins which mechanically lock the ventilation valves closed.

Once the handle is pulled, the postlanding vent switch on panel 15 is placed to either high or low with the postlanding vent valve switch on panel 376 in normal. This operation opens both ventilation valves and actuates the postlanding blower. An attitude sensing circuit is installed to close the valves if the spacecraft is inverted. Switch setting checks by the recovery forces verified that all switch settings were proper but a comment had been made that the handle was "neither completely in or out...[and] appears to be jammed."

The crew reported that postlanding ventilation was adequate, but the chilled cabin could have masked detection of inferior ventilation. The postlanding ventilation valve will be tested to identify the cause.

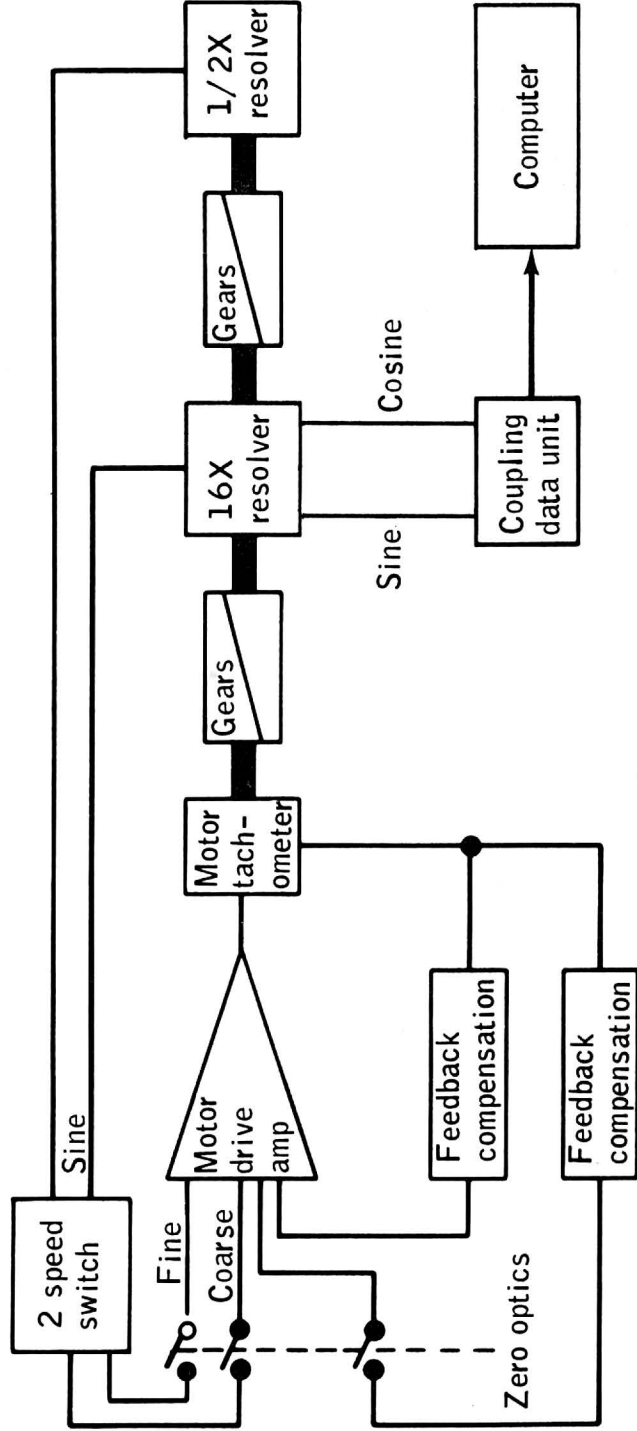
Figure 2.- Zero optics mode circuitry.

Beginning at approximately 40 hours, fluctuations of as much as 0.3 degree were observed in the computer readout of the optics shaft angle. The system had been powered up throughout the flight and had been in the zero optics mode since the star horizon navigation sightings at 31 hours. Crew observation of the manual readout subsequently confirmed that the fluctuation was actually caused by motion of the shaft. The circumstances and time of occurrence were almost identical to a similar situation during the Apollo 12 mission.

A simplified schematic of the optics shaft servo loop mechanization is shown in figure 2. In the zero optics mode, the sine outputs of the half-speed and 16-speed resolvers are routed through a coarse/fine switching network to the motor drive amplifier and are used to null the system. Rate feedback from the motor tachometer is routed to the drive amplifier through a compensation network which removes any bias in the signal. When the zero optics mode is selected, the coupling-data-unit counter and the computer register which contains the shaft angle are zeroed for 15 seconds and then released to follow the 16-speed resolver. The half-speed resolver, the fine/coarse switching network, and the tachometer feedback compensation are used only in the zero optics mode.

An investigation conducted after the Apollo 12 mission did not identify a definite source of the problem, since extreme corrosion from sea water after landing prevented examination of the mechanical drive system and restricted testing to the power and servo assembly which contains the major electronic components. No abnormal indications were found; however, the failure symptoms were reproduced on a breadboard by breaking down the isolation across a transformer in the tachometer feedback compensation network. Although depotting and testing of the actual transformer failed

to produce any evidence of malfunction, this mechanism was considered a likely candidate for a random failure.

The recurrence of the problem under almost identical circumstances on Apollo 13 indicates that the cause is more likely generic than random and that it is time and/or vacuum dependent. The susceptibility of the shaft rather than the trunnion axis also tends to absolve components common to both axes, such as the electronics and the motor drive amplifier. The shaft loop has been shown to be more sensitive than the trunnion to harmonics of the 800-hertz reference voltage introduced into the forward loop; however, because the level of the required null offset voltage is well above that available by induction, this mechanism is considered unlikely.

Tests of the system in the spacecraft and after removal are planned to insure that no other abnormalities exist which could have caused the problem. If none are found, however, the half-speed resolver must be considered the most likely cause. No corrective action would be required because accurate zeroing is unaffected and there is no effect in operational modes.

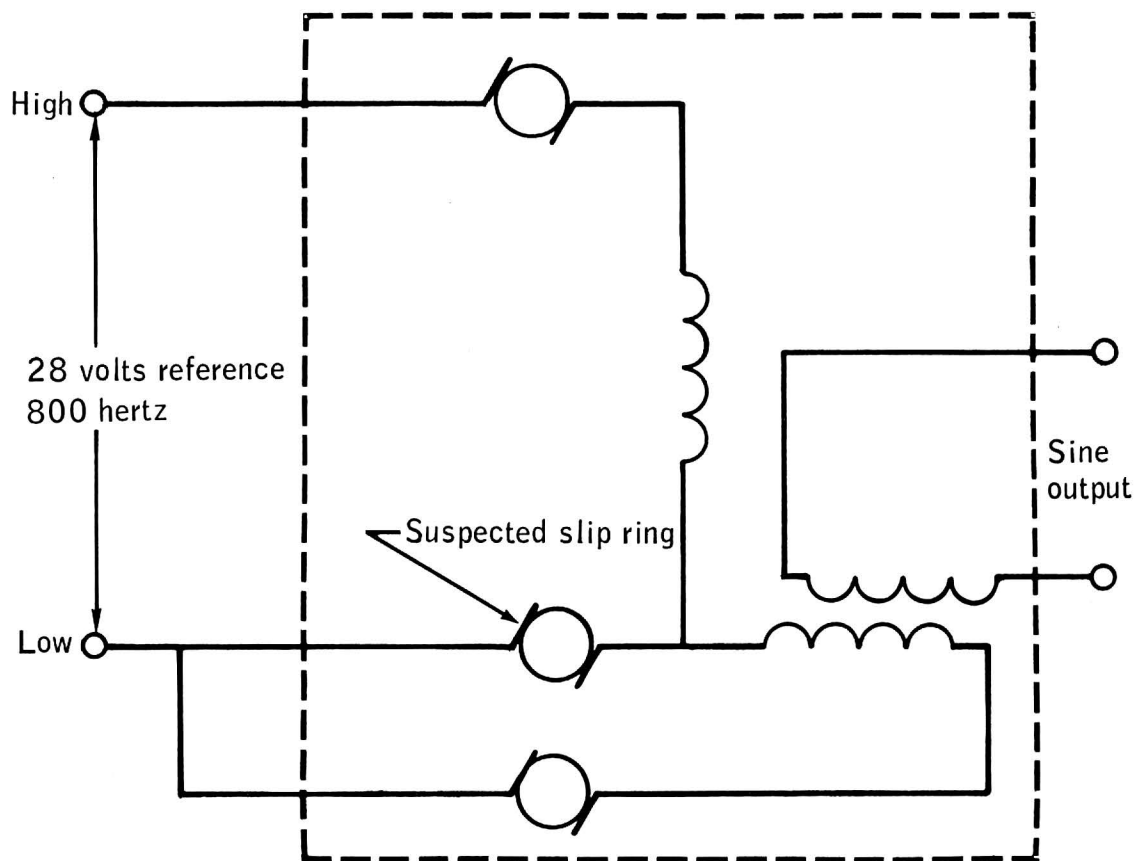
Figure 3.- One-half speed resolver.

The most likely candidate found to date is the half-speed resolver, which is used only in the shaft axis and only to provide an unambiguous zero reference. The reference voltage is applied to the rotor through slip rings connected as shown in figure 3. The cosine winding is not used and is normally shorted out. However, if there is any resistance in the common ground path through the slip ring, then a portion of the reference voltage will appear across the cosine winding and the apparent output null will be offset from zero degrees. Tests indicate that a resistance of 50 ohms will cause an offset of 0.5 degree.

Some evidence of susceptibility to vacuum was exhibited in this class of resolvers when variations of approximately 5 ohms were observed in the slip ring resistance during thermal vacuum testing. The tests were run with the units rotating at 1 rpm, however, and the momentary resistance changes disappeared with the wiping action.

The slip ring resistance mechanism meets all the bounds and constraints on the problem. It is unique to the shaft axis, since none of the other resolvers in the system use slip rings. This resolver is in the optics head which is vented to a vacuum. The rotation of the optics head in a normal operation would wipe the slip rings clean and explain the delay in the fluctuations for some hours after selecting zero optics.

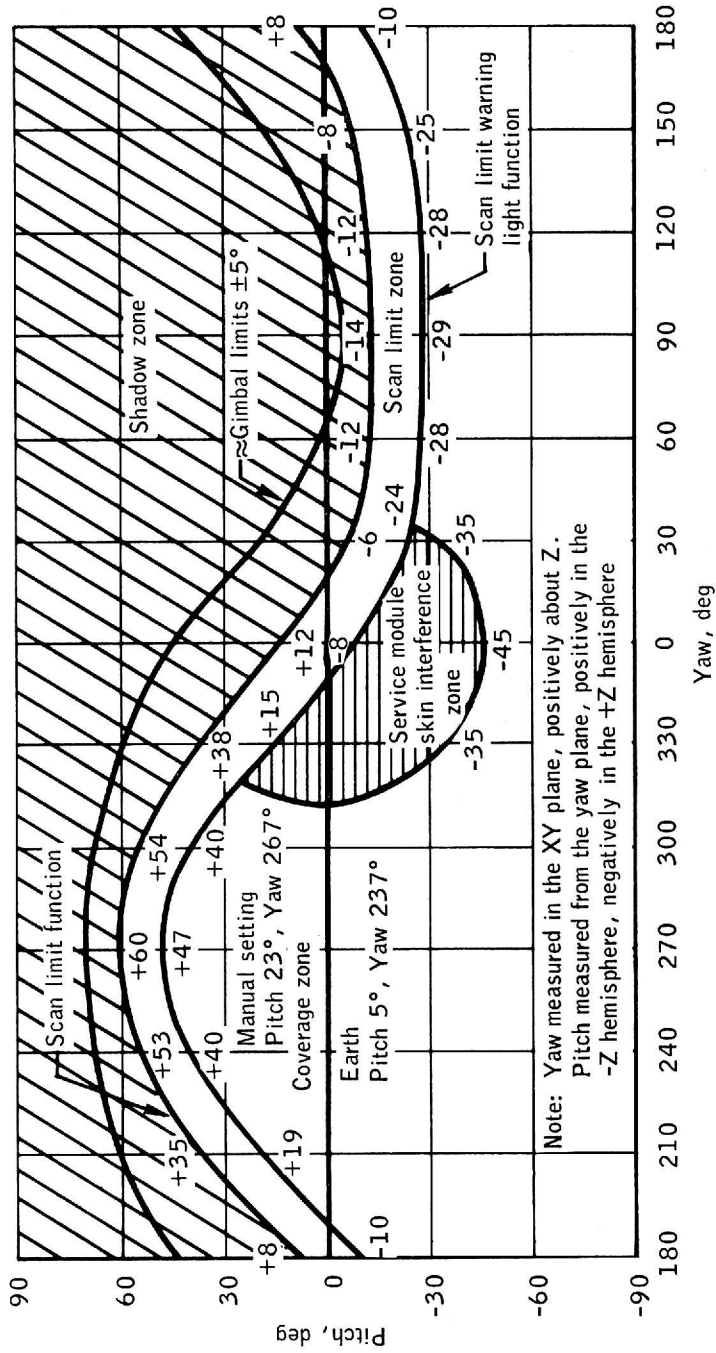
Figure 4.- High gain antenna scan and warning limit.

Prior to television transmission from the spacecraft near 55 hours, difficulty was experienced in obtaining high-gain antenna acquisition and tracking. The command module pilot had manually adjusted the antenna settings to plus 23 degrees pitch and 267 degrees yaw, as requested by the ground at 47 hours 52 minutes. The most favorable settings for 55 hours were actually plus 5 degrees pitch and 237 degrees yaw. The ground had requested settings which were calculated for the originally scheduled transmission 2 hours later. The difference between these two sets of angles pointed the high-gain antenna boresight approximately 35 degrees away from the line of sight to the ground station (fig. 4).

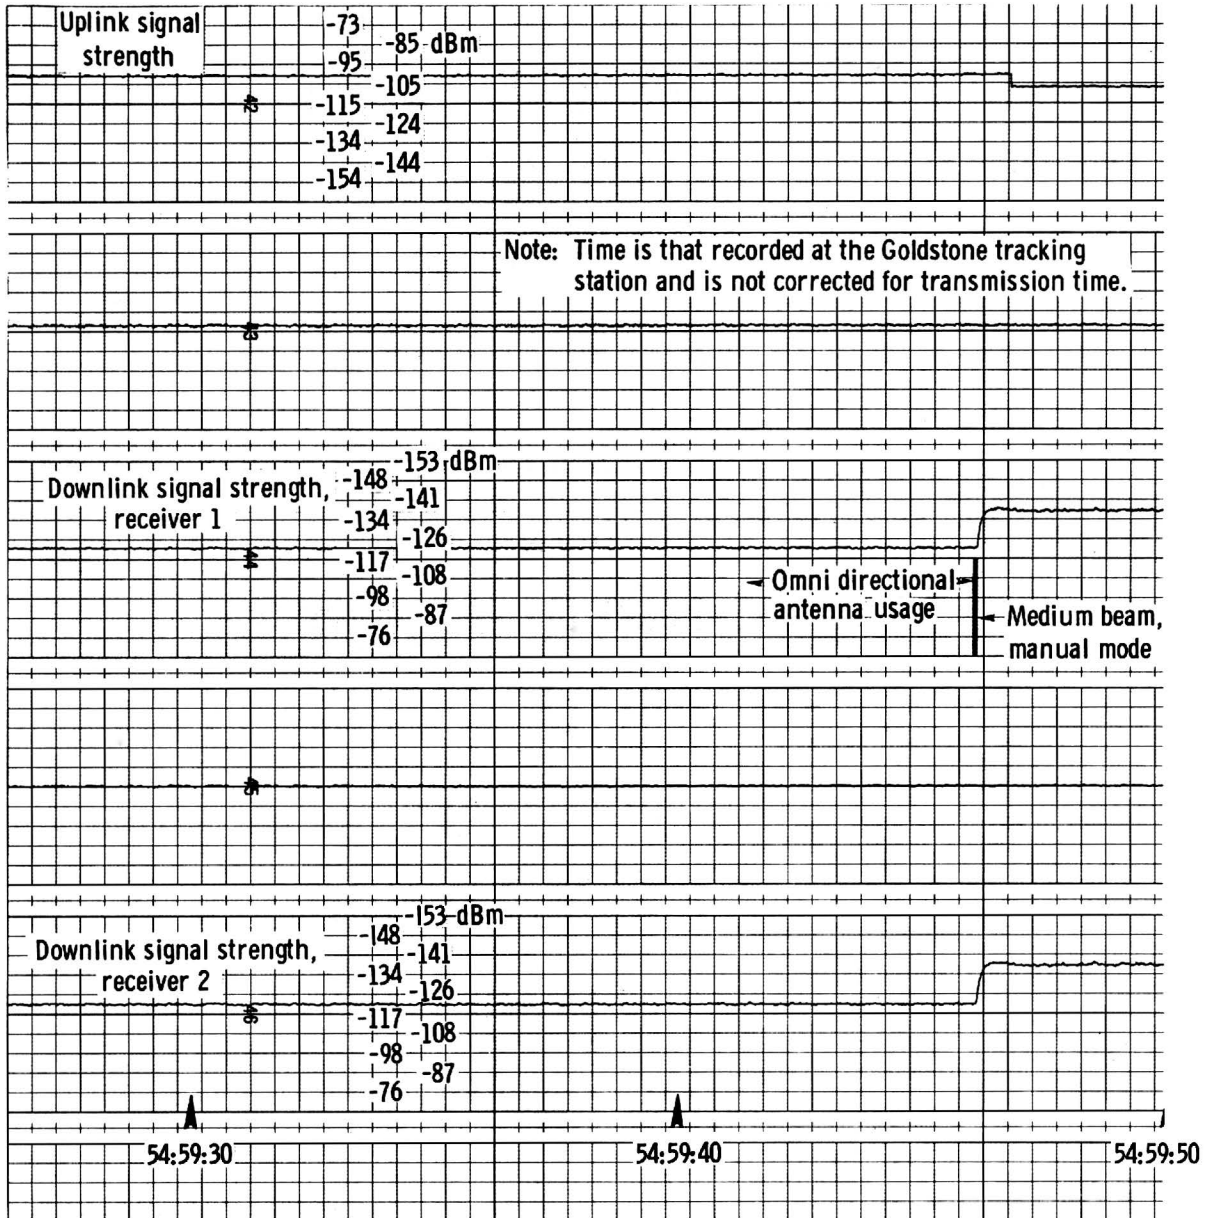
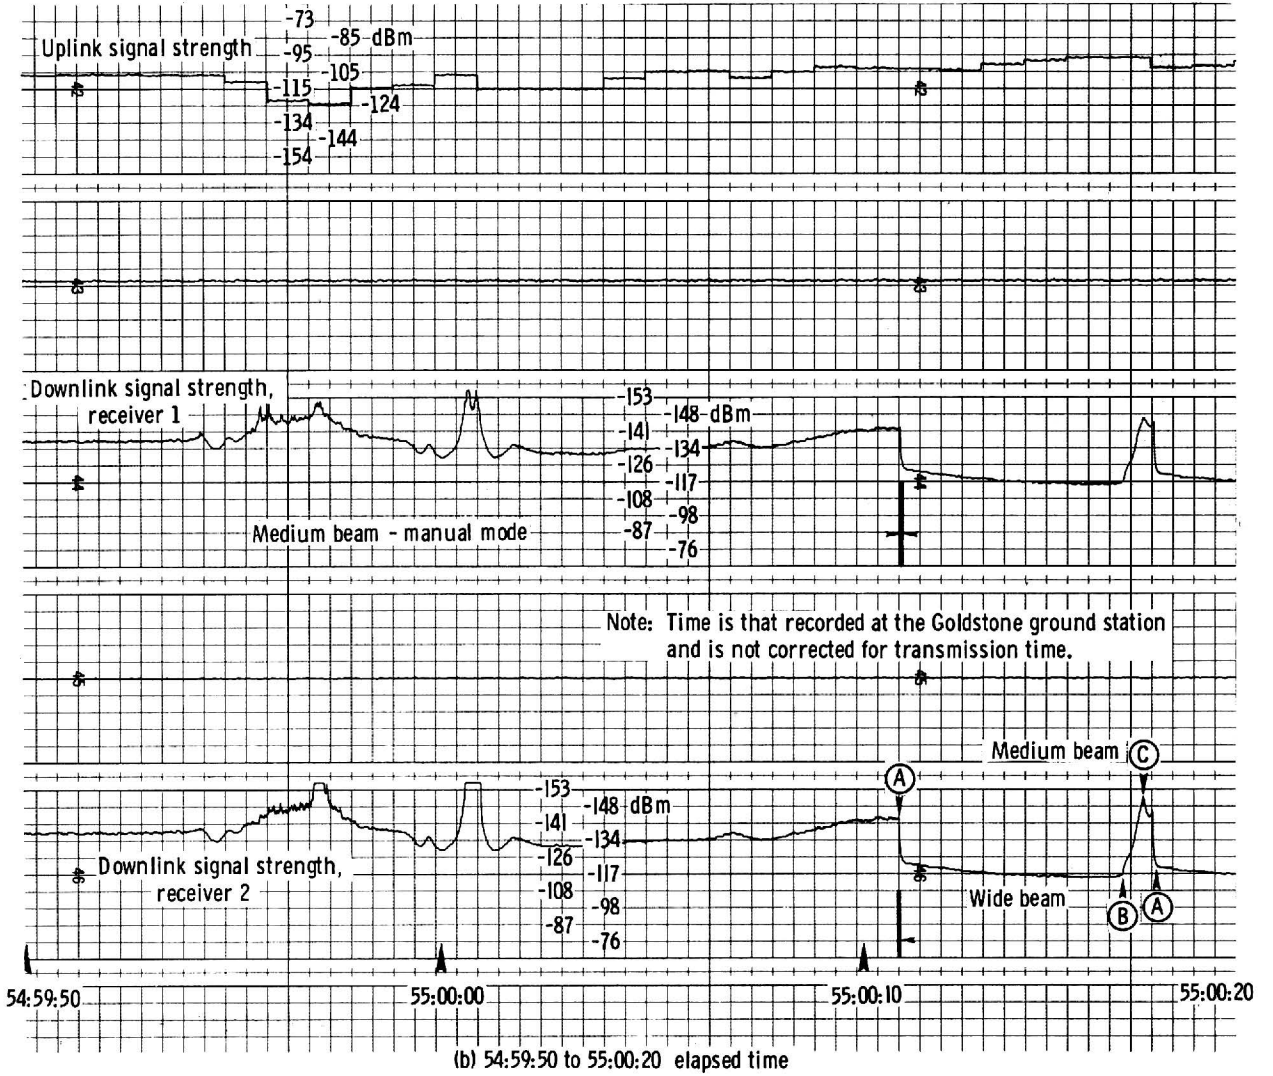
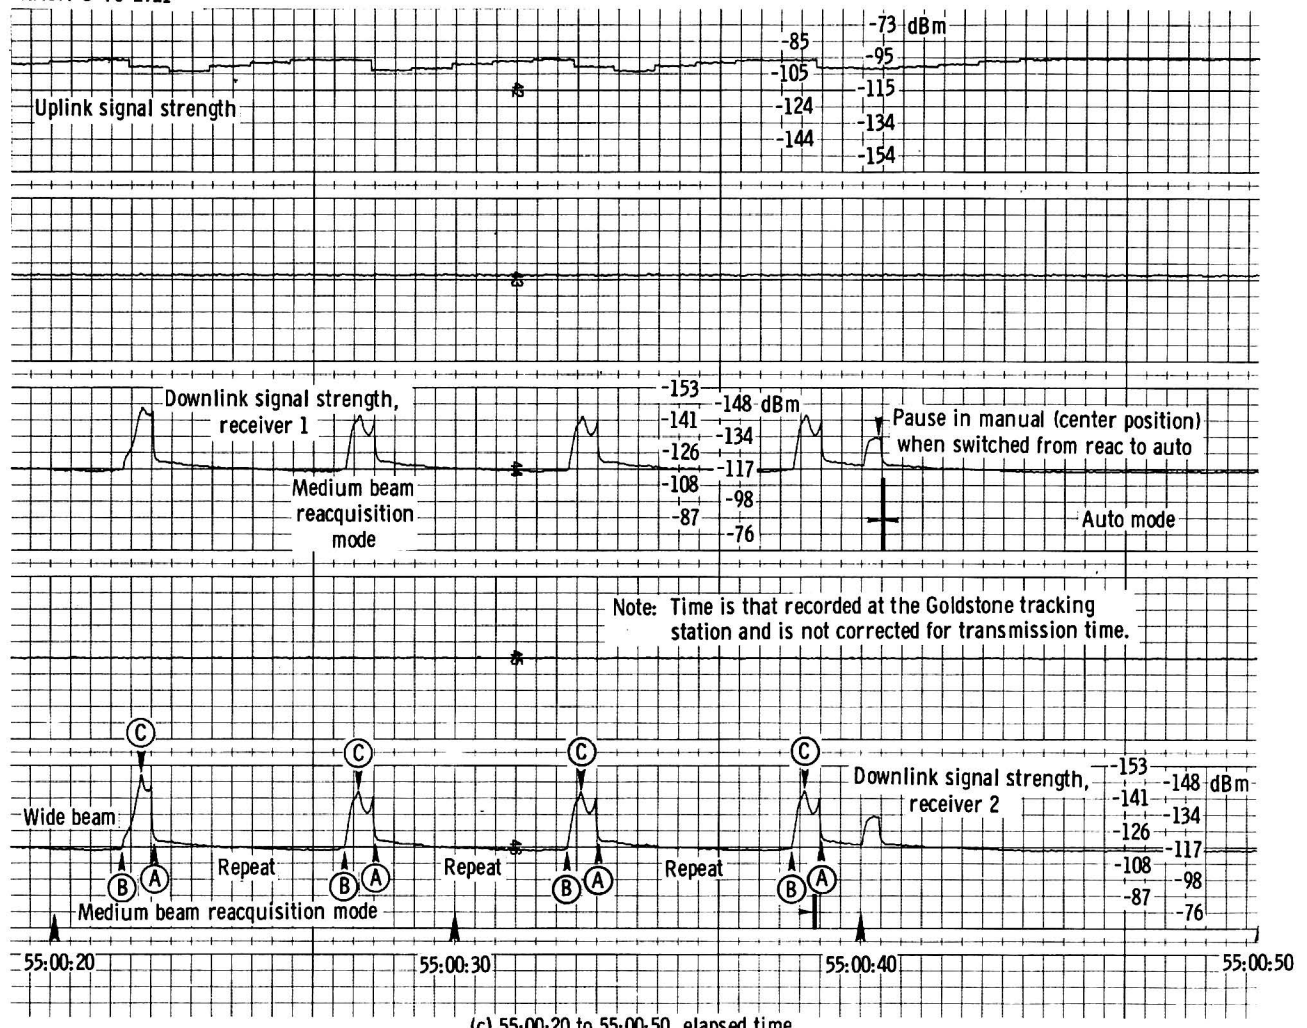
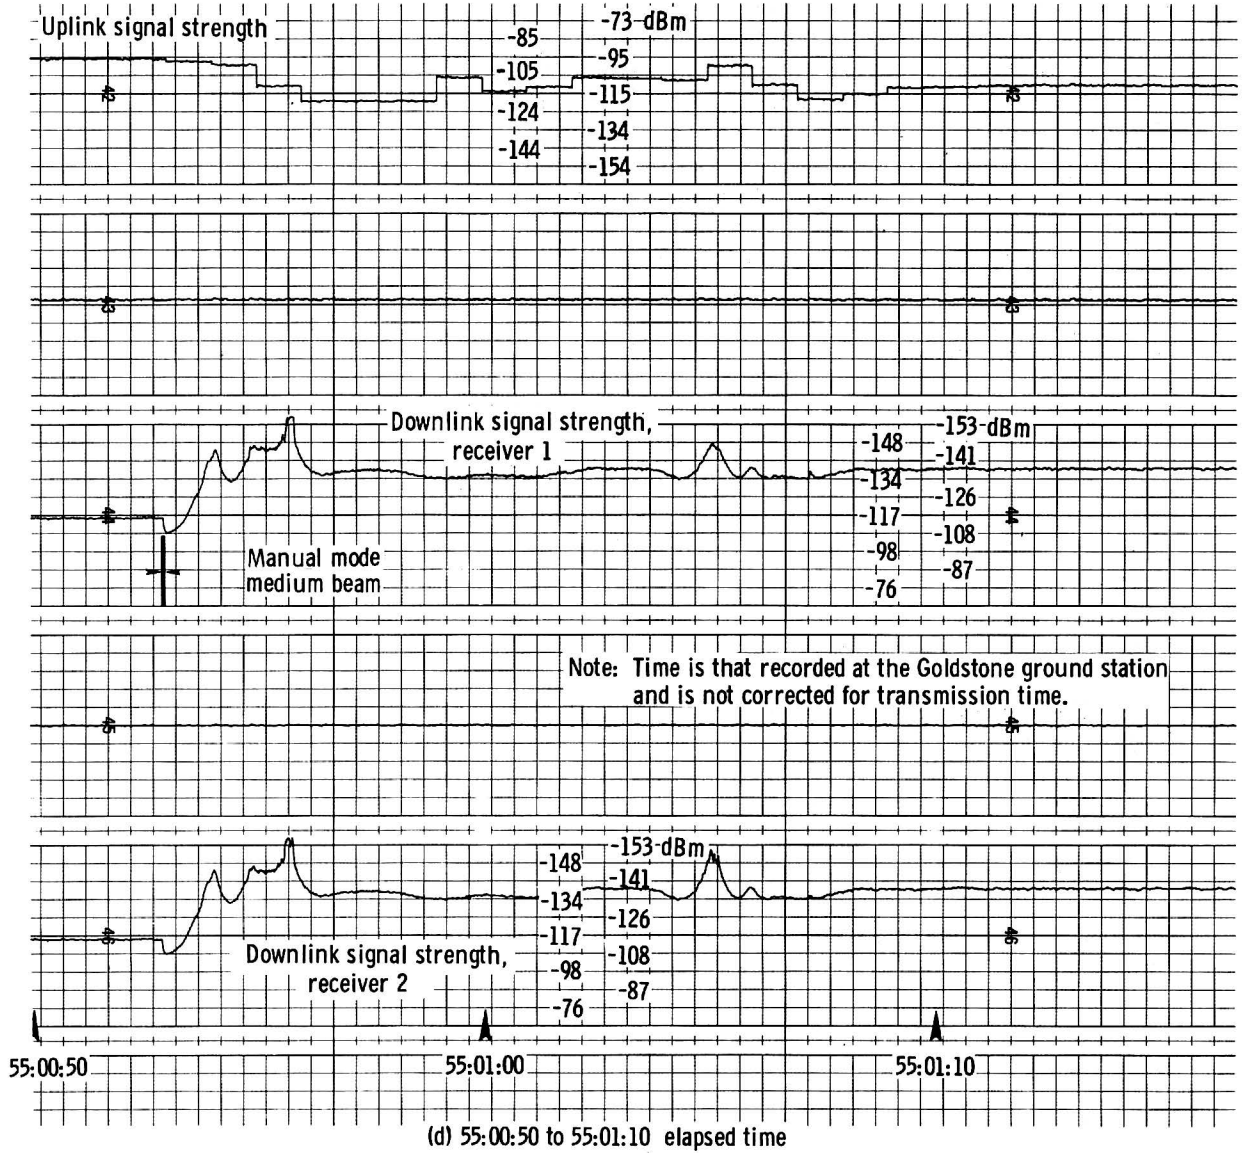
Figure 5. - Recorded signal strengths during high gain antenna operation.

When the transmission was switched from the omnidirectional antenna to manual mode of the high-gain antenna, there was a 6 dB decrease in uplink signal strength and a 17 dB decrease in downlink signal strength (fig. 5a). With the high-gain antenna in the wide beam mode, on or near boresight, the uplink and downlink signal strengths should have been at least equal to the signal strength obtained with an omnidirectional antenna. A comparison of the wide, medium, and narrow beam transmit and receive antenna patterns indicates that the high-gain antenna mode was medium beam and manual at the time of acquisition and remained there until the reacquisition mode was selected at 55:00:10.

Starting at 55:00:10 and continuing to 55:00:40, deep repetitive transients approximately every 5 seconds were noted on the phase modulated downlink (fig. 5a). The transients were approximately 30 dB for 0.75 second. This type of signature could be caused by the high-gain antenna operating in the auto or reacquisition mode with medium beam selected and a misalignment existing between the boresight of the wide and narrow received beams. This boresight shift could cause the antenna to switch from wide beam to a narrow beam null, off axis. It could also cause tracking in narrow beam at very low levels without switching to wide beam. The misalignment effects can be illustrated with the aid of figure 5a. Starting at A, the antenna was switched in to the reacquisition mode with the medium beam selected and acquisition was normal in wide beam from about 35 degrees away from the earth line of sight (pitch 5 degrees, yaw 237 degrees). At point B, the antenna switched from wide beam track to narrow beam track and the transmitted beam changed from wide to medium. As a result of the wide-to-narrow-beam boresight misalignment, the antenna switched into the first null of the received narrow beam. The decrease in automatic gain control due to the null created a false track signal and started the antenna to track from B to C position. The antenna tracked in narrow beam until a sufficient amplitude modulation level was reached causing it to switch back to wide beam. The antenna tracked away from the earth line of sight while in the null region of the narrow beam, explaining why there was repeated tracking in wide beam from A to B.

In summary, the spacecraft and ground radio frequency data, voice transcripts, and crew debriefing notes indicate that a misalignment existed between the boresight of the wide and narrow received beams of the S-band high-gain antenna. This misalignment prevented smooth switch-over from wide beam to narrow beam operation during acquisition in the auto or reacquisition modes. The beam effective misalignment could have been caused by a defective radio frequency stripline coaxial cable, mechanical failure, or radio frequency feedlines. The problem most likely resulted from a quality defect in material or manufacturing assembly, and no hardware changes will be made. Manufacturing and inspection procedures will be reviewed to insure that any necessary assembly and/or inspection instructions be effected.

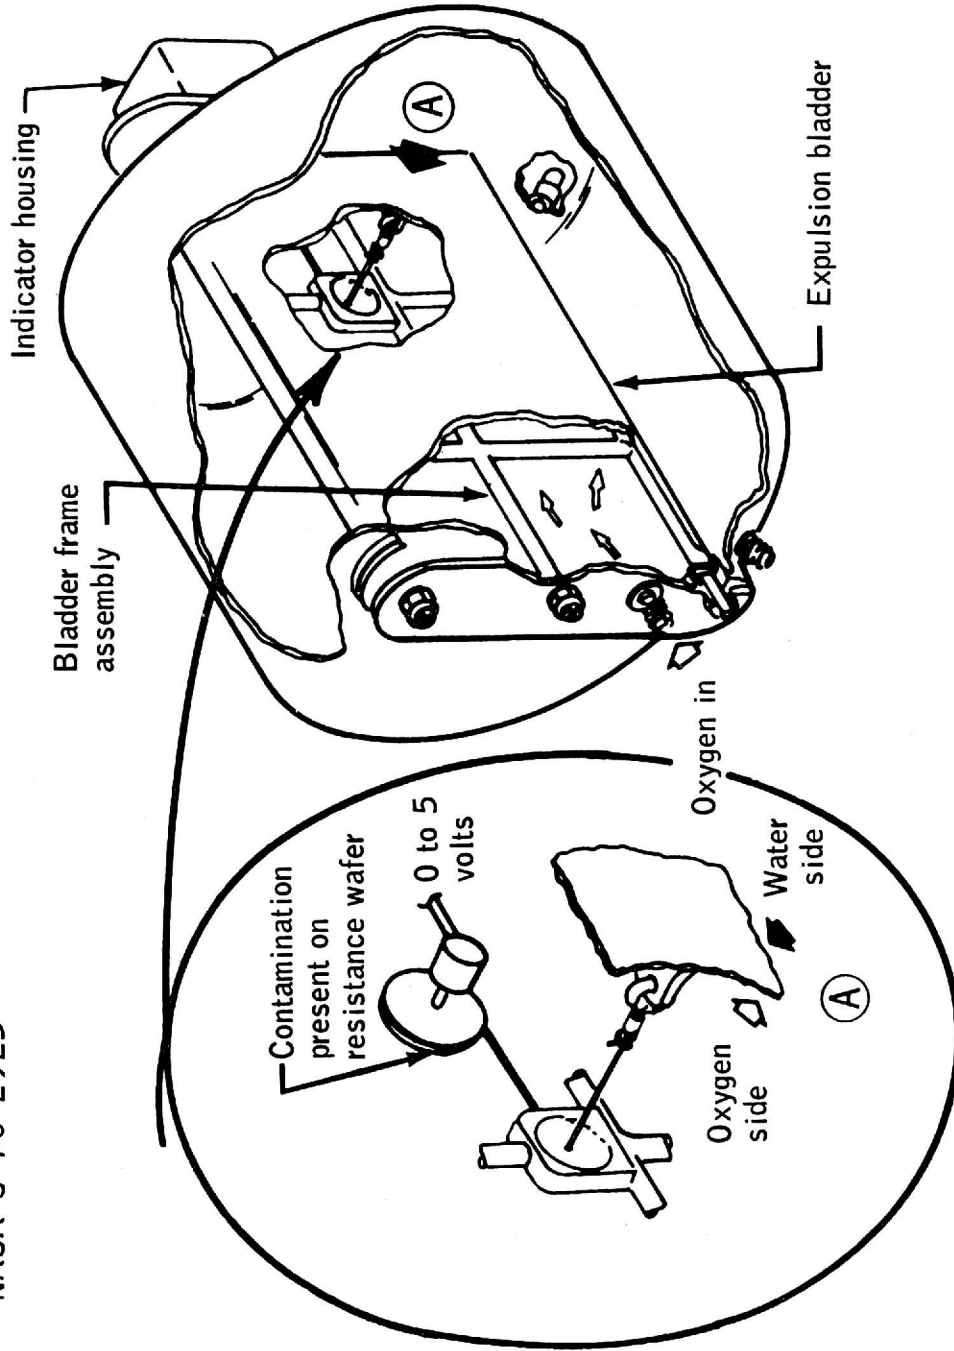
Figure 6.- Area of failure in erratic water transducer.

The potable water quantity measurement fluctuated briefly on two occasions during the mission. At 22:41:00, the reading decreased from 98 percent to 79 percent for about 5 minutes and then returned to a normal reading of approximately 102 percent. Another fluctuation was noted at 37:38:00, at which time the reading decreased from its upper limit to 83.5 percent, and then returned to the upper limit over a period of 7 seconds.

This transducer has operated erratically on previous missions. Testing after Apollo 8, traced the failure during that mission to moisture contamination within the transducer. Similar fluctuations were noted during Apollo 12 and postflight testing revealed a minute quantity of undetermined contamination on the surface of the resistance wafer (fig. 6). Tests using aluminum hydroxide as a contaminant reproduced the anomalous transducer operation. Apollo 13 postflight testing is planned.

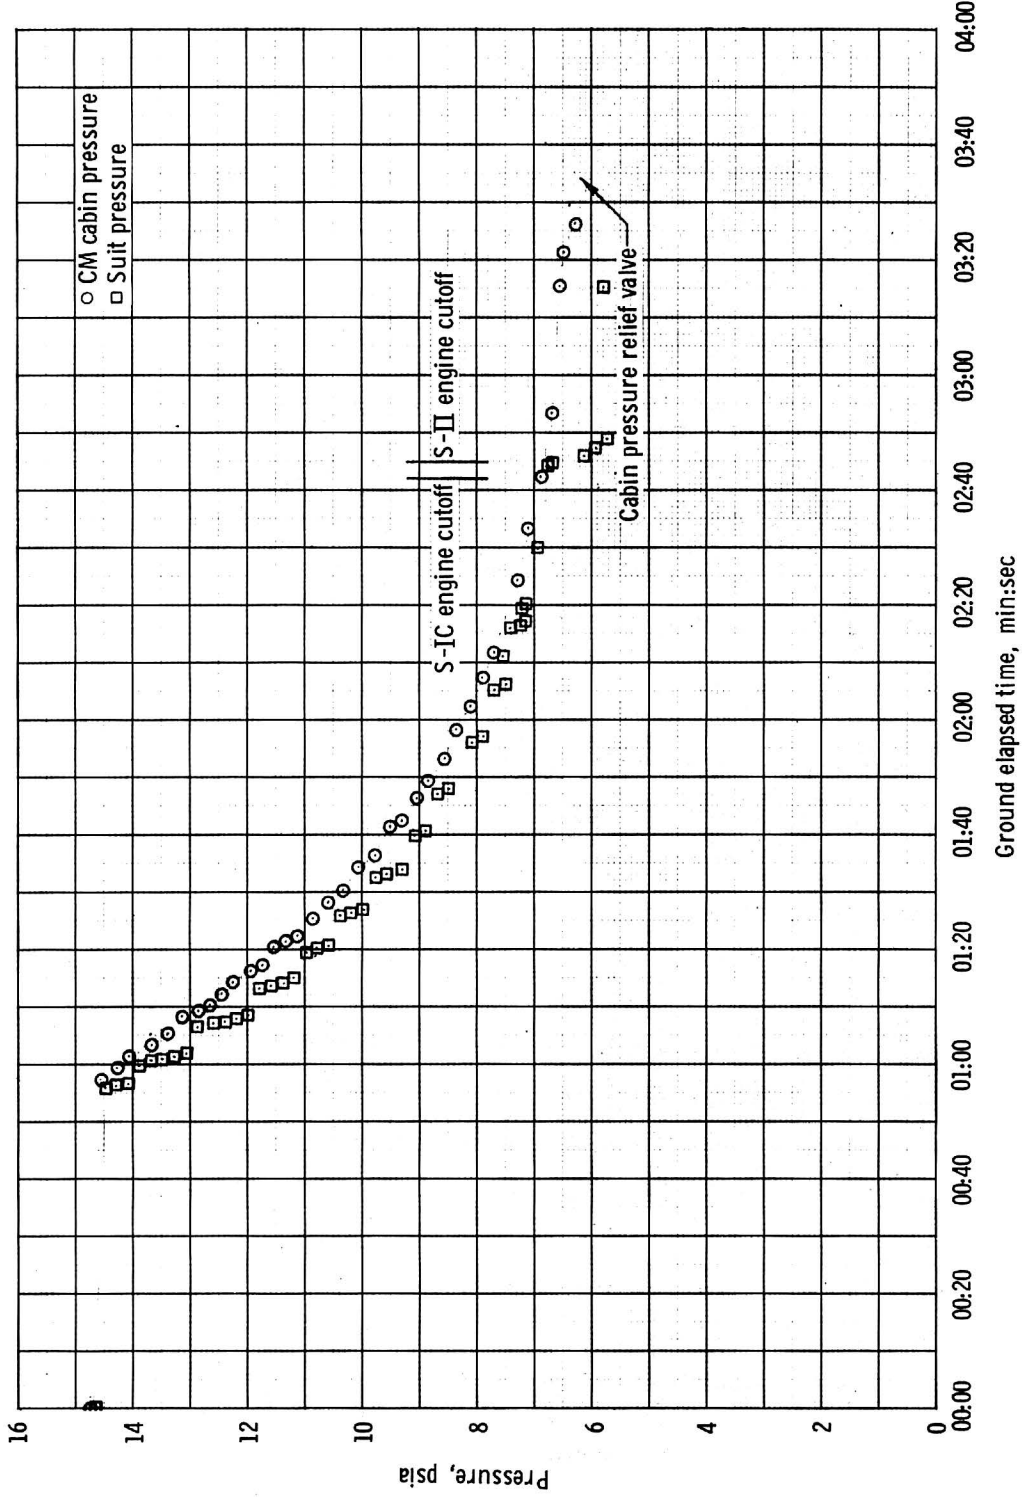
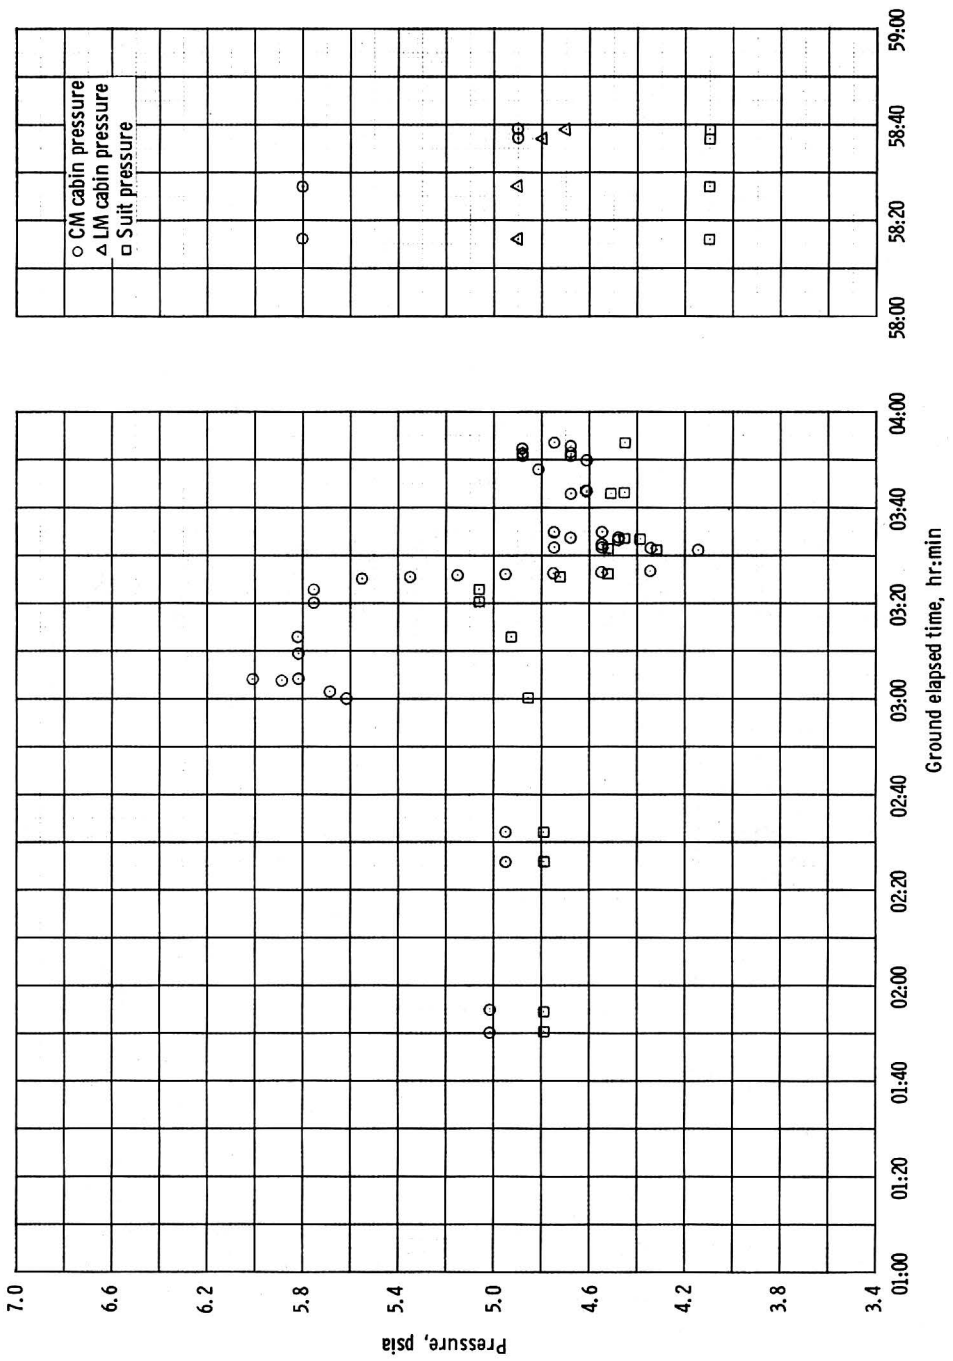
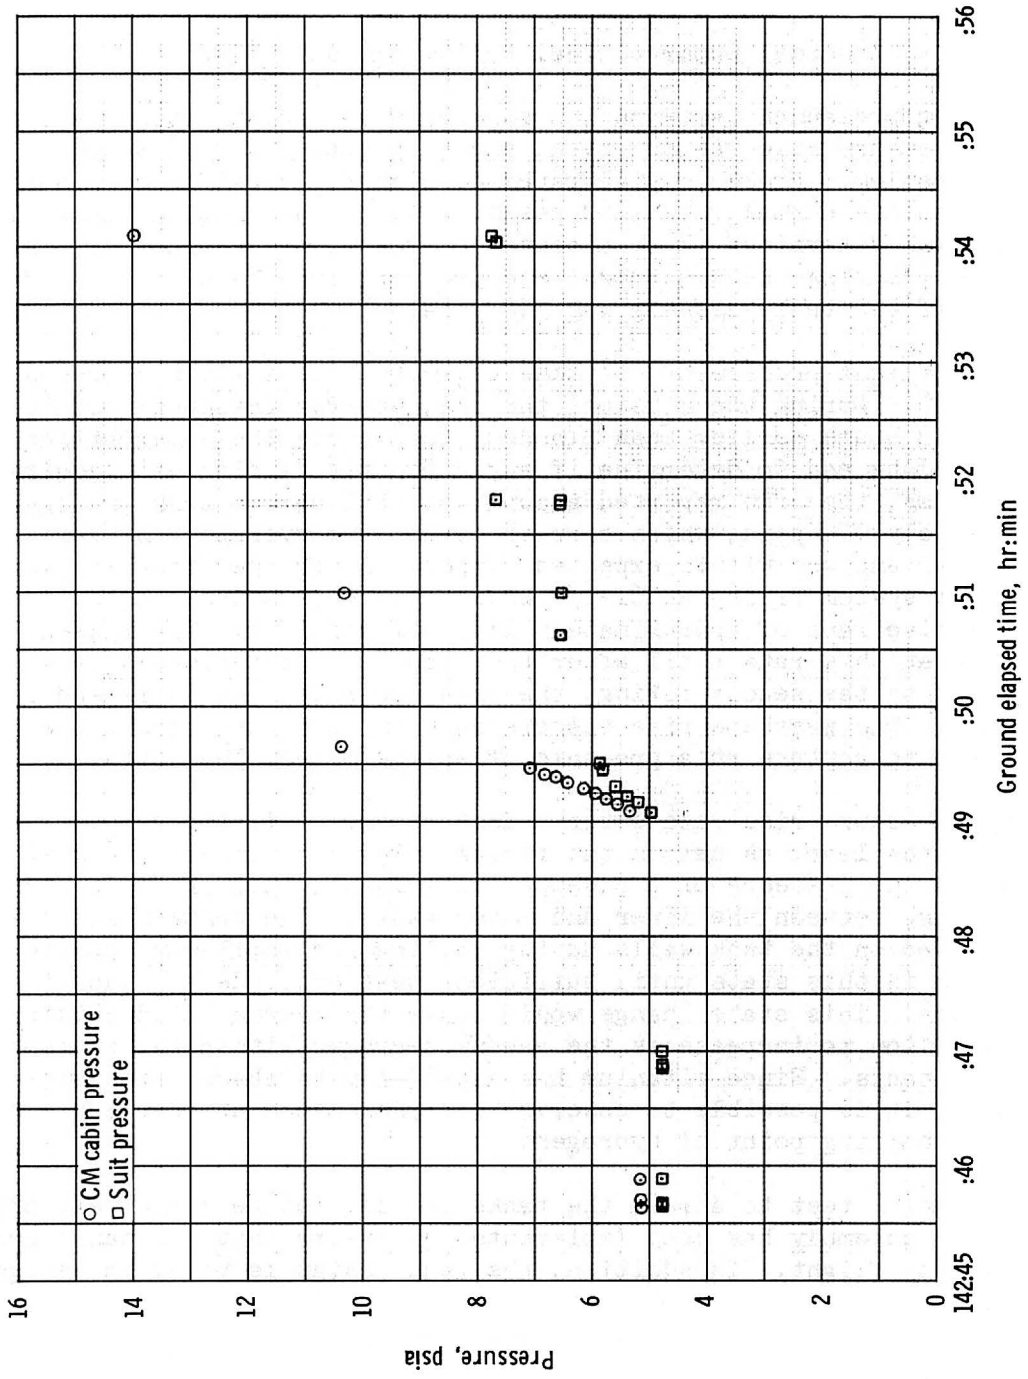
(a) Lift-off through 4 minutes.
Figure 7. - Suit and cabin pressure.

During launch the suit pressure transducer reading followed cabin pressure until 00:02:45, when it suddenly dropped from 6.7 to 5.7 psia coincident with S-II engine ignition. The difference between the two measurements decreased to only 0.2 psi by 1-1/2 hours, when the cabin reached its nominal regulated pressure of 5.0 psia. For the shirtsleeve mode, the suit and cabin pressure readings should be nearly equal. During the normal changes in the command module cabin pressure, associated with the initial lunar module pressurization from about 3 to 4 hours, the suit pressure measurement responded sluggishly and indicated as much as 1 psi low while moving in a narrow band. Subsequently, the measurement output decayed and remained in the 4.1 to 4.3 psia range until deactivation at 58-1/2 hours. During periods when the spacecraft cabins were interconnected, the corresponding cabin pressure readings were approximately equal.

The suit measurement indicated correctly during the brief instrumentation power-up periods at 102 and 123 hours. However, the suit indication was approximately 0.3 psi lower than cabin pressure just prior to entry and increased to only 7.7 psia just prior to landing, when the cabin pressure was reading 13.9 psia (fig. 7).

The suit transducer also indicated low and showed a similarly erratic operation during the Apollo 12 mission. Postflight testing determined the cause to be internal contamination from particles which either remained in the transducer from improper cleaning after electroless nickel plating or were self-generated.

Postflight testing will be conducted to determine the exact cause of the Apollo 13 failure.

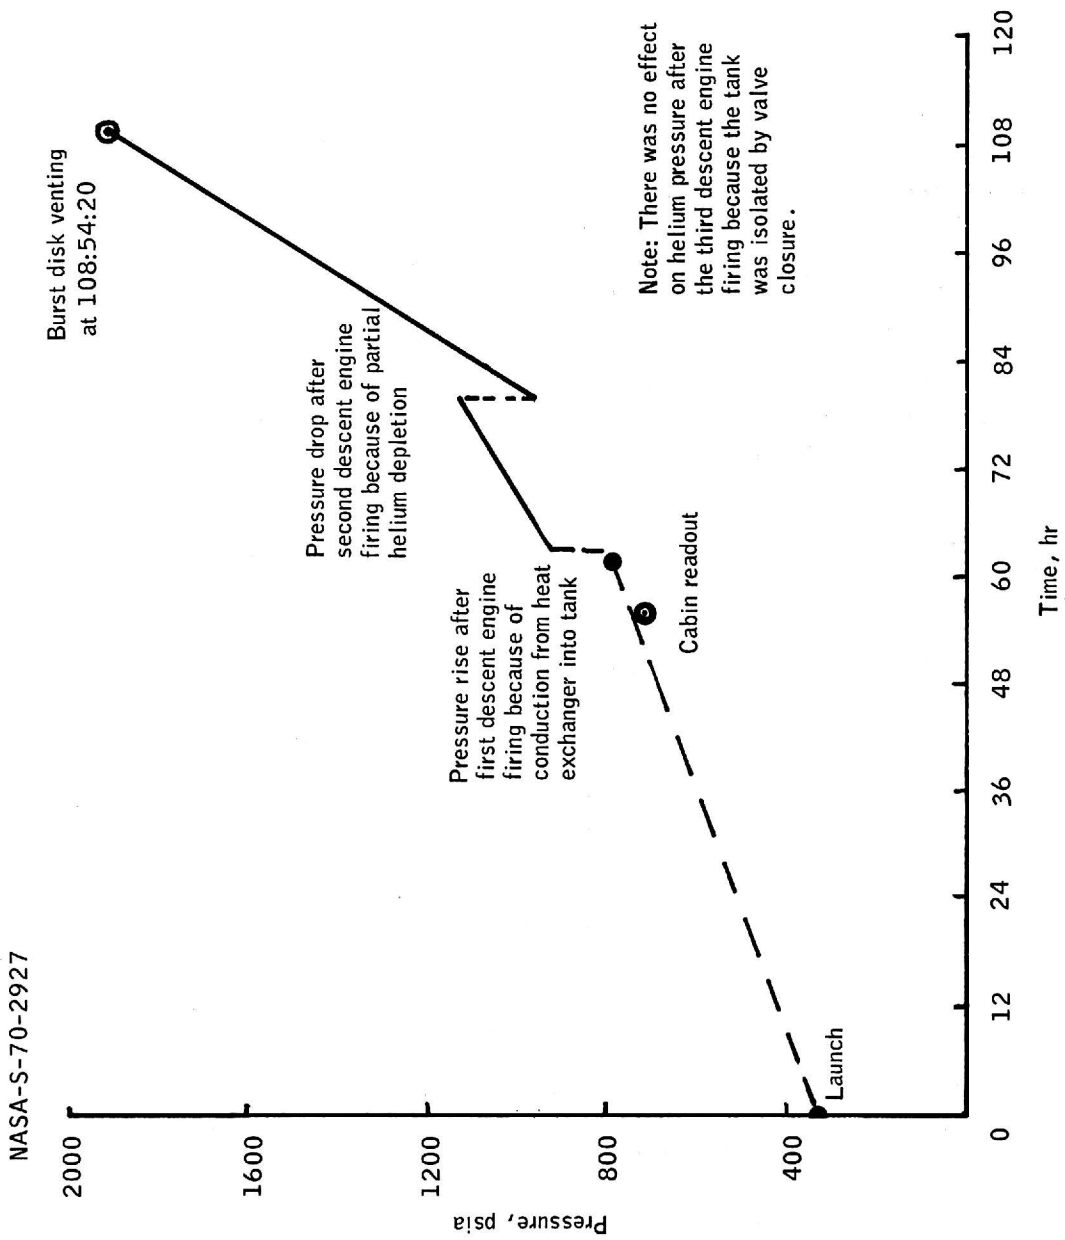
Figure 8.- Inflight profile of supercritical helium tank pressures.

During prelaunch tests on the supercritical helium tank, an abnormal rate of pressure rise was observed, and a special test was added to evaluate the problem. Pressure rise rates as high as 14 psi/hr were noted, compared to the normal rate of 8 psi/hr. Based on a nominal lunar landing, the tank was determined to be acceptable even with the abnormally high rise rate. During the countdown, the pressure rise rate was 8 psi/hr and at lift-off the tank pressure was 356 psia.

An inflight profile of the tank pressure versus time is presented in figure 8. During the mission, the crew entered the lunar module at 55 hours, 3 hours earlier than planned, to observe the supercritical helium rise rate and to determine if any corrective action was required. At this time, the crew reported a supercritical helium tank pressure of approximately 720 psia, which corresponded to an average rise rate of 6.53 psi/hr and was within expected ranges. After the first descent propulsion system firing at 61-1/2 hours, the helium tank exhibited a pressure rise rate of approximately 11.5 psi per hour. The pressure rise continued at this rate until after the second descent propulsion maneuver. Subsequent to the second firing, the pressure rise rate increased further to 33 psi. The pressure rise associated with this rate caused the safety burst disk to rupture at a pressure of approximately 1937 psia.

The pressure rise rate after a descent engine firing should normally remain at the level as before the firing. The most likely cause of this anomaly is the presence of a gaseous contaminant, most probably hydrogen, in the space between the inner and outer tanks. The contaminant would be condensed on the tank walls during filling and chill-down operations and remain in this state until sufficient heat was added to vaporize the contaminate. This state change would cause the thermal conductivity of the insulation to increase as the vacuum degraded within the space between the tanks. Since titanium has a tendency to absorb free hydrogen molecules, it is possible to observe this phenomenon at temperatures above the boiling point of hydrogen.

A special test to screen the tanks for all future spacecraft prior to vehicle assembly has been implemented to assure that the tanks are suitable for flight. In addition, the tank design is being investigated to determine the means by which the vacuum jacket can become contaminated, what the contaminant might be, and any other possible causes of the increased thermal conductivity.
