NATIONAL AERONAUTICS AND SPACE ADMINISTRATION

APOLLO 13
30-DAY FAILURE AND ANOMALY LISTING REPORT

MANNED SPACECRAFT CENTER
HOUSTON, TEXAS
MAY 1970

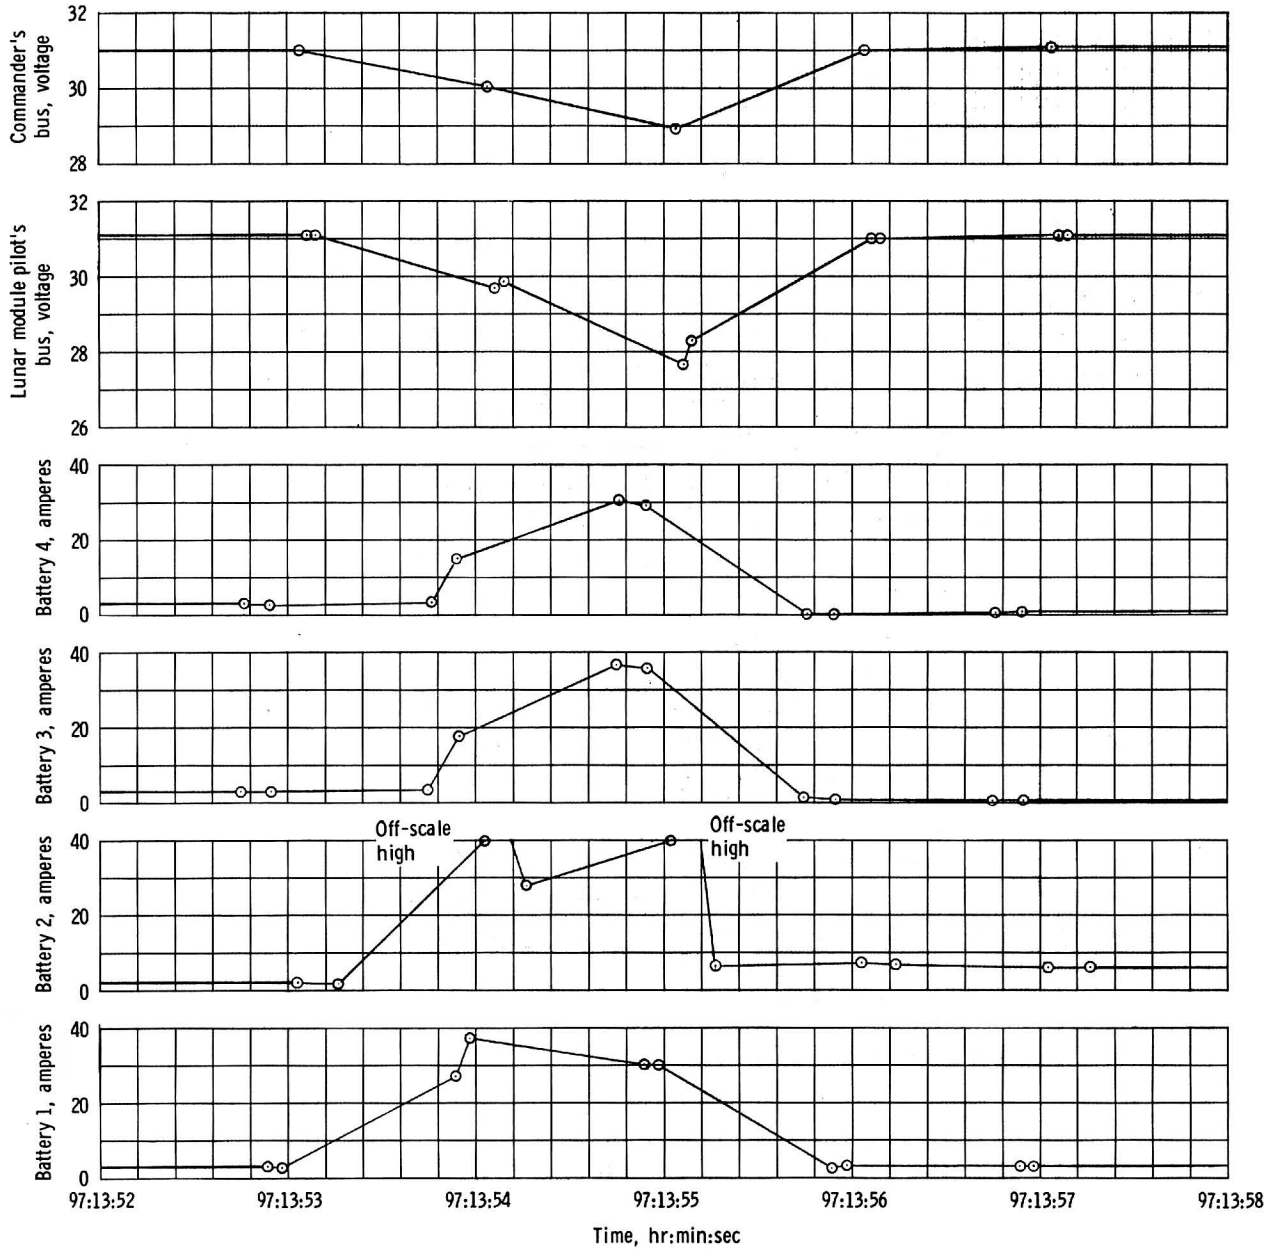
Figure 9. - Battery transients.

At 97:14:42, the crew reported a thumping noise and snowflakes venting from quadrant 4 of the lunar module descent stage. All four descent batteries experienced current transients at 97:13:53 for about 2 seconds, with corresponding drops in dc bus voltage (fig. 9). Also, the glycol pressure differential for the heat transport system decreased momentarily, indicating that the glycol pump slowed down for a brief period.

The crew stated that the current spikes occurred not more than 30 seconds before the thumping noise, and not afterwards, and that there was no activity in the vehicle at that time. The current spikes were probably caused by a momentary short circuit in the Lunar Module Pilot side of the dc electrical system, which includes descent batteries 1 and 2 (fig. 10). The current surge was not high enough to open the balance load cross-tie circuit breakers nor to trip a battery off the bus as a result of an overcurrent or reverse current condition.

Descent battery 2 experienced the highest current surge, which was off-scale high and in excess of 60 amperes. This condition could have been a reverse current into the battery, since the instrumentation system cannot differentiate between reverse and forward currents. Immediately after the current surges, battery 1 current returned to the value existing immediately before the surges. However, battery 2 provided about 80 percent of the total current. Within 10 minutes thereafter, all batteries were properly sharing the current load.

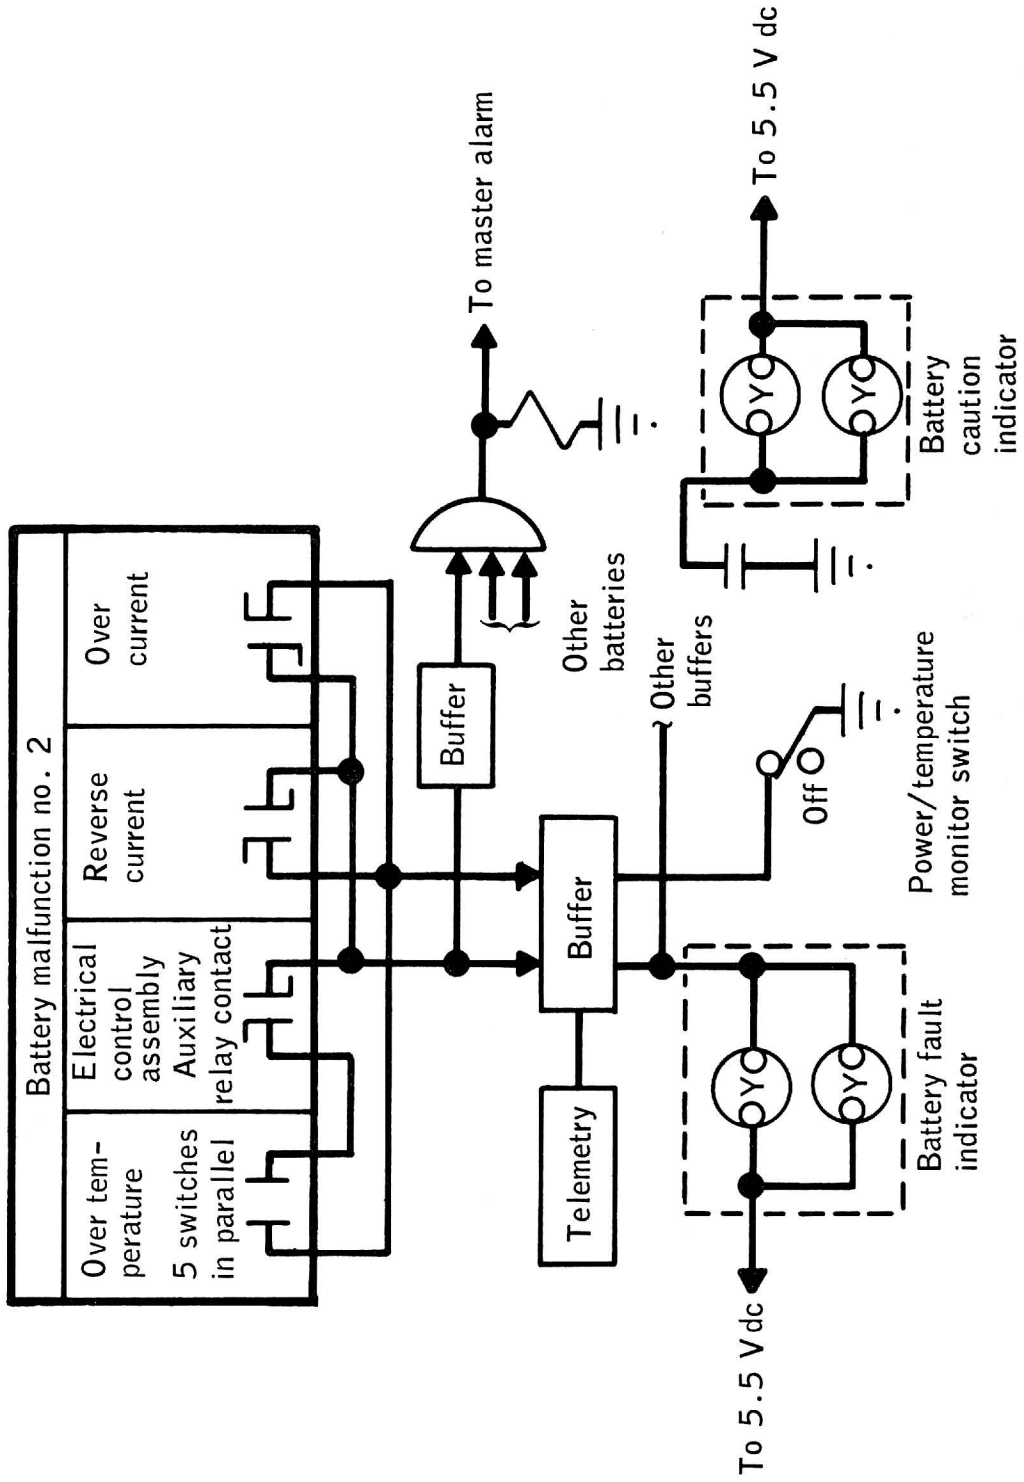
Figure 12.- Battery 2 malfunction circuit.

The battery malfunction light illuminated at 99:51:09 with a corresponding master alarm. The malfunction was isolated to battery 2 by switching the power temperature monitor switch to the battery 2 position and observing the corresponding component caution light. This analysis indicated that either a battery 2 overtemperature, overcurrent, or reverse current condition had occurred (fig. 12).

A battery overcurrent could not have occurred, because the electrical control assembly did not automatically remove the battery from the electrical buses. The battery was manually removed from the bus for over an hour and then reconnected. The battery malfunction light extinguished when the battery was removed from the bus but illuminated immediately when the battery was reconnected. This sequence indicates that a reverse current condition was not the cause of the malfunction indication because reverse current must exist for 4 to 6 seconds before the electrical control assembly will again illuminate the light. The remaining possible cause is either a battery overtemperature condition or a malfunction in the overtemperature sensing and display circuit.

Glycol loop temperatures and battery performance before and after the warning indicated that the battery was operating normally and at a normal temperature. Temperature is sensed in the battery by five bi-metallic, hermetically sealed, snap-action temperature sensing switches connected in parallel. These switches have experienced no prior failures and are designed to close at 145 percent $\pm 5^{\circ}$ F and open at 125 percent $\pm 5^{\circ}$ F.

After the battery was replaced on the bus, the light remained illuminated for a brief period and then began flickering intermittently. Since the light flickered on and off, switch hysteresis would preclude that a temperature switch was being activated. A low resistance path (less than 250 kilohms) between the switch wires or from the signal wire to ground will actuate the light. This could have been caused by the battery electrolyte bridging the switch terminals. Contamination in the auxiliary relay of the electrical control assembly could also have caused the light to illuminate. These relays have a history of contamination and are not screened before installation.

The wiring, battery, and relays are under investigation.

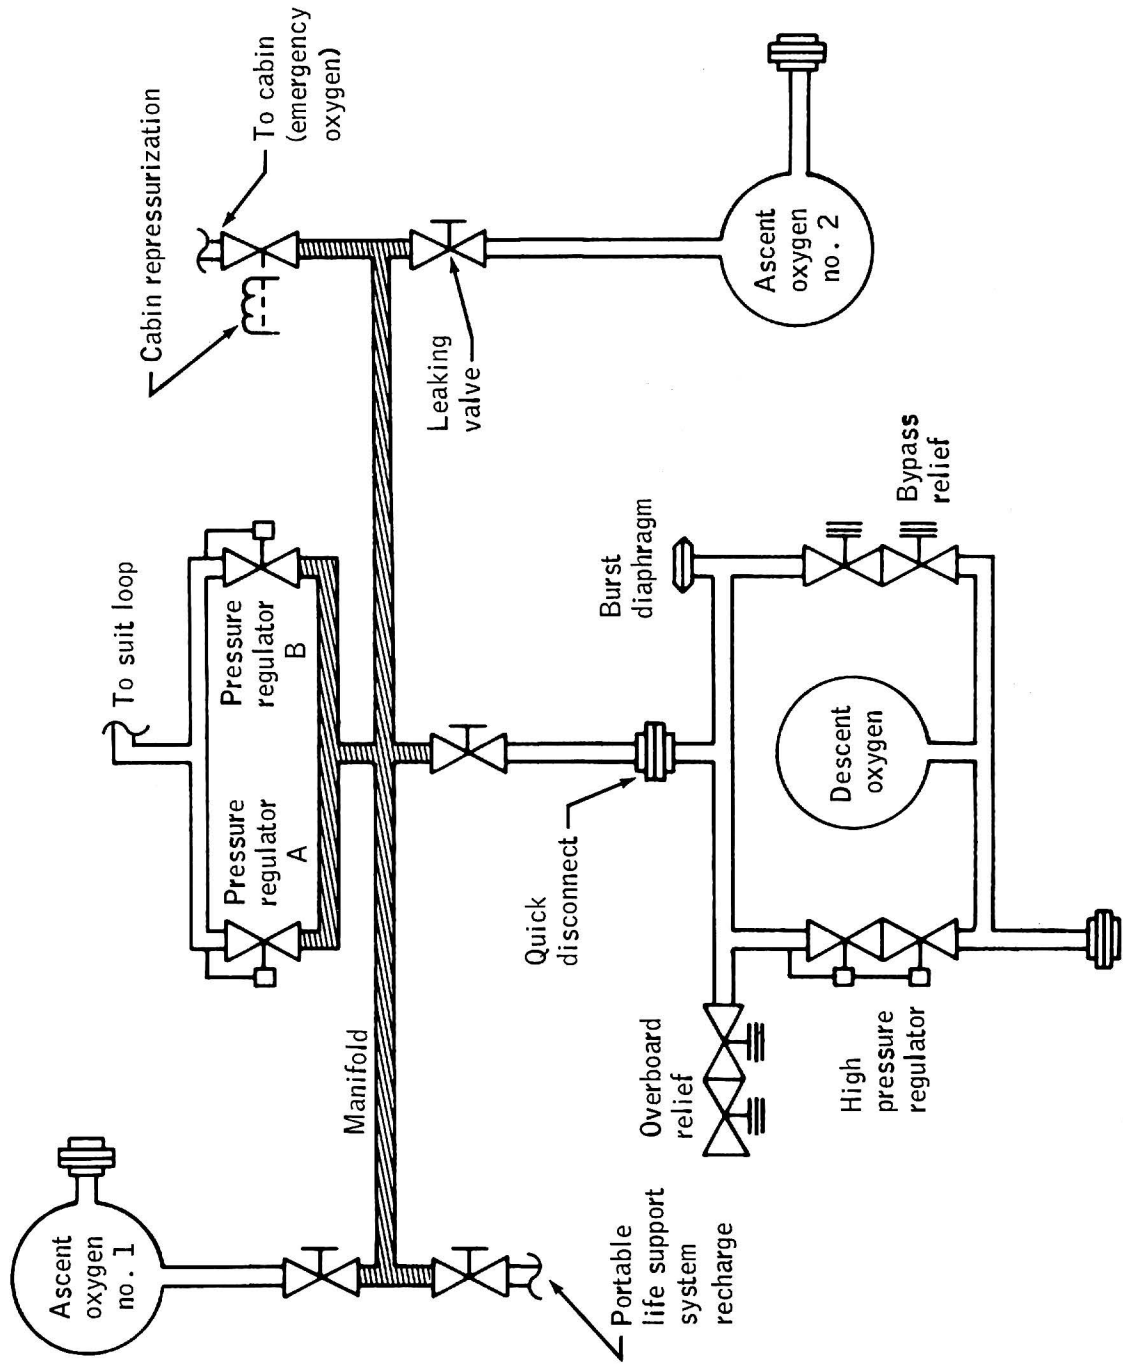
Figure 13. - Oxygen supply system .

During the flight, the pressure in the ascent stage oxygen tank 2 increased, indicating a reverse leakage through the shutoff valve from the oxygen manifold (fig. 13) into the tank. The leak rate, with a maximum differential pressure of 193 psi, varied from about 0.22 lb/hr (70 000 scc/hr) to zero when the tank pressure reached manifold pressure. Allowable leakage for the valve in either direction is 360 scc/hr. Preflight test data indicate a reverse leakage of 360 scc/hr and no excessive leaking in the forward direction.

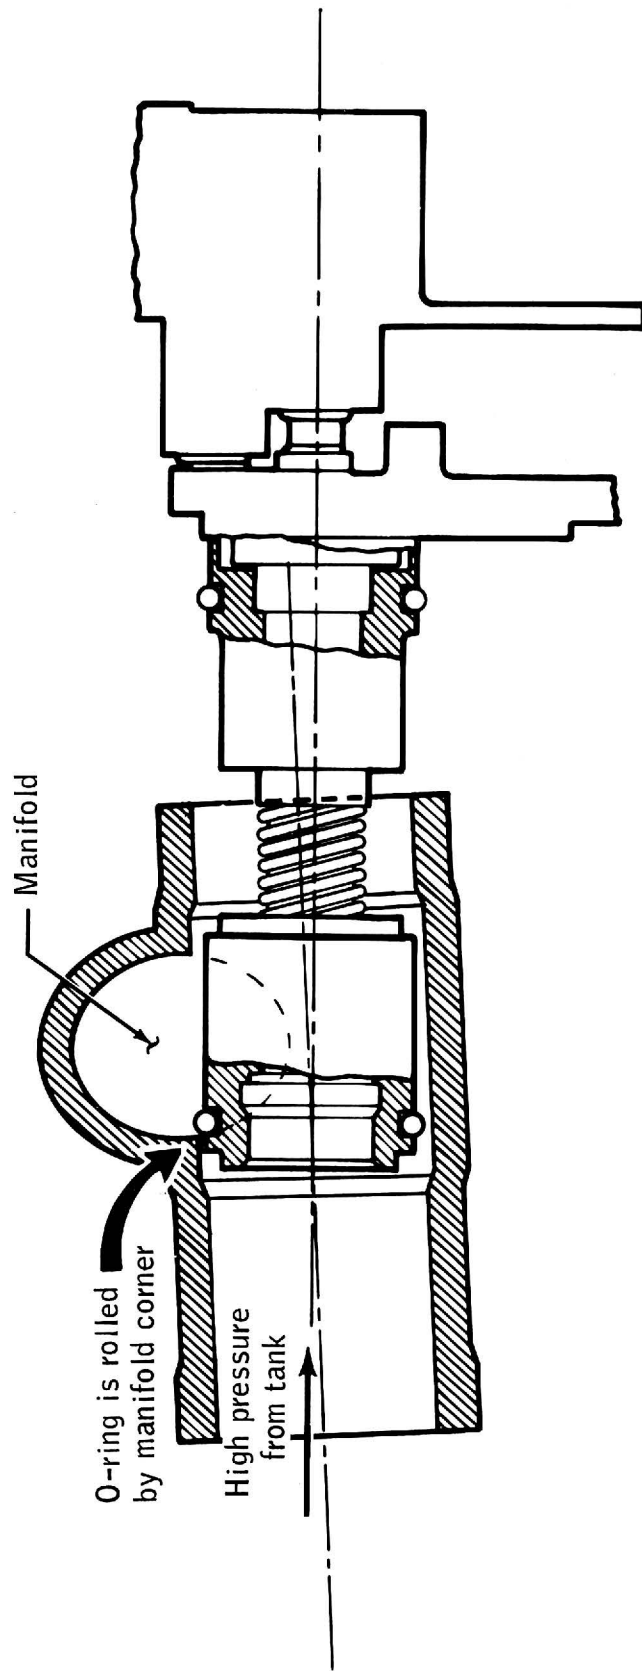
Figure 14.- Oxygen tank shutoff valve partially installed.

The internal portion of three valves of this type had been replaced previously on the spacecraft because of excessive leakage through the ascent oxygen tank 1 shutoff valve. A rolled, or displaced, O-ring (fig. 14) was found to be the cause of the leakage. When the valve is installed, the forward O-ring can roll when it passes the manifold port. Subsequent pressure cycling can cause the O-ring to move and cause a leak.

The valve installation procedure is being evaluated to determine if a better means can be found to preclude rolling, or displacing, the forward O-ring. Also, a method of measuring the valve leakage in both directions, with new leakage limits at both high and low pressure differentials, is being evaluated for use at the launch site.

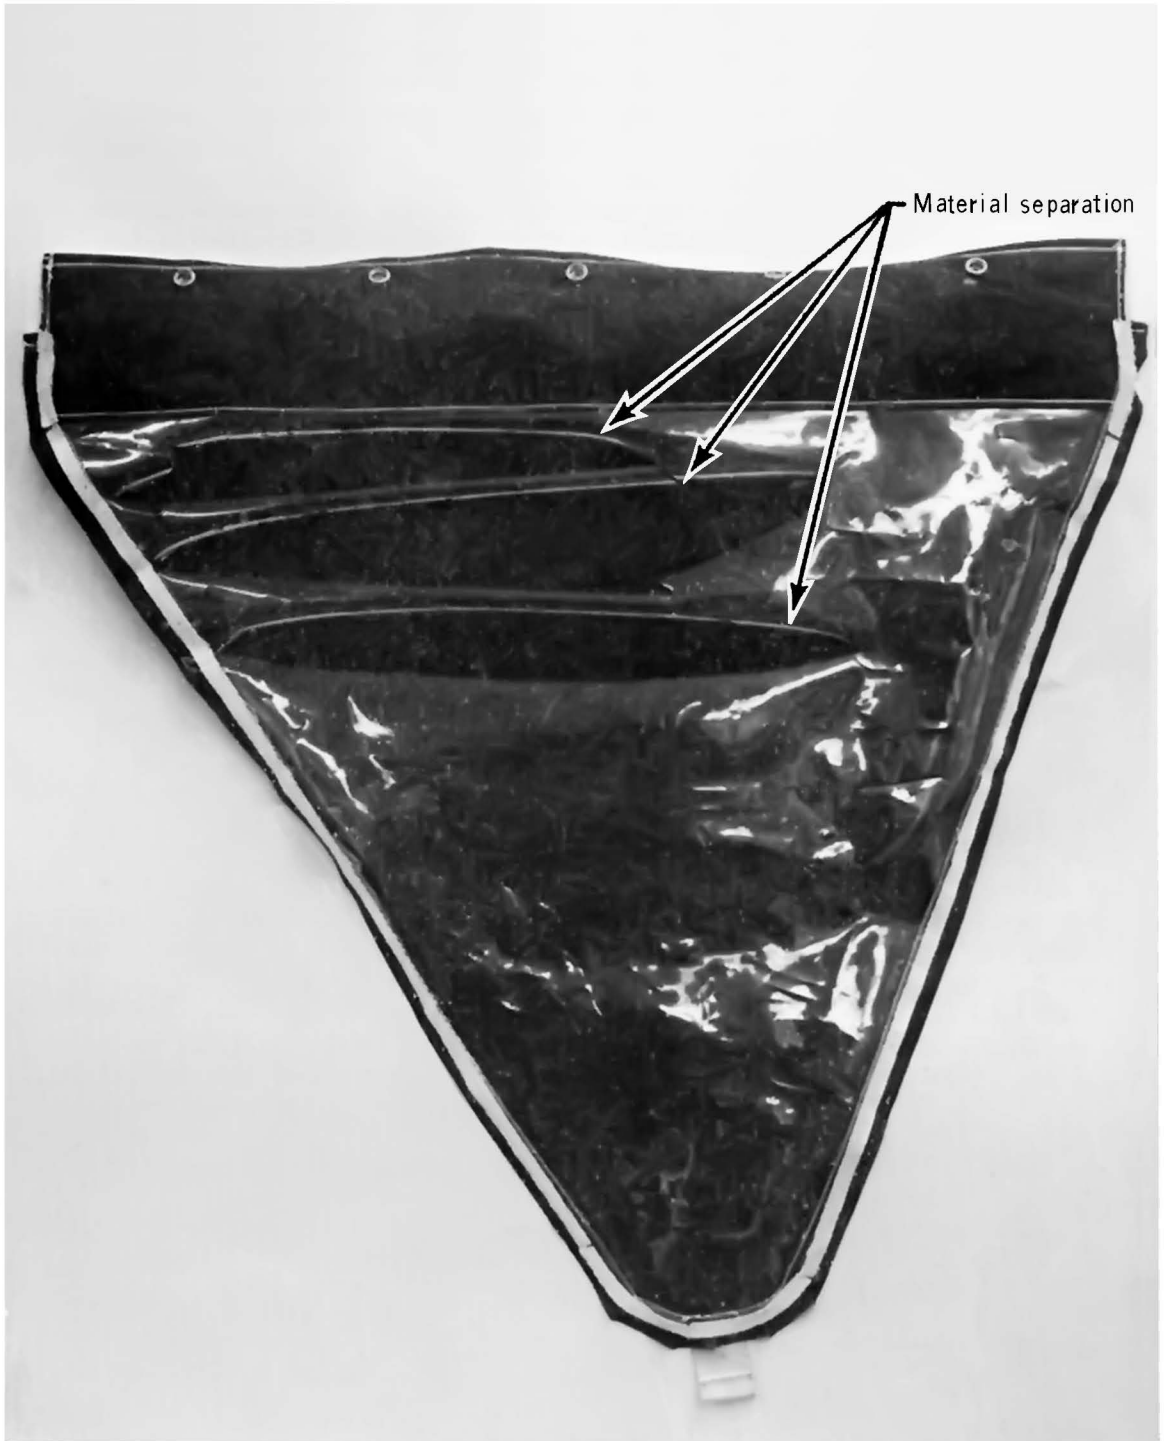
Figure 15.- Cracked left-hand window shade.

The left-hand window shade showed three large cracks when it was first placed in the stowed position during flight (fig. 15).

Cracking as a result of embrittlement of the shades has been previously identified as a problem. The manufacturer had reprocessed the shades by reheating and quenching to obtain an acceptable configuration. Prior to flight, a set of the new shades were available for the Apollo 13 spacecraft if they were needed. The shades already installed were examined visually for cracks, cycled ten times each, and reexamined. No indication of cracks was found, and these shades were subsequently used for flight.

Inflight examination of the cracked shade indicated that the three cracks, which extended 80 percent of the distance across and in the upper left 40 percent portion, propagated from sewing stitch holes on the periphery of the shade. Close examination of these holes indicated that short cracks, 1/8-inch long or less, extended from more than 80 percent of the stitch holes in a direction parallel with the curl axis of the shade. The

shades are heat formed into a curl so that any crack parallel with the curl axis would tend to "self-extend" when the shade was deployed, or uncurled. In effect, the material would be stress relieving itself through cracking.

A failure analysis has indicated the cracks are caused by excessive brittleness and can be controlled by proper heating and quenching to give a more ductile material.

The process to produce an acceptable shade with a ductility in excess of 25 percent is being developed by the supplier. New shades employing the more ductile material will be manufactured using techniques that preclude sewing directly onto the Aclar material. The shades will be subjected to a design verification test that will include complete mission simulation of thermal vacuum cycling. A design verification test will be performed.
